# Inspection Photos

API: 05-067-08171

Operator: HILCORP ENERGY COMPANY

Inspection Date: 4/12/2018

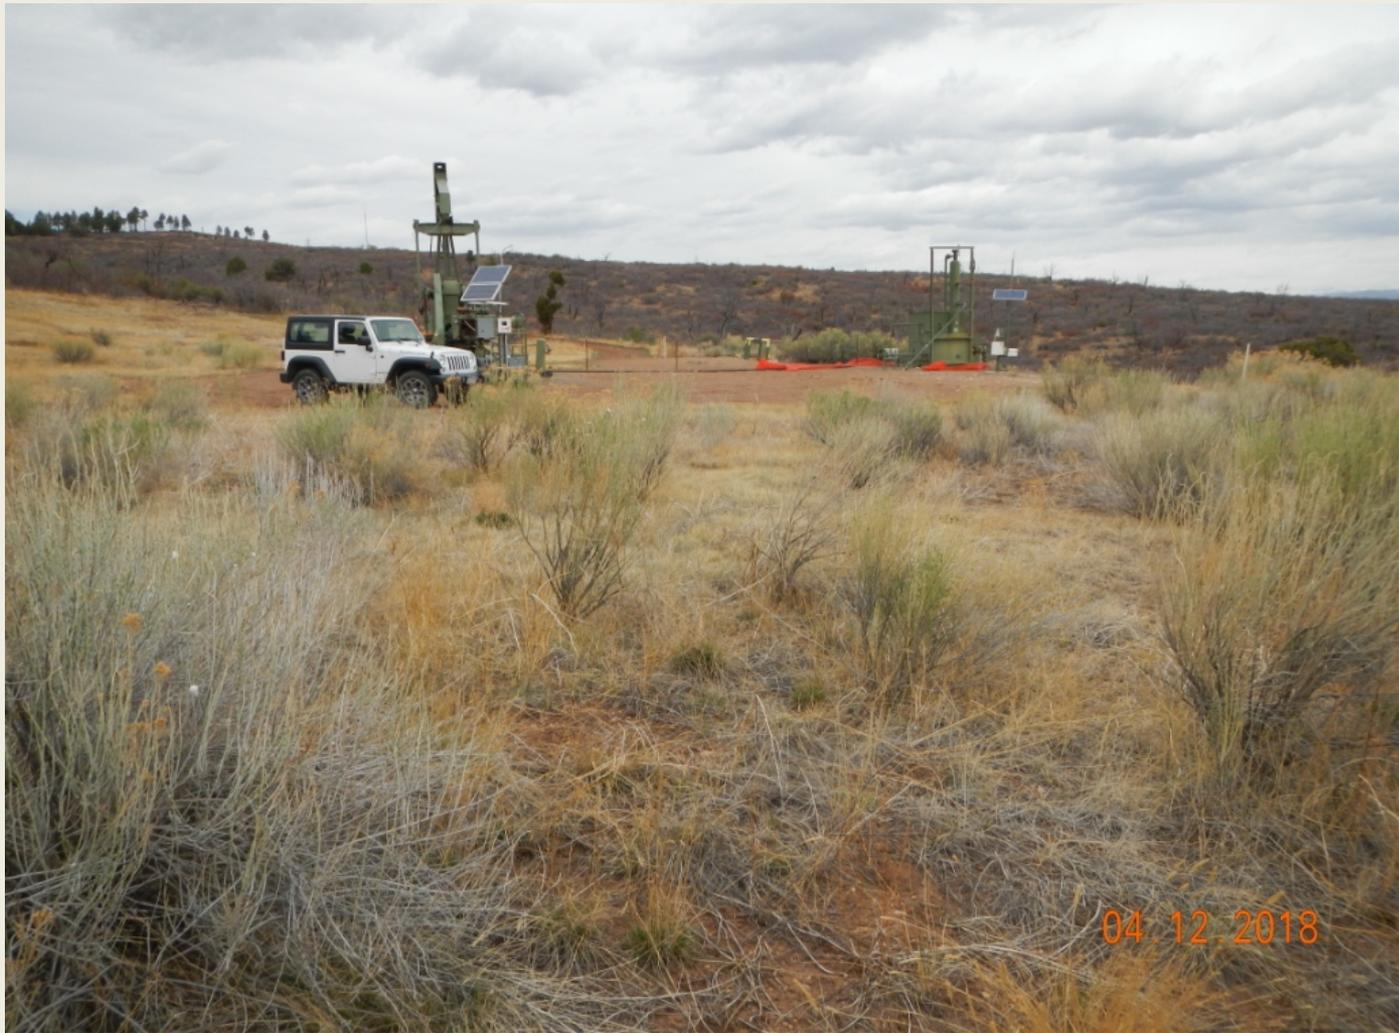
**Photo 1. View of the project area from the southeastern corner facing center.**

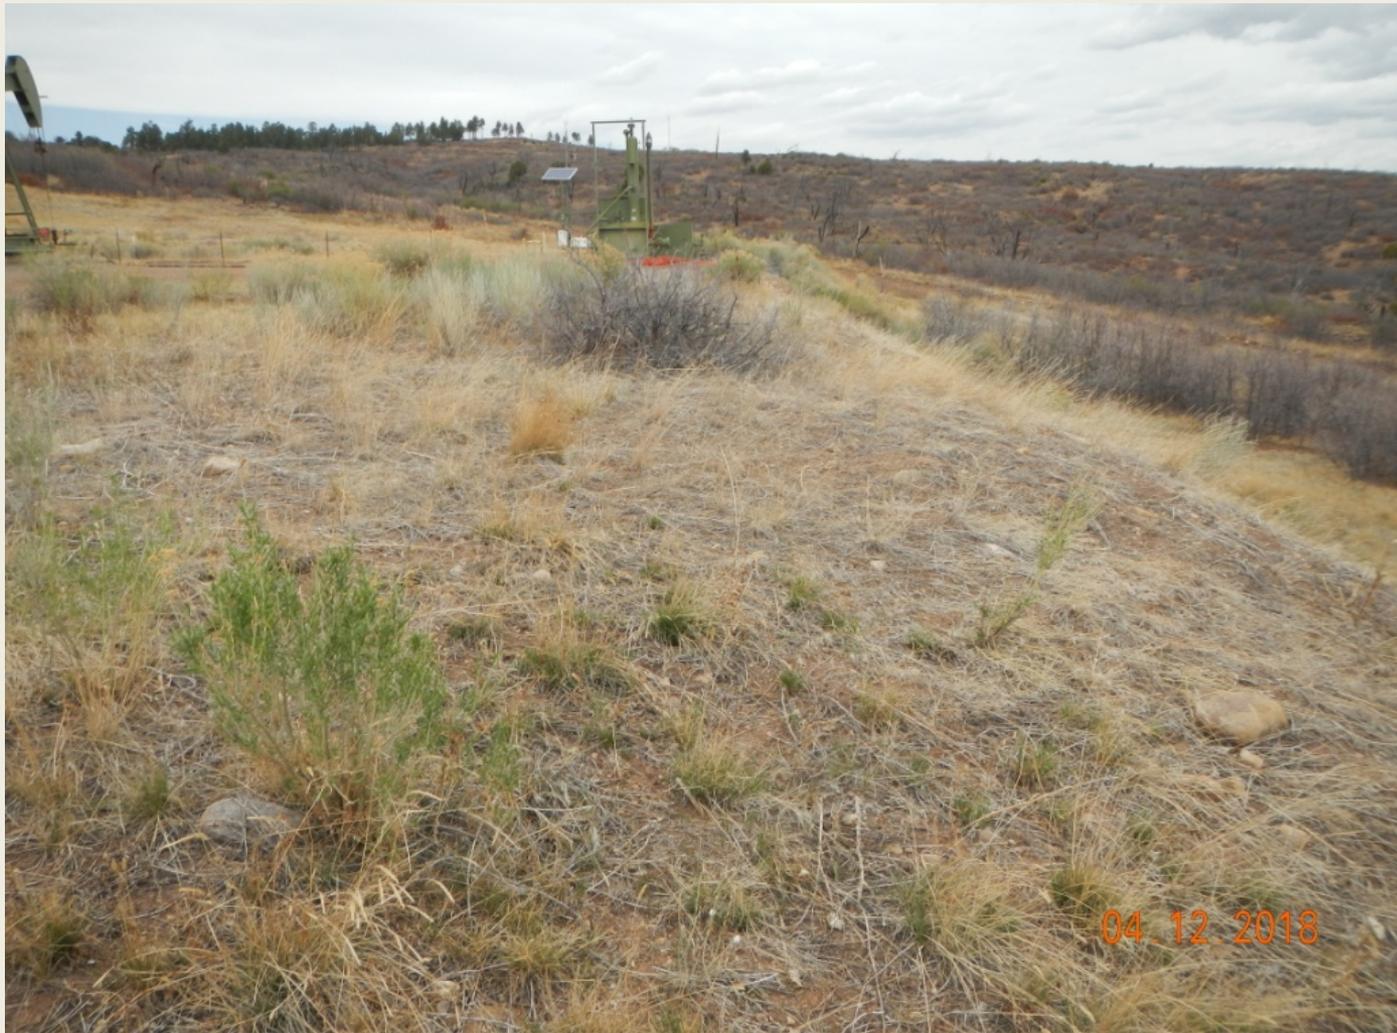
**Photo 2. View of the eastern portion of the project area from the southeastern corner facing northward. Revegetation is progressing, largely with western wheatgrass (*Pascopyrum smithii*), crested wheatgrass (*Agropyron cristatum*), and rubber rabbitbrush (*Chrysothamnus nauseosus*).**

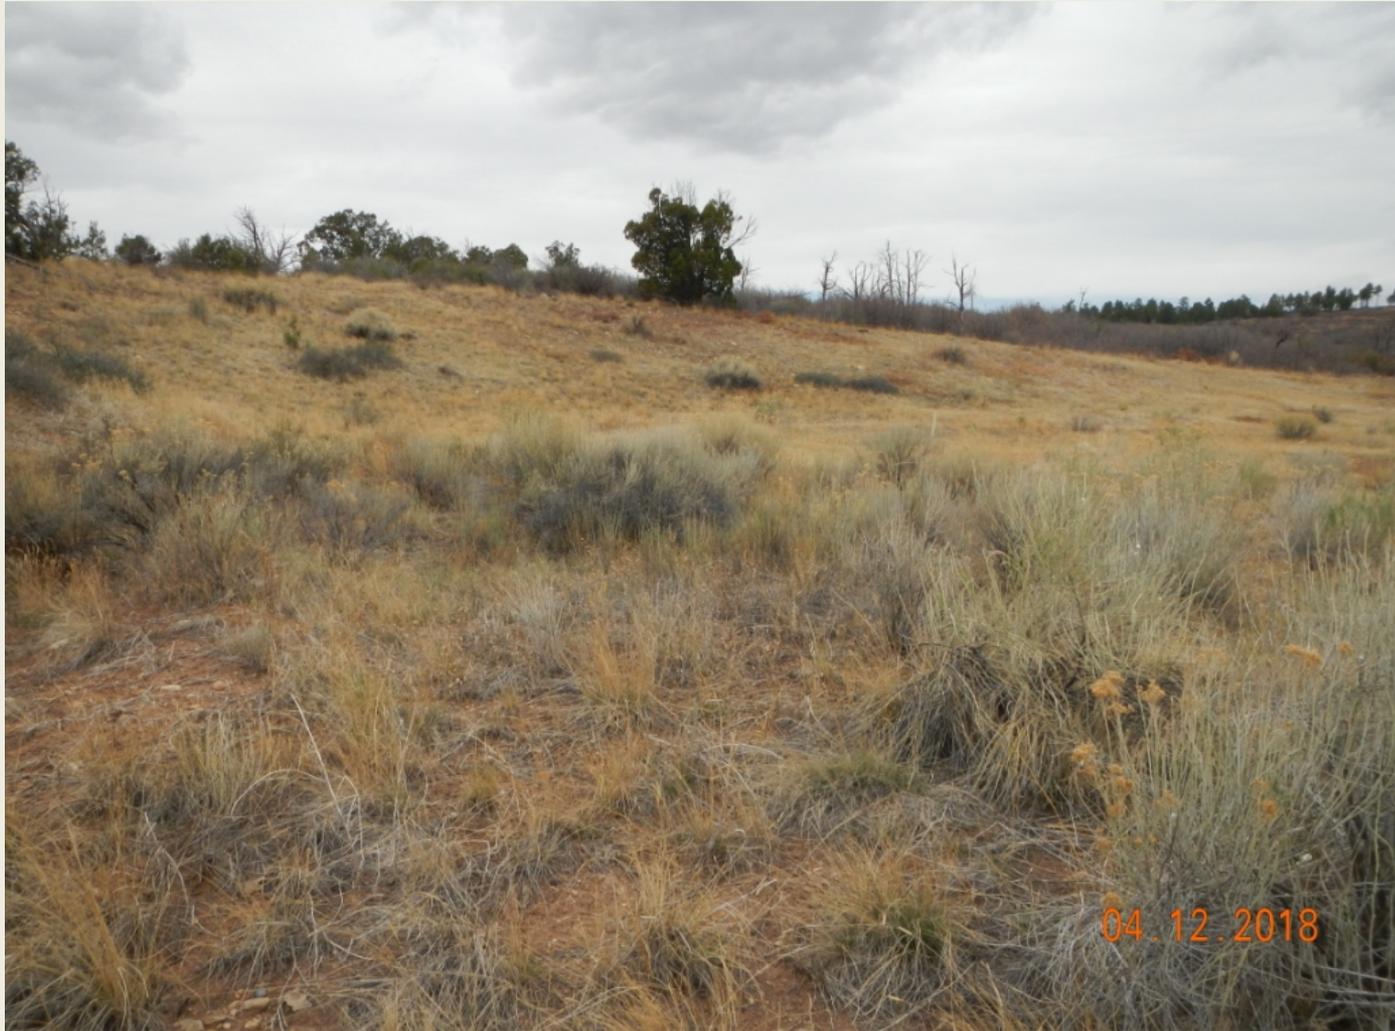
**Photo 3. View of the western portion of the project area from the southern portion facing northwestward.**

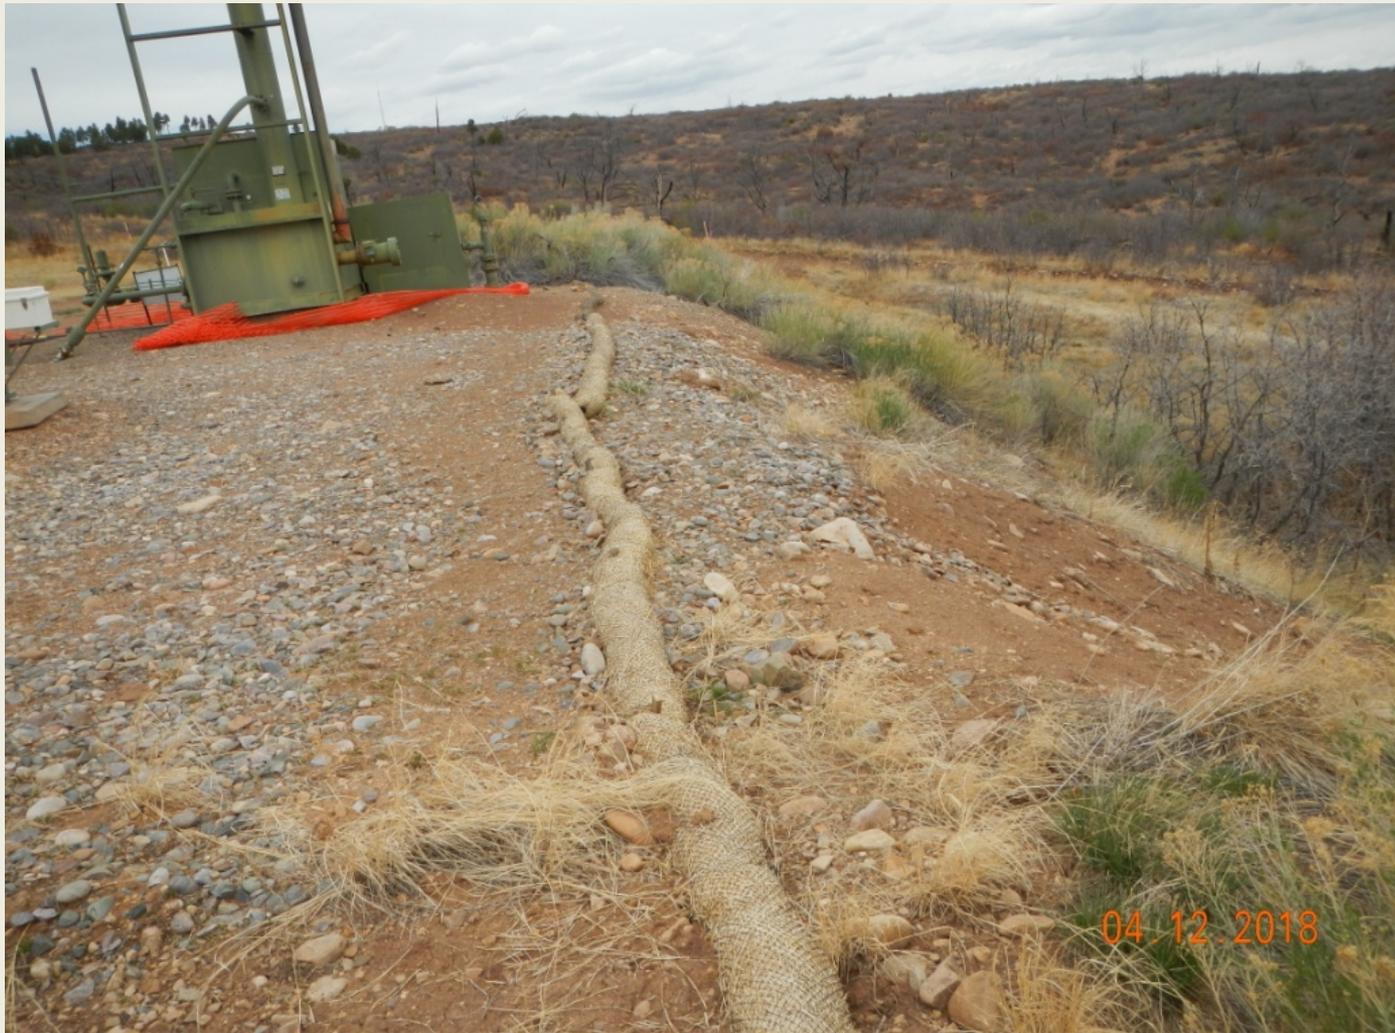
**Photo 4. View of wattles on the eastern edge of the working area. This is a temporary stormwater control and will need careful monitoring and maintenance as needed.**

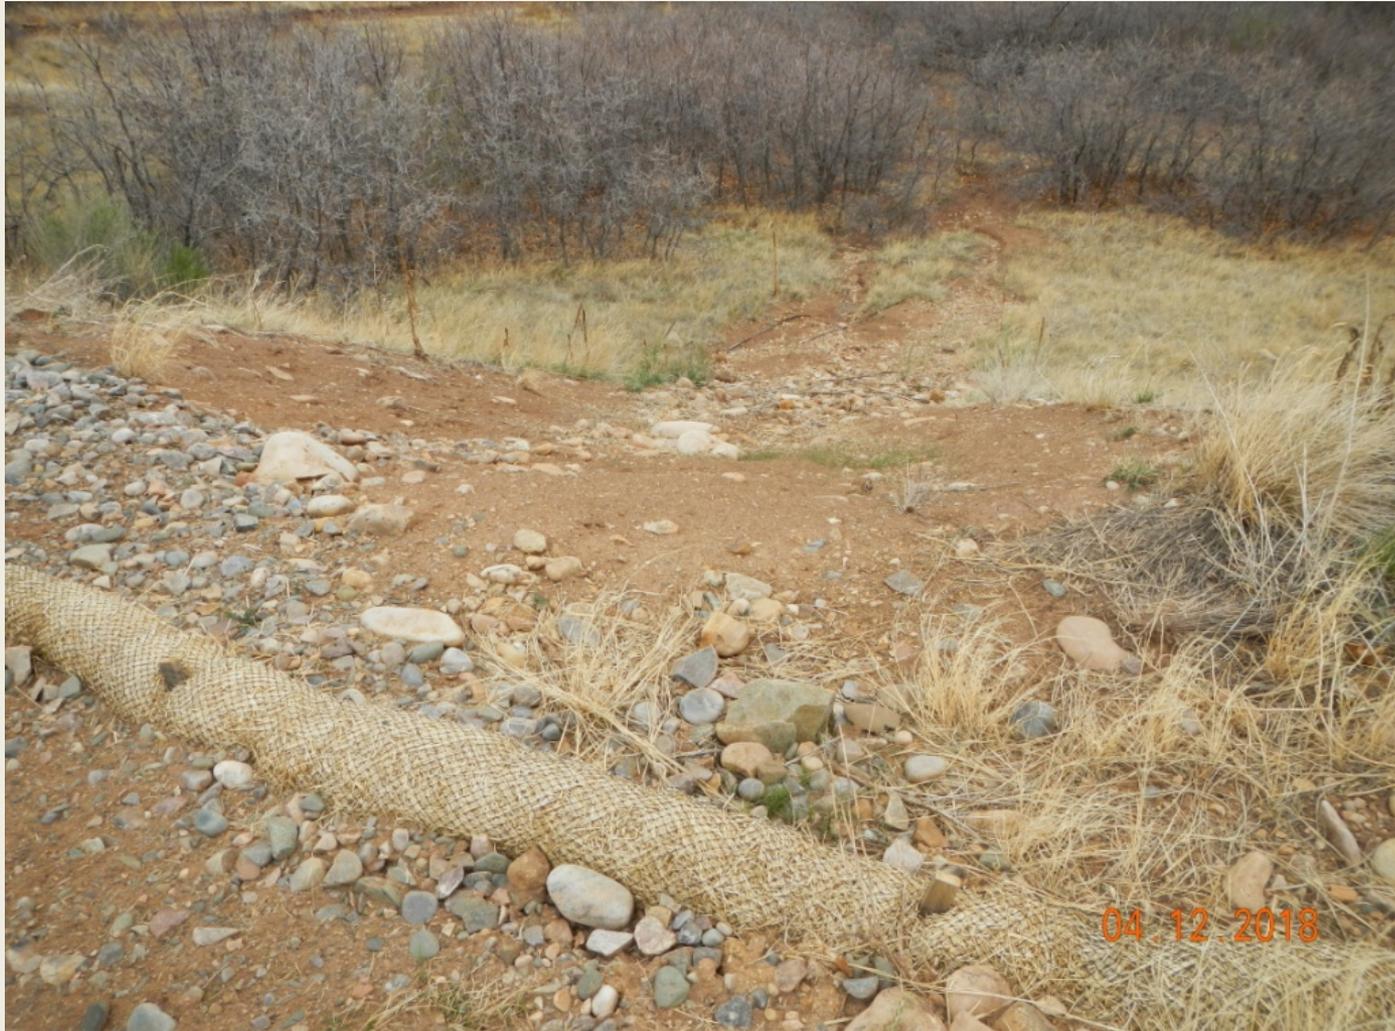
**Photo 5. View of area in eastern project area with exposed soils, appears to be disturbed for erosion control and needs re-seeding/stabilization measures.**

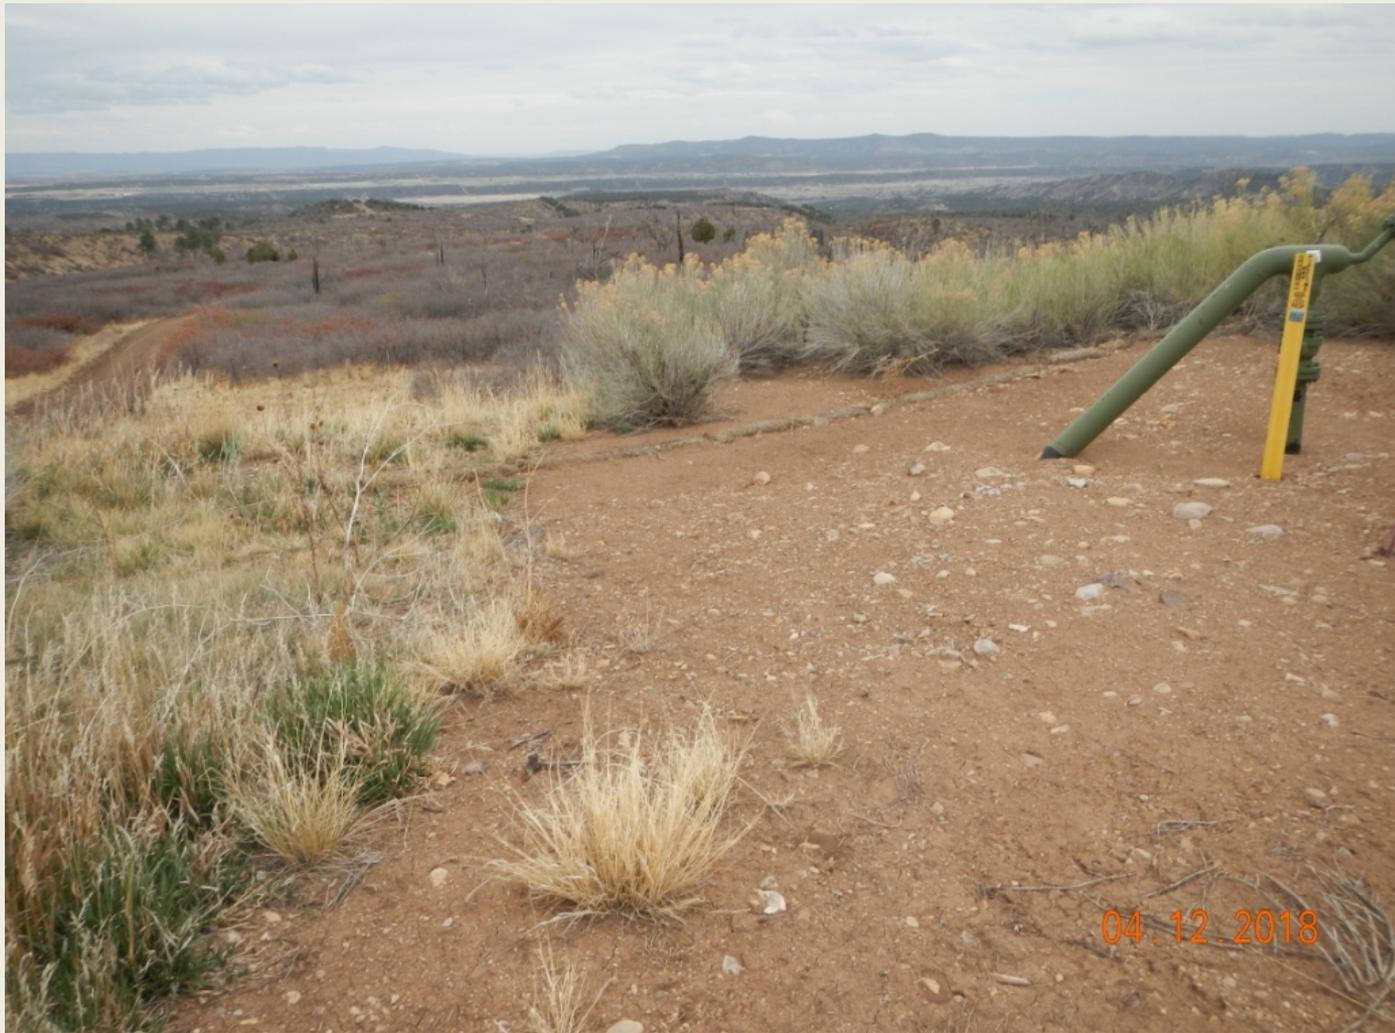
**Photo 6. View of wattles in the northeastern edge of the project area that are full of sediment and need maintenance.**

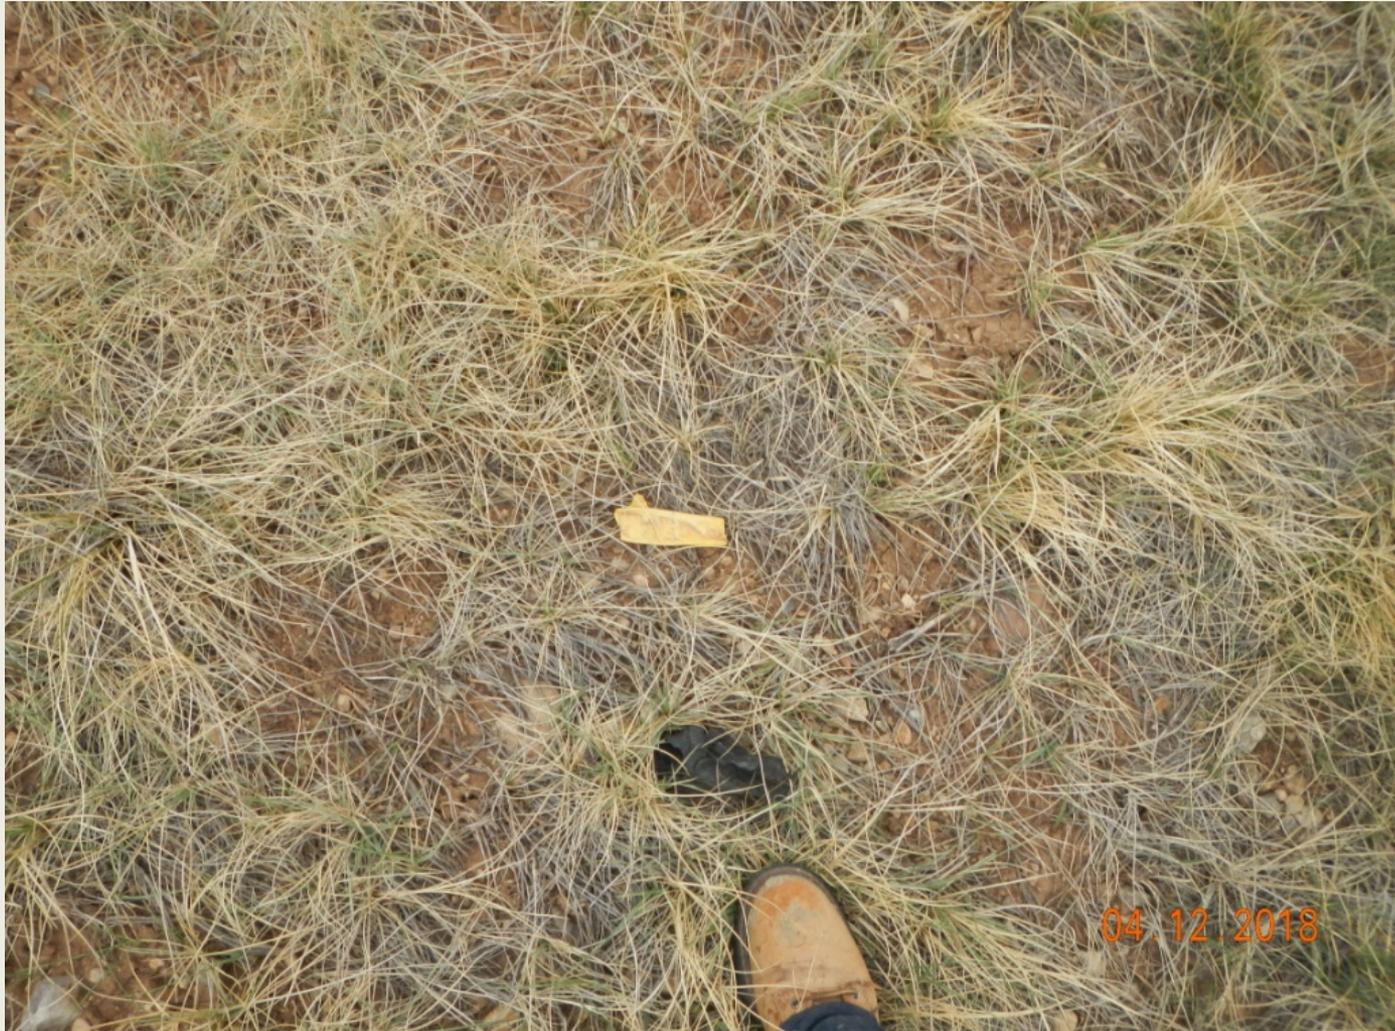
**Photo 7. View of an example of portion of liner material in project area. Several of these are present on the well pad and within the interim reclamation area.**
