# Inspection Photos

API: 05-067-08640

Operator: HILCORP ENERGY COMPANY

Inspection Date: 4/12/2018

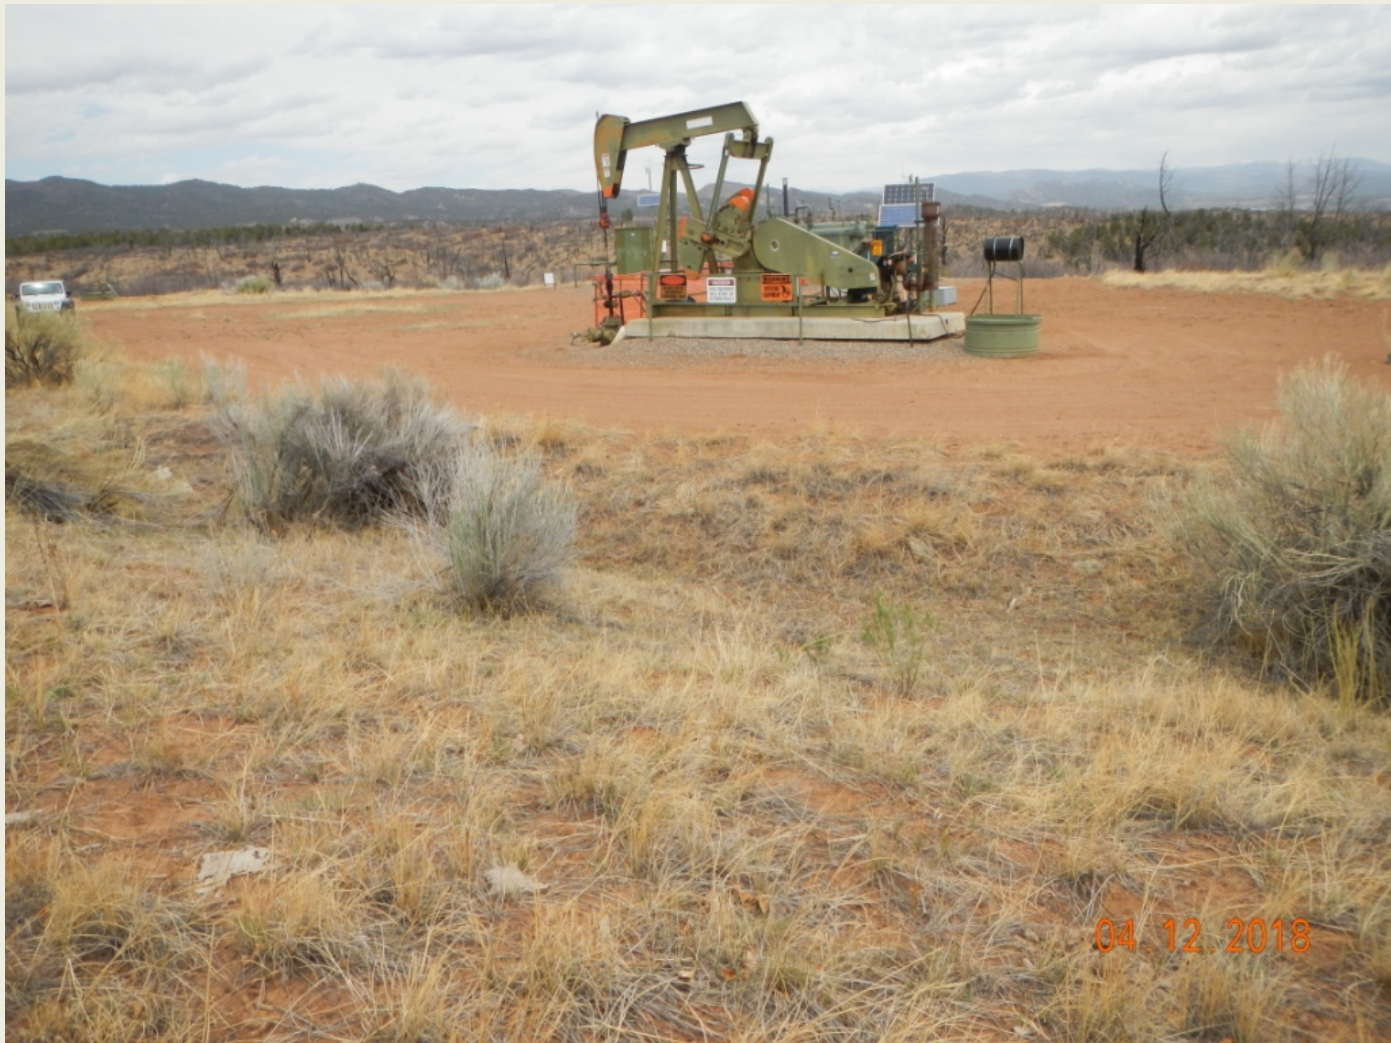
**Photo 1. View of the project area from the southwestern corner facing center.**

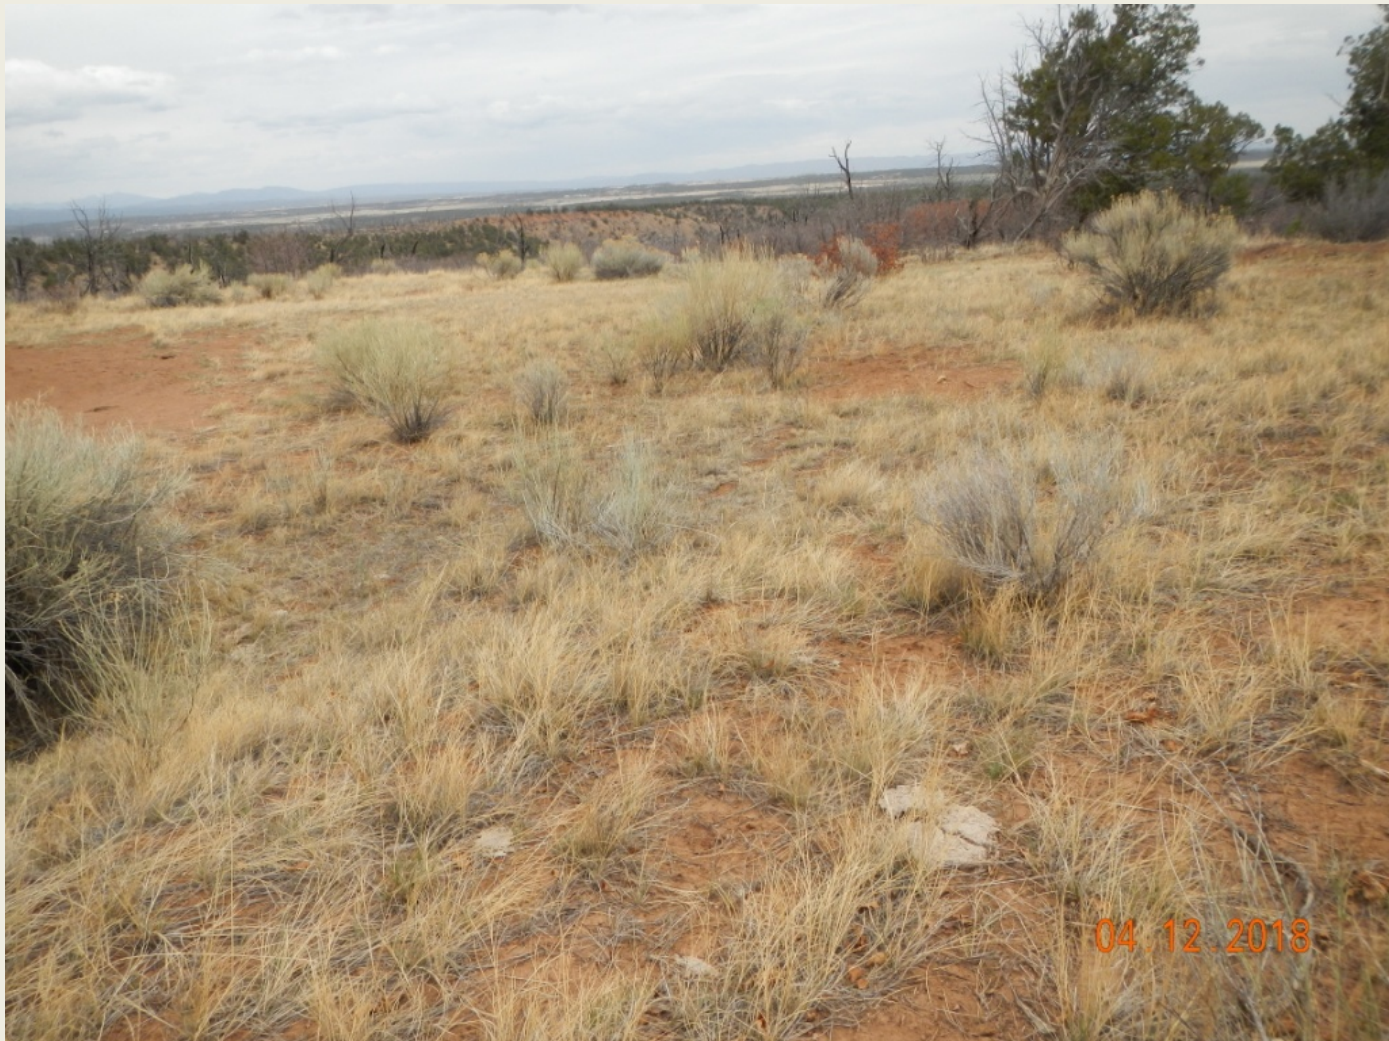
**Photo 2. View of the southern portion of the project area from the southwestern corner facing eastward. Revegetation is progressing, largely with western wheatgrass (*Pascopyrum smithii*), crested wheatgrass (*Agropyron cristatum*), and rubber rabbitbrush (*Chrysothamnus nauseosus*).**

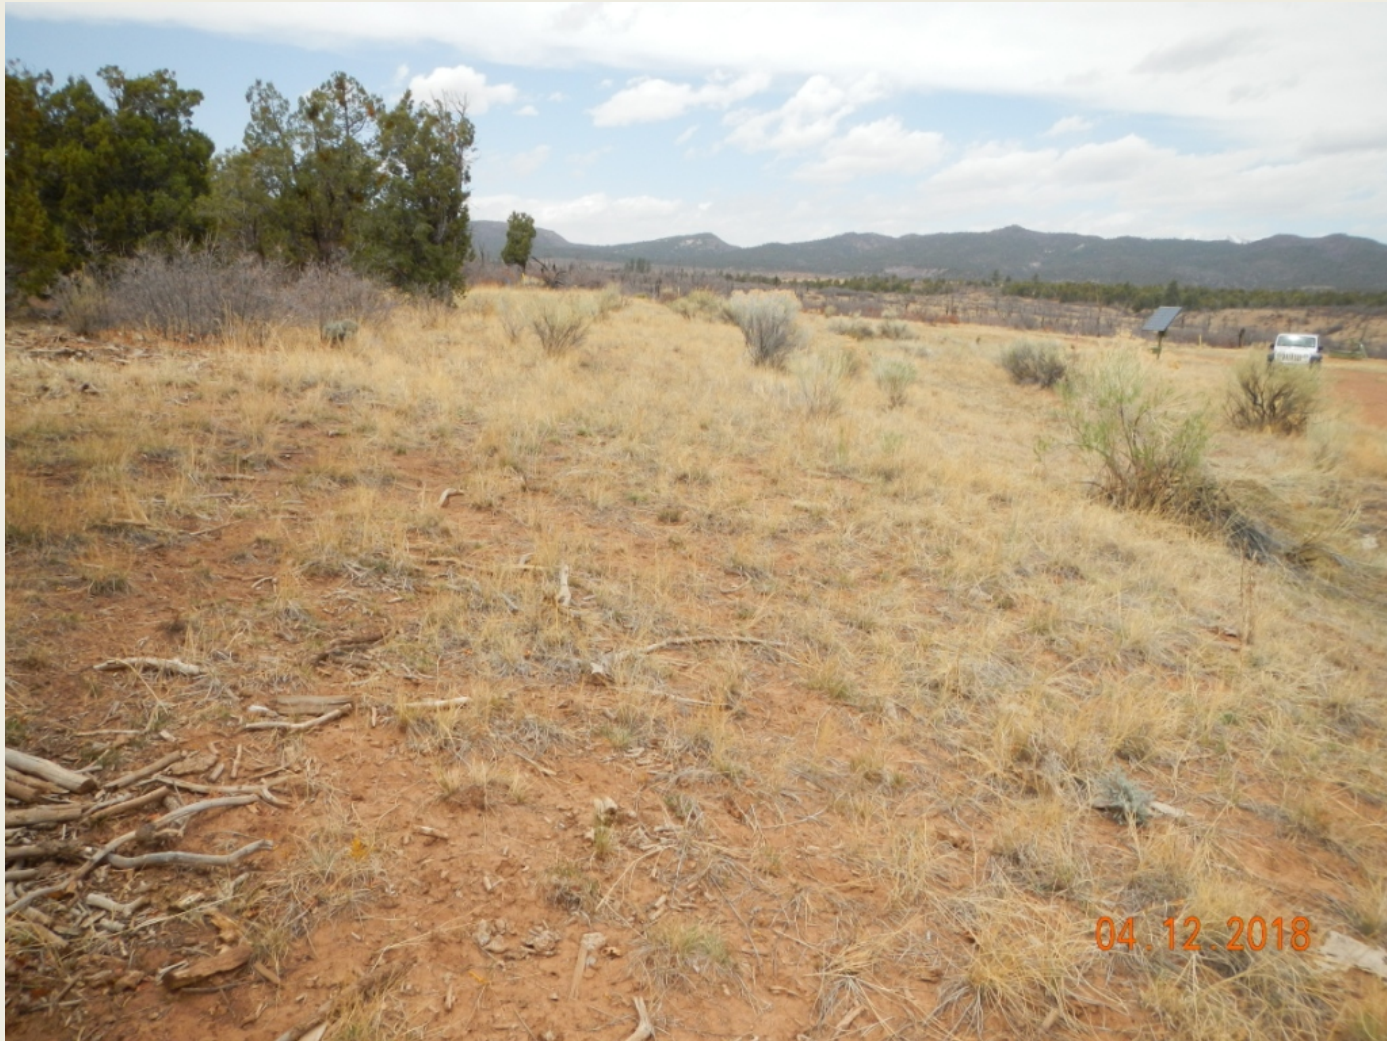
**Photo 3. View of the western portion of the project area from the southwestern portion facing northward.**

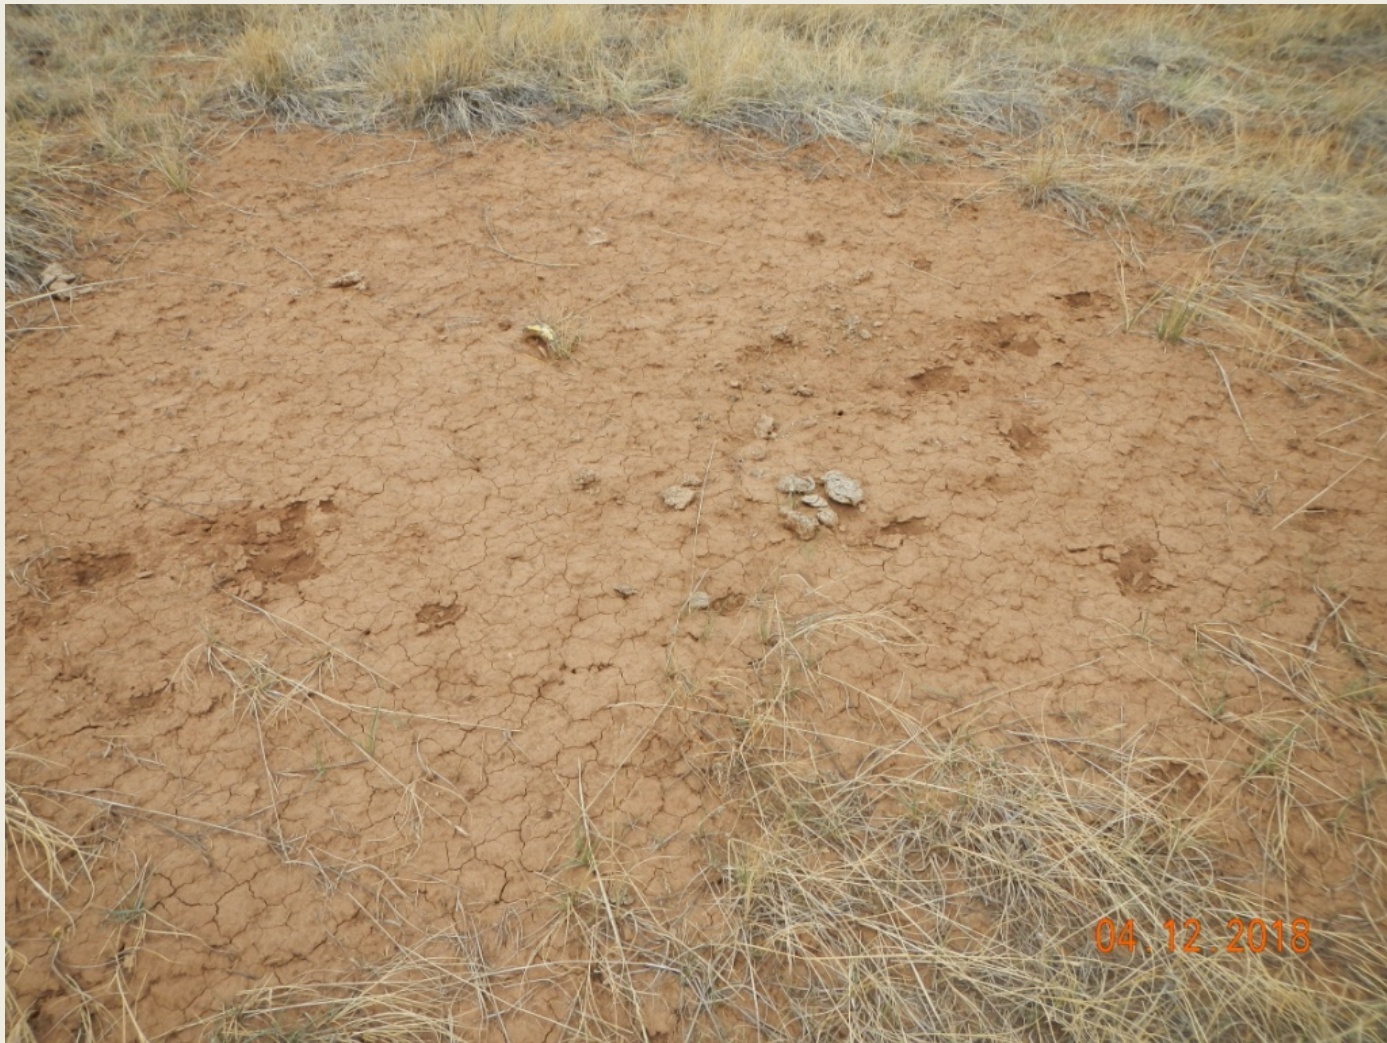
**Photo 4. View of unmarked rig anchor within the interim reclamation area.**

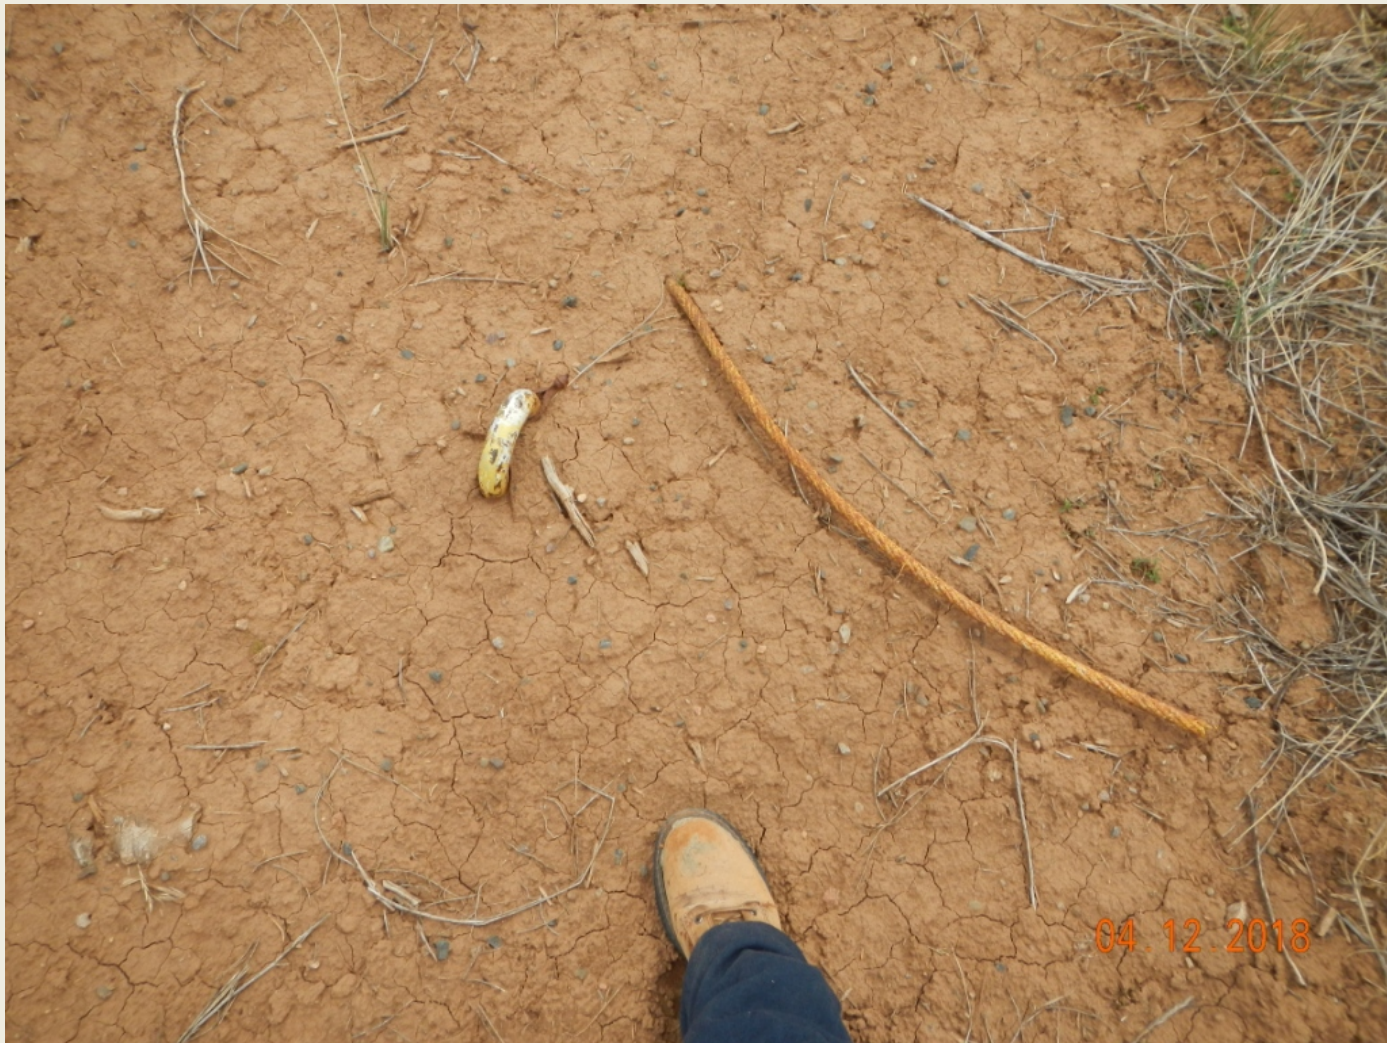
**Photo 5. View of another unmarked rig anchor within the project area.**

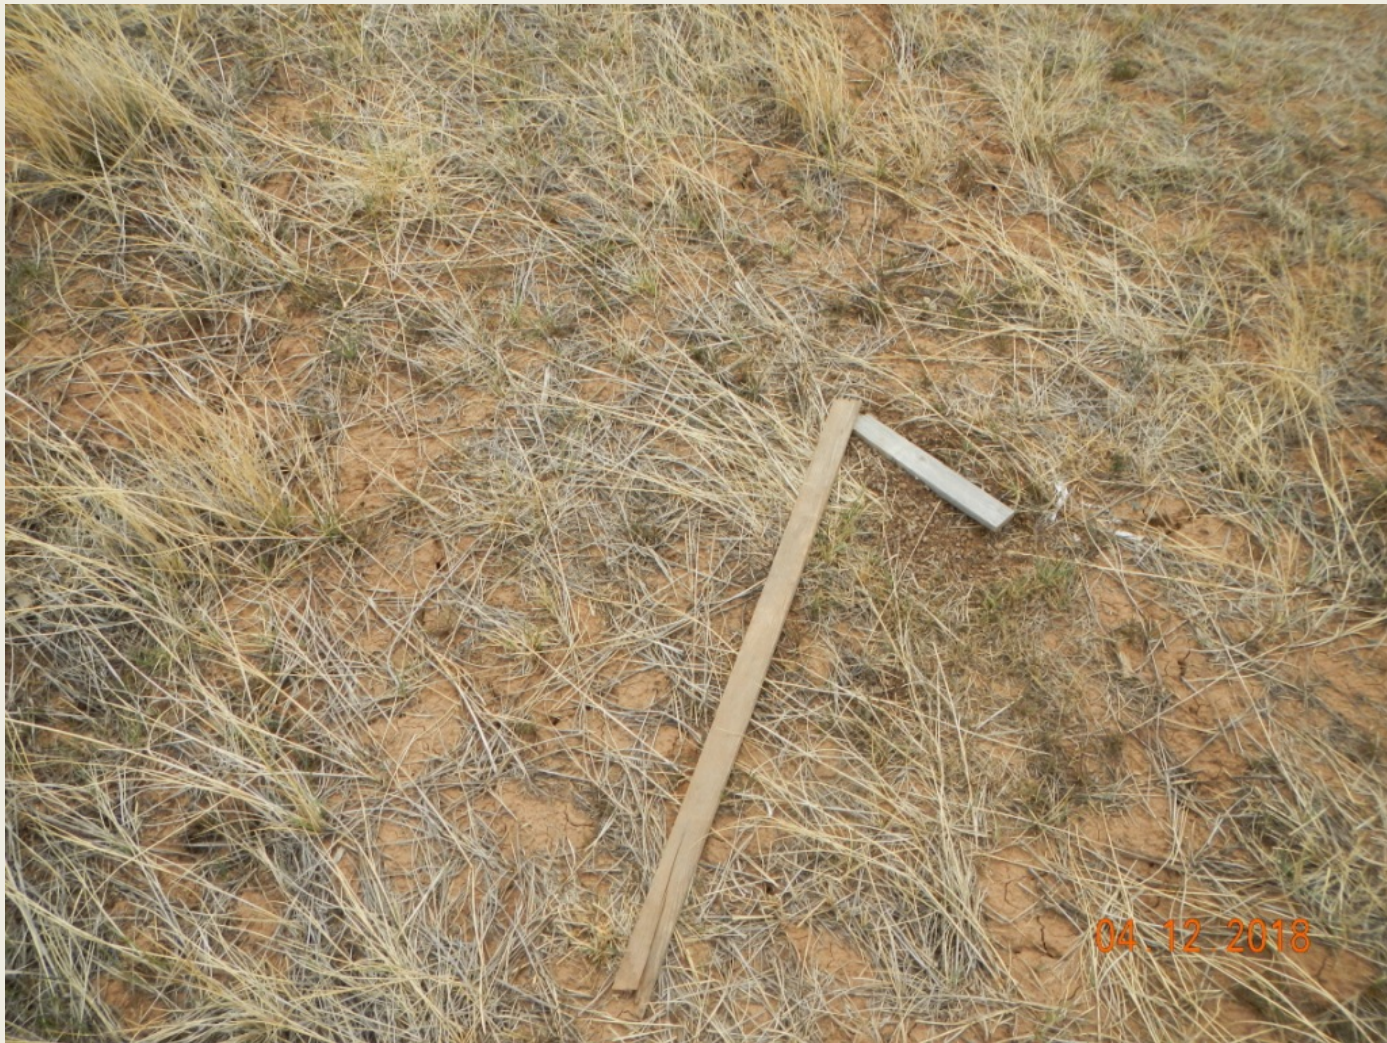
**Photo 6. View of wood debris within the interim reclamation area. Wood, liner debris, and small pieces of trash observed throughout the project area.**

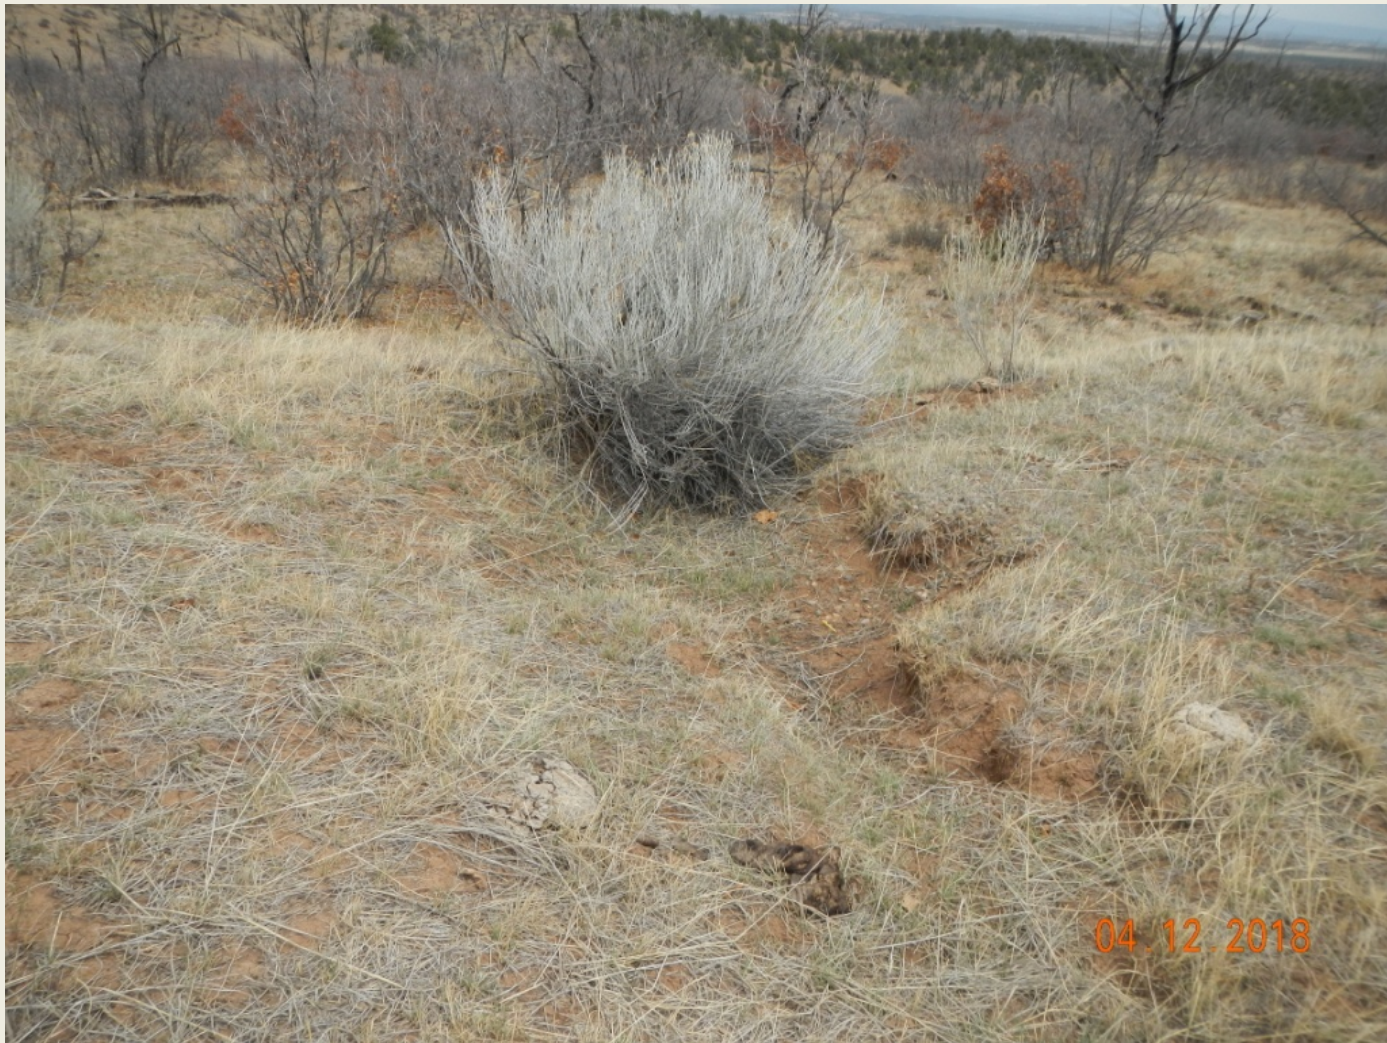
**Photo 7. View of head-cut and erosional channel forming within the northeastern portion of the project area.**

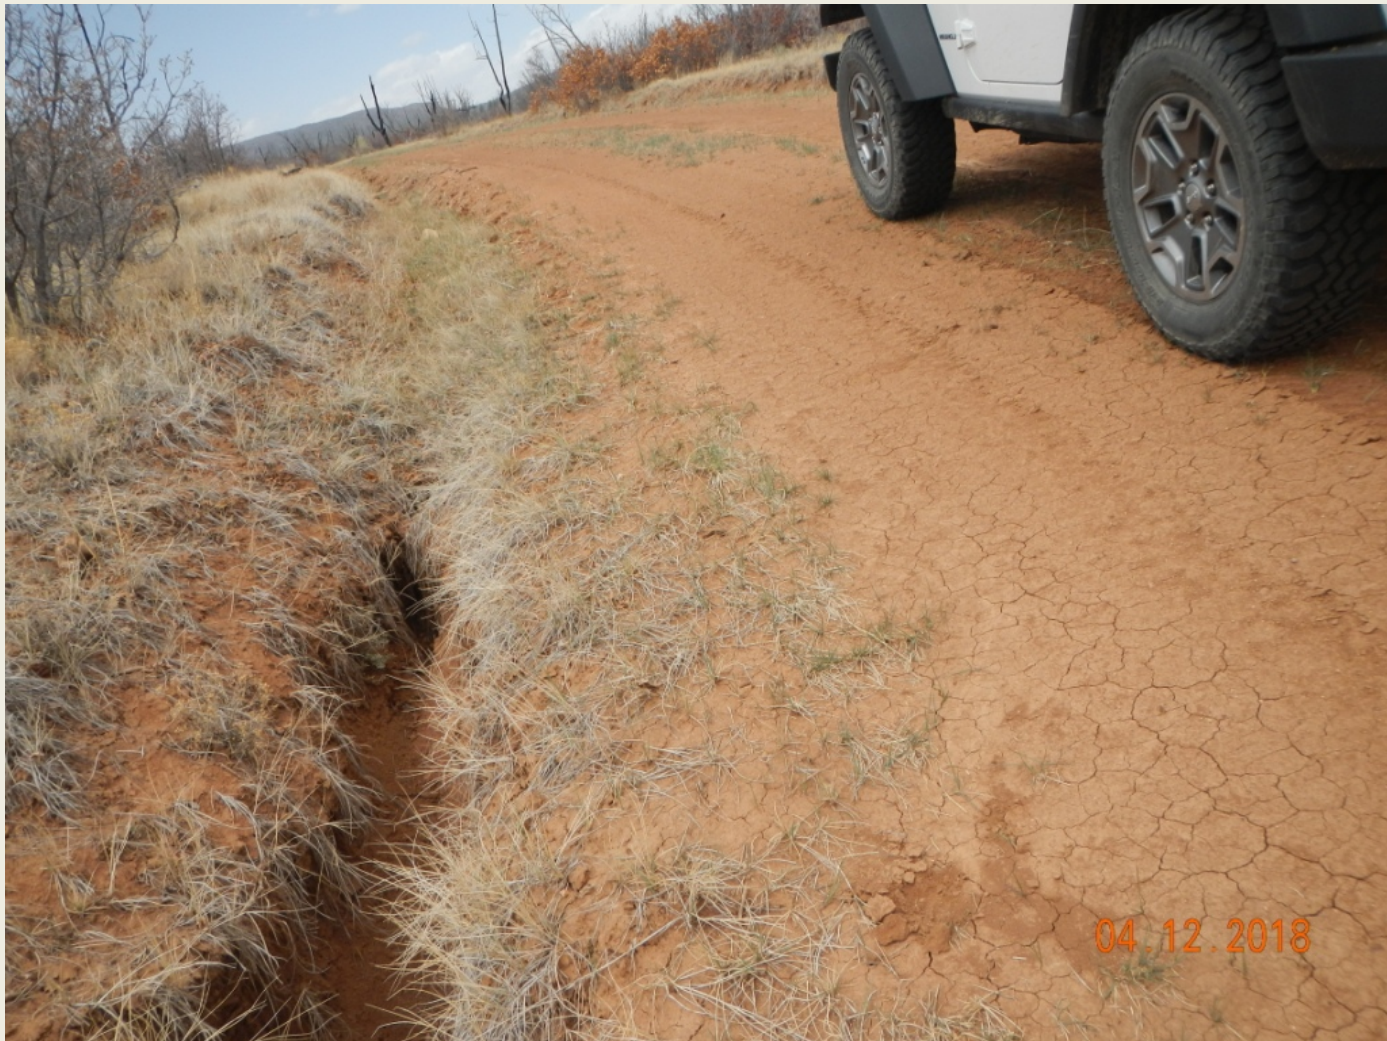
**Photo 8. View of head-cut and erosional channel forming along the access road, up to 1.5 feet deep.**
