GOLDEN EAGLE MINE NW-3-6-95 API# 05-071-06405 – TIMBER CREEK  
OGCC OPERATOR NUMBER 10672 – INSPECTION DATE: APRIL 26, 2018  
CORRECTIVE ACTIONS COMPLETED REGARDING COGCC FIR DOCUMENT # 680102757

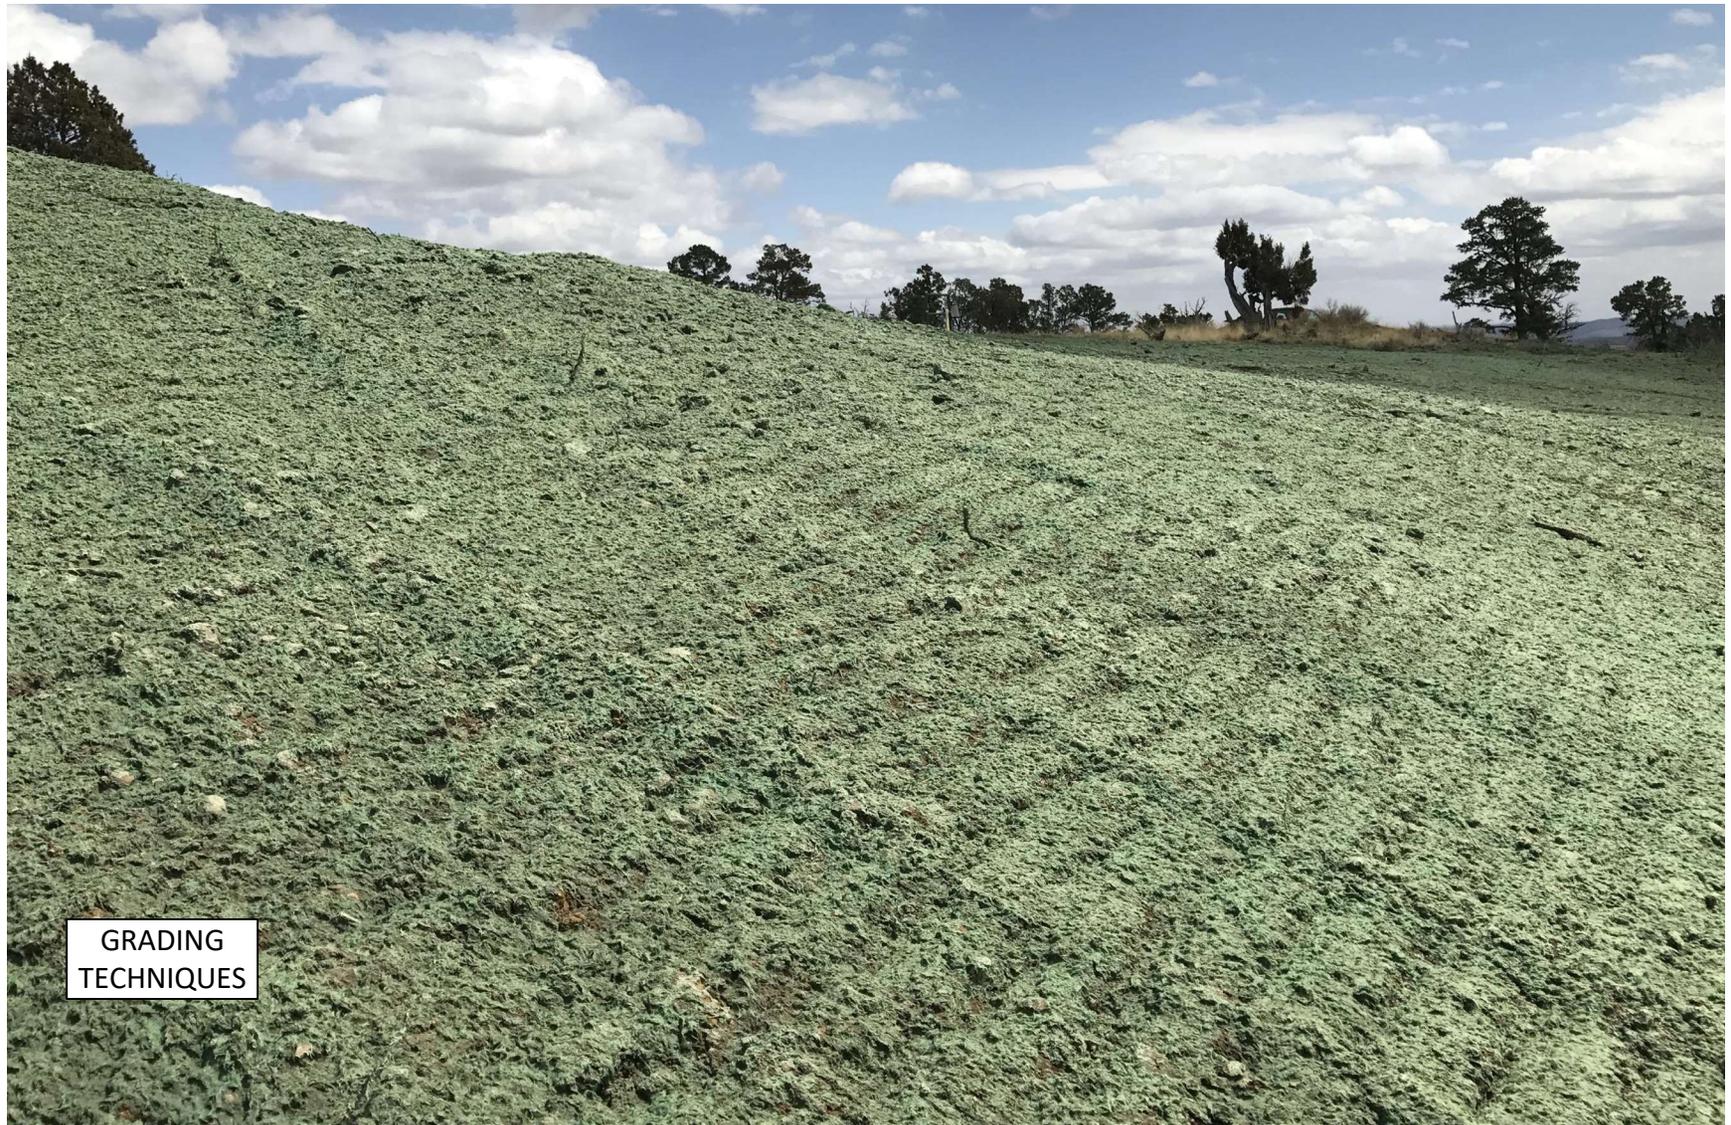
PHOTO 3 : GOLDEN EAGLE MINE NW-3-6-95 RECLAMATION FACING EAST.

GRADING  
TECHNIQUES

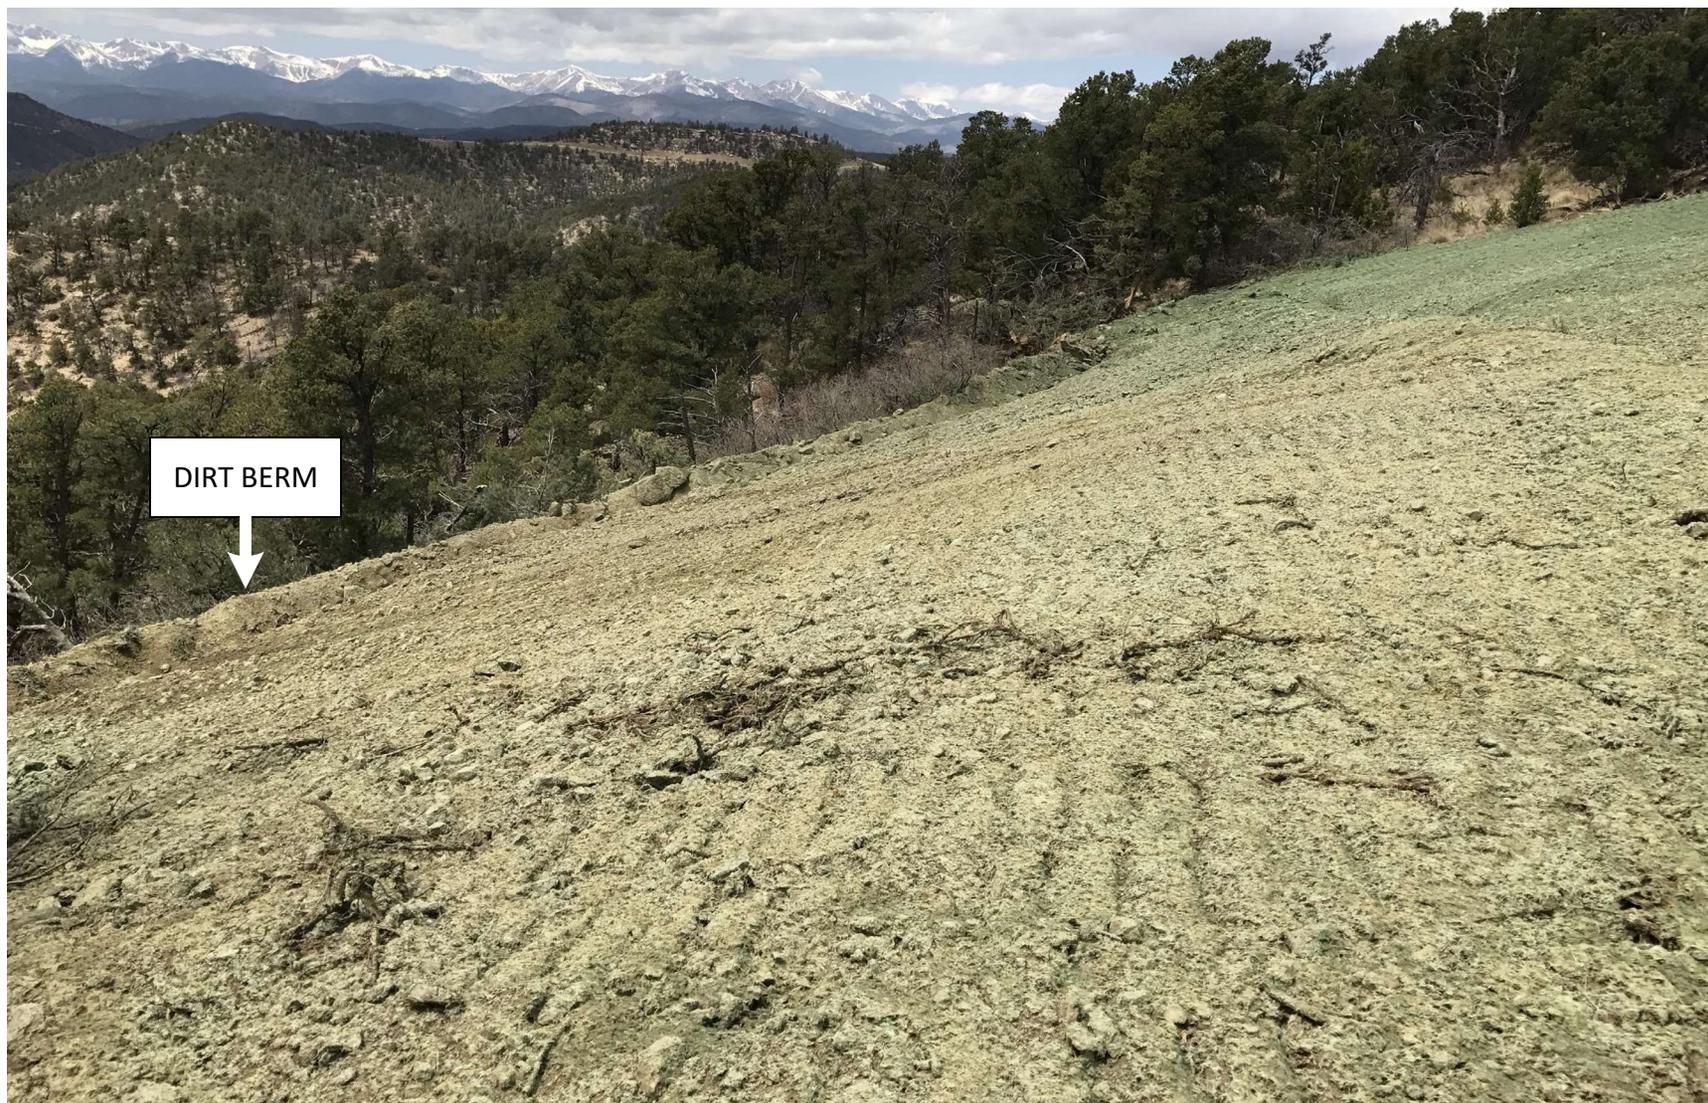
PHOTO 4 : GOLDEN EAGLE MINE NW-3-6-95 RECLAMATION FACING WEST. VIEW OF RECLAIMED FILL SLOPE.
