Construction and Stormwater Inspection

Operator: KERR MCGEE OIL & GAS ONSHORE LP #47120

Location ID: 454520

Inspection Photos
Location Name: ENGLISH FARMS /8-10HZ
Location ID: 454520

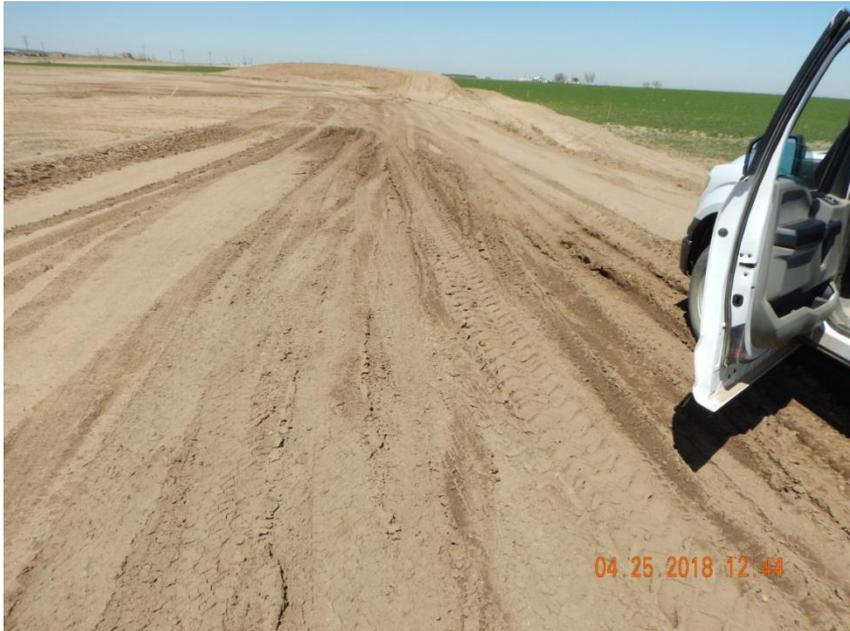
Photo 1. Photo taken from the entrance of the location, facing North. Operator has failed to install a vehicle tracking device to prevent track of material offsite.

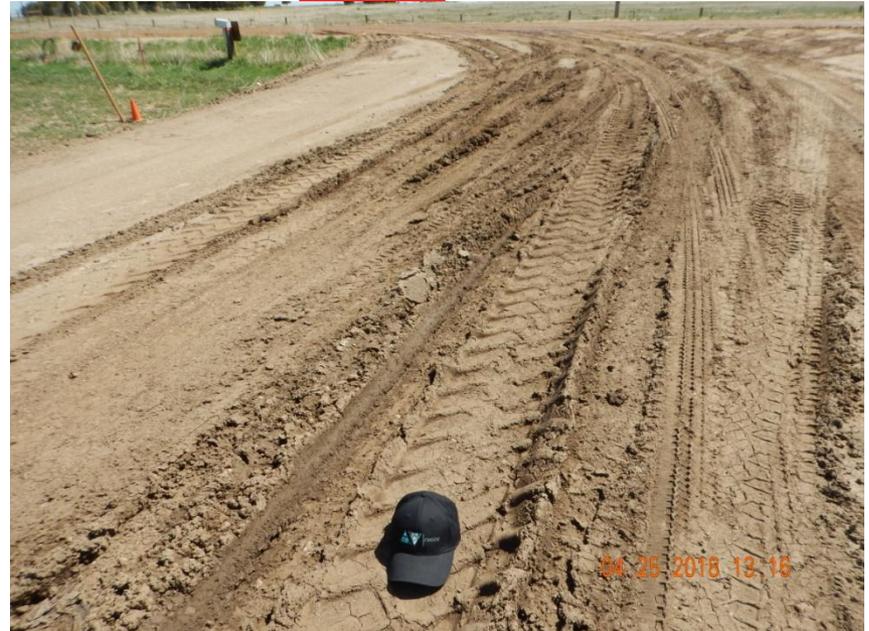
Photo 2. Photo taken from the entrance of the location, facing South. See comments under Photo 1.

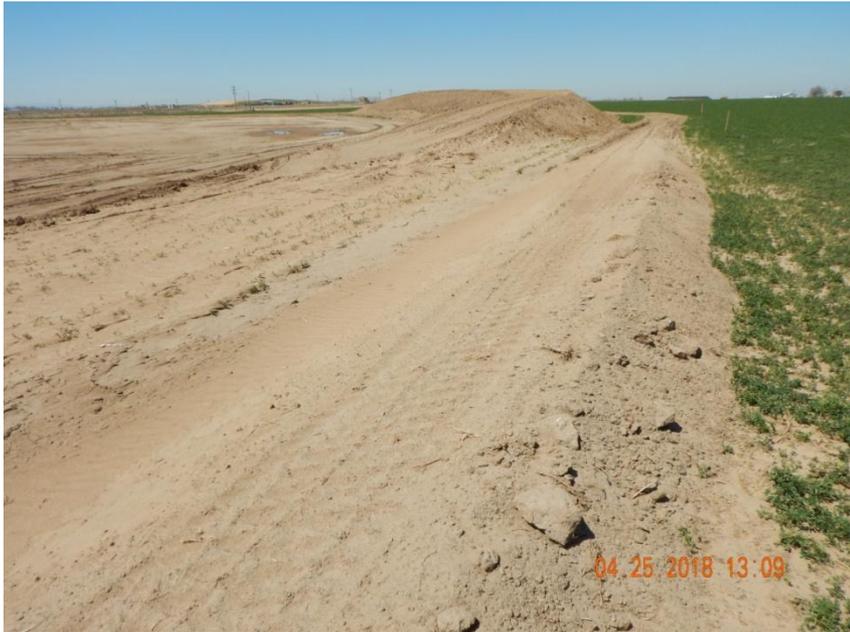
Photo 3. Photo taken from the eastern perimeter of the location, facing North. Ditch and berm BMP has been installed along the entire perimeter of the location. Portions of the berm do not appear to be stabilized. An unconsolidated berm BMP is not a proper functioning BMP. Photo also illustrates ditch BMP filling up with fines from unconsolidated soil material from the well pad. Appears topsoil is being stored along the northeastern and southwestern perimeter of the location.

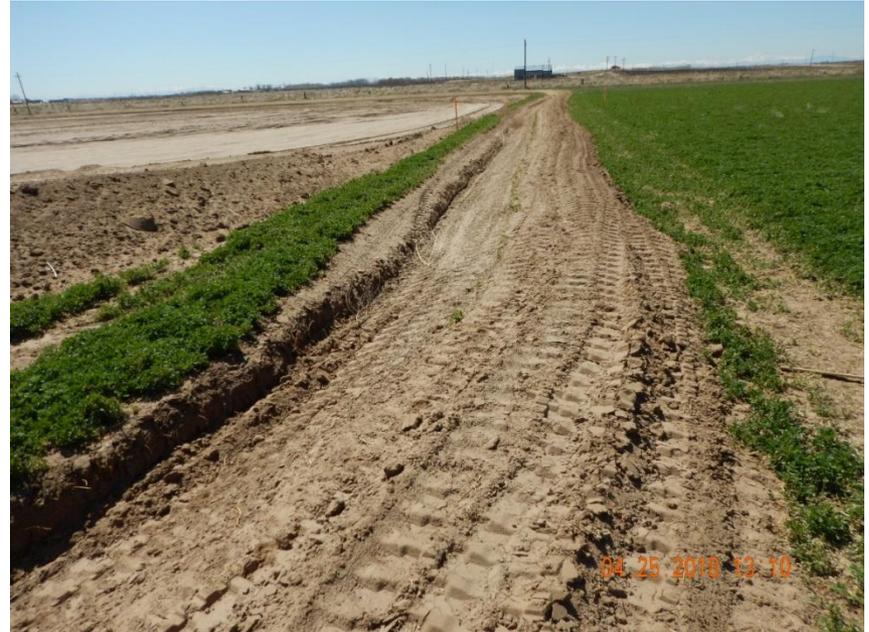
Photo 4. Photo taken from the northeast perimeter of the location, facing West. See comments under Photo 3.

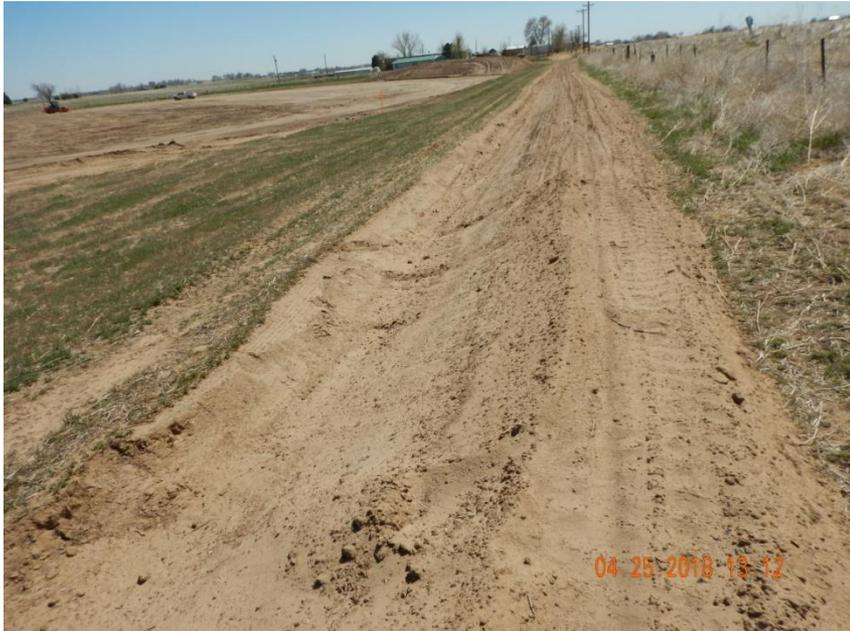
Photo 5. Photo taken from the northwest perimeter of the location, facing South. See comments under Photo 3.

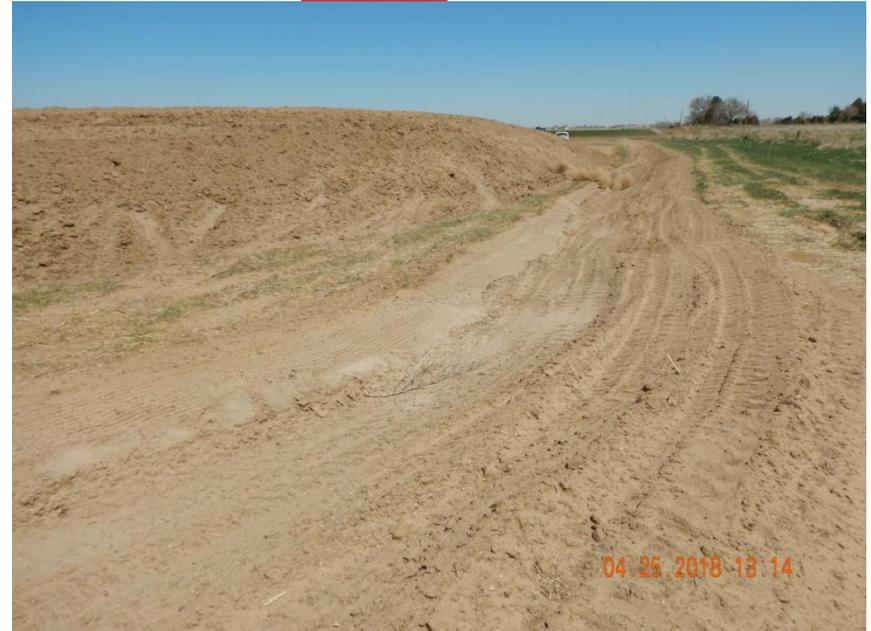
Photo 6. Photo taken from the southwest perimeter of the location, facing East. See comments under Photo 3.

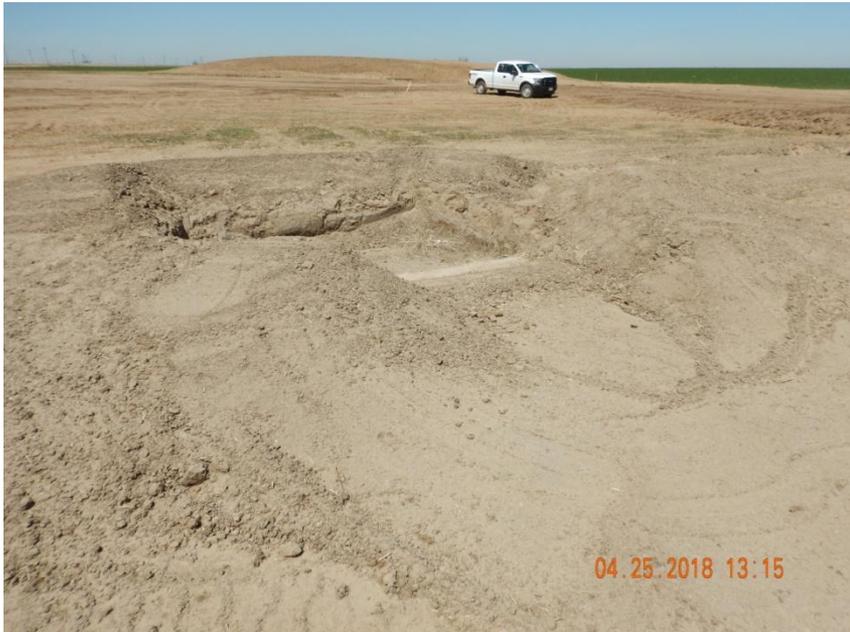
Photo 7. Photo taken from the southern perimeter of the location, facing North. Sediment trap is in-process of being constructed.
