Inspection Photo
Dunn 16
API# 045-07041
Inspection # 689301002

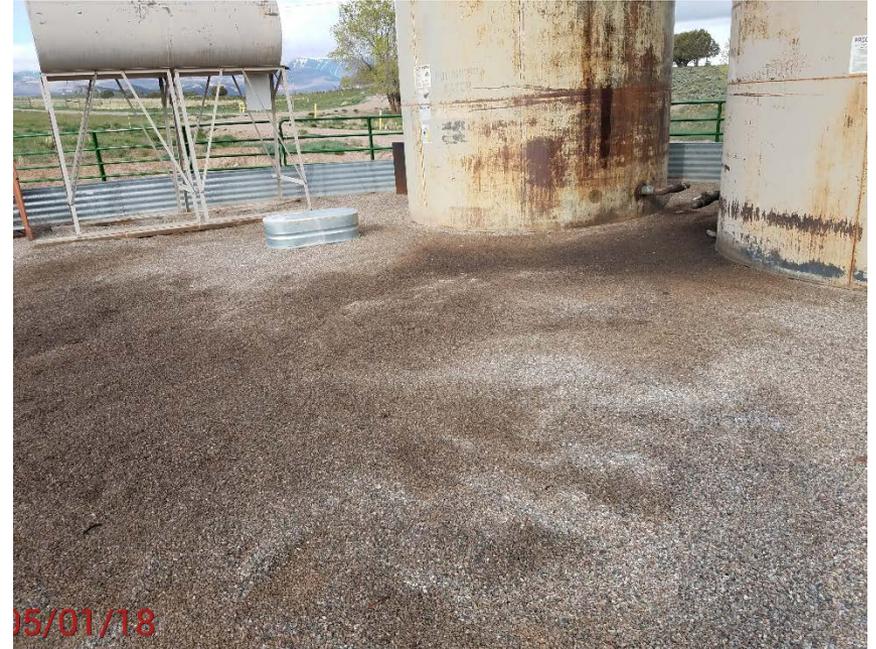
Location photo # 2 stained material in tank battery

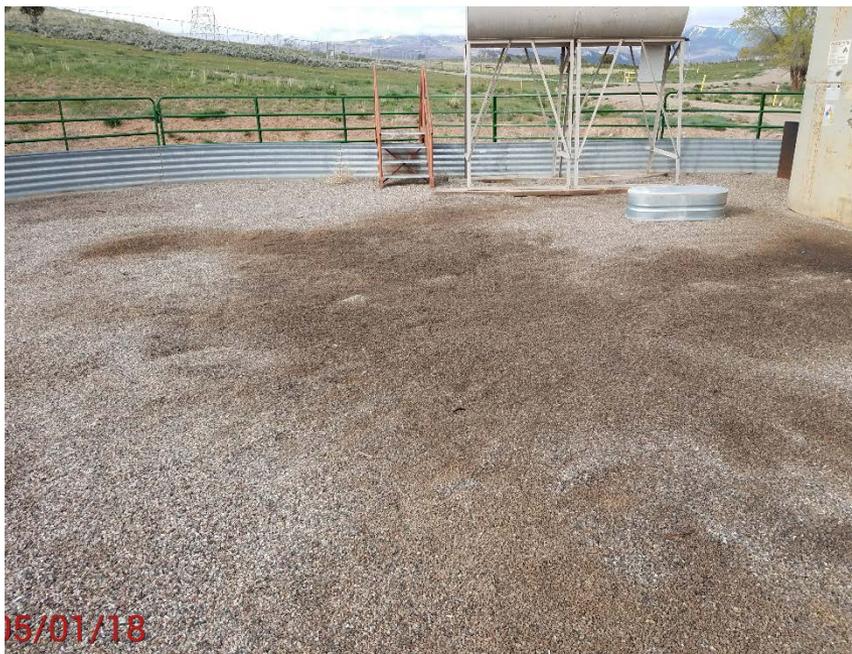
Location photo # 3 Stained material

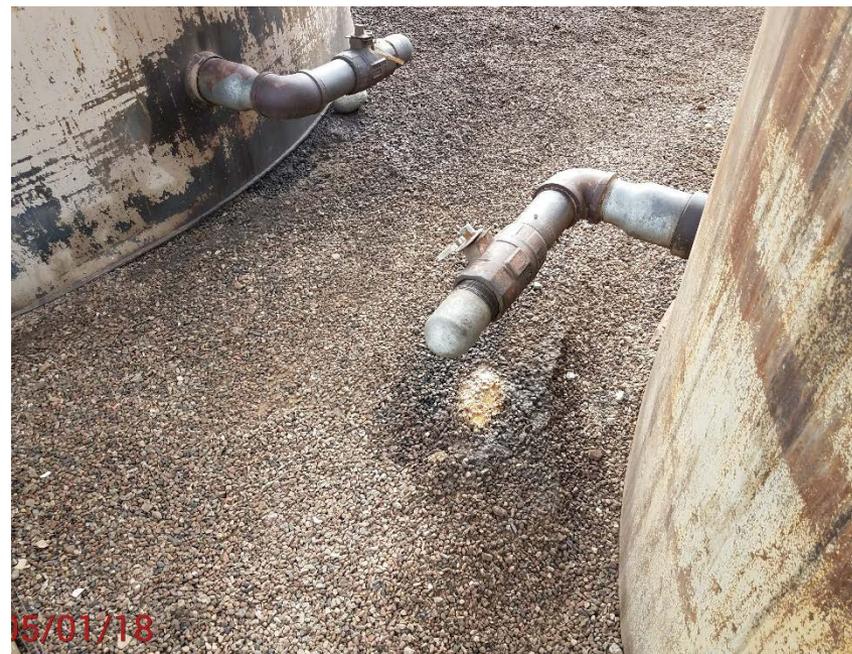
Location photo # 4, Stained material in tank battery, leaking valve

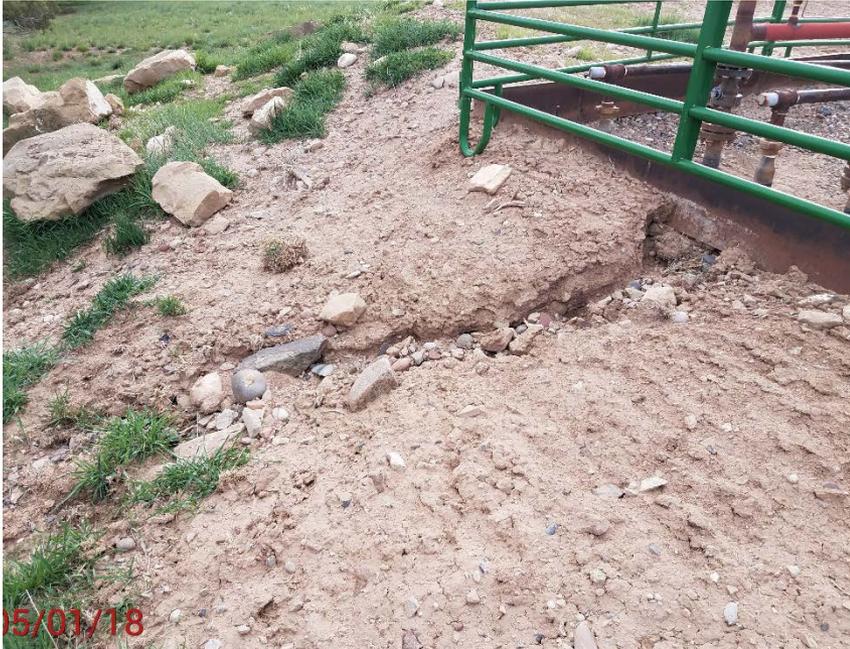
Location photo # 5 storm water issue behind separator

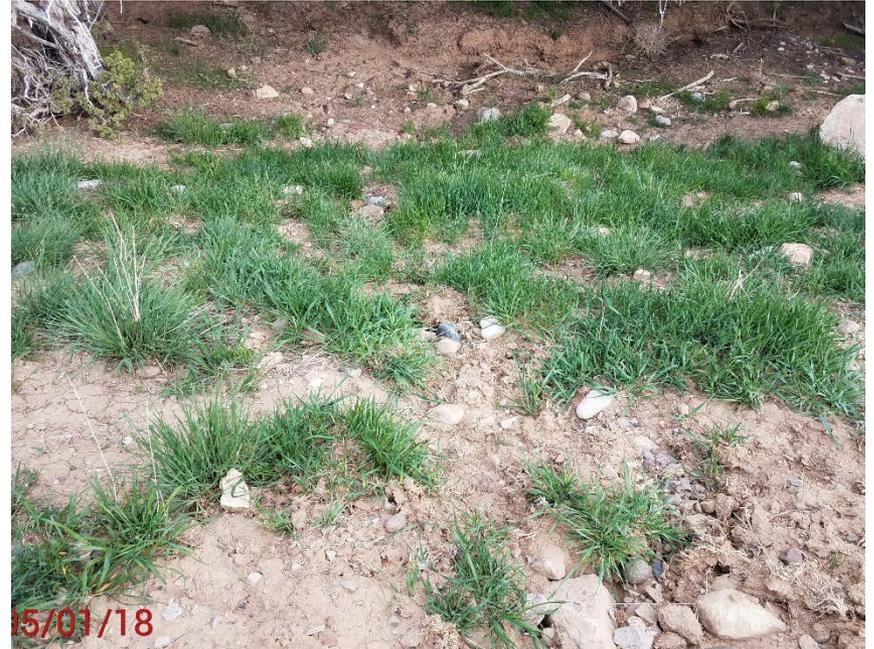
Location photo # 6, Storm water issue

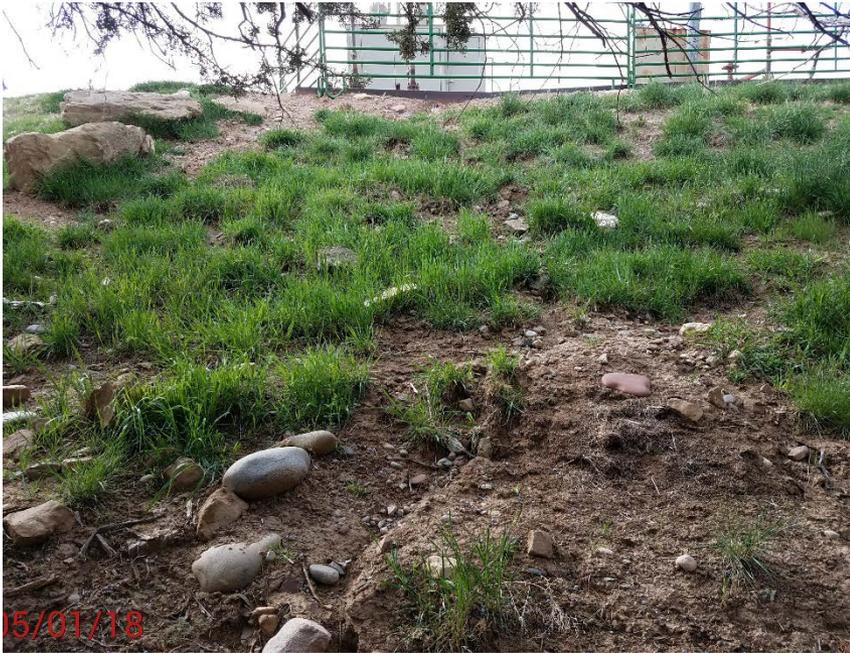
**Location photo # 7, Storm water issue,
looking East towards the vessel**

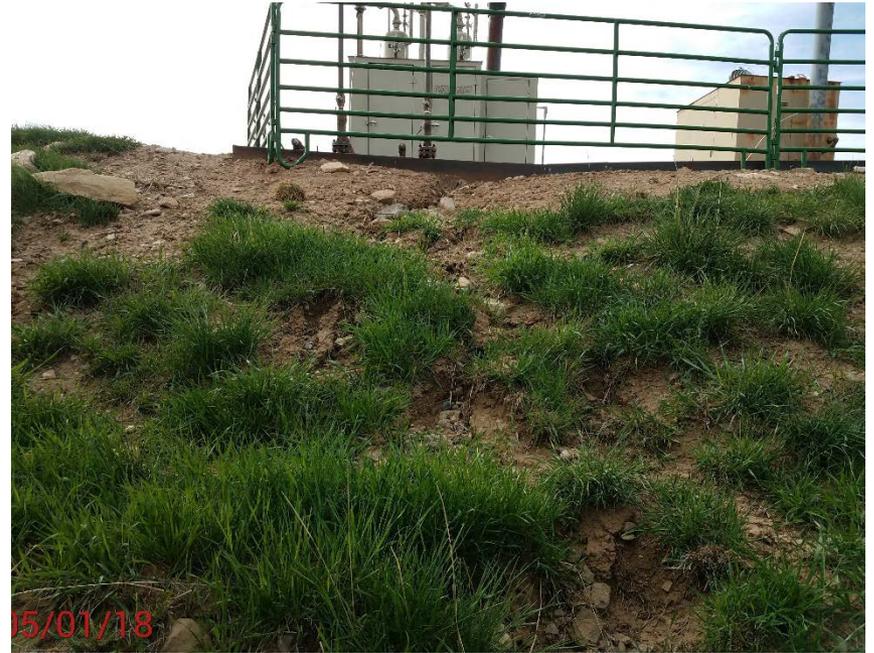
Location photo # 8, Storm water issue

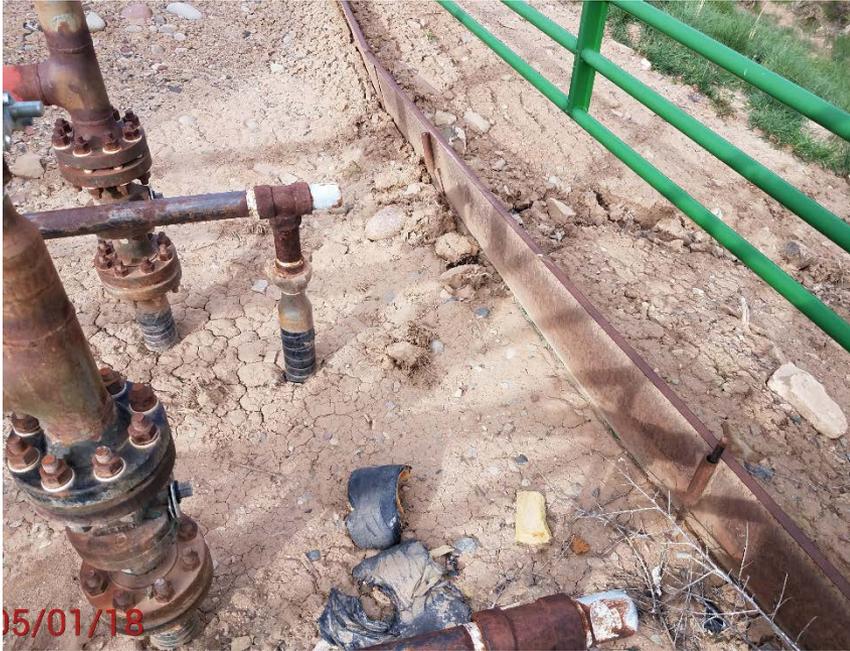
Location photo # 9 storm water issue behind separator
