Inspection Photos
Location Name: Brantner 30-9
Location ID: 323643

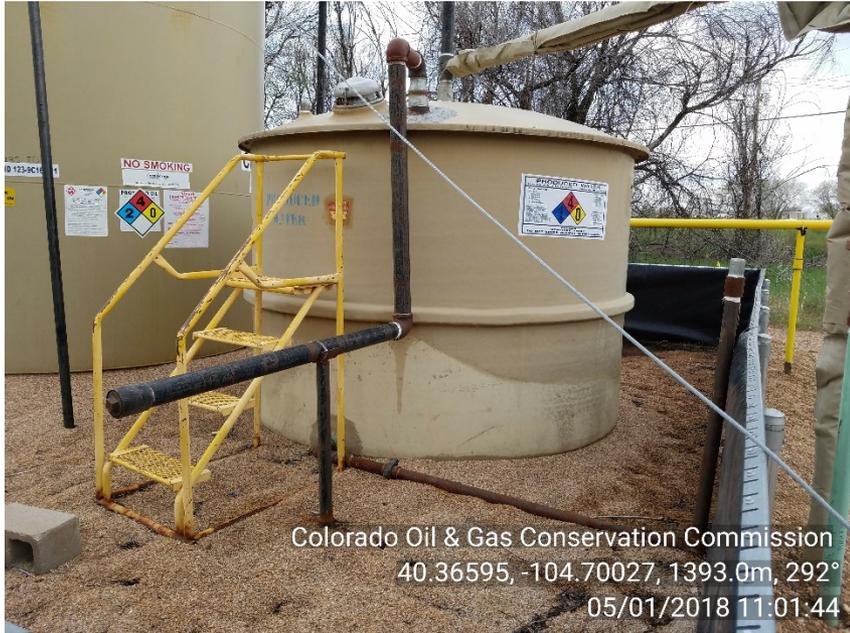
Produced Water Tank Corrective Action: Equipment not anchored or inadequately anchored

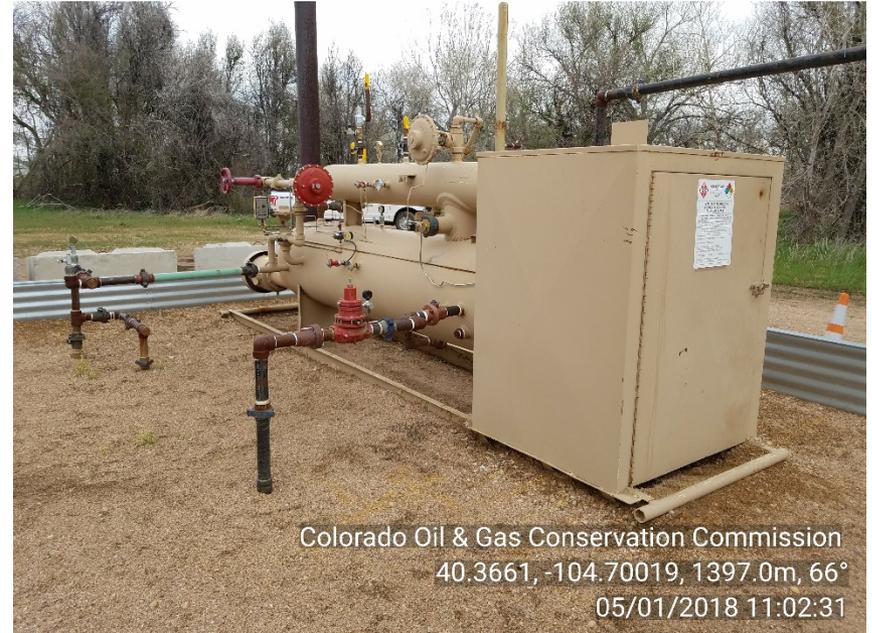
Separator, Corrective Action: Equipment not anchored or inadequately anchored
