Inspection Photos 04/27/18
Location: KP Kauffman Paul Heinze #1
API # 05-123-08382

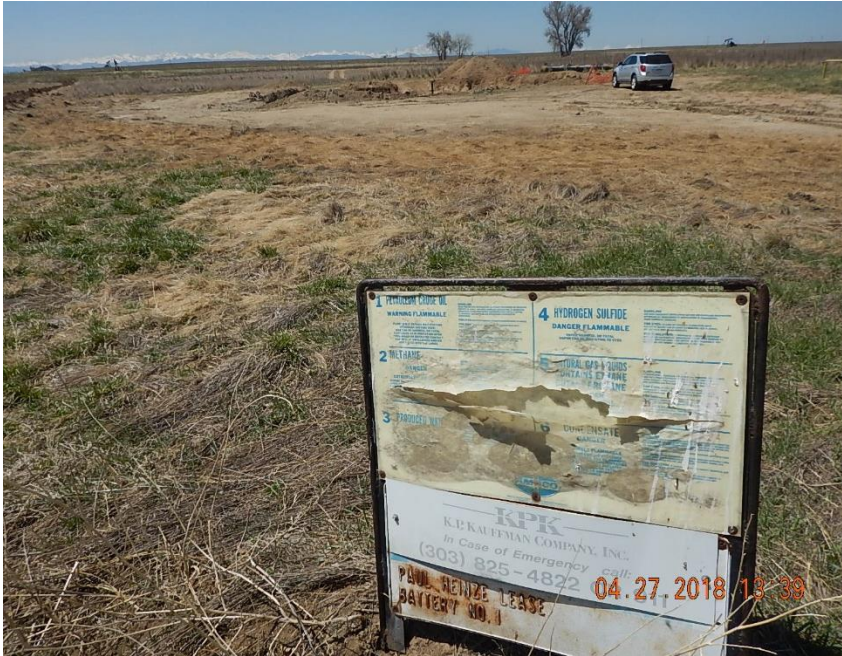
Signage and view toward excavation (looking NW)

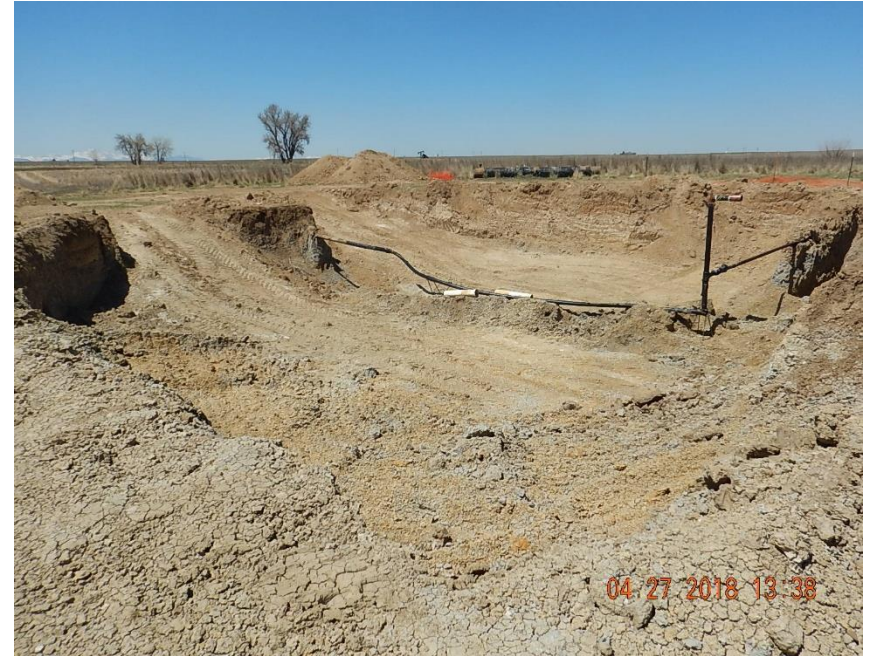
View of excavation and flowline repair work in progress
Looking North

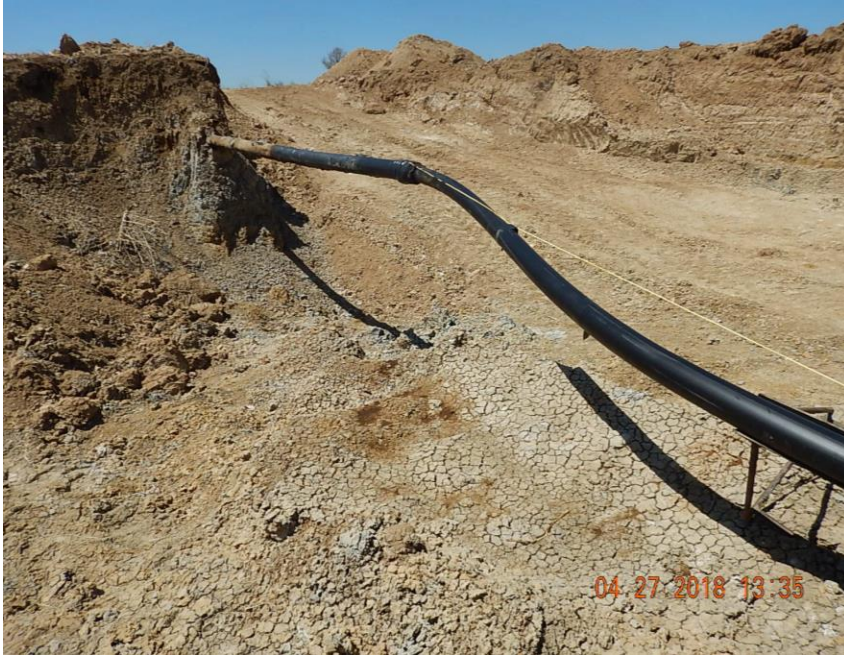
View of flowline repair in progress; area where poly has been stung (slip lined) in to existing pipe (w tracer wire)

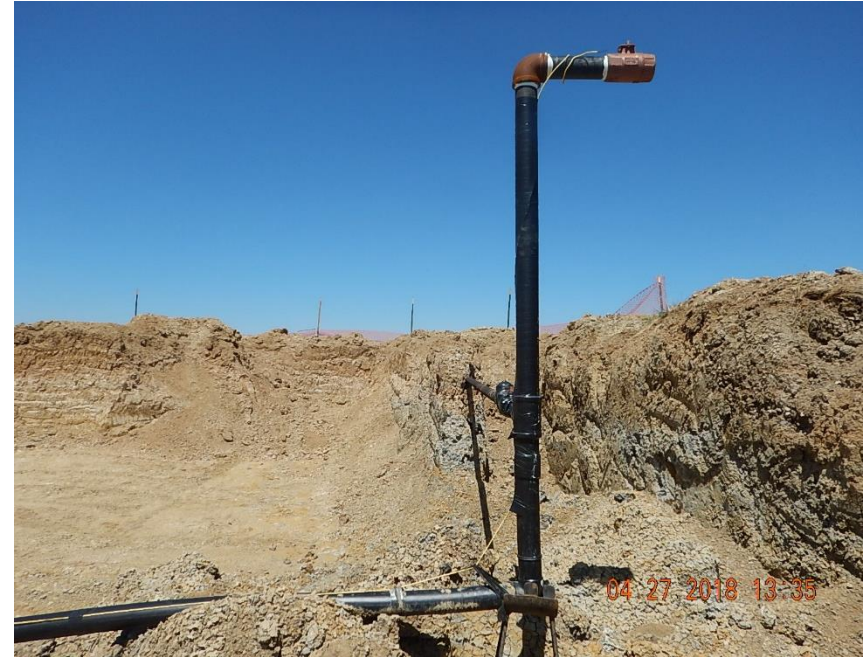
View of flowline repair; in area of well tie in and installation of riser/ valve set

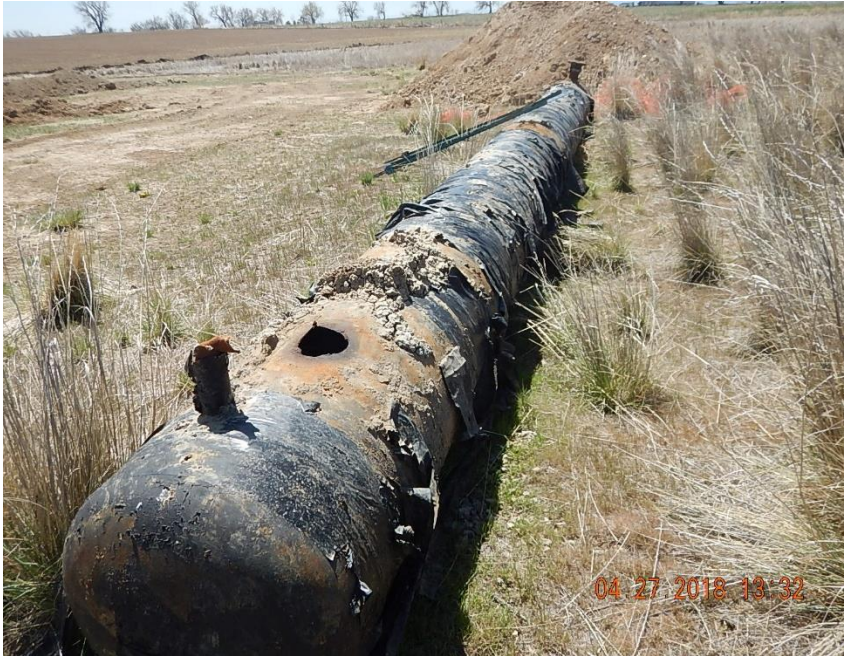
Photo of buried vessel removed from excavation; lacking integrity with obvious corrosion holes

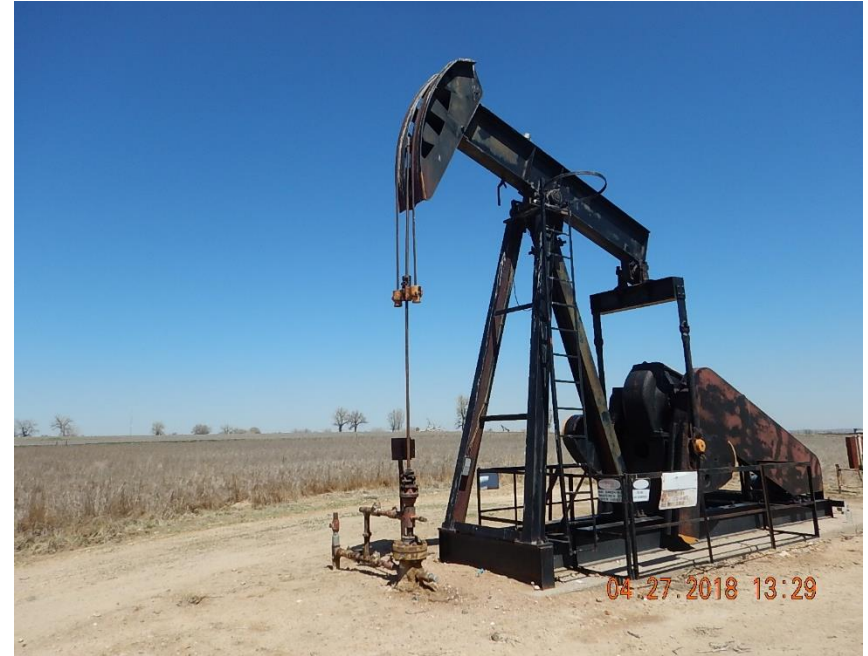
View of pump jack/ wellhead
