GOLDEN EAGLE MINE NW-3-5-95 API# 05-071-06406 – TIMBER CREEK  
OGCC OPERATOR NUMBER 10672 – INSPECTION DATE: MAY 01, 2018  
CORRECTIVE ACTIONS COMPLETED REGARDING COGCC FIR DOCUMENT # 680102758

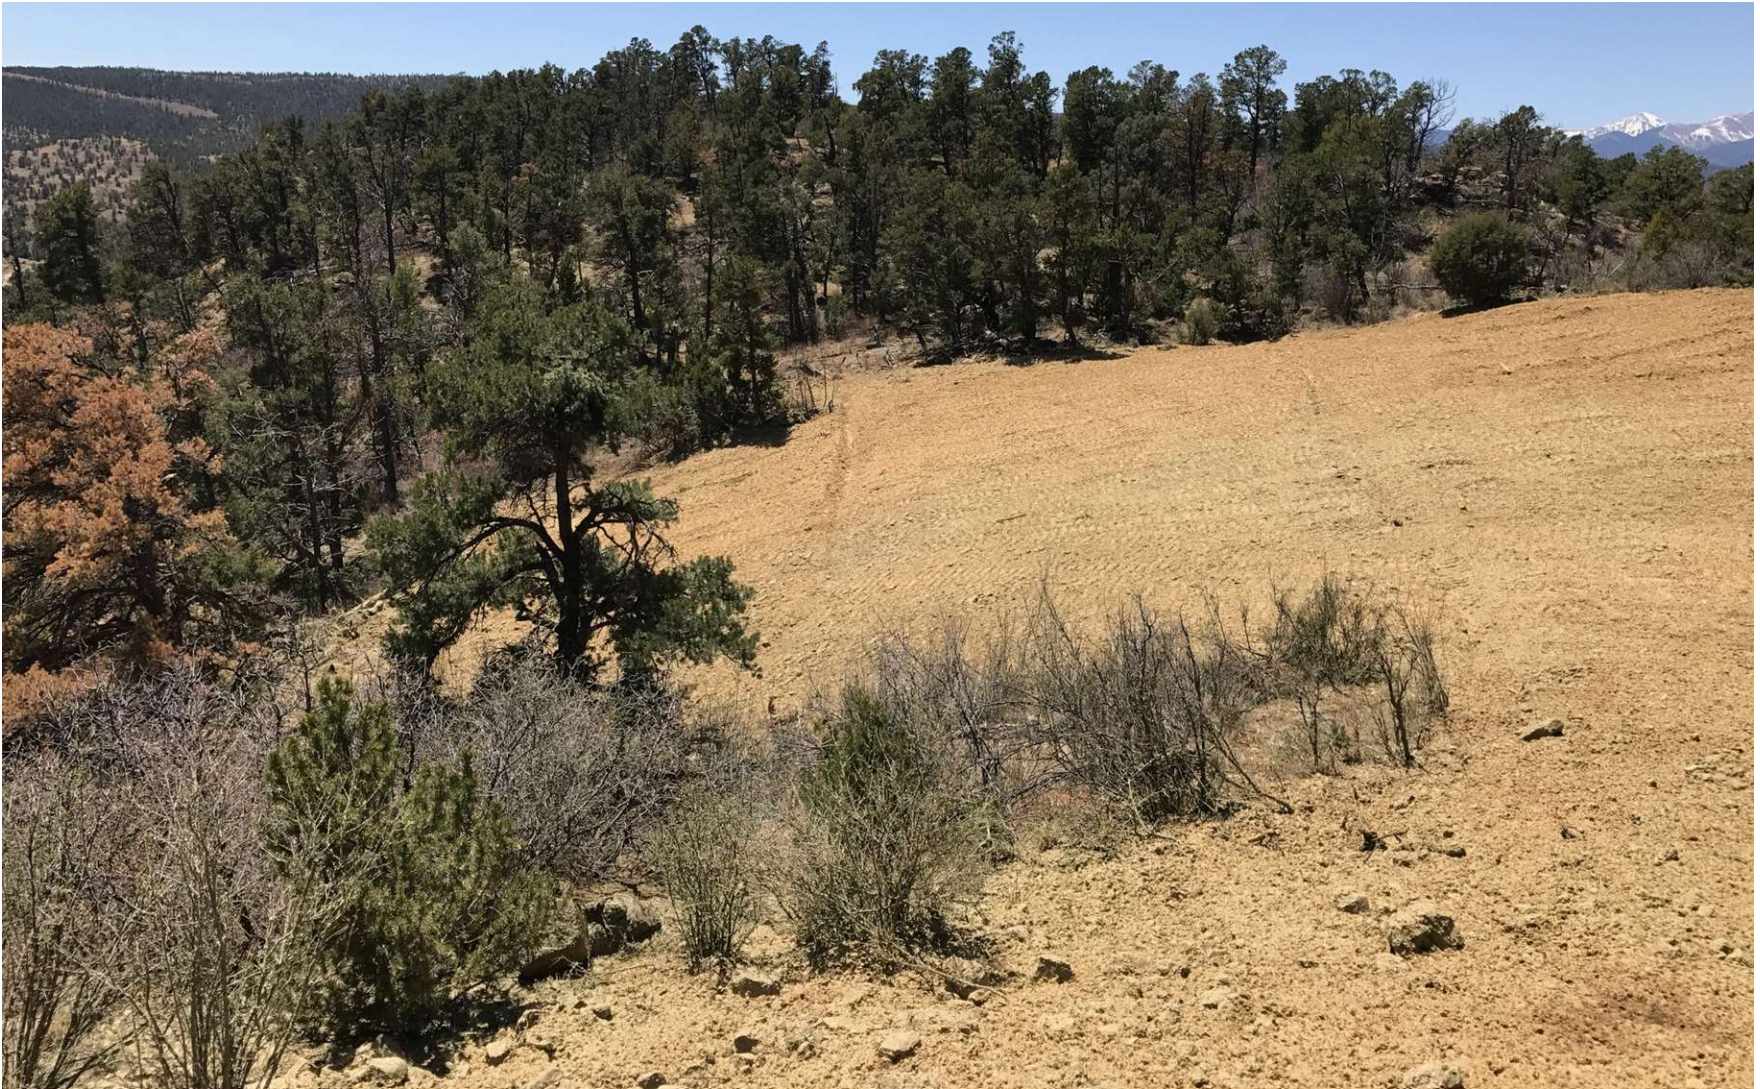
PHOTO 1: OVERVIEW OF LOCATION TO WEST. THE ACCESS ROAD AND WELL PAD WERE RECONTOURED TO MATCH THE SURROUNDING TERRAIN. THIS PROCESS ALLOWED FOR SOIL DECOMPACTION. THE TOPSOIL STOCKPILE WAS USED TO RECLAIM LOCATION. GRADING TECHNIQUES WERE INSTALLED ON THE CONTOUR TO PROMOTE GROUND INFILTRATION AND PREPARE THE SOIL FOR SEEDING. THE EARTH DISTURBANCE WAS STABILIZED BY HYDRO-SEEDING USING AN APPROVED HILL RANCH SEED MIX TO PROMOTE THE ESTABLISHMENT OF VEGETATION. ALL PIPING AND DEBRIS WERE REMOVED FROM LOCATION.

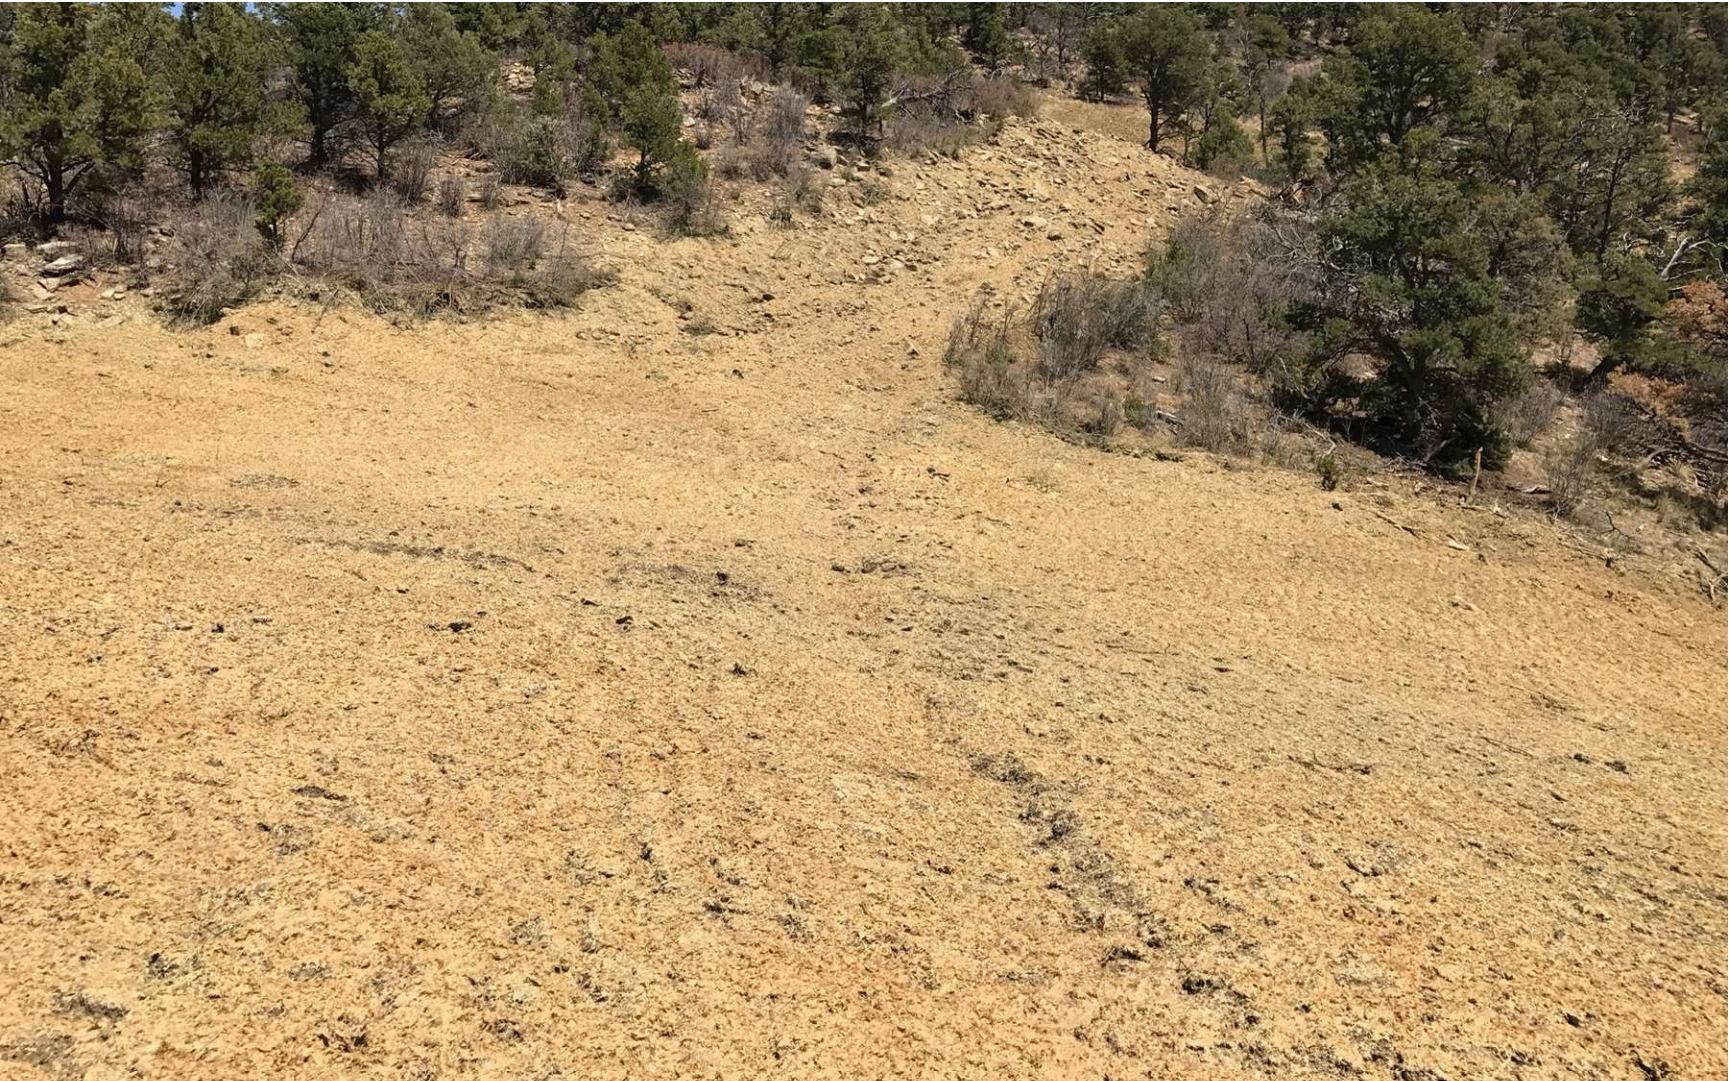
PHOTO 2: VIEW NORTHEAST ALONG THE RECLAIMED WELL PAD AND ACCESS ROAD. THE ACCESS ROAD AND WELL PAD WERE RECONTOURED TO MATCH THE SURROUNDING TERRAIN WHICH CORRECTED THE EROSION ISSUES. GRADING TECHNIQUES WERE INSTALLED ON THE CONTOUR TO PROMOTE GROUND INFILTRATION AND PREPARE THE SOIL FOR SEEDING. THE EARTH DISTURBANCE WAS STABILIZED BY HYDRO-SEEDEDING USING AN APPROVED HILL RANCH SEED MIX TO PROMOTE THE ESTABLISHMENT OF VEGETATION.

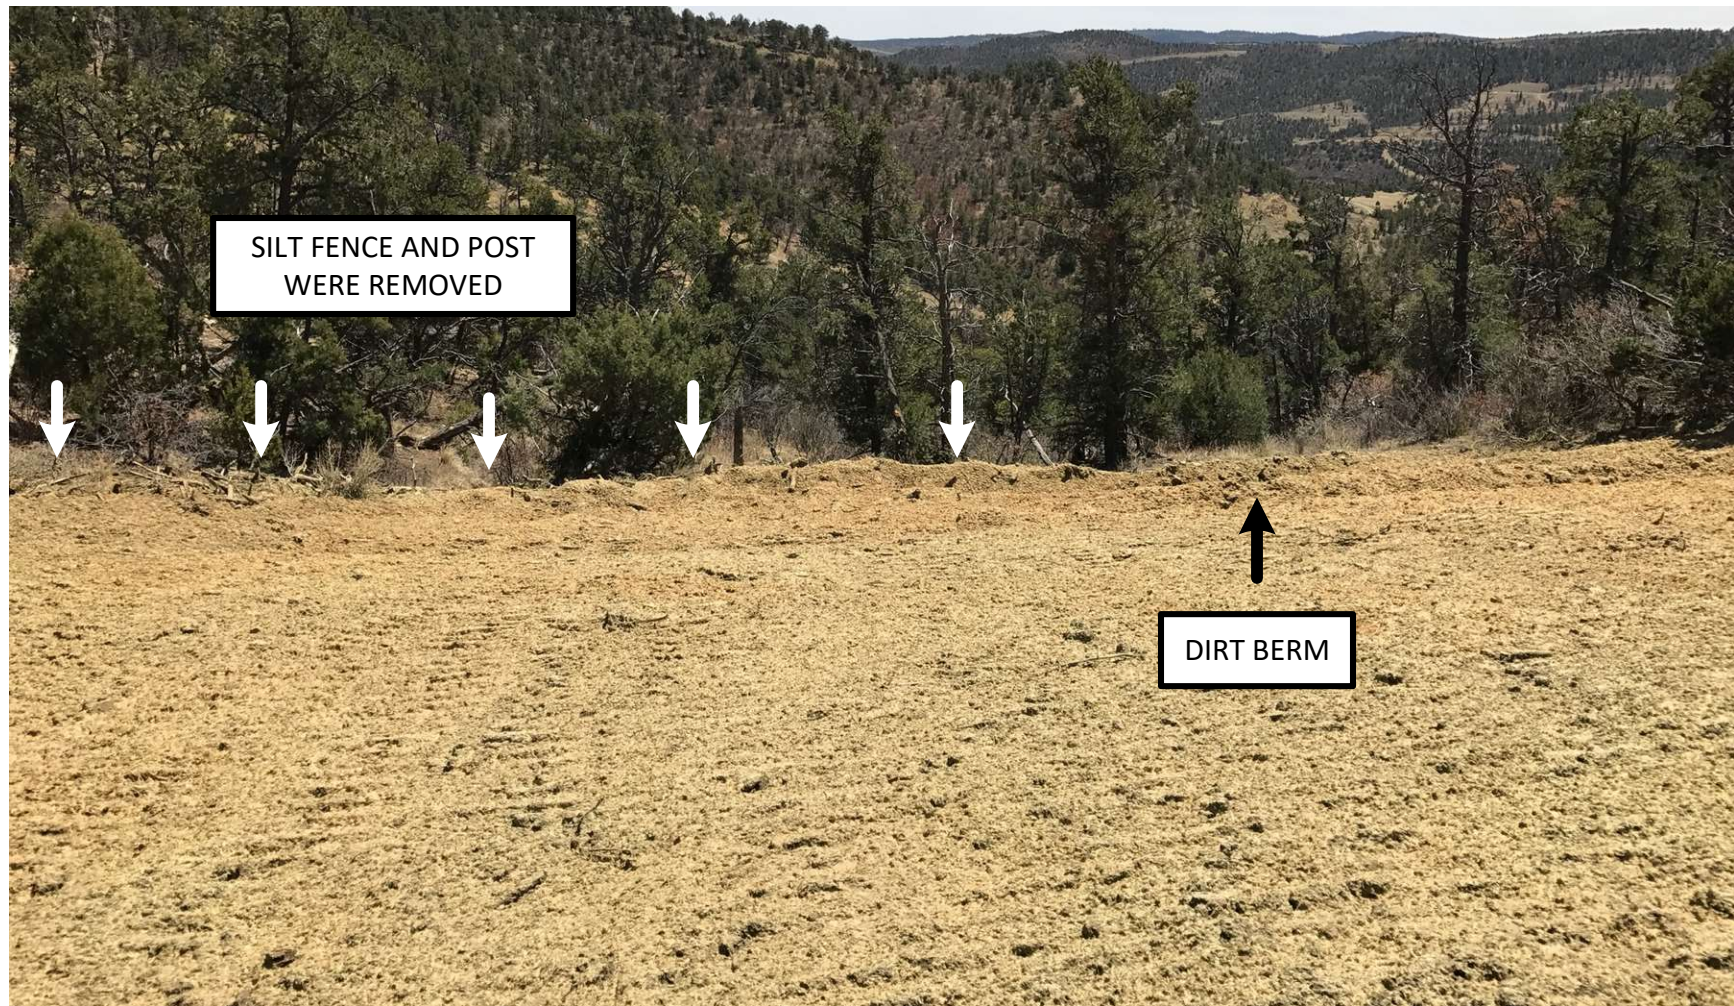
PHOTO 3: BASE OF RECLAIMED WELL PAD FILL SLOPE. THE WELL PAD WAS RECONTOURED TO MATCH THE SURROUNDING TERRAIN WHICH CORRECTED THE SEVERE EROSION ISSUES. GRADING TECHNIQUES WERE INSTALLED ON THE CONTOUR TO PROMOTE GROUND INFILTRATION AND PREPARE THE SOIL FOR SEEDING. A DIRT BERM WAS INSTALLED TOE OF SLOPE TO PROVIDE SEDIMENT CONTROL. THE EARTH DISTURBANCE WAS STABILIZED BY HYDRO-SEEDING USING AN APPROVED HILL RANCH SEED MIX TO PROMOTE THE ESTABLISHMENT OF VEGETATION. THE SILT FENCE AND DEBRIS WERE REMOVED FROM LOCATION.

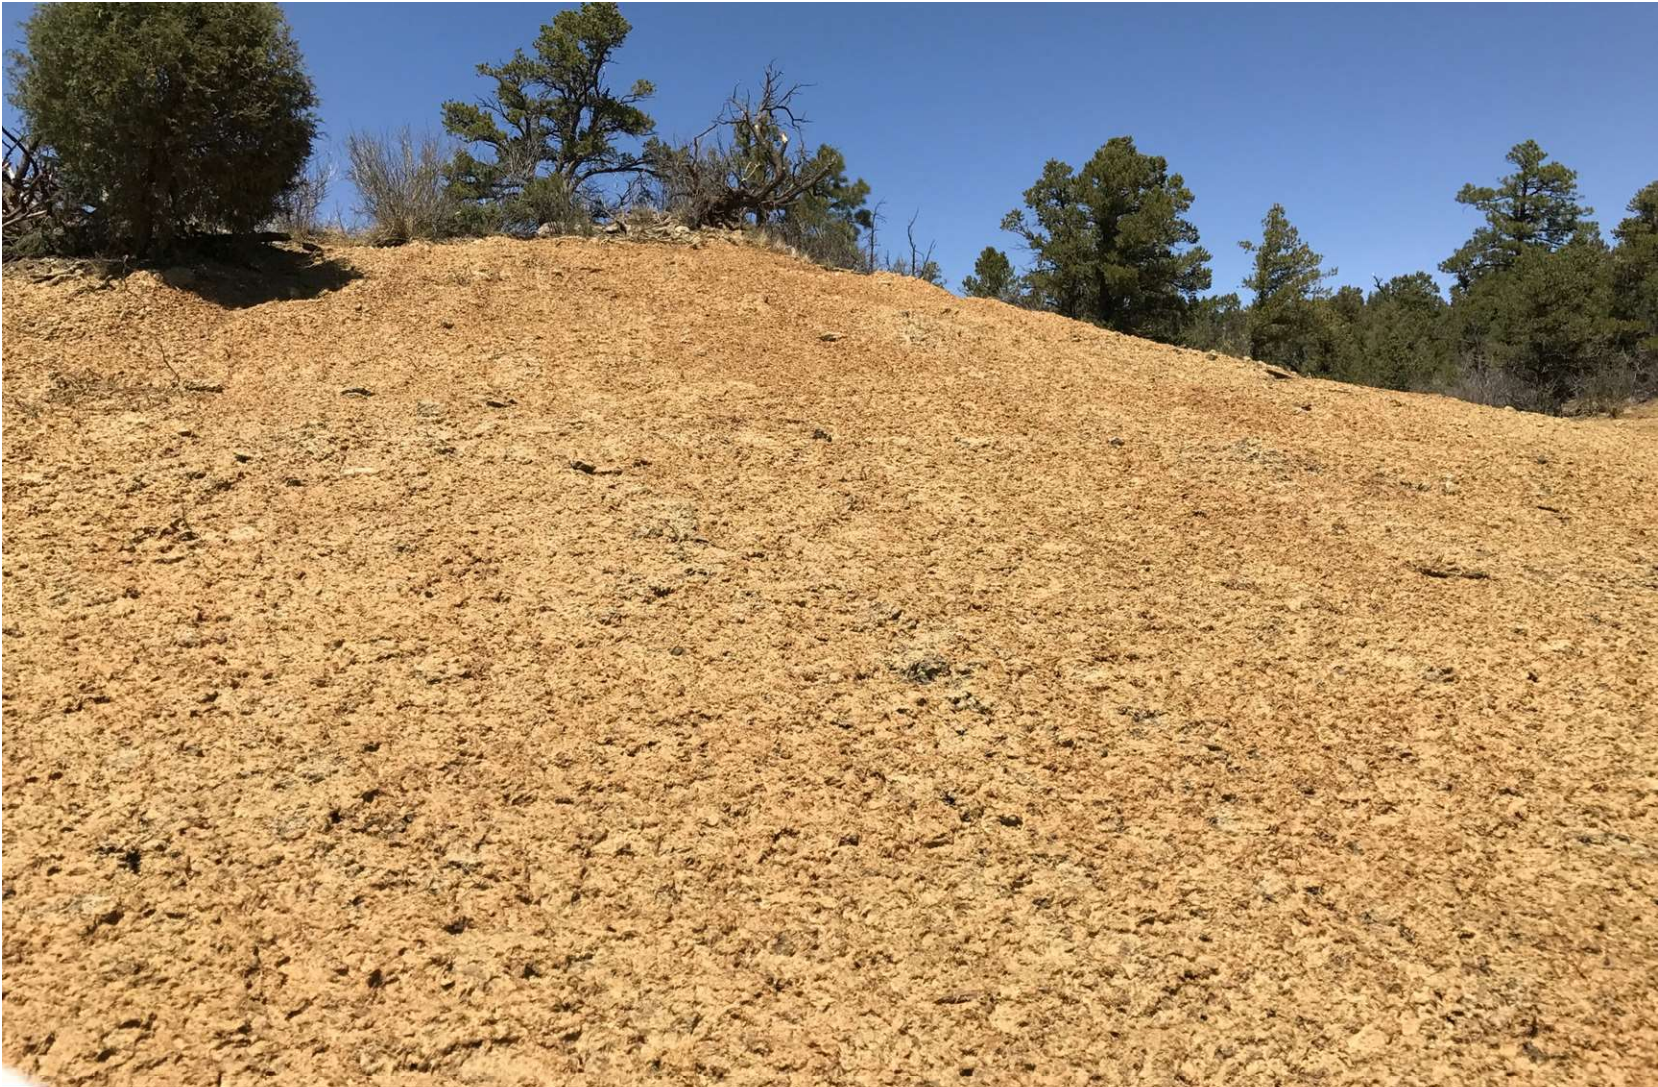
PHOTO 4: FACING NORTHWEST AT THE RECLAIMED CUT SLOPE OF WELL PAD. THE WELL PAD WAS RECONTOURED TO MATCH THE SURROUNDING TERRAIN. GRADING TECHNIQUES WERE INSTALLED ON THE CONTOUR TO PROMOTE GROUND INFILTRATION AND PREPARE THE SOIL FOR SEEDING. THE EARTH DISTURBANCE WAS STABILIZED BY HYDRO-SEEDING USING AN APPROVED HILL RANCH SEED MIX TO PROMOTE THE ESTABLISHMENT OF VEGETATION.

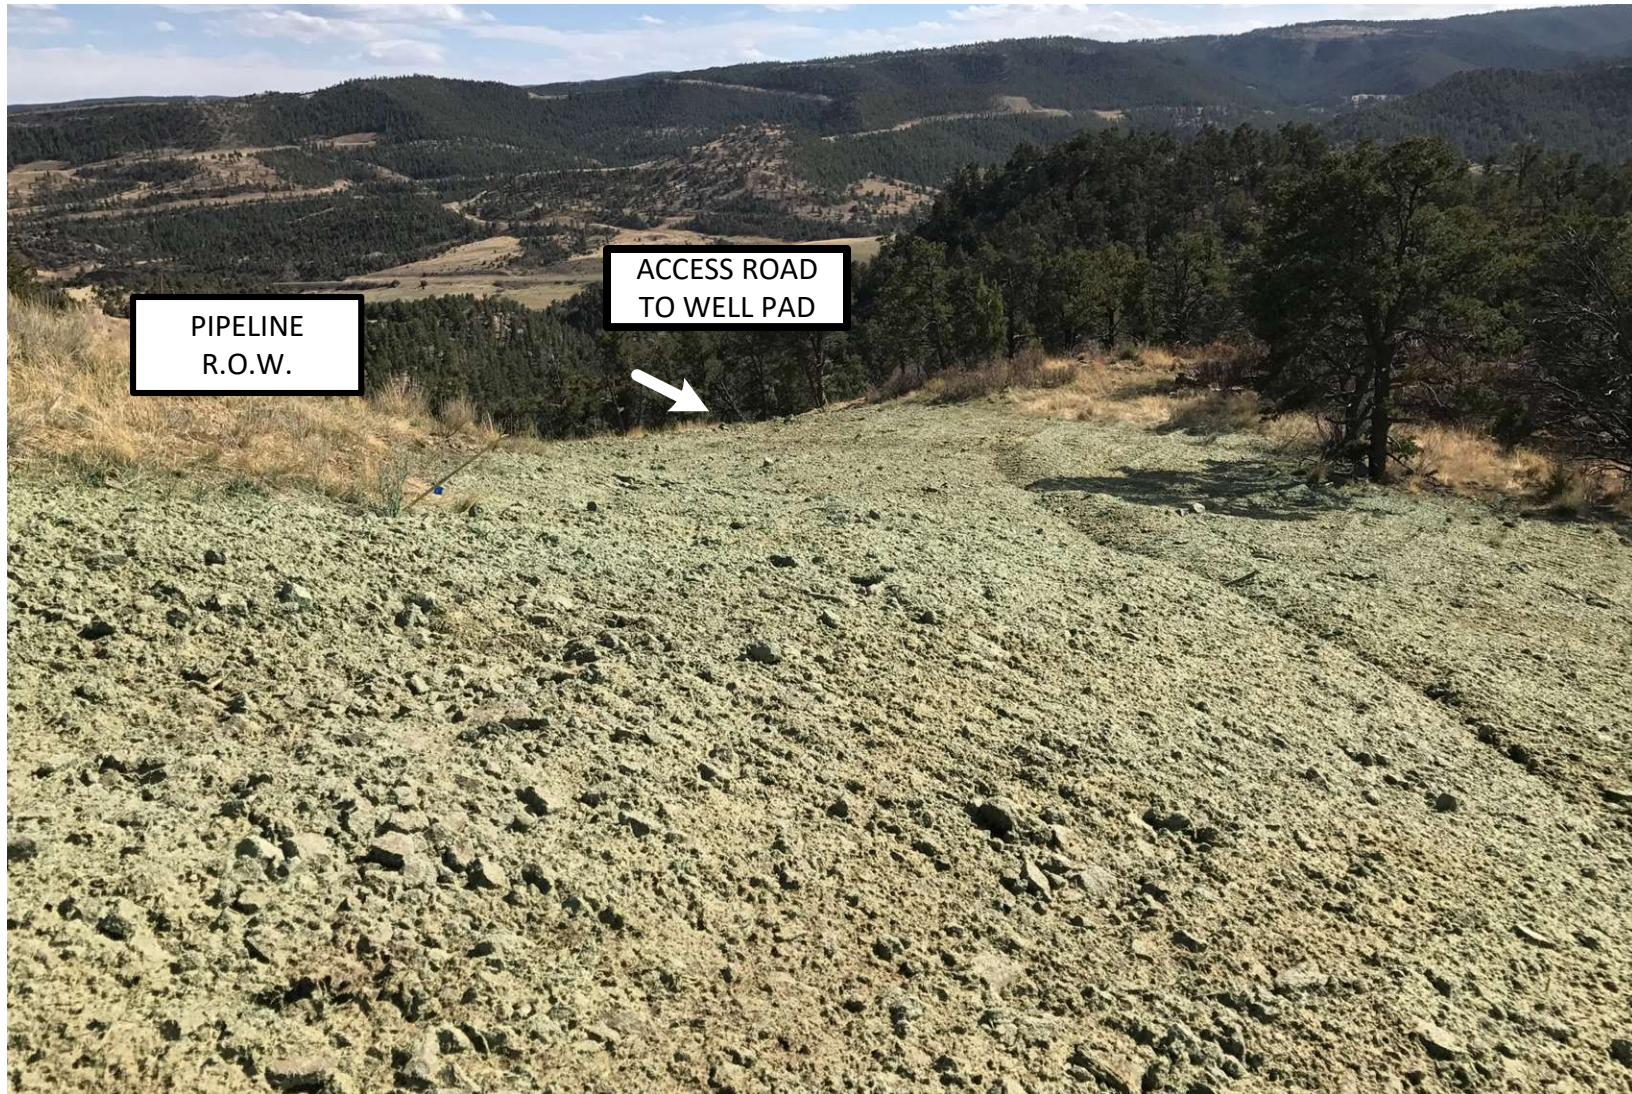
PHOTO 5: FACING SOUTH, THE ACCESS ROAD/PIPELINE R.O.W. WAS RECONTOURED TO MATCH THE SURROUNDING TERRAIN. GRADING TECHNIQUES WERE INSTALLED ON THE CONTOUR TO PROMOTE GROUND INFILTRATION AND PREPARE THE SOIL FOR SEEDING. THE EARTH DISTURBANCE WAS STABILIZED BY HYDRO-SEEDING USING AN APPROVED HILL RANCH SEED MIX TO PROMOTE THE ESTABLISHMENT OF VEGETATION.

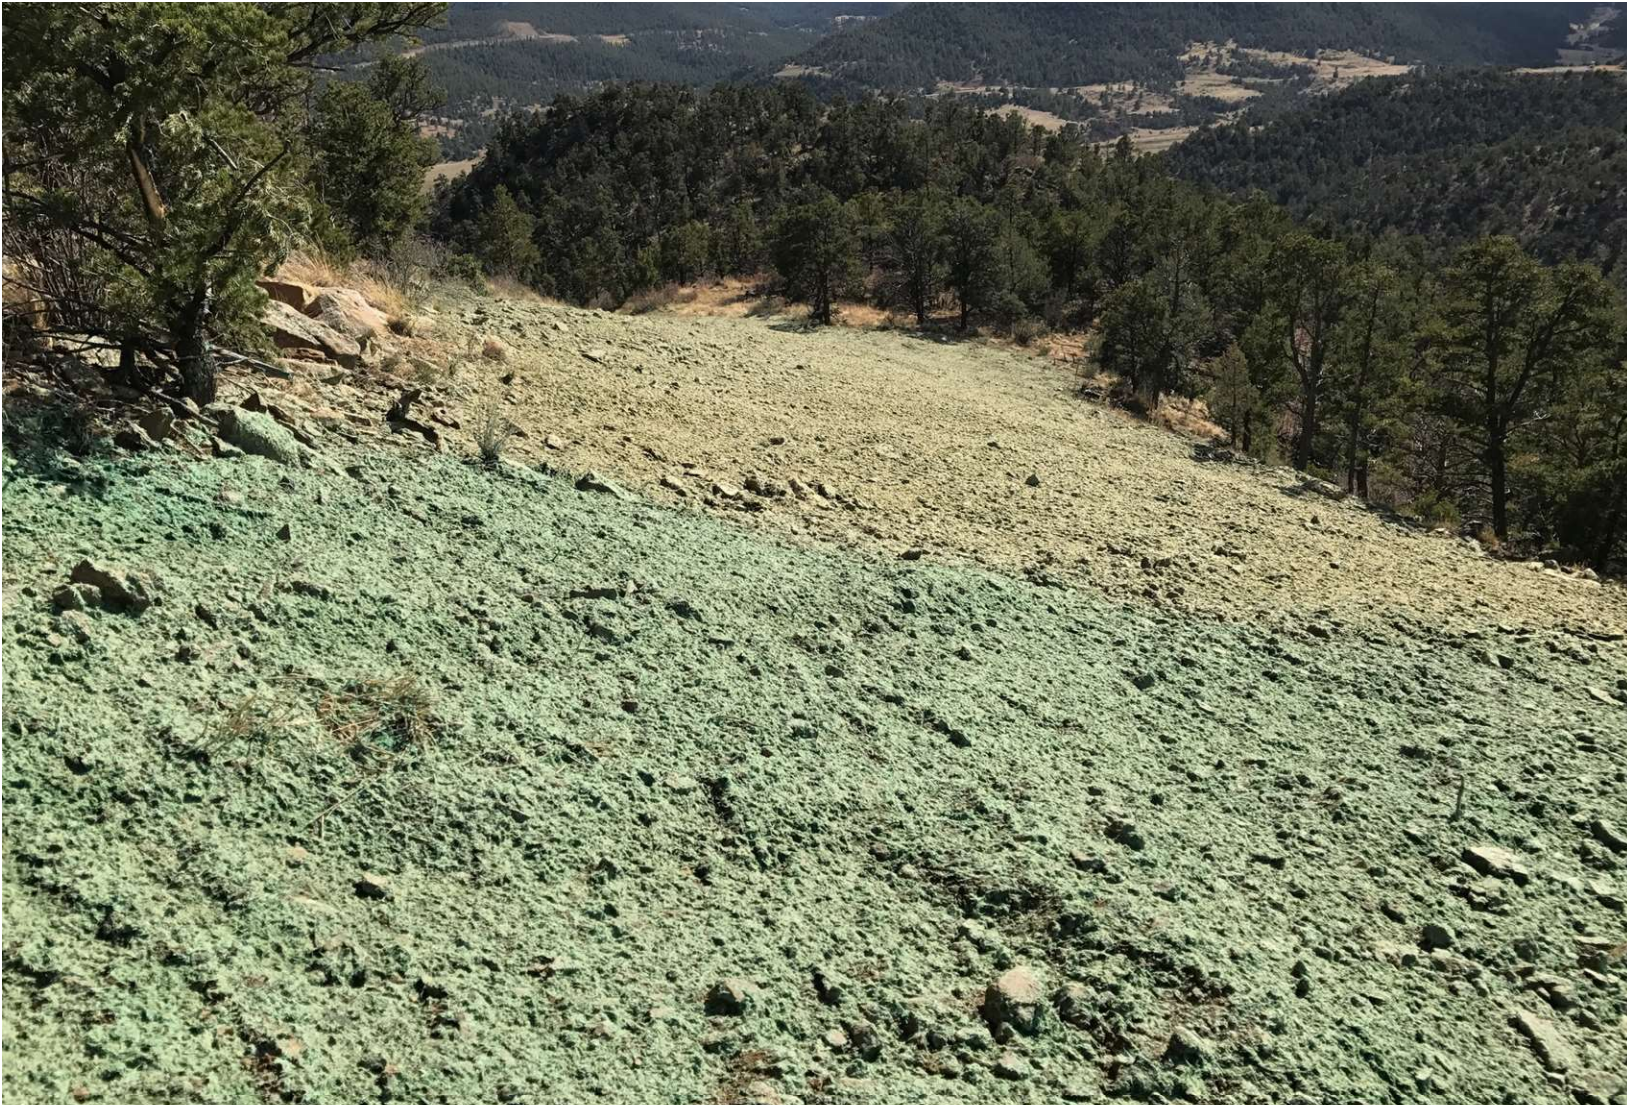
PHOTO 6: FACING SOUTH, THE ACCESS ROAD/PIPELINE R.O.W. WAS RECONTOURED TO MATCH THE SURROUNDING TERRAIN. GRADING TECHNIQUES WERE INSTALLED ON THE CONTOUR TO PROMOTE GROUND INFILTRATION AND PREPARE THE SOIL FOR SEEDING. THE EARTH DISTURBANCE WAS STABILIZED BY HYDRO-SEEDING USING AN APPROVED HILL RANCH SEED MIX TO PROMOTE THE ESTABLISHMENT OF VEGETATION.

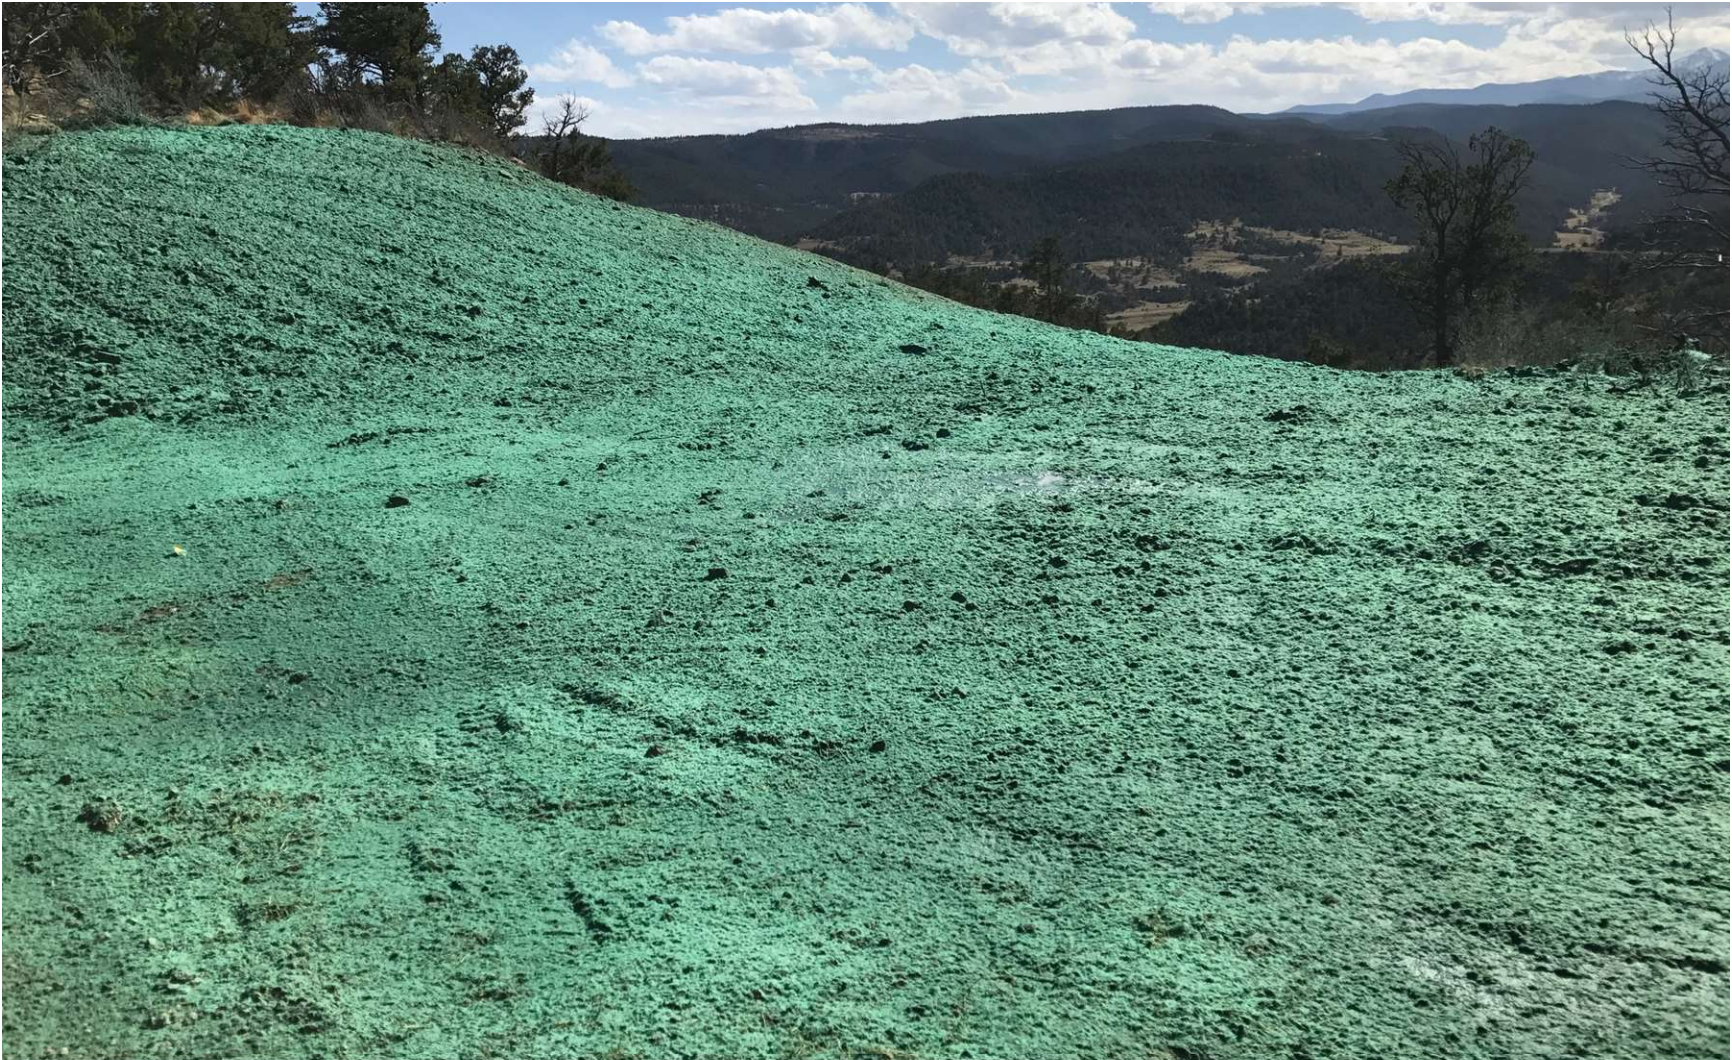
PHOTO 7: NORTHEAST END OF RECLAMATION ADJACENT TO THE MAIN LEASE ROAD IN LOPEZ CANYON. THE ACCESS ROAD/ PIPELINE R.O.W. WAS RECONTOURED TO MATCH THE SURROUNDING TERRAIN. GRADING TECHNIQUES WERE INSTALLED ON THE CONTOUR TO PROMOTE GROUND INFILTRATION AND PREPARE THE SOIL FOR SEEDING. THE EARTH DISTURBANCE WAS STABILIZED BY HYDRO-SEEDING USING AN APPROVED HILL RANCH SEED MIX TO PROMOTE THE ESTABLISHMENT OF VEGETATION.
