Inspection Photos 4/27 – 5/1 2018
Location: 8 North LLC Dawson 2-10
API # 05-013-06087 Location ID #446622

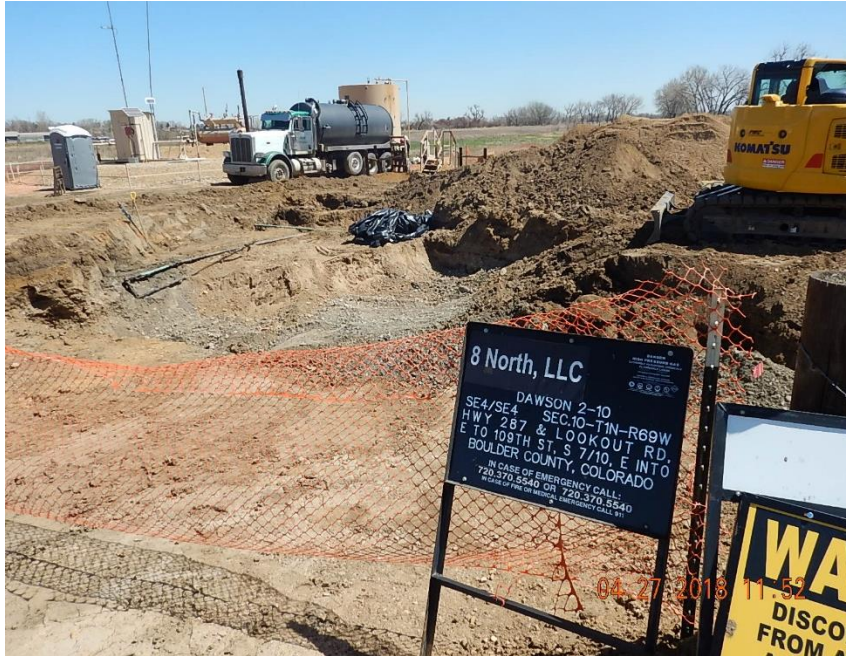
Location signage and view of phase 1 remediation area on location. Flowlines are exposed in the excavation (view East)
Note: Photo taken 4/27/18

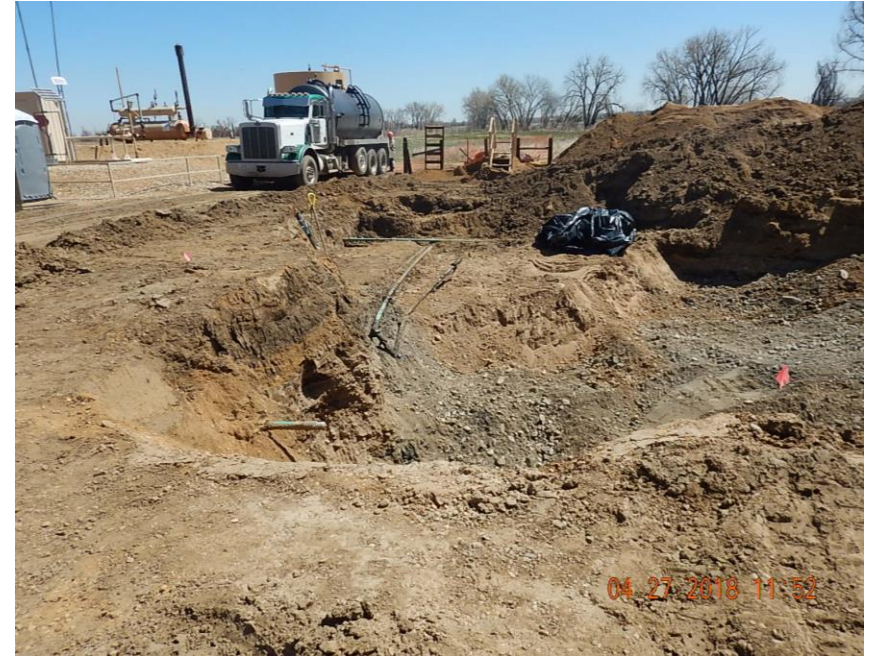
Closer view of excavated area exposing both active dump lines and (previously unknown) historically abandoned flowlines (view to East)
Note: Photo taken 4/27/18

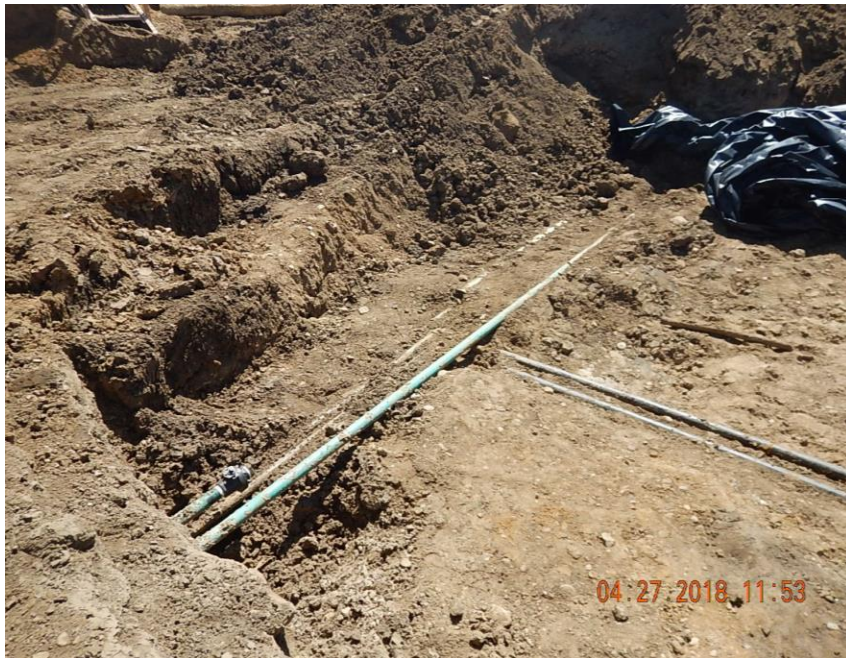
Closer view of flowlines exposed in excavation; The short valved/ plugged line is the active Crude Oil dump flowline (isolated during remediation); and (4) historically abandoned flowlines. Note: Photo taken 4/27/18

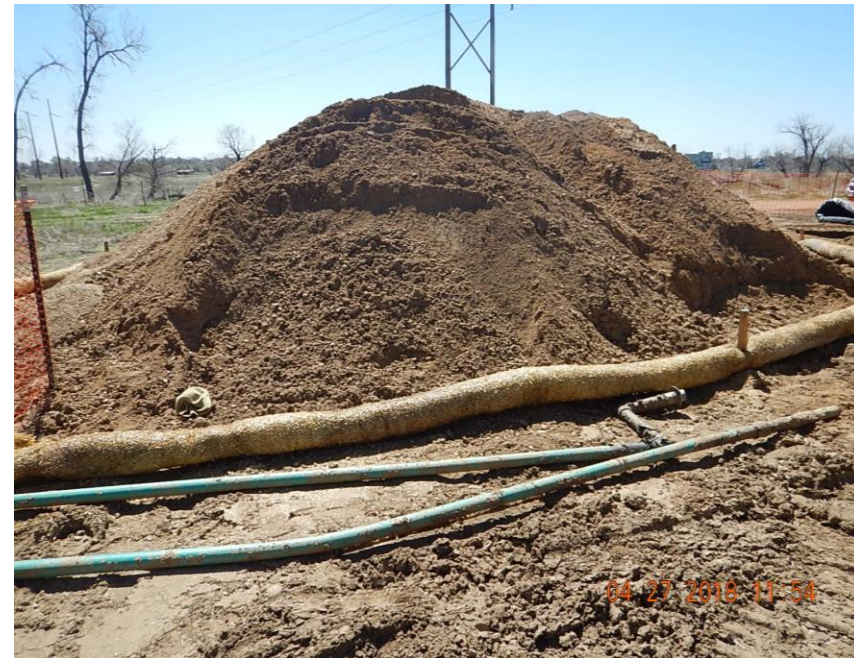
Waddles surrounding soils stockpile and flowline pipe materials removed from excavated area.

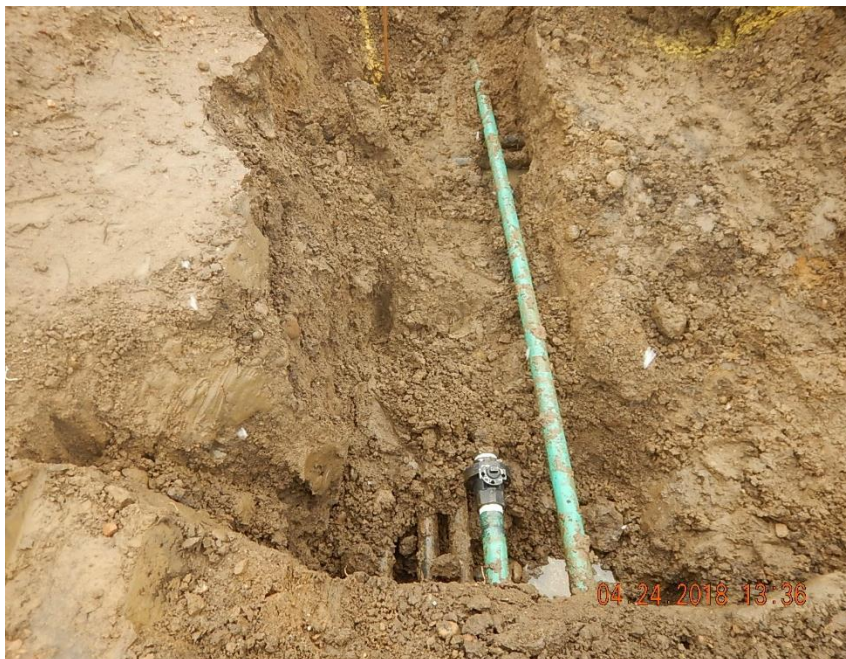
**Close up view of flowlines exposed in excavation; (1) Valved/
plugged (FBE coated) active flowline; (4) historically
abandoned flowlines were discovered while excavating.**

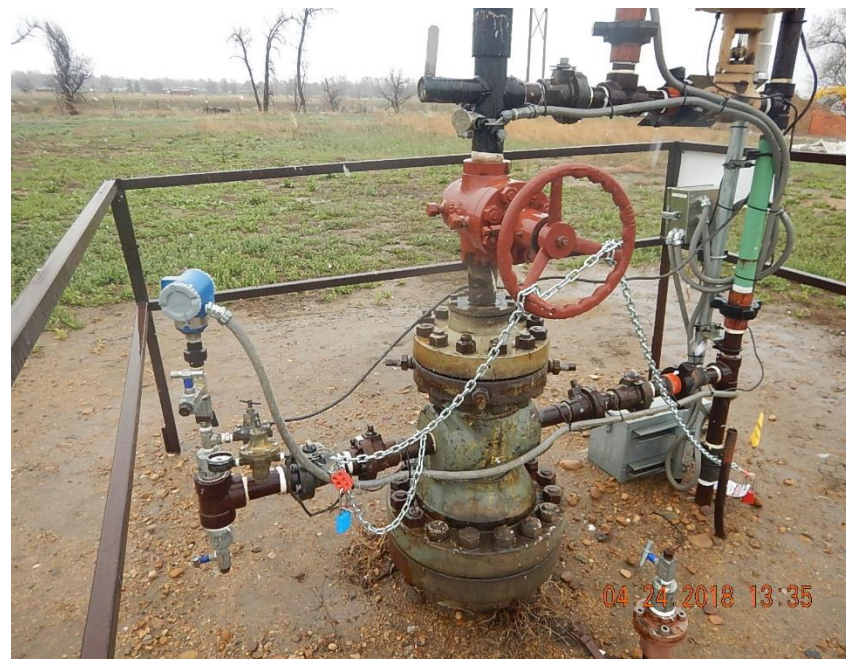
Photo of shut in wellhead (Locked out/ Tagged out)

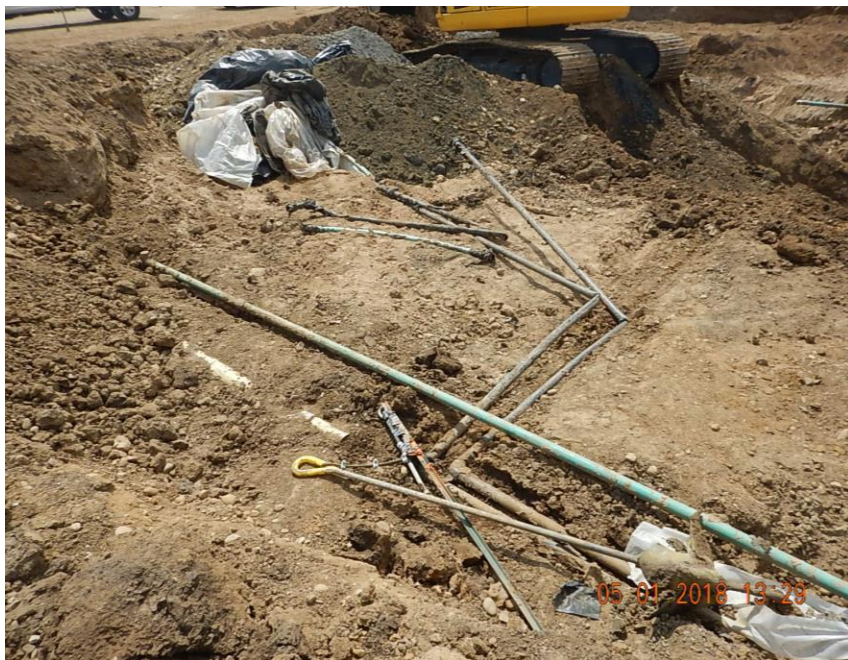
View of (4) historically abandoned flowlines discovered while excavating; in process of being removed

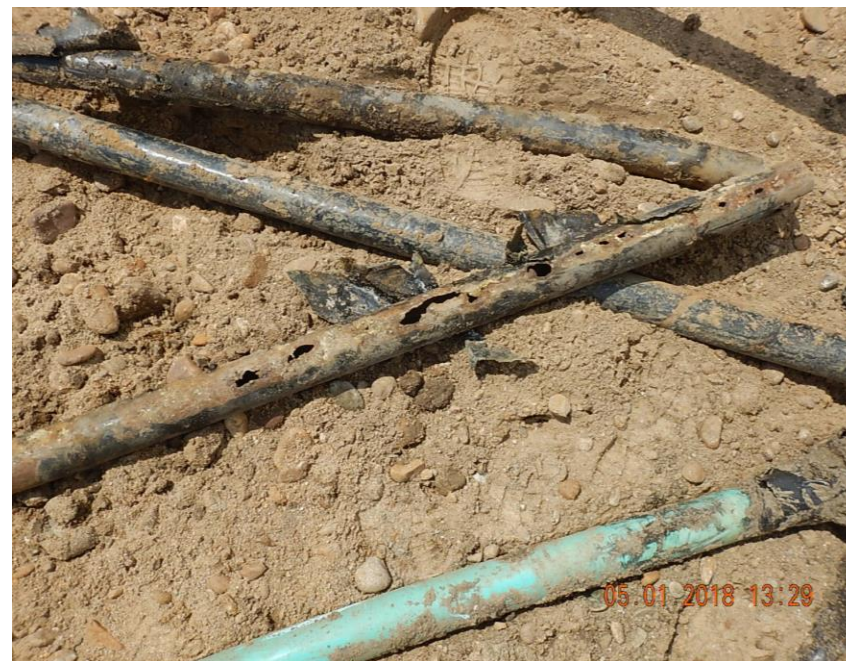
Corrosion holes observed in sections of the historically abandoned flowlines.
