Inspection Photos

Operator: WIEPKING-FULLERTON ENERGY LLC -
96340

Location ID: 436579

Inspection Doc. Number: 682503291
Lincoln County, CO

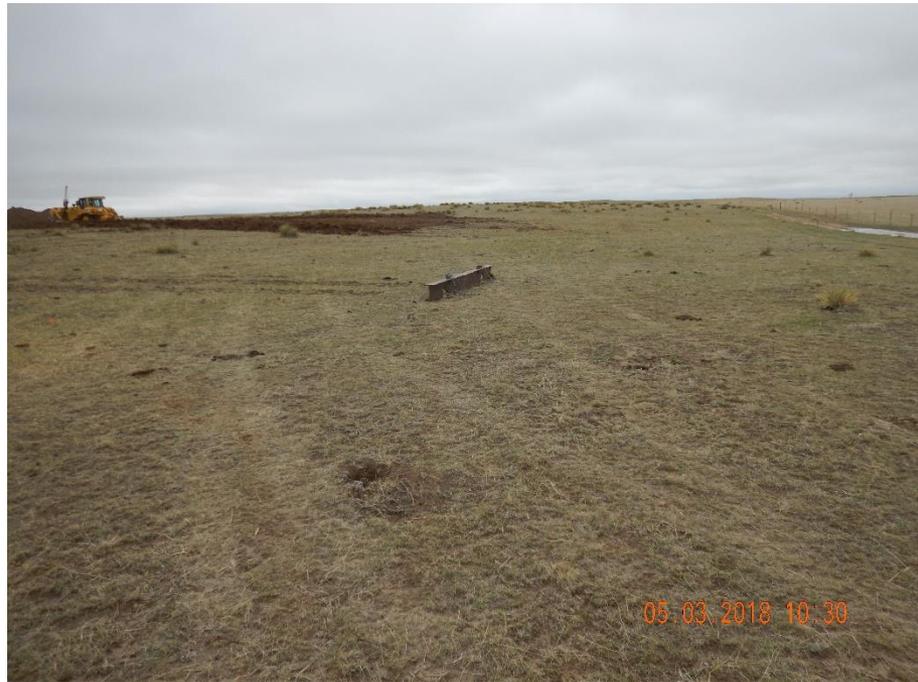
Photo 1: Photo taken from the southeast end of the constructions site, facing north. Photo shows construction activities in process, however, no stormwater and sediment control BMPs have been installed.

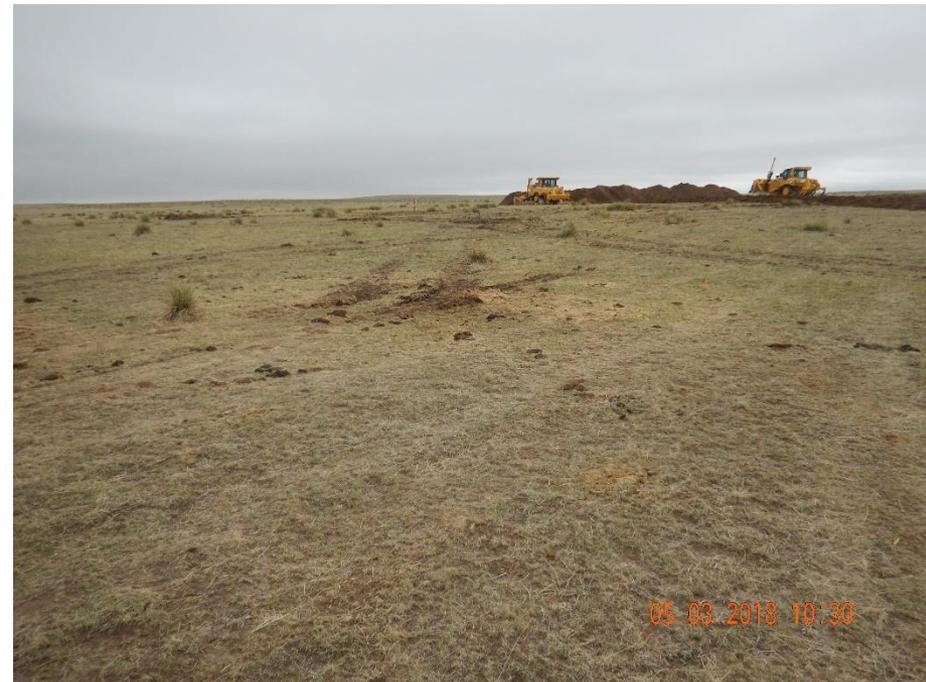
Photo 2: Photo taken from the southeast end of the constructions site, facing west. Photo shows construction activities in process, however, no stormwater and sediment control BMPs have been installed.

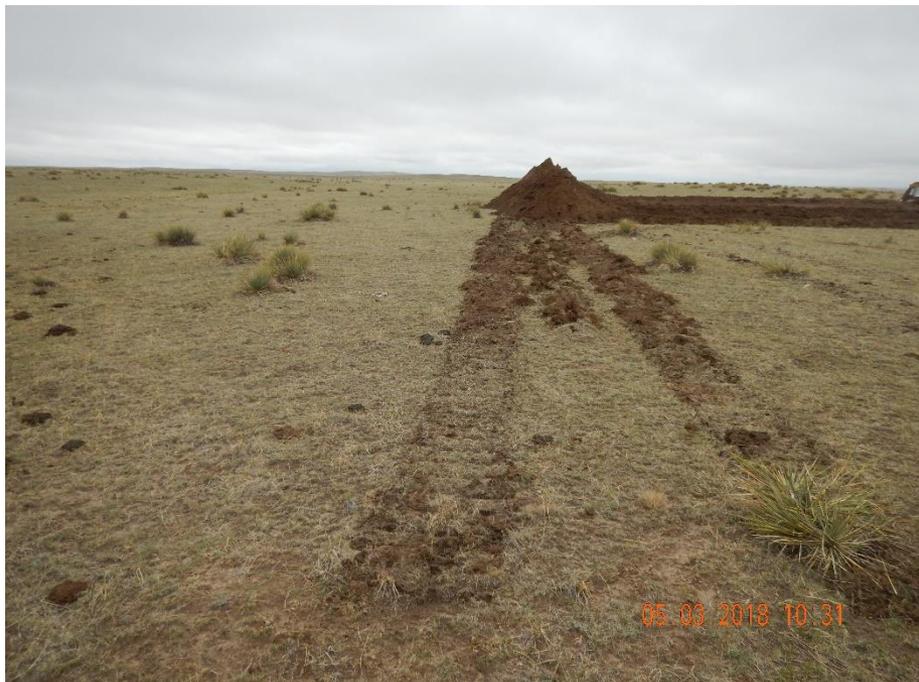
Photo 3: Photo taken from the southwest end of the constructions site, facing north. Photo shows construction activities in process, however, no stormwater and sediment control BMPs have been installed.

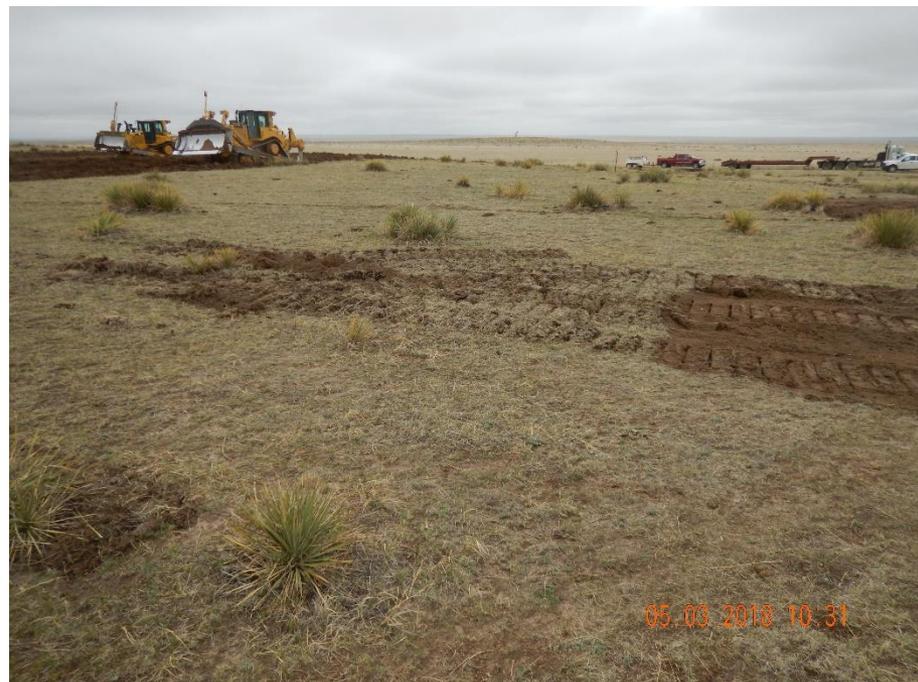
Photo 4: Photo taken from the southwest end of the constructions site, facing east. Photo shows construction activities in process, however, no stormwater and sediment control BMPs have been installed.

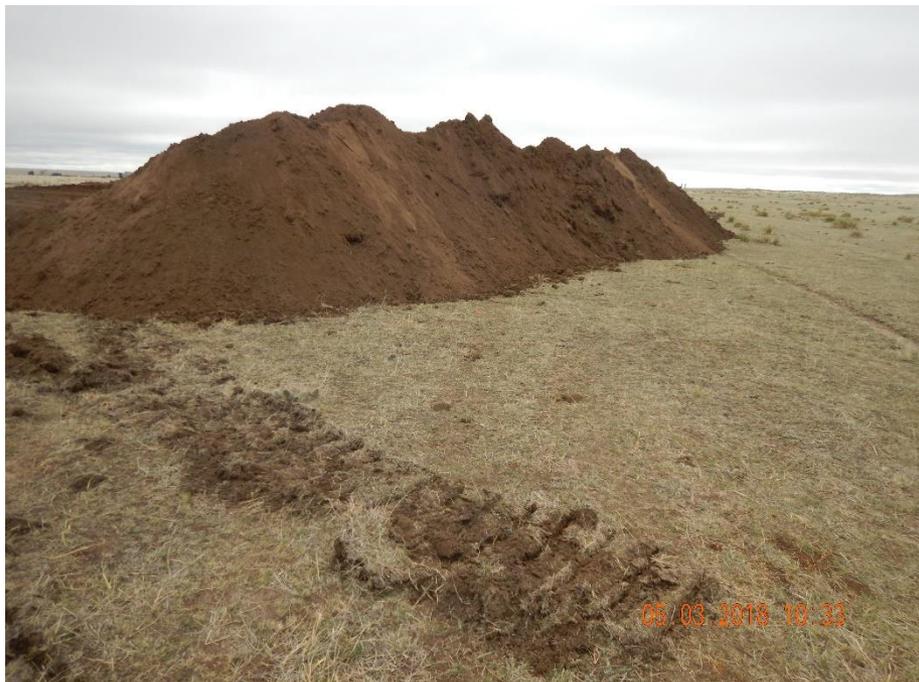
Photo 5: Photo taken from the northwest end of the construction site, facing south. Photo shows construction activities in process, and the topsoil pile however, no stormwater and sediment control BMPs have been installed.

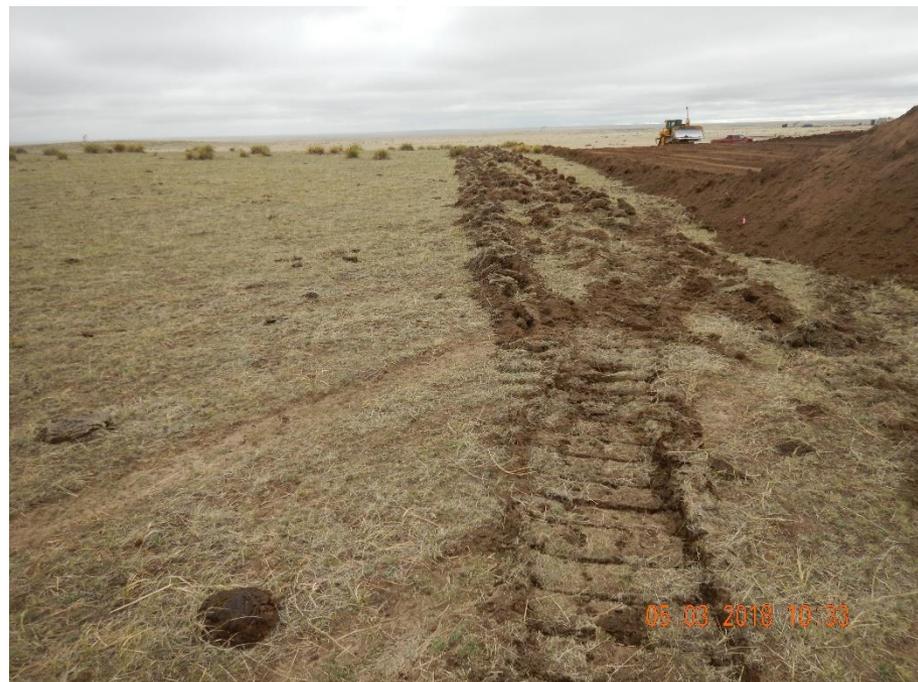
Photo 6: Photo taken from the northwest end of the construction site, facing east. Photo shows surface roughening has been installed on the northern perimeter of the location. Surface roughening alone is insufficient for a control.

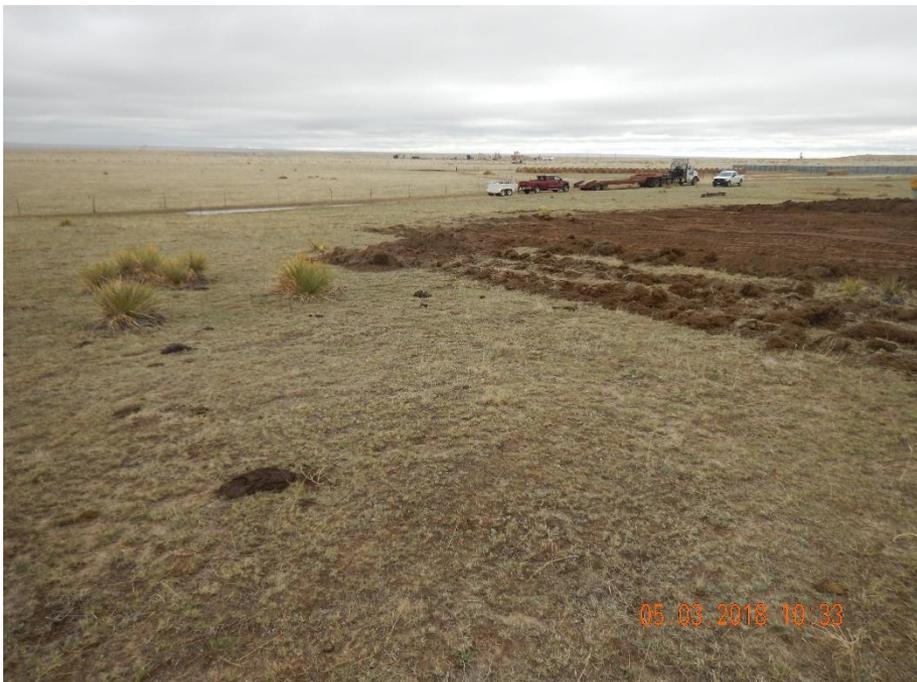
Photo 7: Photo taken from the north end of the construction site, facing southeast. Photo shows construction activities in process, and the topsoil pile however, no stormwater and sediment control BMPs have been installed.

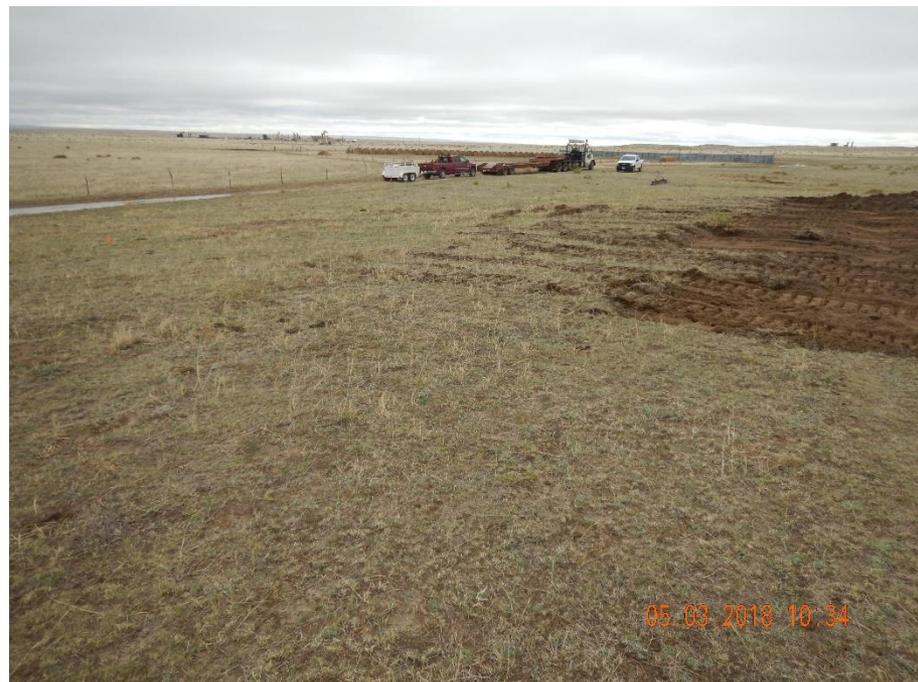
Photo 8: Photo taken from the north end of the construction site, facing southeast. Photo shows construction activities in process, and the topsoil pile however, no stormwater and sediment control BMPs have been installed.
