Inspection Photos

Operator: WIEPKING-FULLERTON ENERGY LLC -
96340

Location ID: 433577

Inspection Doc. Number: 682503301
Lincoln County, CO

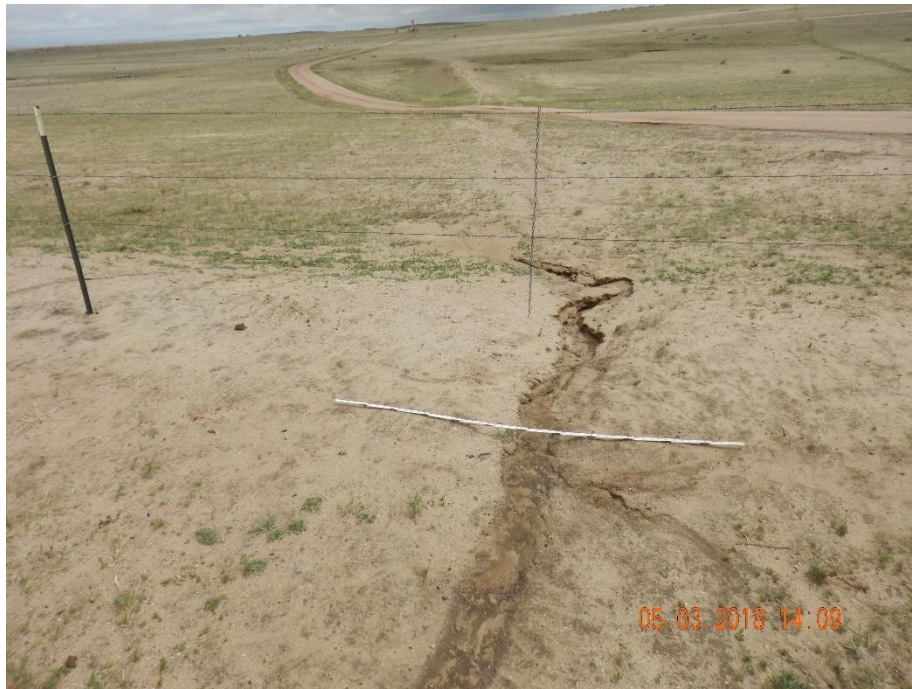
Photo 1: Photo taken from the southwest end of the location, facing south. Photo shows stormwater erosion degradation resulting in sediment transport from location onto the interim areas. 6 foot measuring stick for reference.

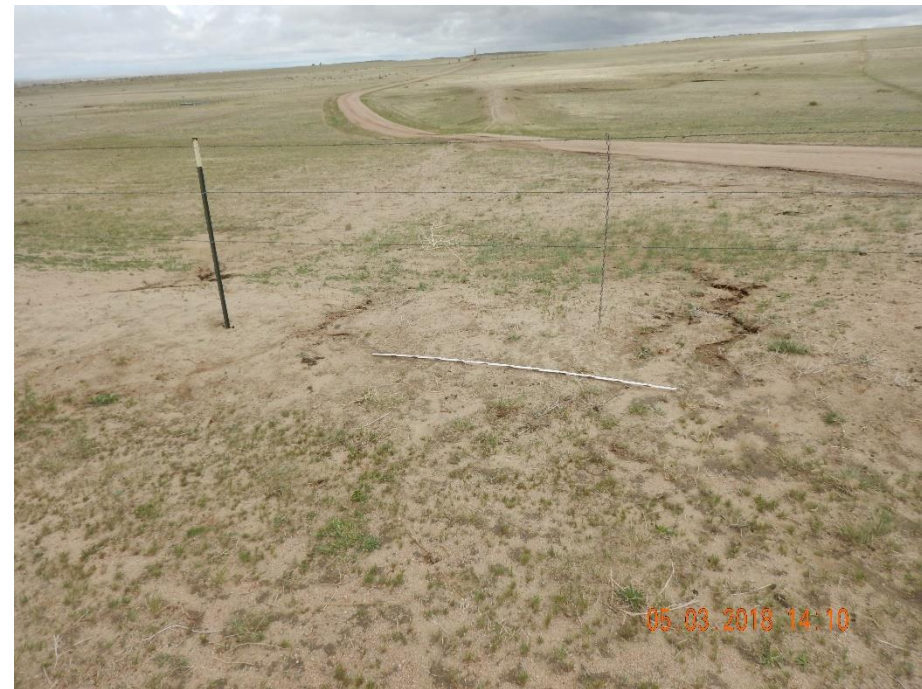
Photo 2: Photo taken from the southwest end of the location, facing south. Photo shows stormwater erosion degradation resulting in sediment transport from location onto the interim areas. 6 foot measuring stick for reference.

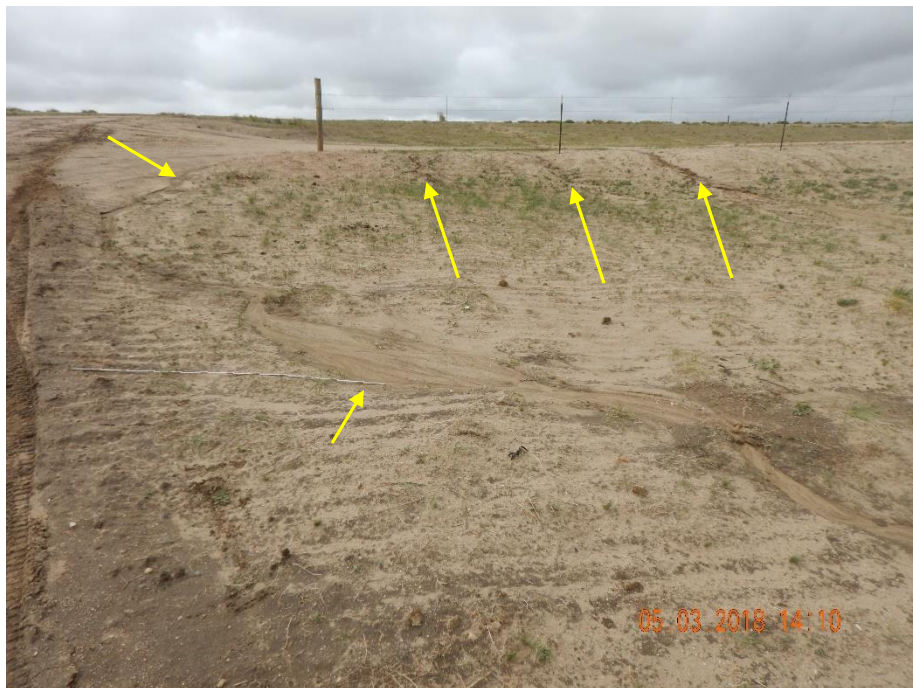
Photo 3: Photo taken from the southwest end of the location, facing north. Photo shows stormwater erosion degradation resulting in sediment transport from location and access road onto the interim areas.

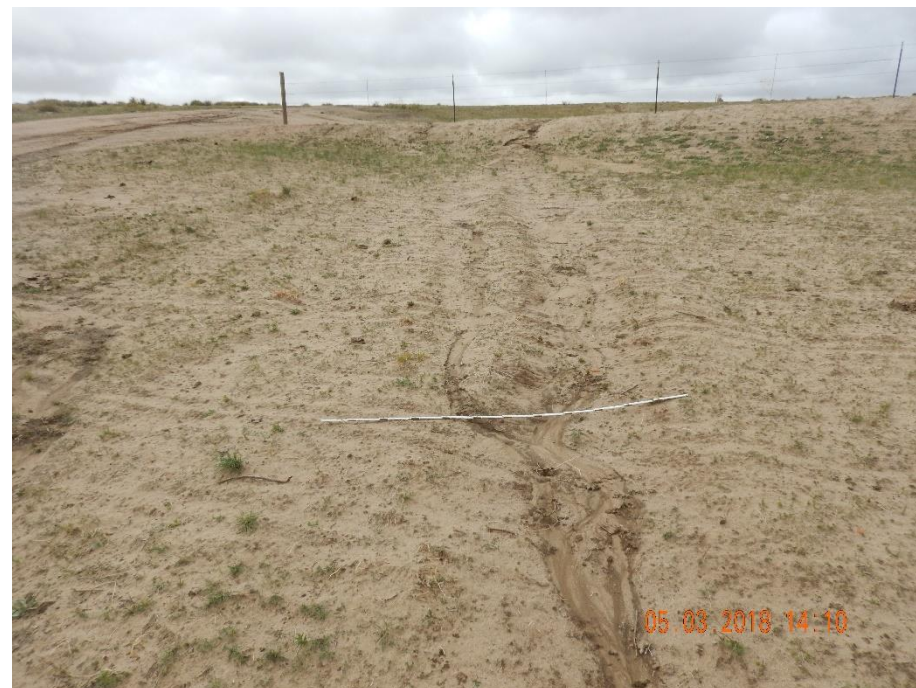
Photo 4: Photo taken from the interim areas south of the location, facing north. Photo shows stormwater erosion degradation resulting in sediment transport from location onto the interim areas. 6 foot measuring stick for reference

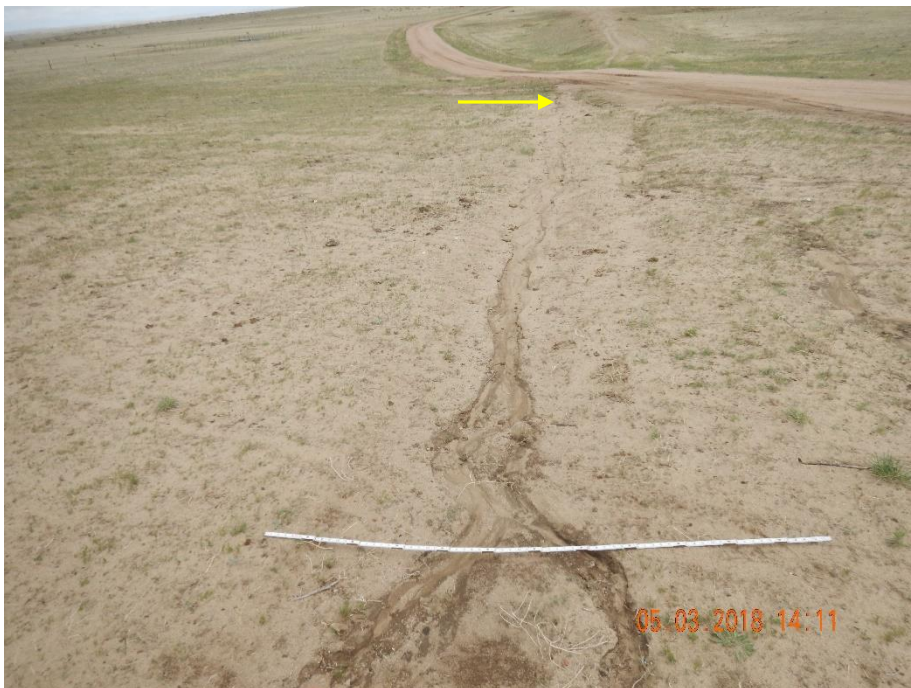
Photo 5: Photo taken from the interim areas south of the location, facing south. Photo shows stormwater erosion degradation resulting in sediment transport from location onto the interim areas. 6 foot measuring stick for reference

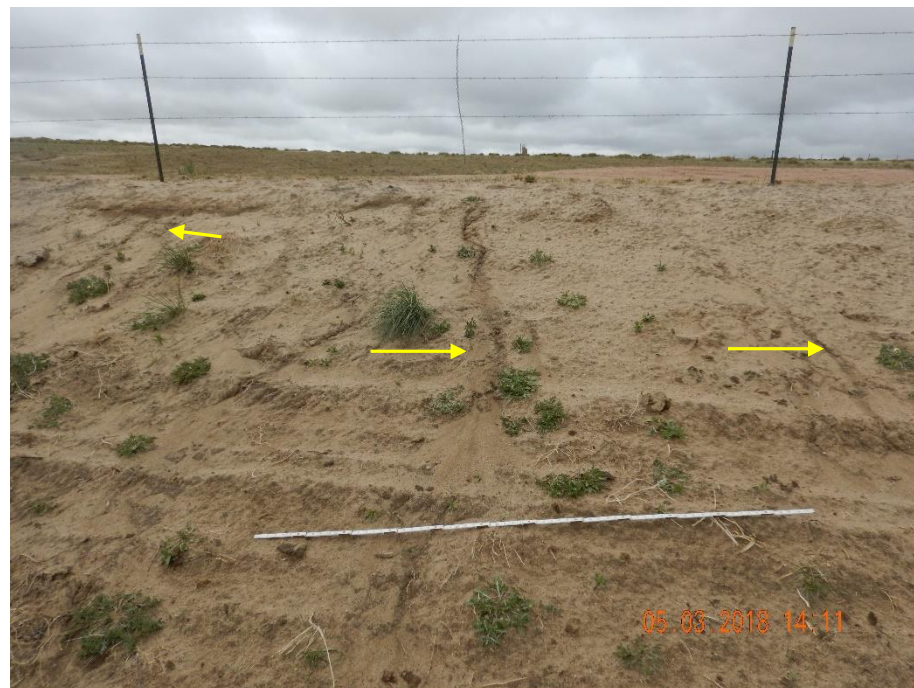
Photo 6: Photo taken from the south end of the location. Photo shows stabilization concerns on the the slopes of the well pad. Insufficient stormwater and sediment control BMPs in place.

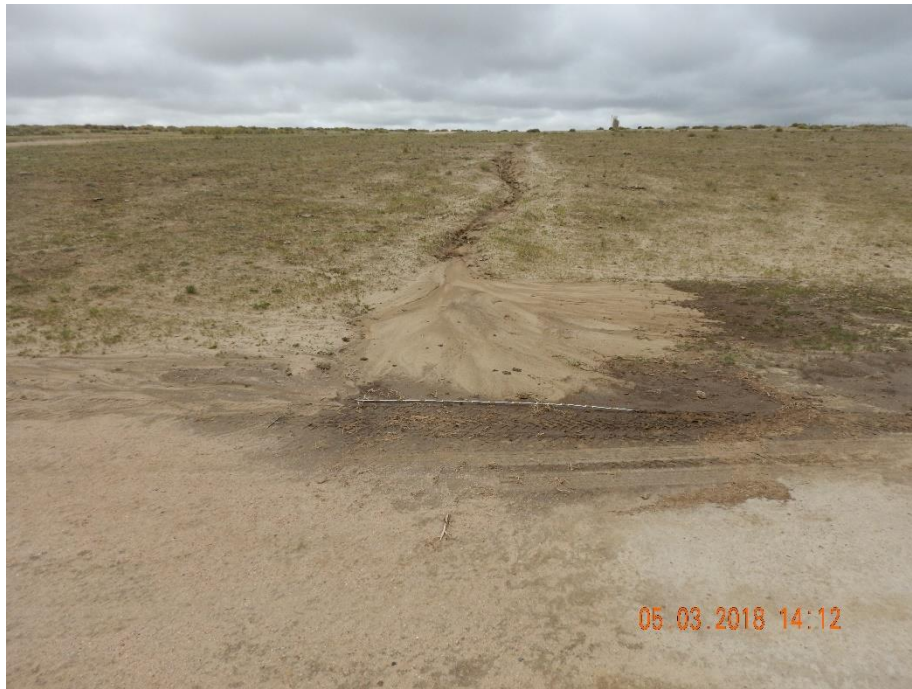
Photo 7: Photo taken from the west end of the location, facing north. Photo shows stormwater erosion degradation resulting in sediment transport from the interim areas onto the location. 6 foot measuring stick for reference.

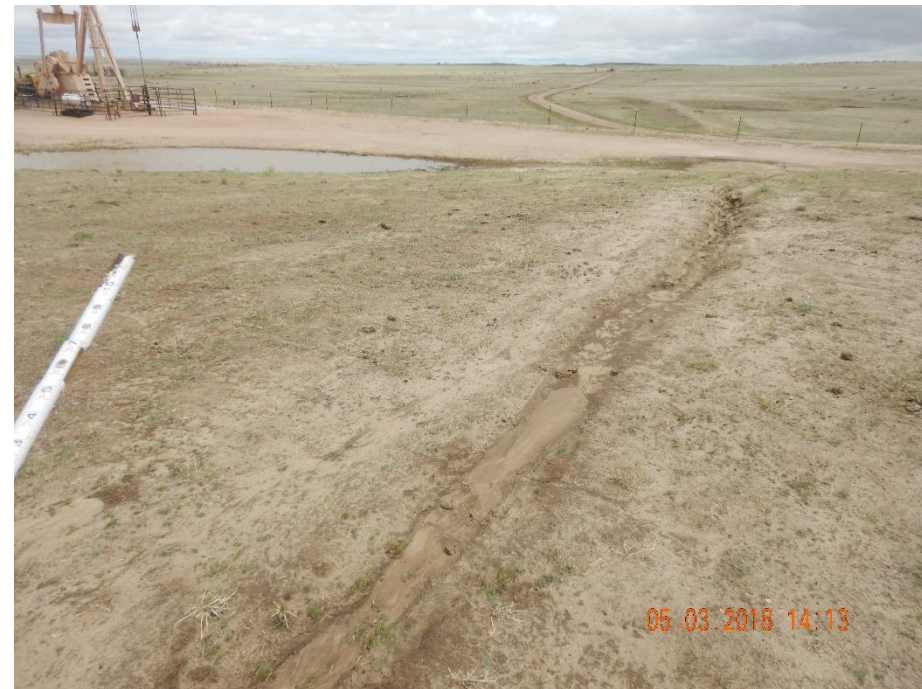
Photo 8: Photo taken from the interim areas on the northwest end of the location, facing south. Photo shows stormwater erosion degradation resulting in sediment transport from the interim areas onto the location.
