**Inspection Photo
Clough RWF 321-14
API# 045-14028
Inspection # 689301042**

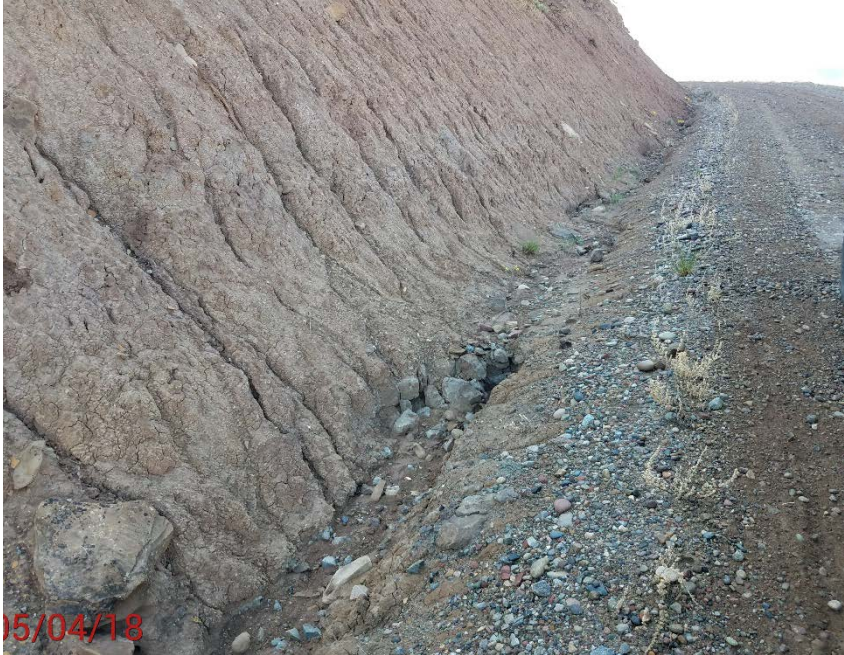
Location photo # 1 Ditch erosion along the side of the road

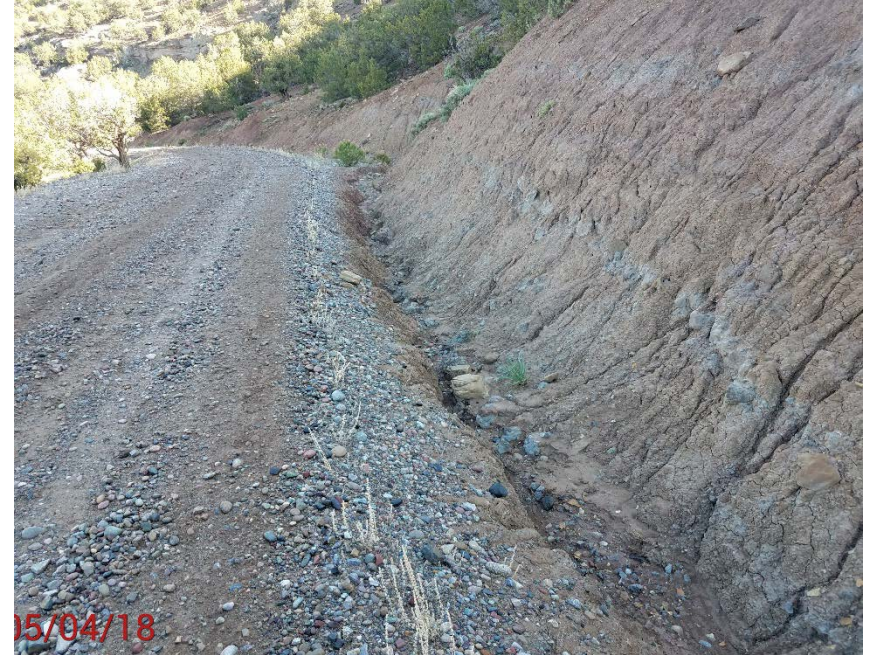
Location photo #2 Ditch erosion along the side of the road

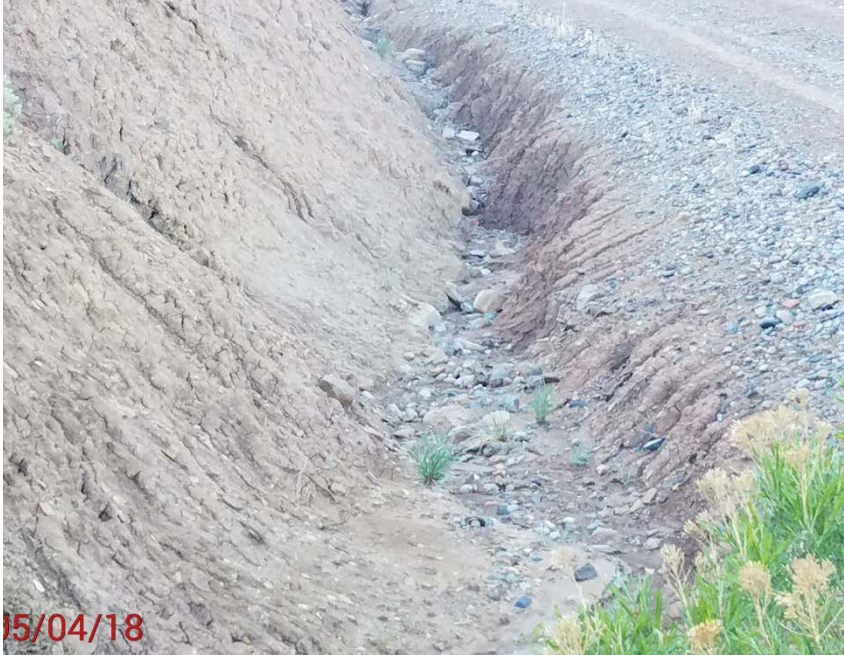
Location photo # 1 Ditch erosion along the side of the road

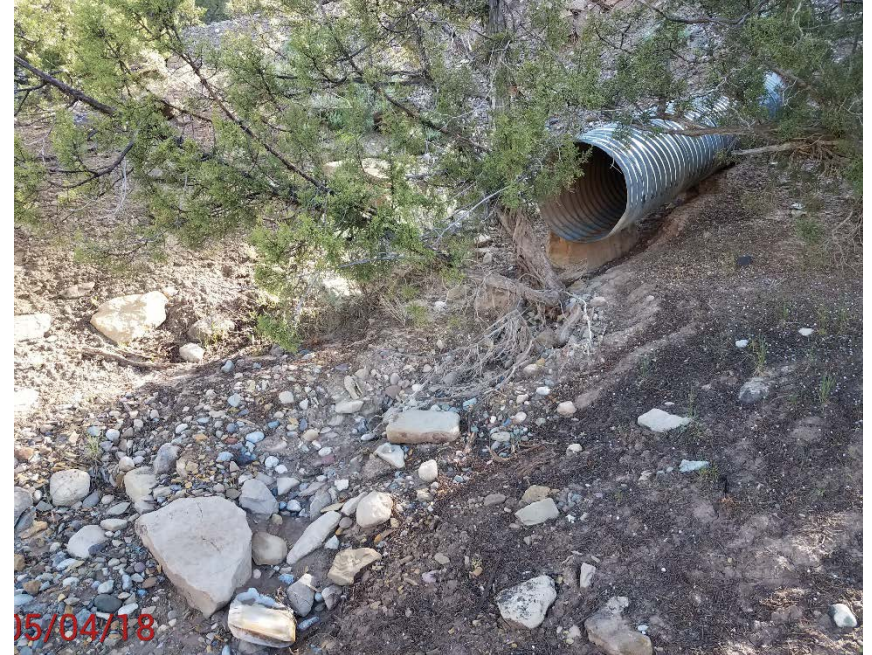
Location photo #2 Erosion at out let of culvert

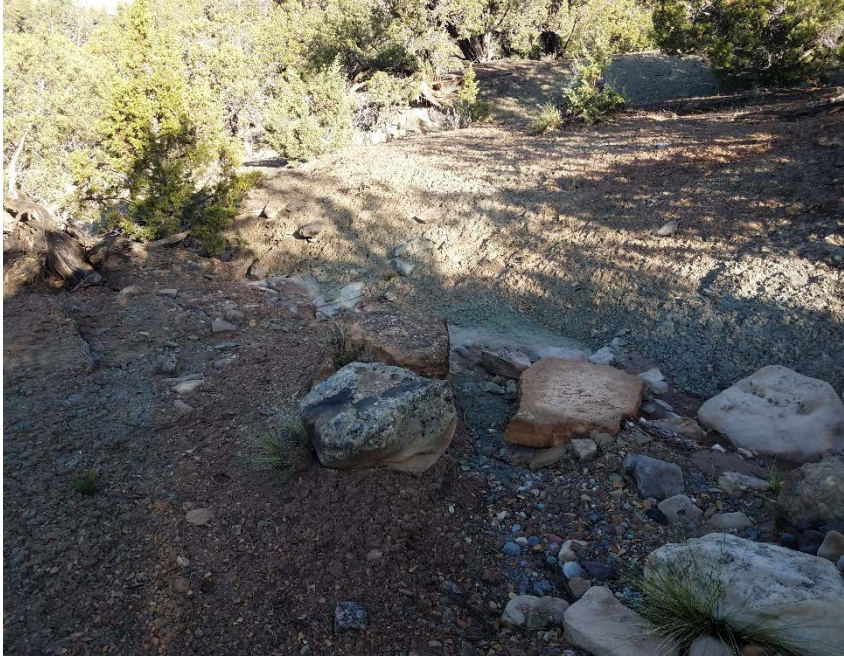
Location photo # 1 Continued Erosion below culvert

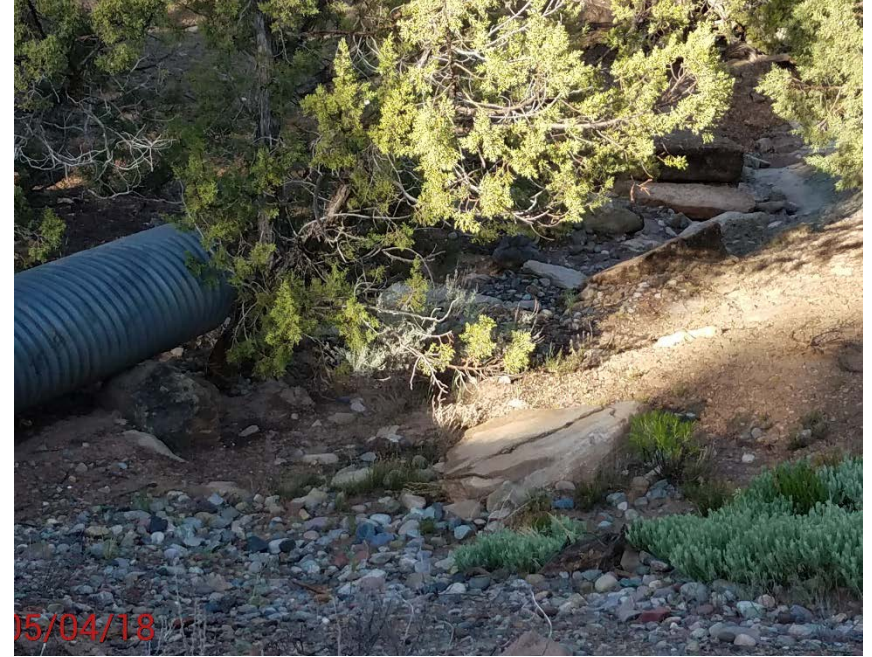
Location photo #2 Culvert Erosion
