**Inspection Photo
Clough RWF 34-14
API# 045-08991
Inspection # 689301049**

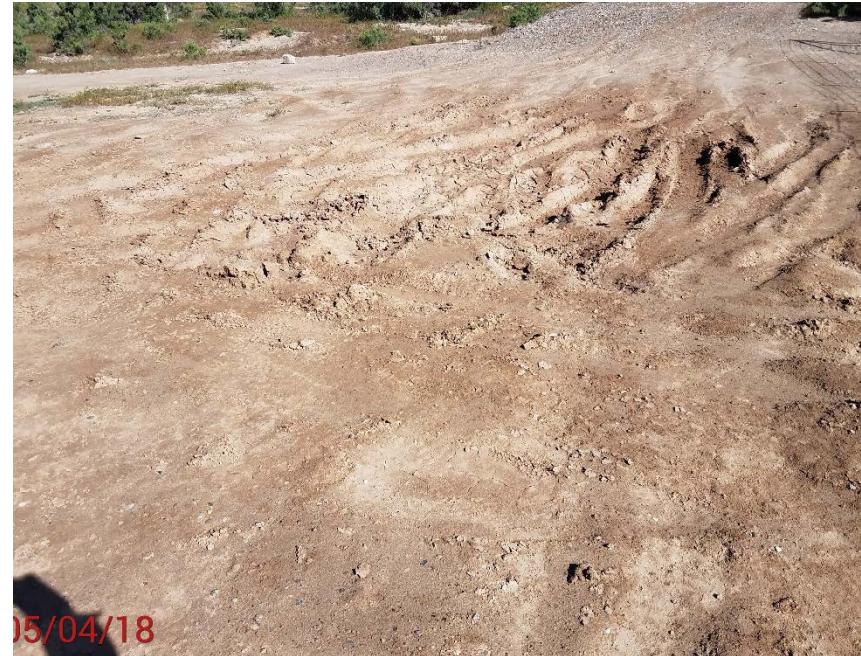
Location photo #2, Ruttred location

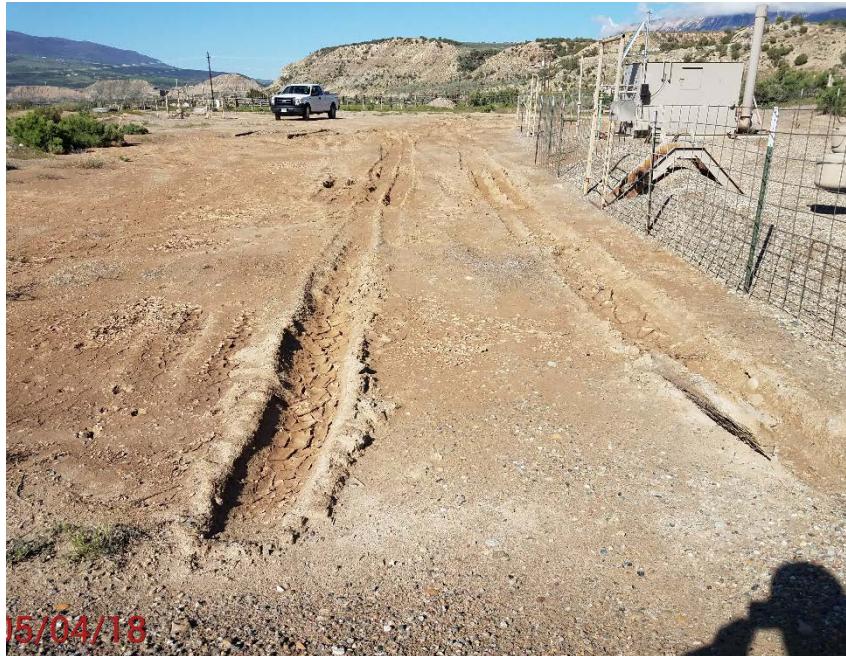
Location photo # 3 Ruttred location
