**Inspection Photos**  
**Location Name: Haley-Ray 611N61W / 21SWSW**  
**Location #: 305413**

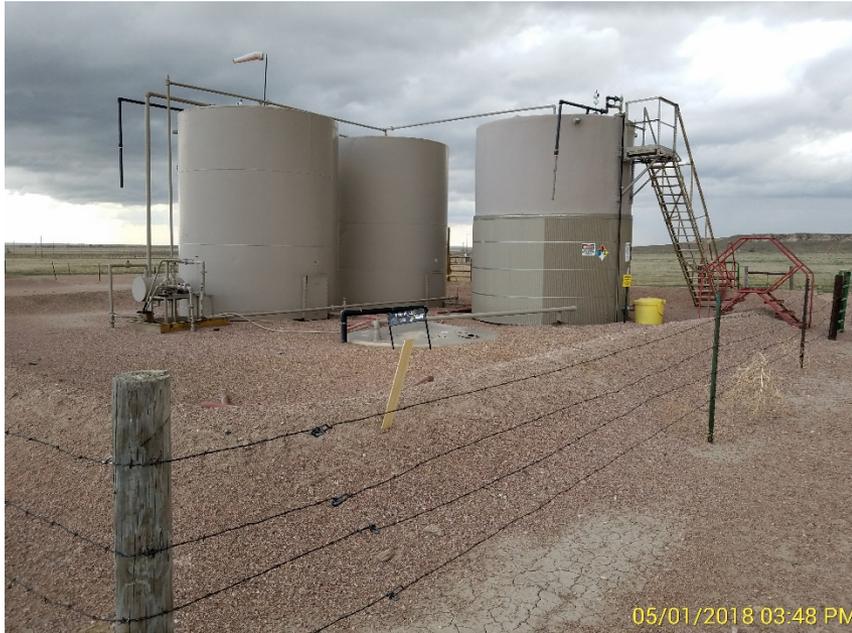
**Photo #1**  
**Facing NW**  
**Animal burrows in berms have been filled**

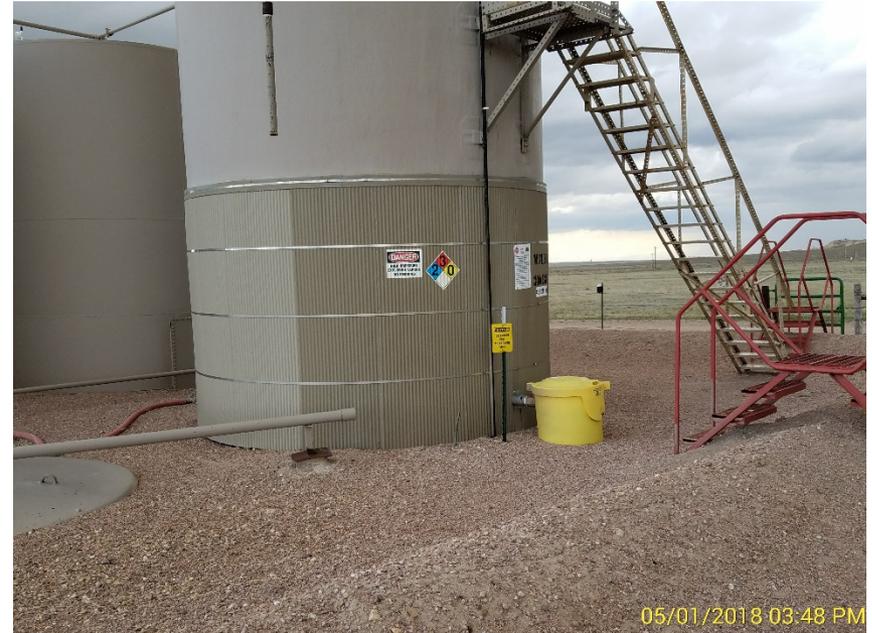
**Photo #2**  
**Facing NW**  
**Unused fittings have been removed**

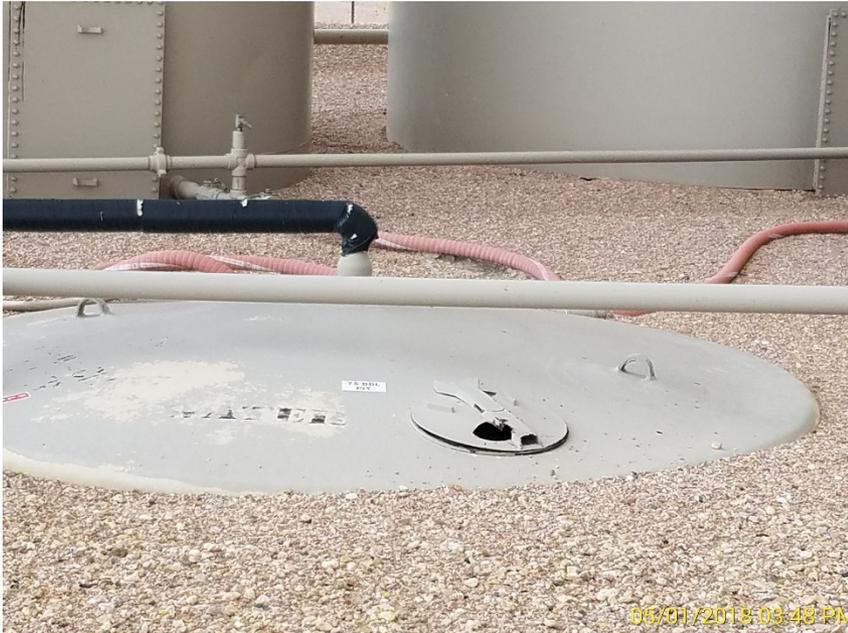
**Photo #3**  
**Facing West**

**PBV – Fiberglass H2O tank capacity now shown**

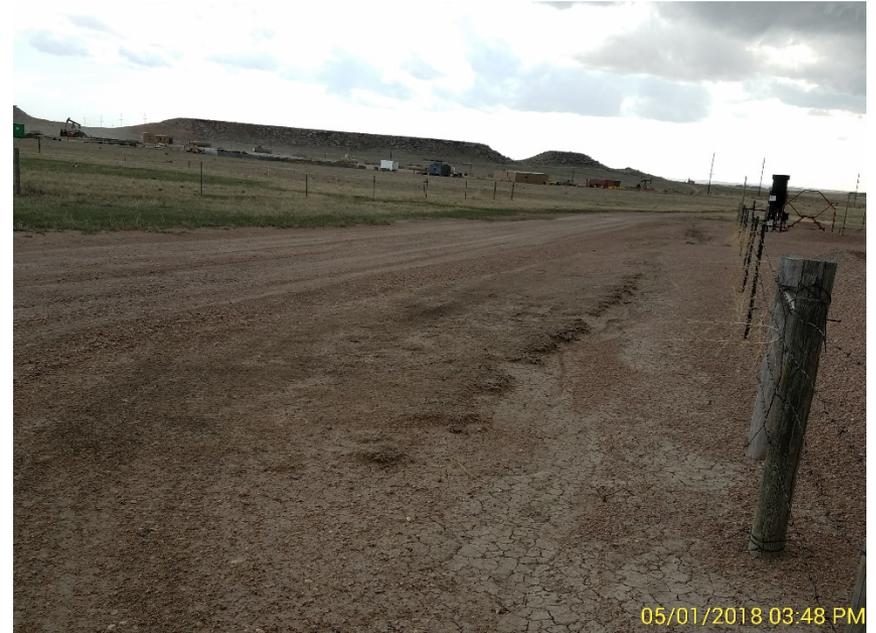
**Photo #4**  
**Facing West**

**Severe erosion appears to have been mitigated**

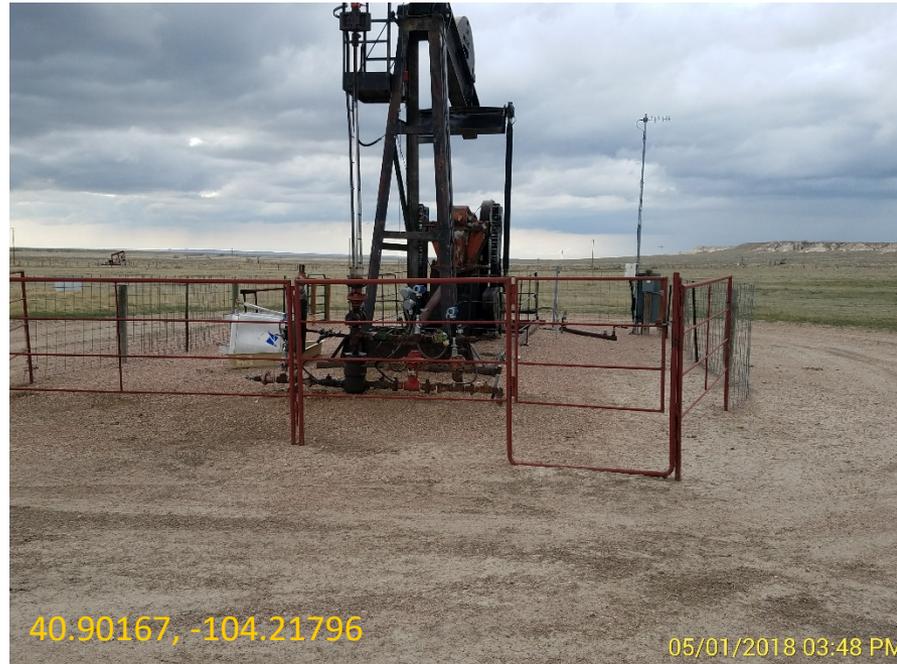
**Photo #5**

**Haley Ray 13-21 wellhead facing NW.  
Stained soil appears to have been mitigated.**
