Inspection Photo
Miller 14D-6-691
API# 045-14098
Inspection # 689301065

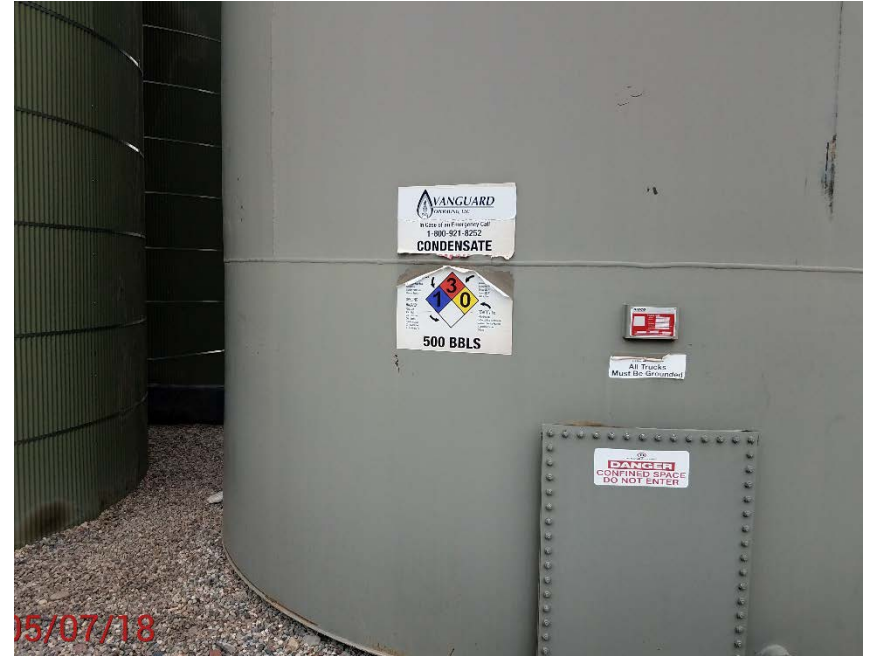
Location photo # 4, Peeling Tank sign

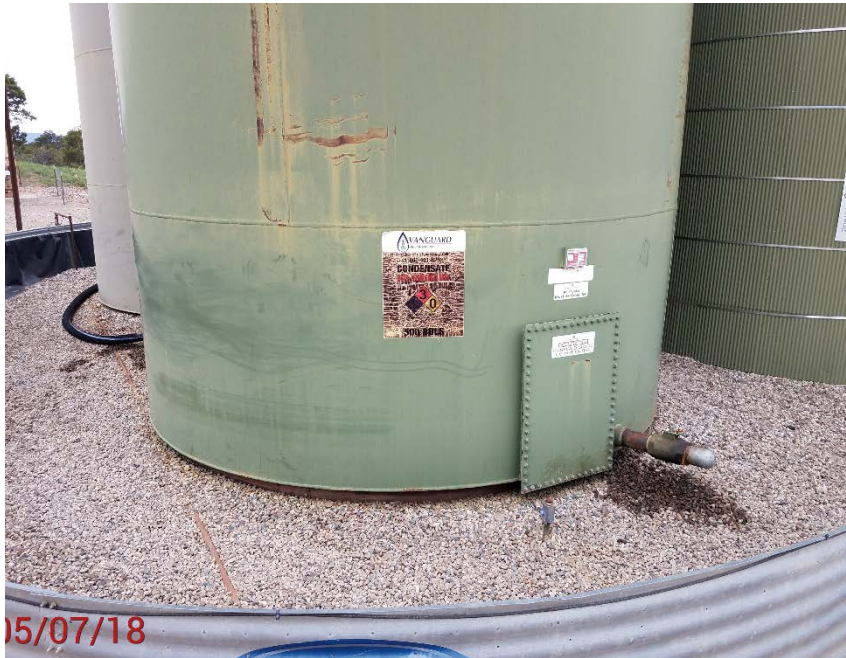
Location photo # 5, Sign not legible

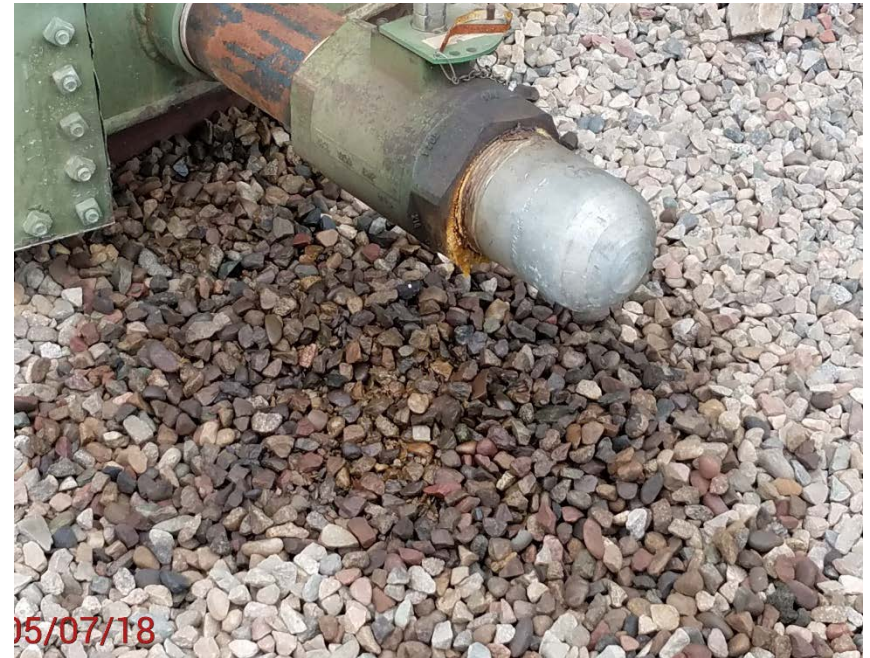
Location photo #6, Stained rock in tank battery containment.

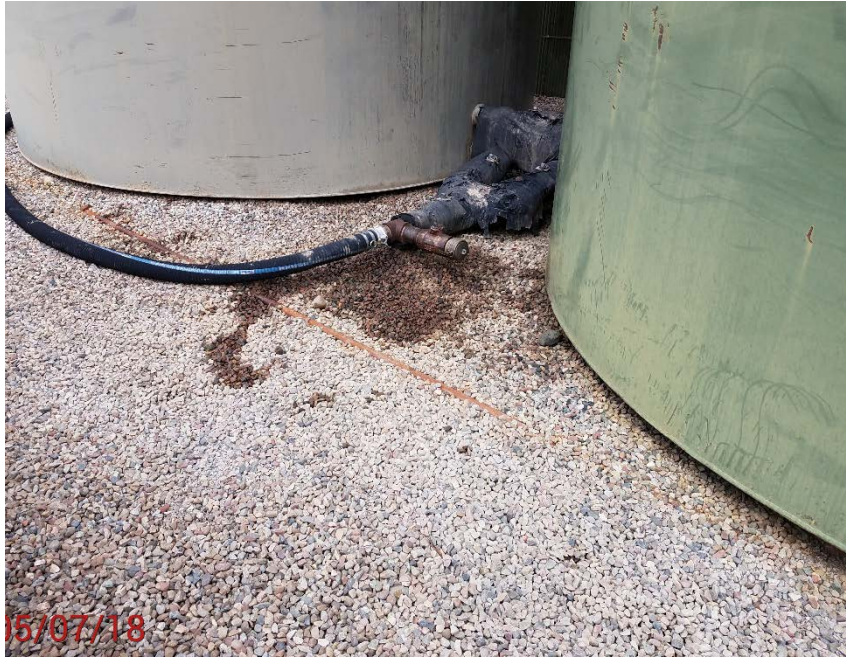
**Location photo # 7, Stained rock in tank
battery containment**

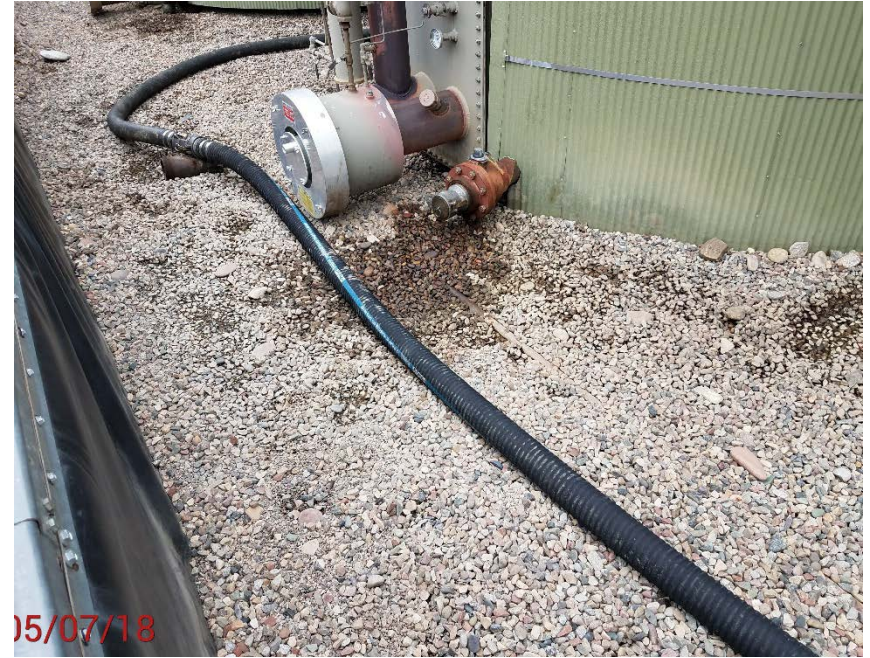
**Location photo # 8, stained rock in tank
battery containment**

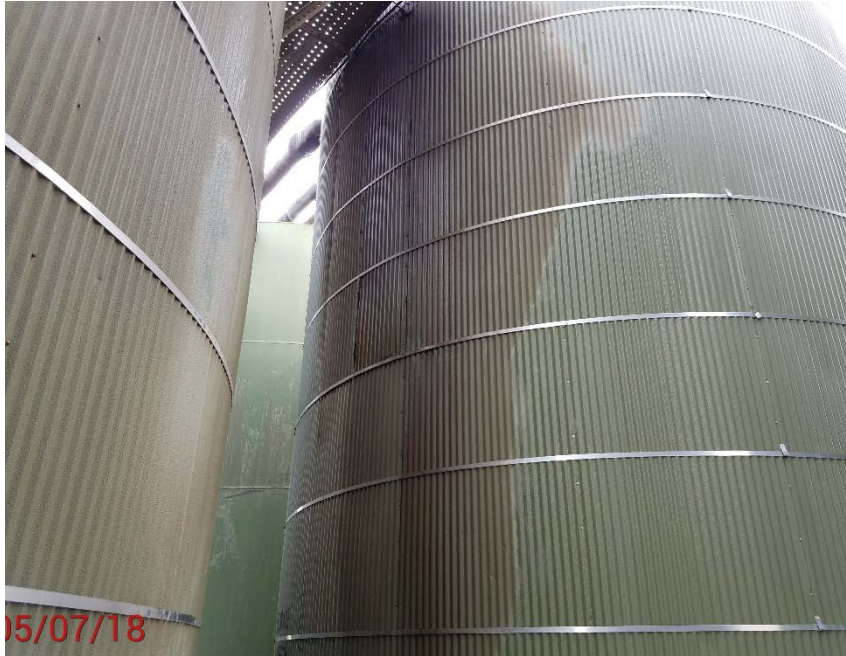
Location photo # 9, oily residue on tanks

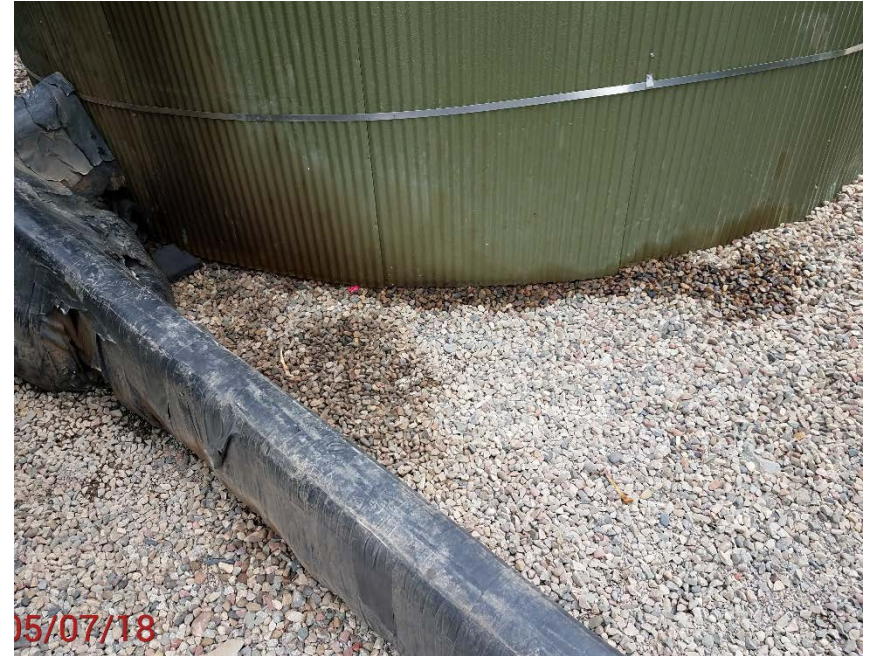
**Location photo # 10, stained rock in tank
battery containment**

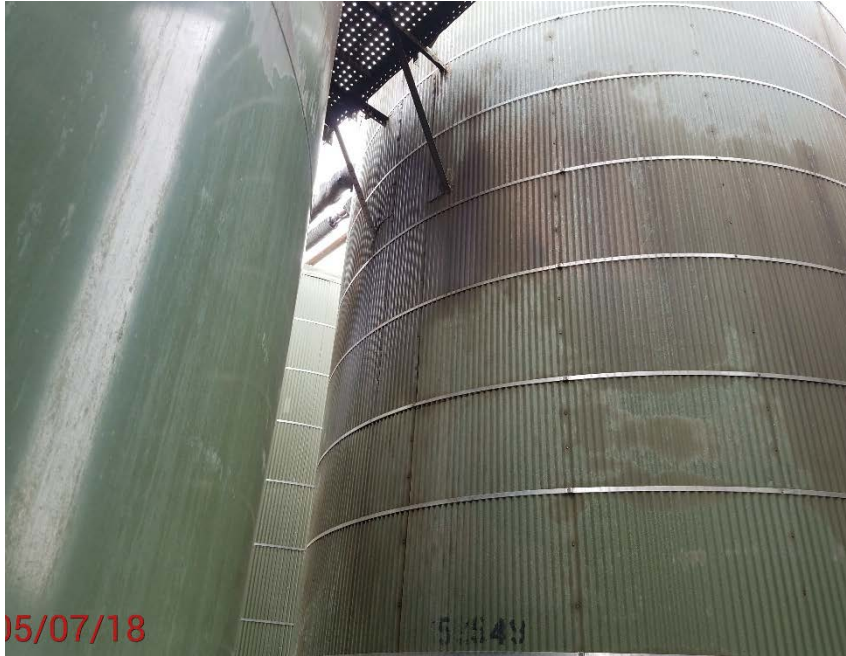
Location photo # 11, oily residue on tank

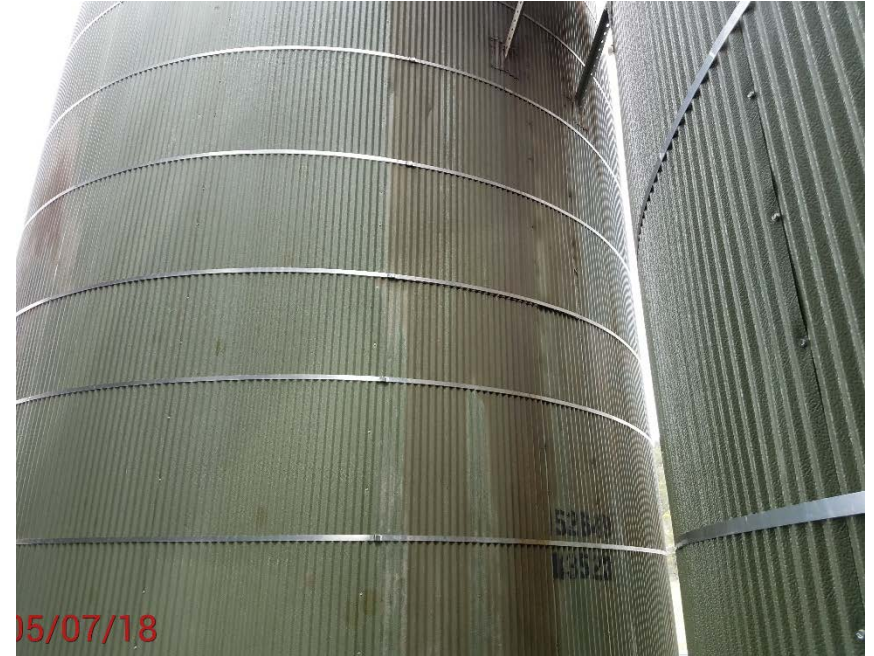
Location photo # 12, Oily residue on tank

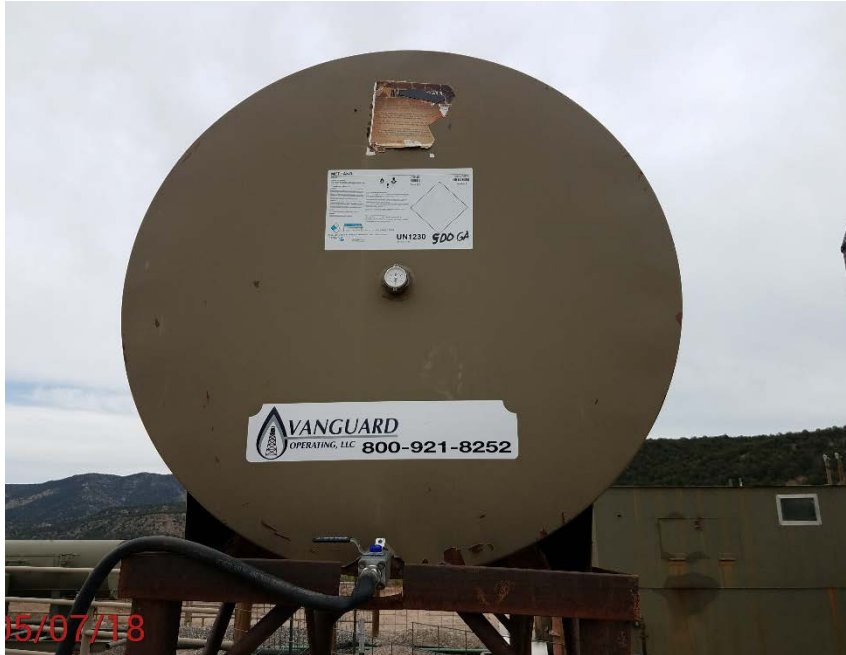
Location photo # 13, Faded sign on methanol tank

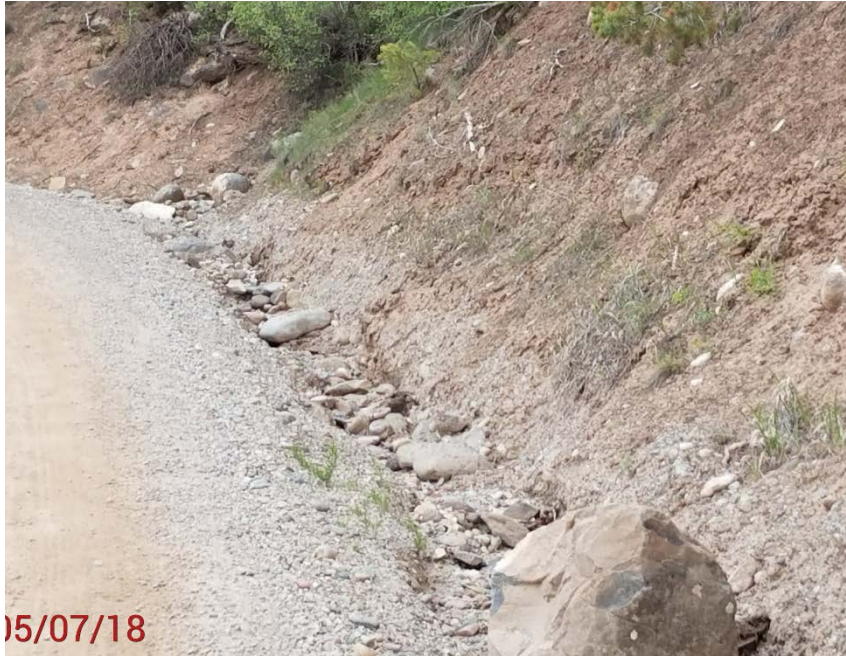
Location photo # 14, Storm water issue on access road

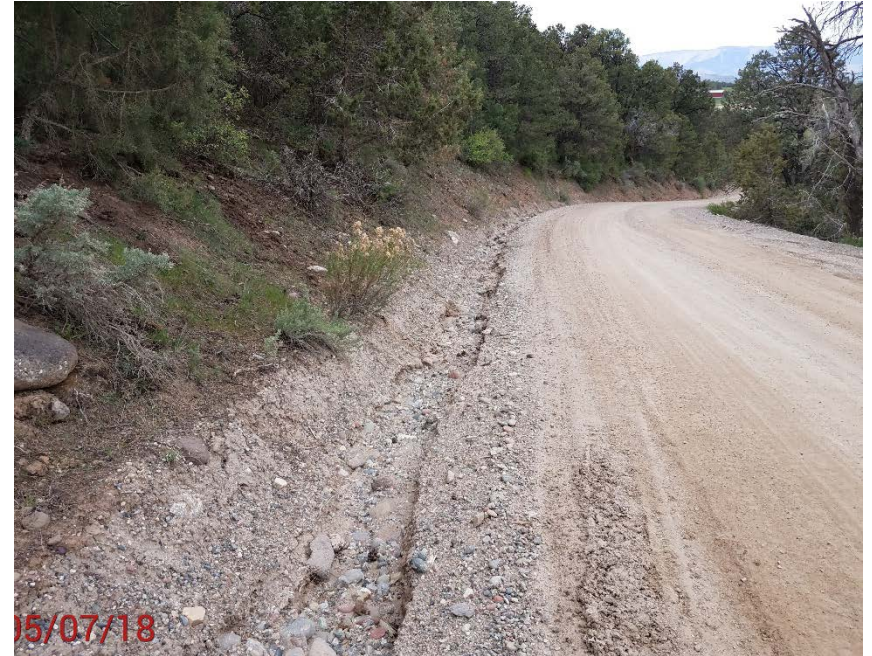
Location photo # 15, Storm water issue on access road

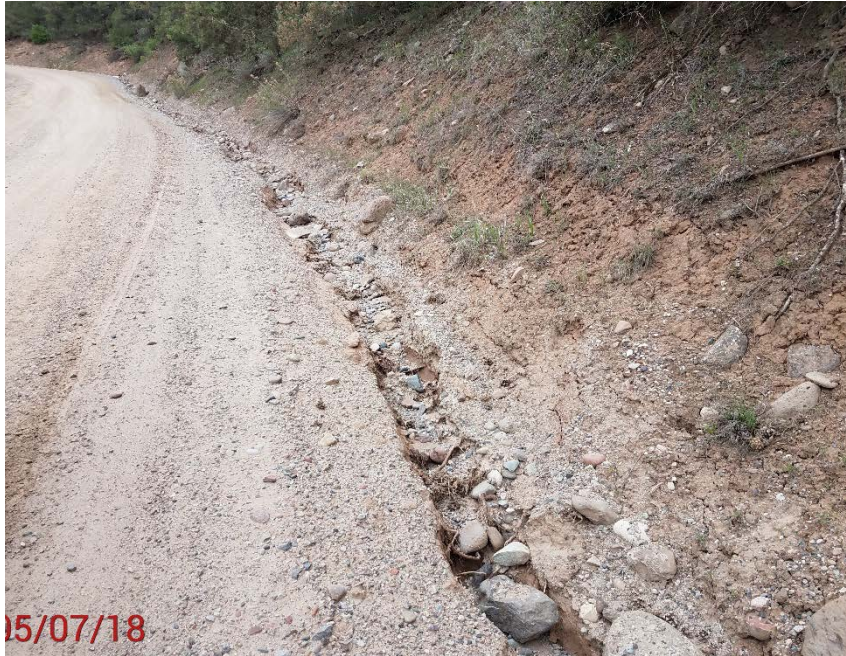
Location photo # 16, Storm water issue on access road

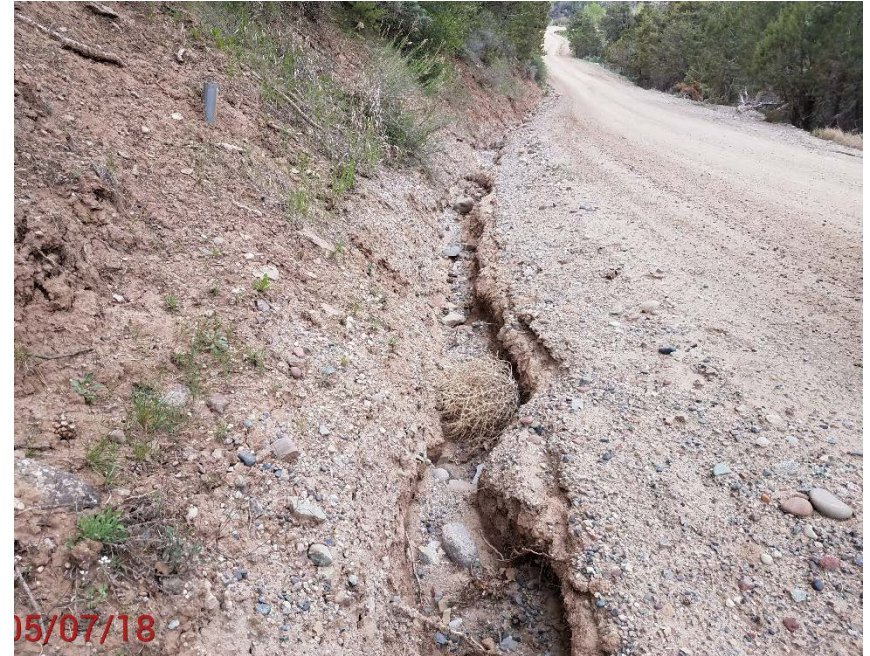
Location photo # 17, Storm water issue on access road

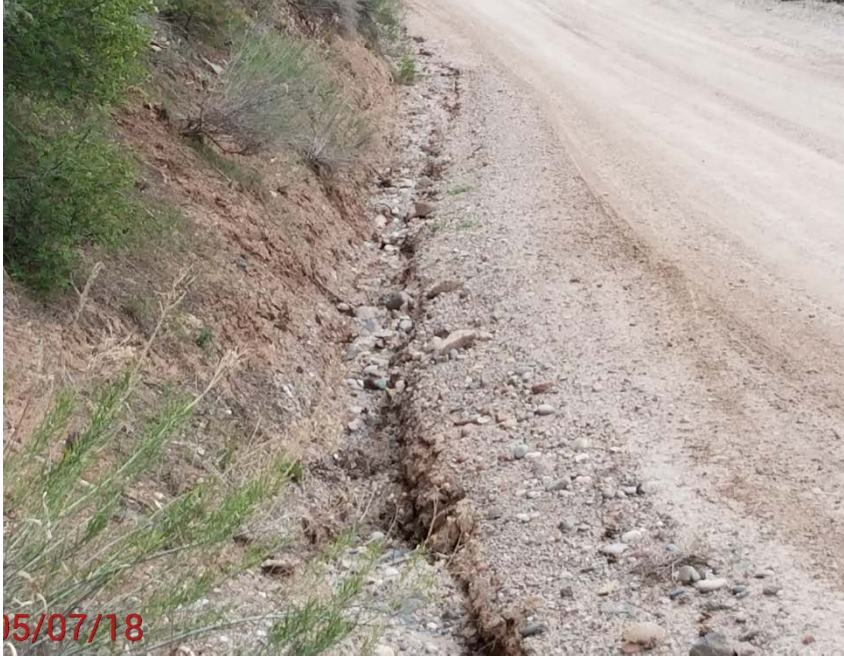
Location photo # 18, Storm water issue on access road

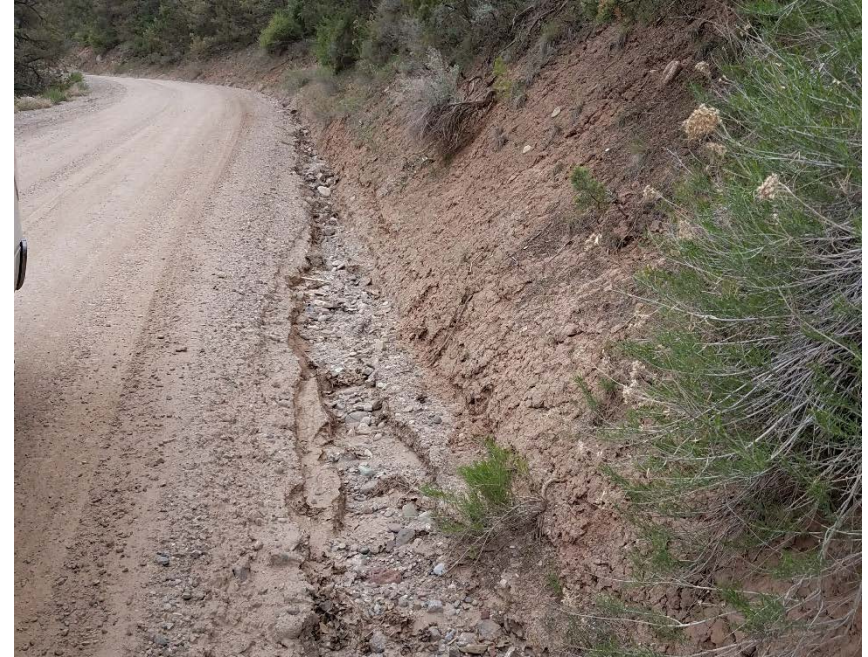
Location photo # 19, Storm water issue on access road
