# Inspection Photos

API: 05-083-06728

Operator: KINDER MORGAN CO2 CO LP

Inspection Date: 4/18/2018

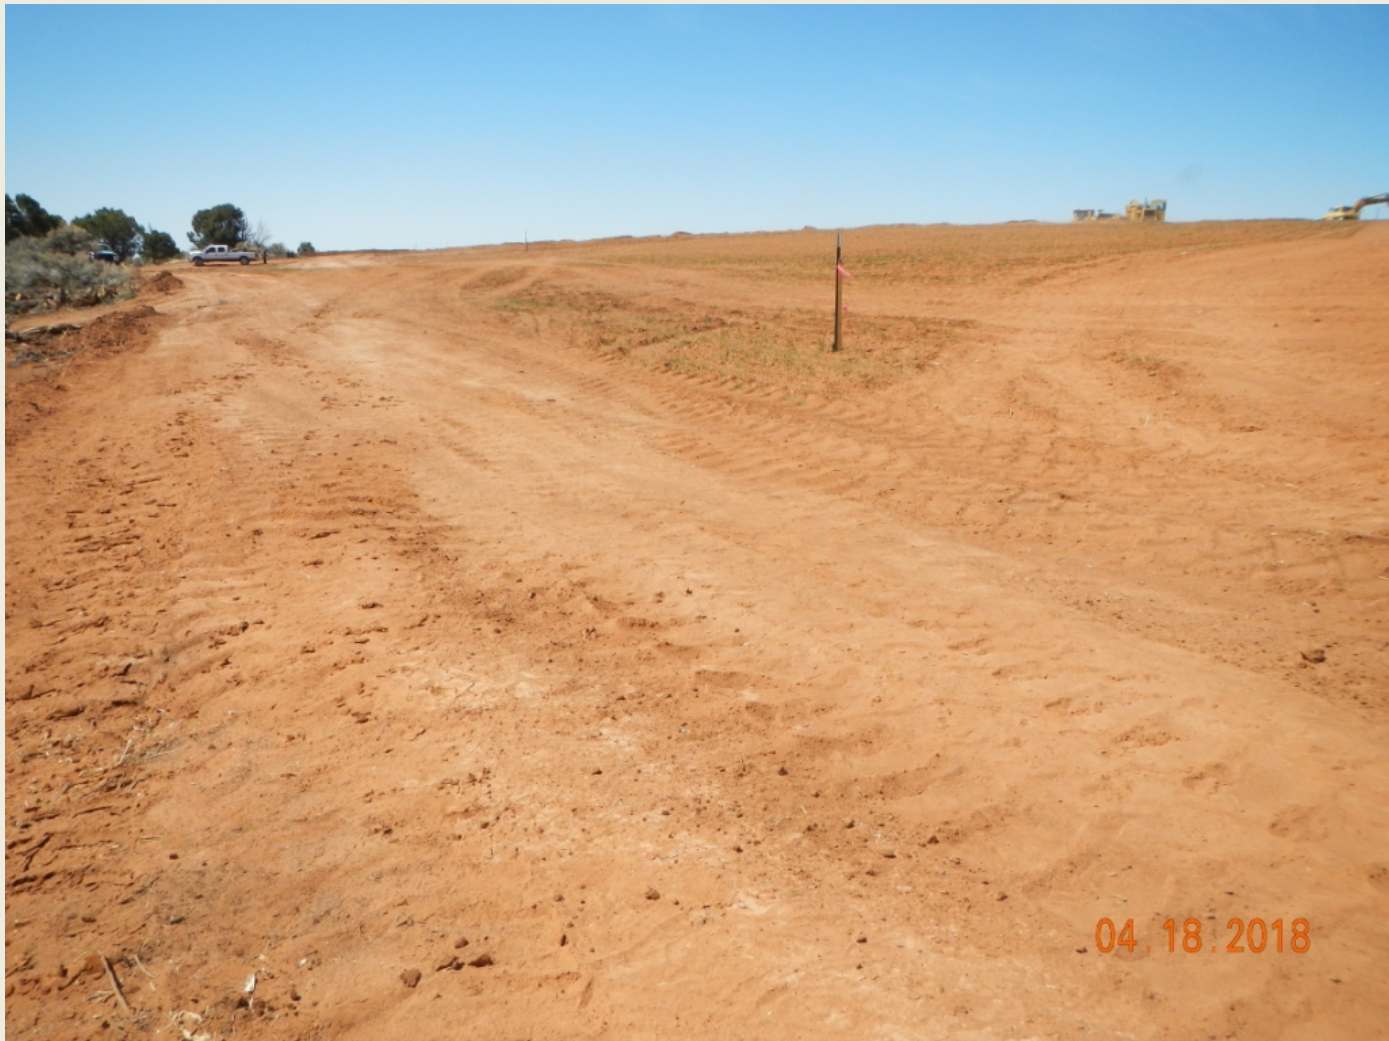
**Photo 1. View of the project area from the northeastern corner facing center.**

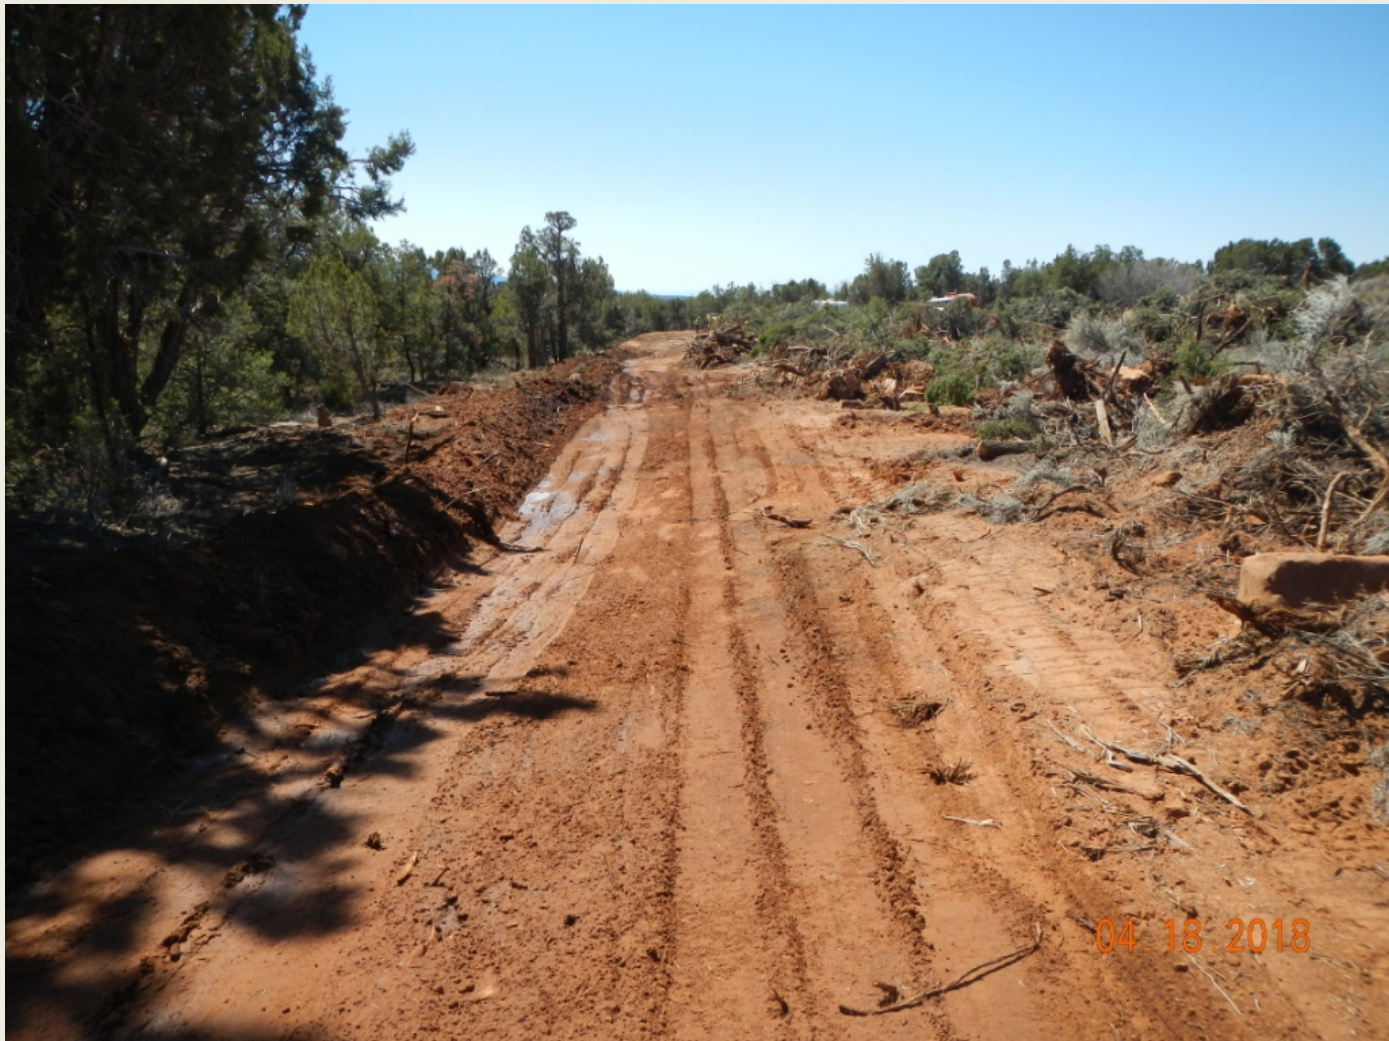
**Photo 2. View of the edge of the project area from the northeastern corner facing southward. Vegetation removal is occurring and berms are being constructed. Per communication with onsite management, berm compaction will be completed this day.**

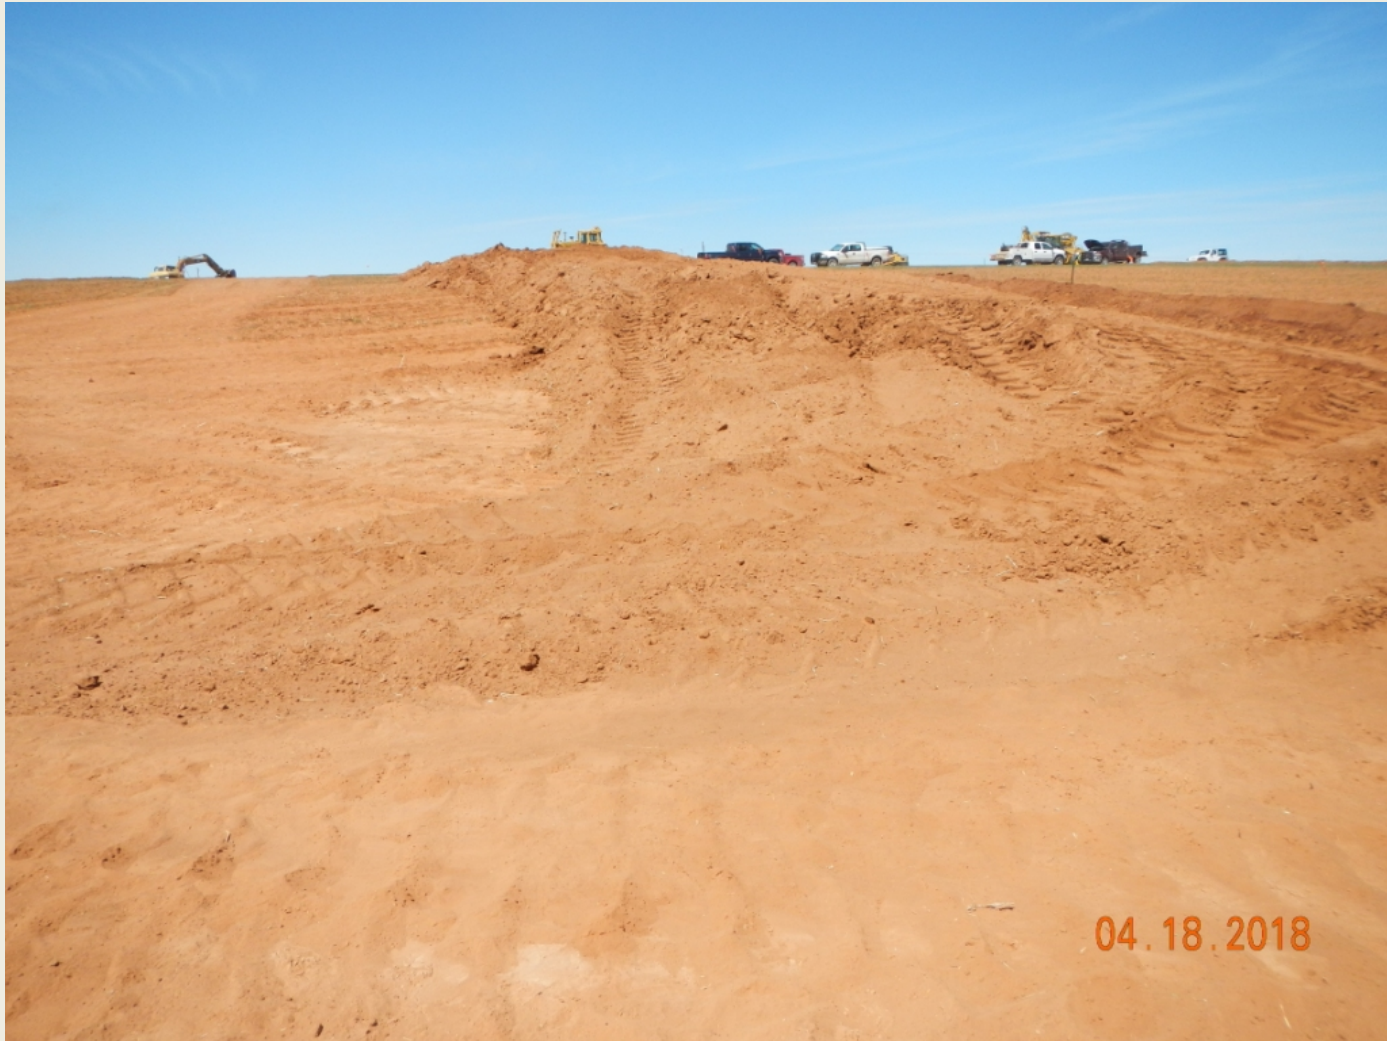
**Photo 3. View of the northern portion of the project area from the northeastern portion facing westward.**

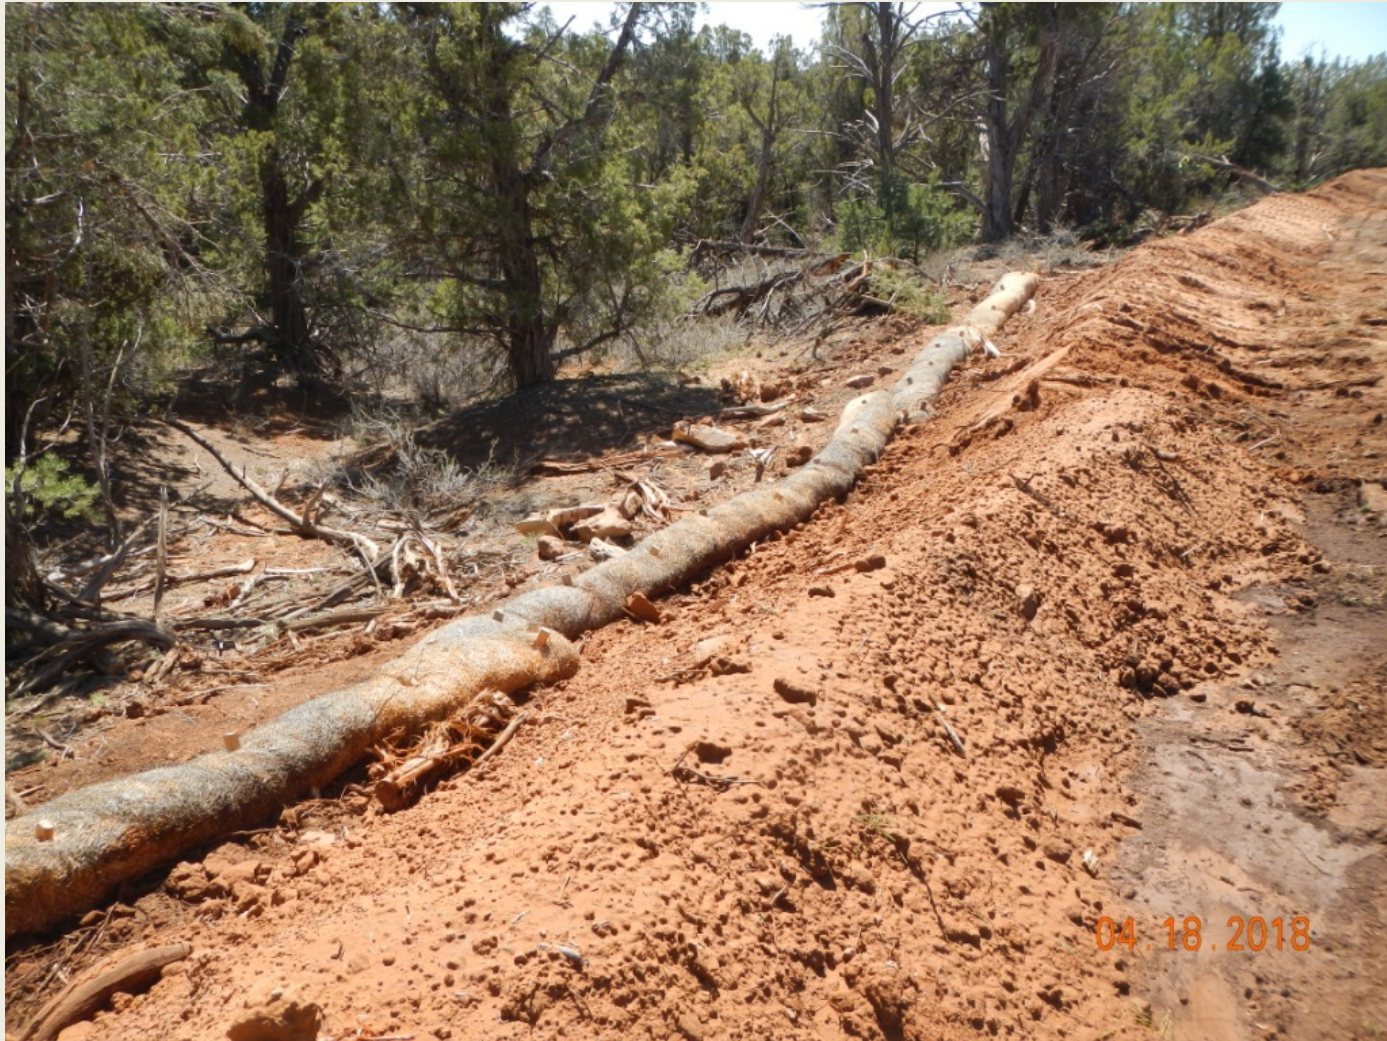
**Photo 4. View of wattles in the eastern project area. Wattles should be placed outside of disturbed soils to prevent runoff.**

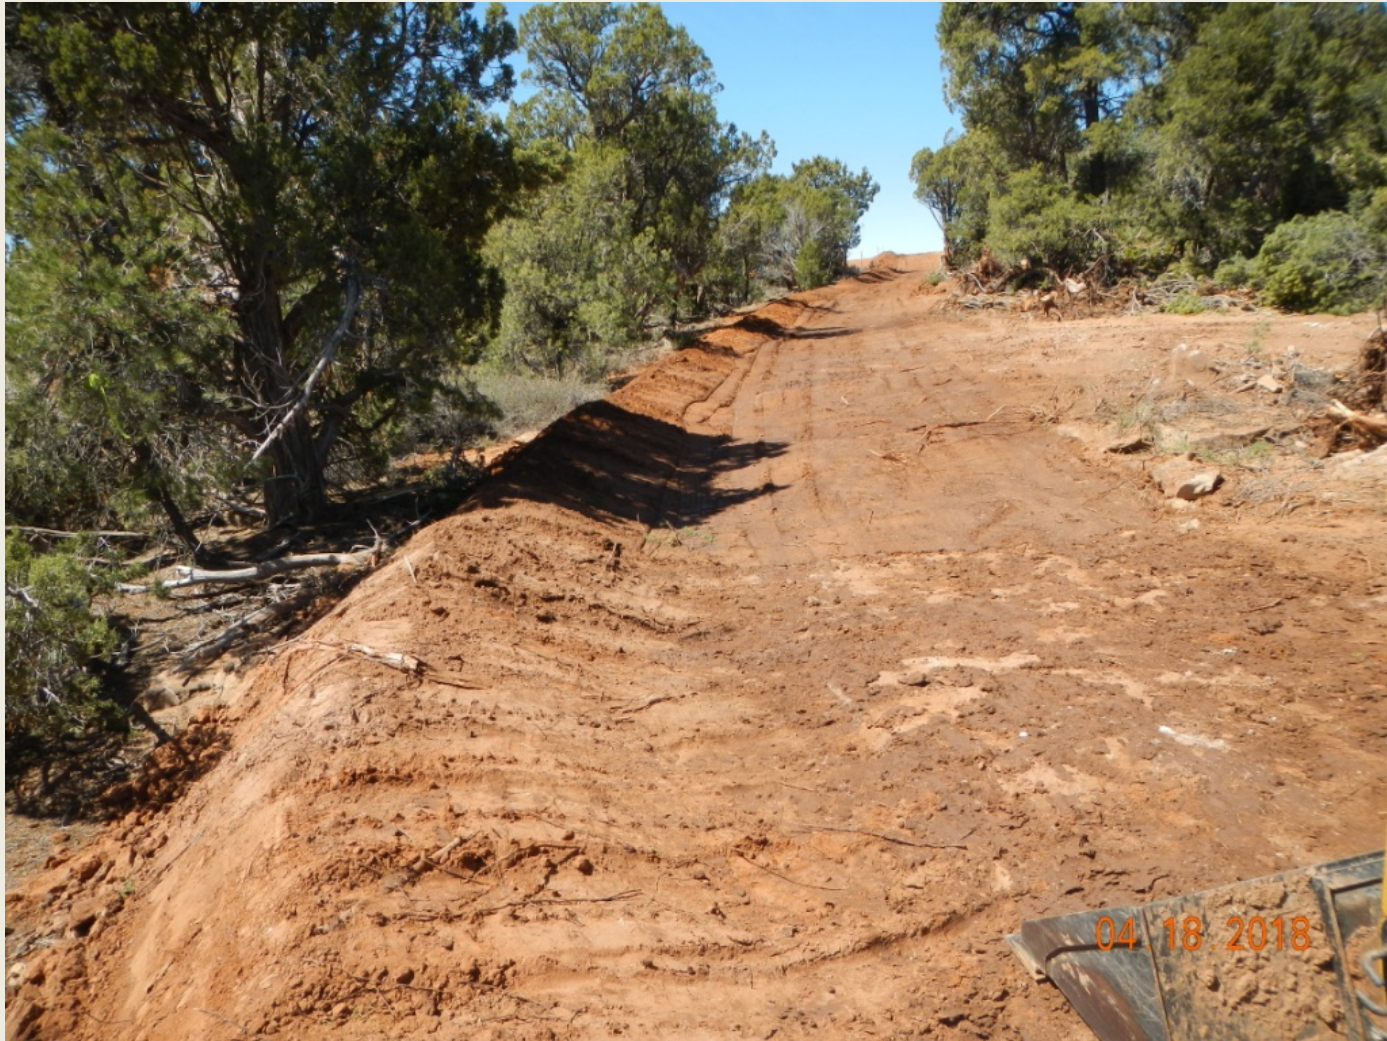
**Photo 5. View of the southeastern edge of the project area. Berms are properly compacted here. Vegetation on the well pad is in process of removal.**

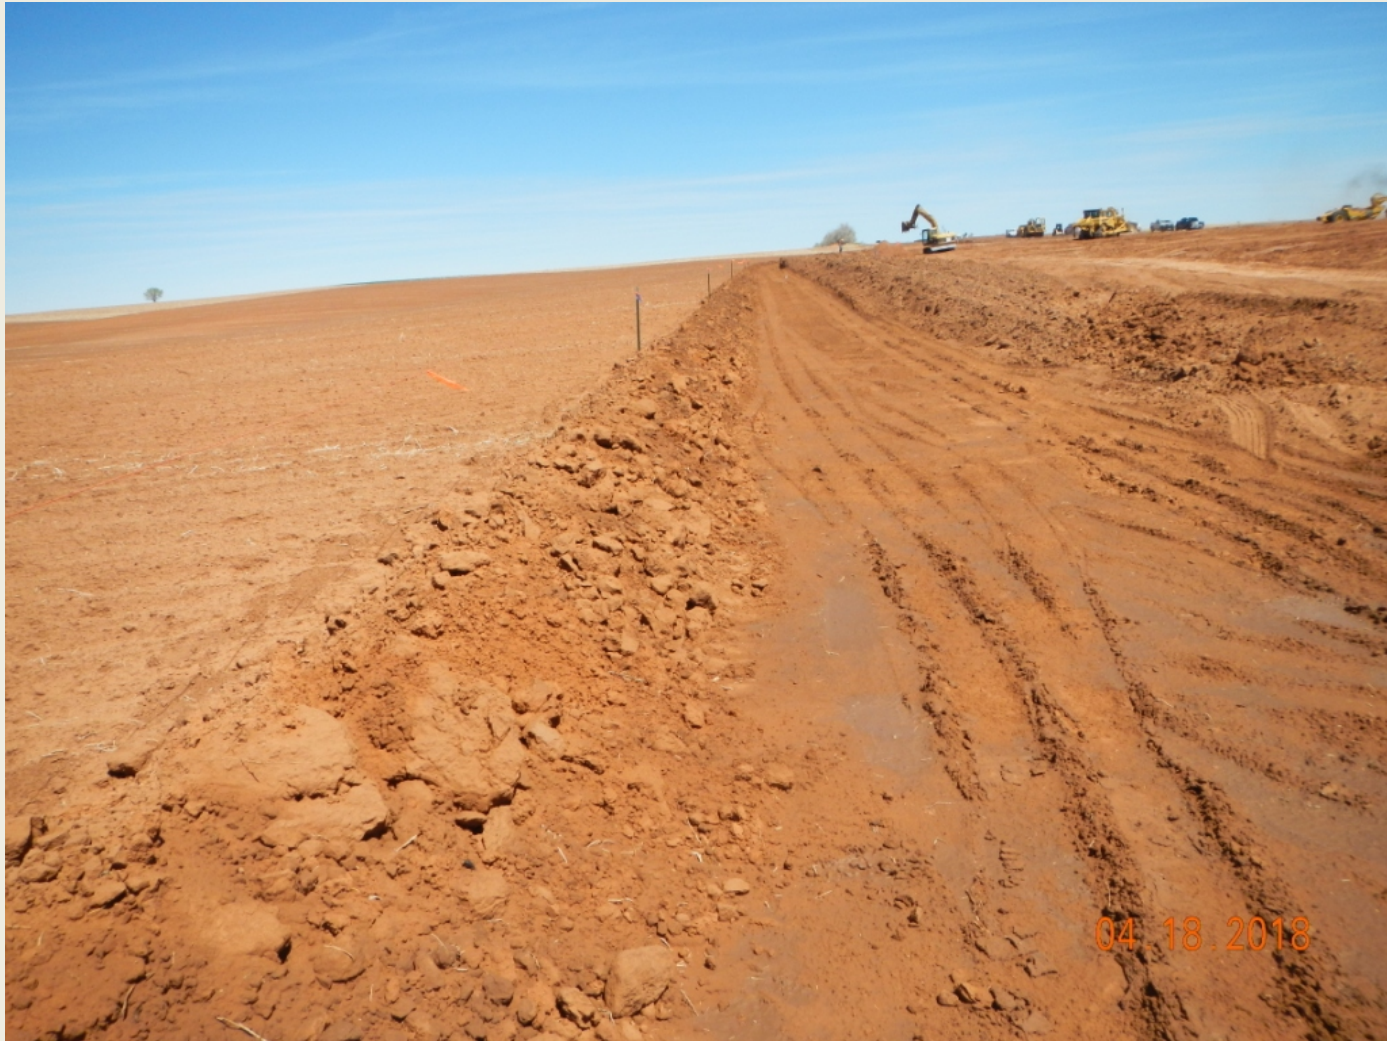
**Photo 6. View of the western edge of the project area facing northward.**
