# Inspection Photos

API: 05-083-06542

Operator: QEP

Inspection Date: 4/18/2018

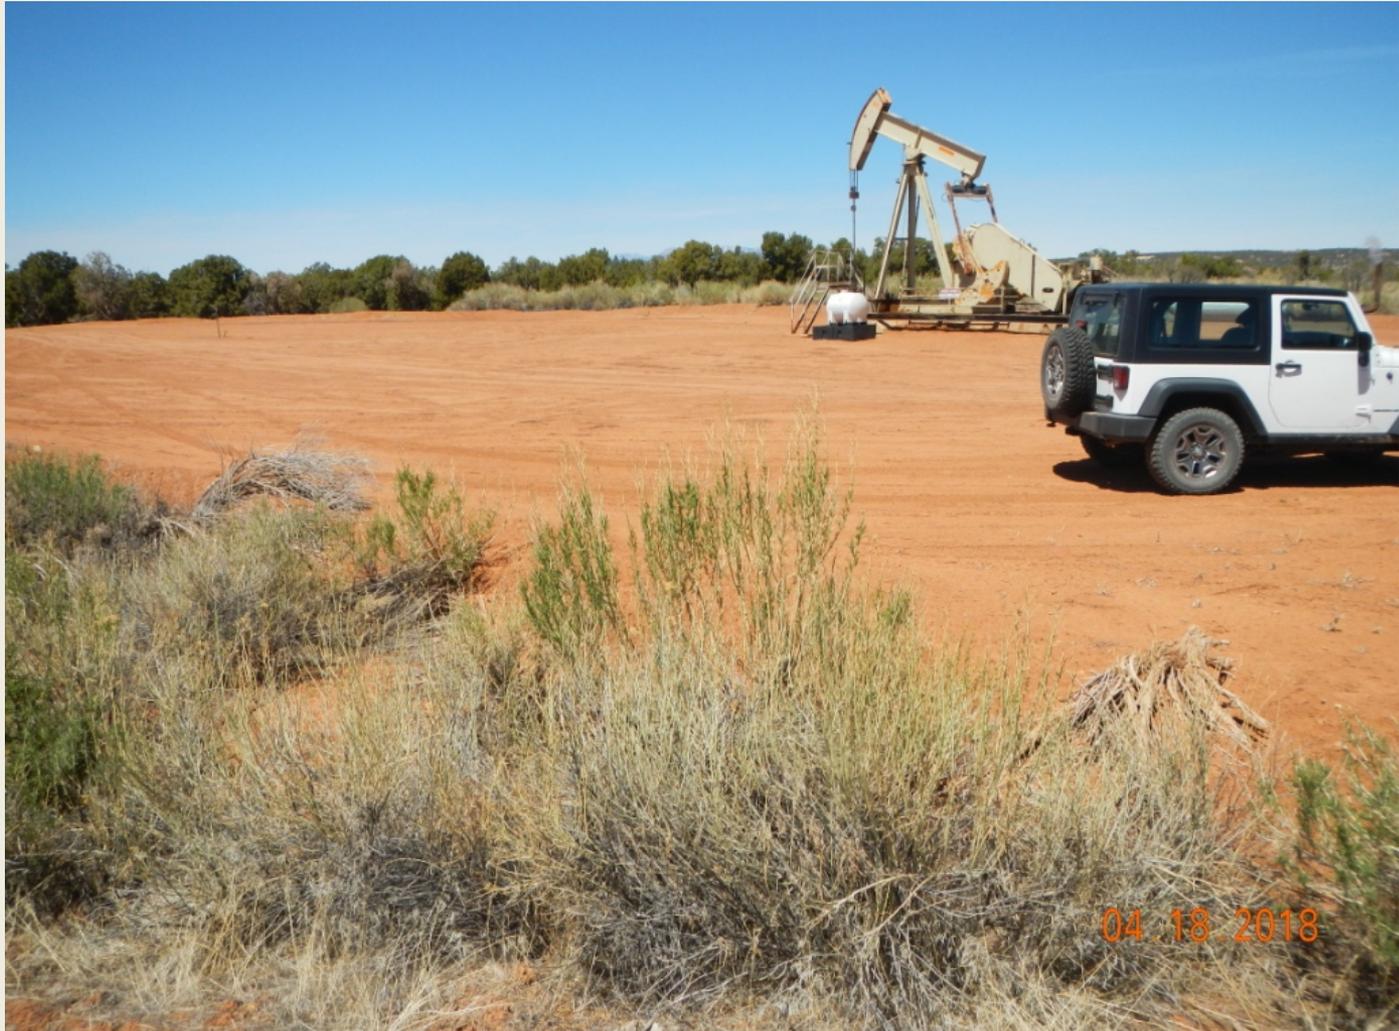
**Photo 1. View of the project area from the southeastern corner facing center.**

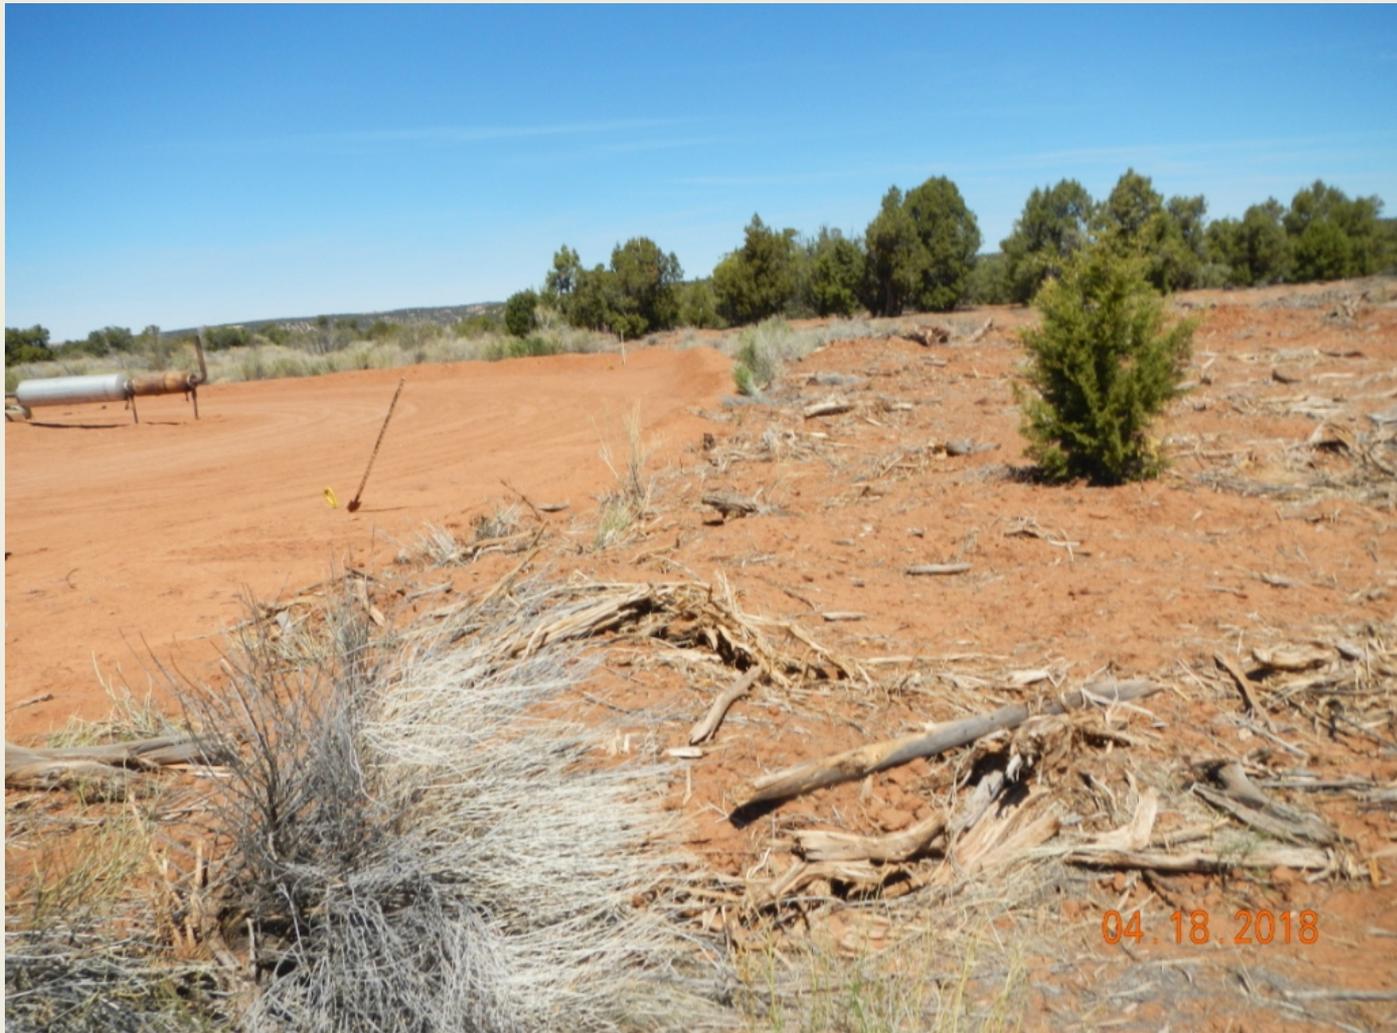
**Photo 2. View of the eastern edge of the working area from the southeastern edge facing northward. Soil berm is removed.**

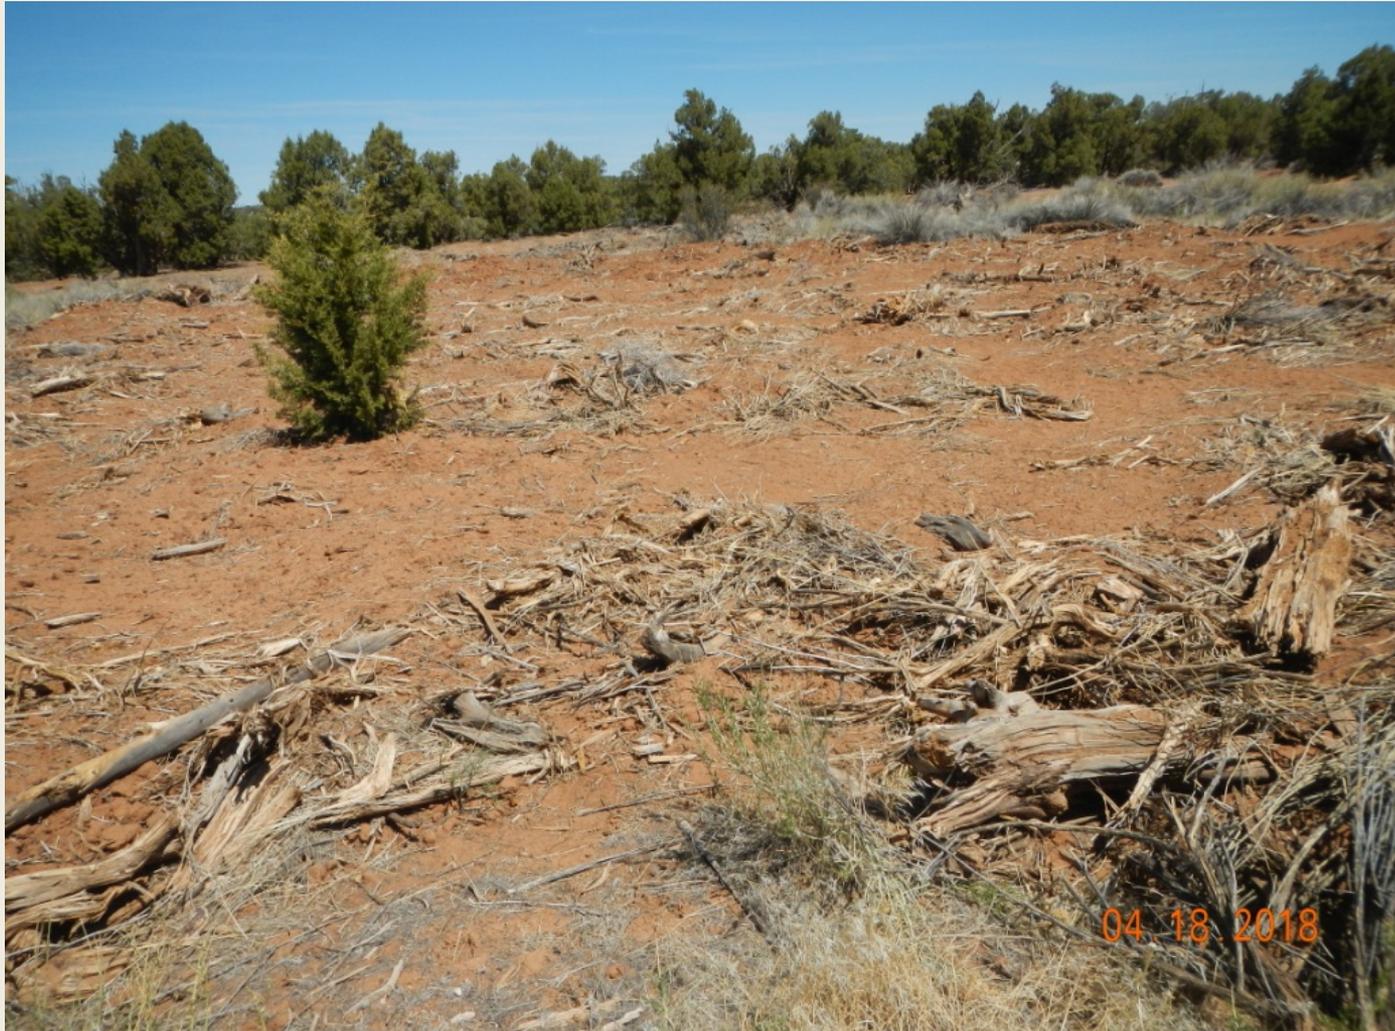
**Photo 3. View of the eastern portion of the interim reclamation area. Area is re-seeded in response to previous inspection. Revegetation and weeds need to be monitored in this area.**
