# Inspection Photos

API: 05-083-06575

Operator: QEP

Inspection Date: 4/18/2018

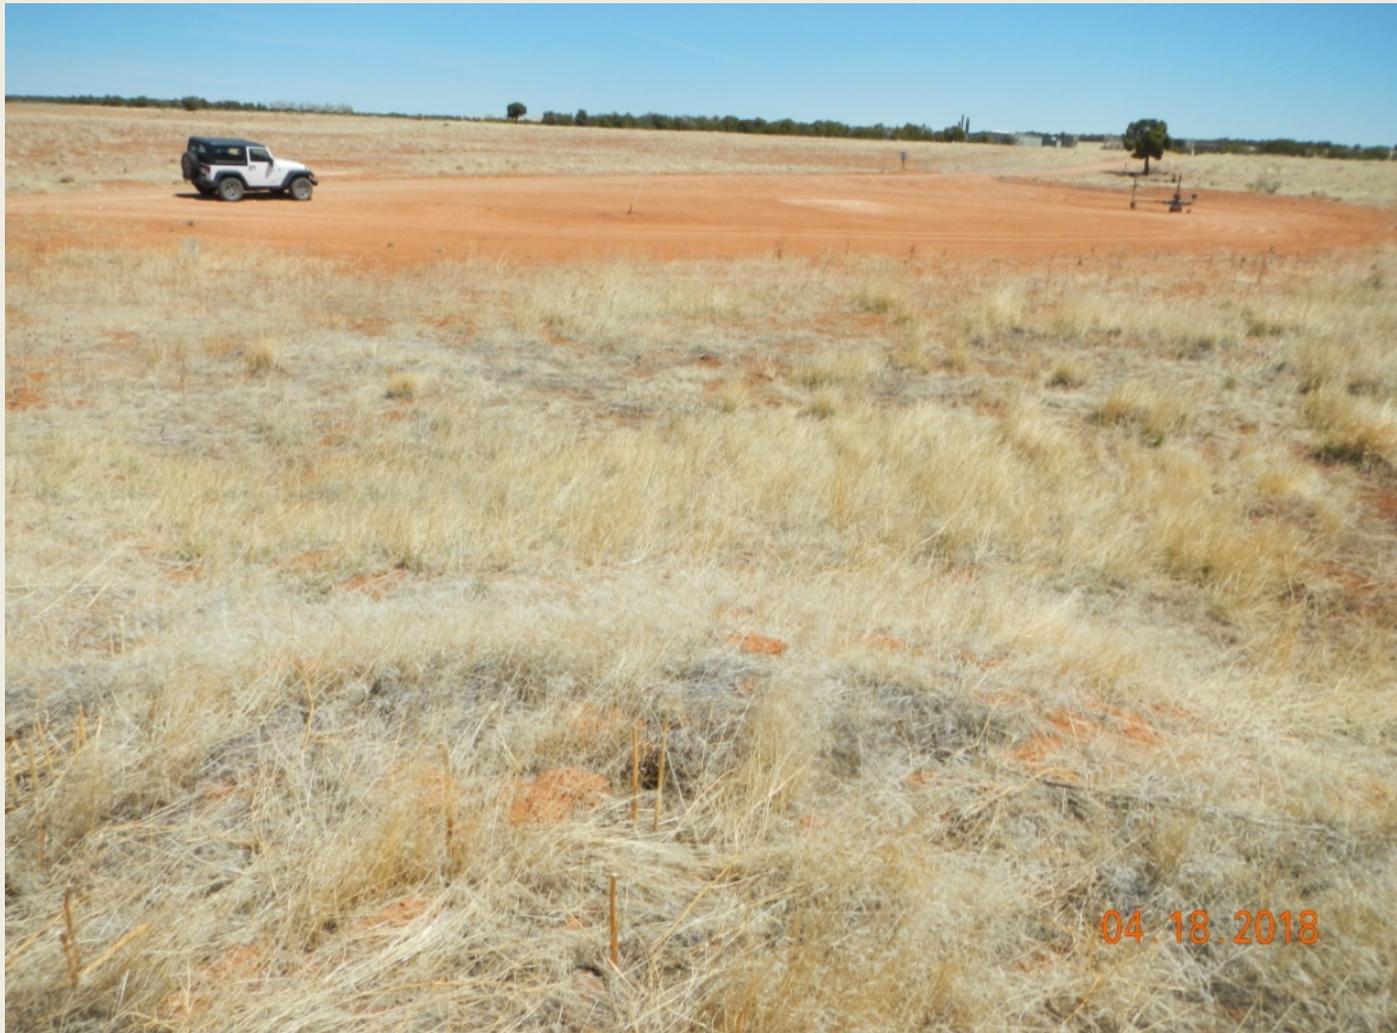
**Photo 1. View of the project area from the southwestern corner facing center.**

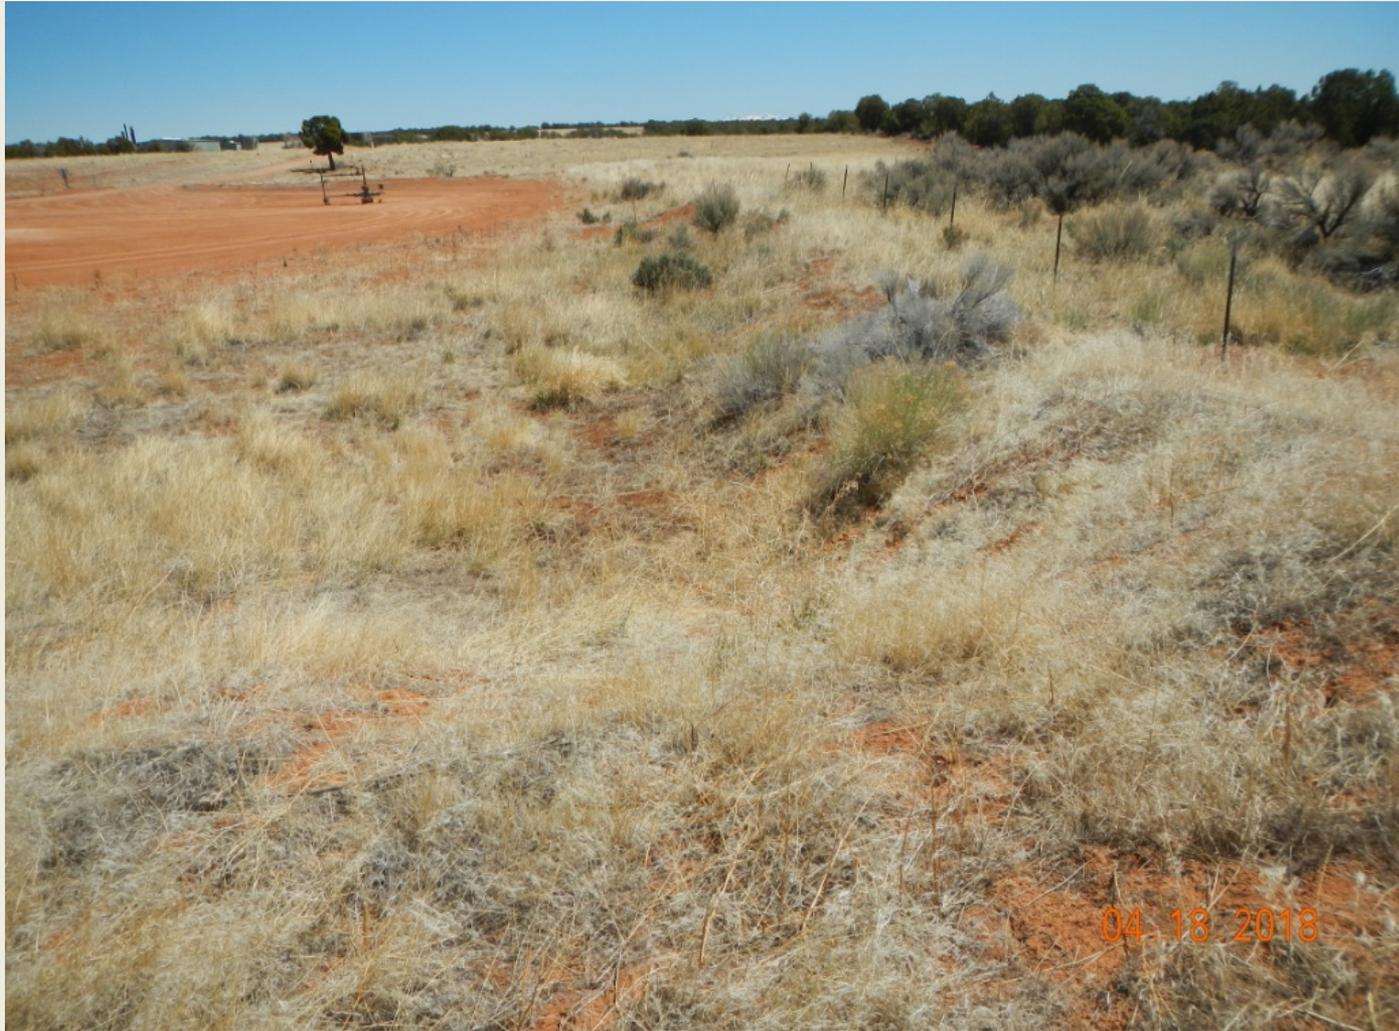
**Photo 2. View of the southern project area from the southwestern corner facing eastward. Revegetation is progressing but largely weedy with cheatgrass (*Bromus tectorum*).**

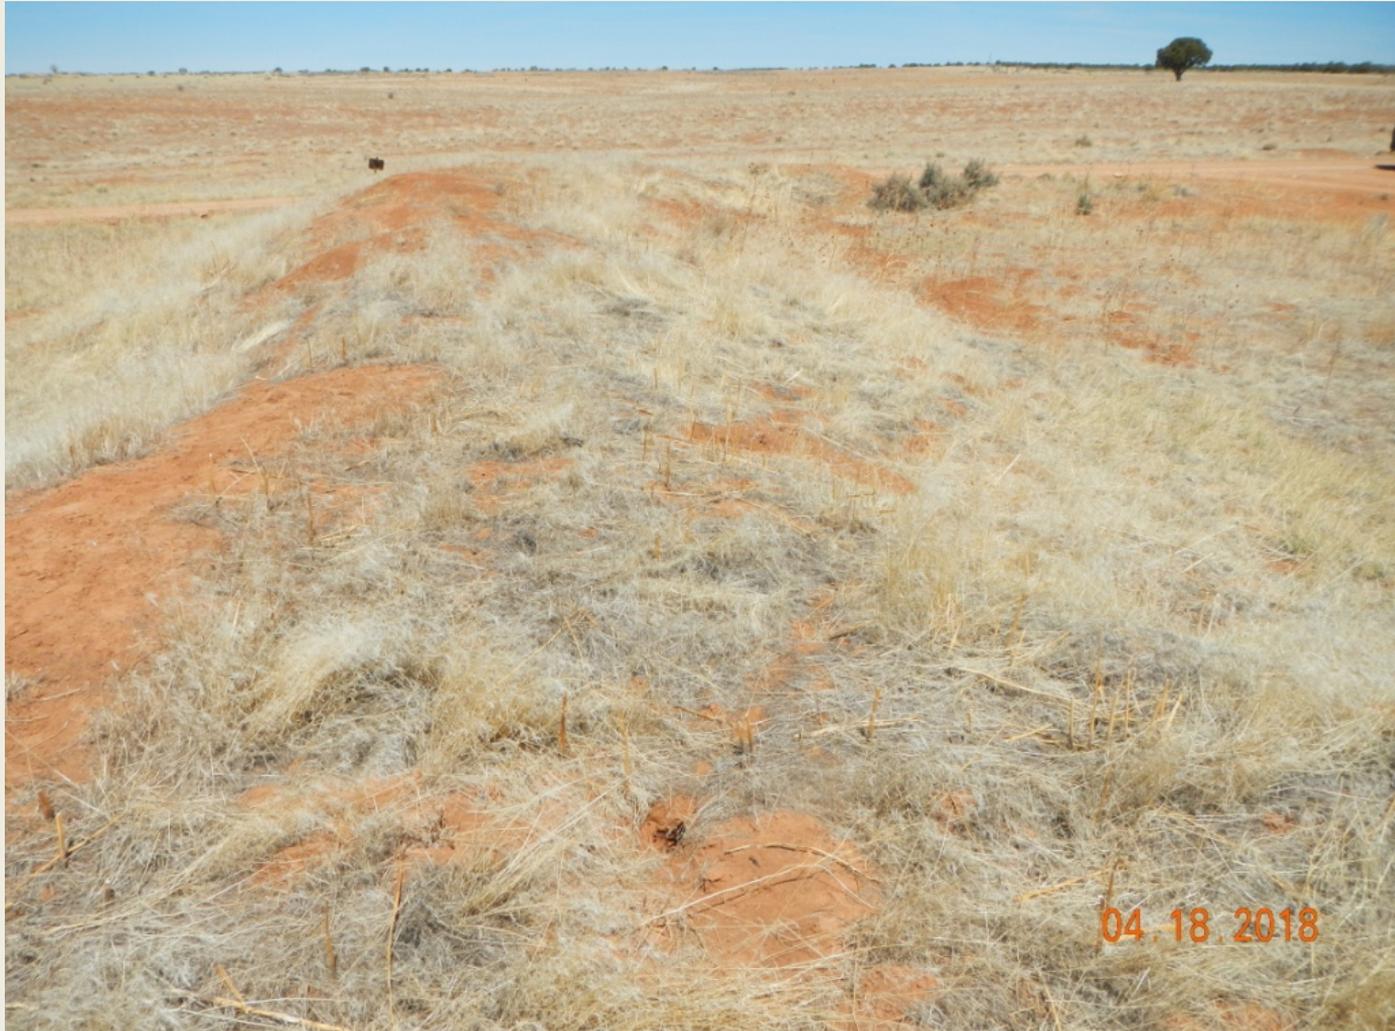
**Photo 3. View of the northeastern portion of the project area from the eastern edge facing northward.**
