GOLDEN EAGLE MINE NW-3-3-95 API# 05-071-06397 – TIMBER CREEK
OGCC OPERATOR NUMBER 10672 – INSPECTION DATE: MAY 07, 2018
CORRECTIVE ACTIONS COMPLETED REGARDING COGCC FIR DOCUMENT # 680102767

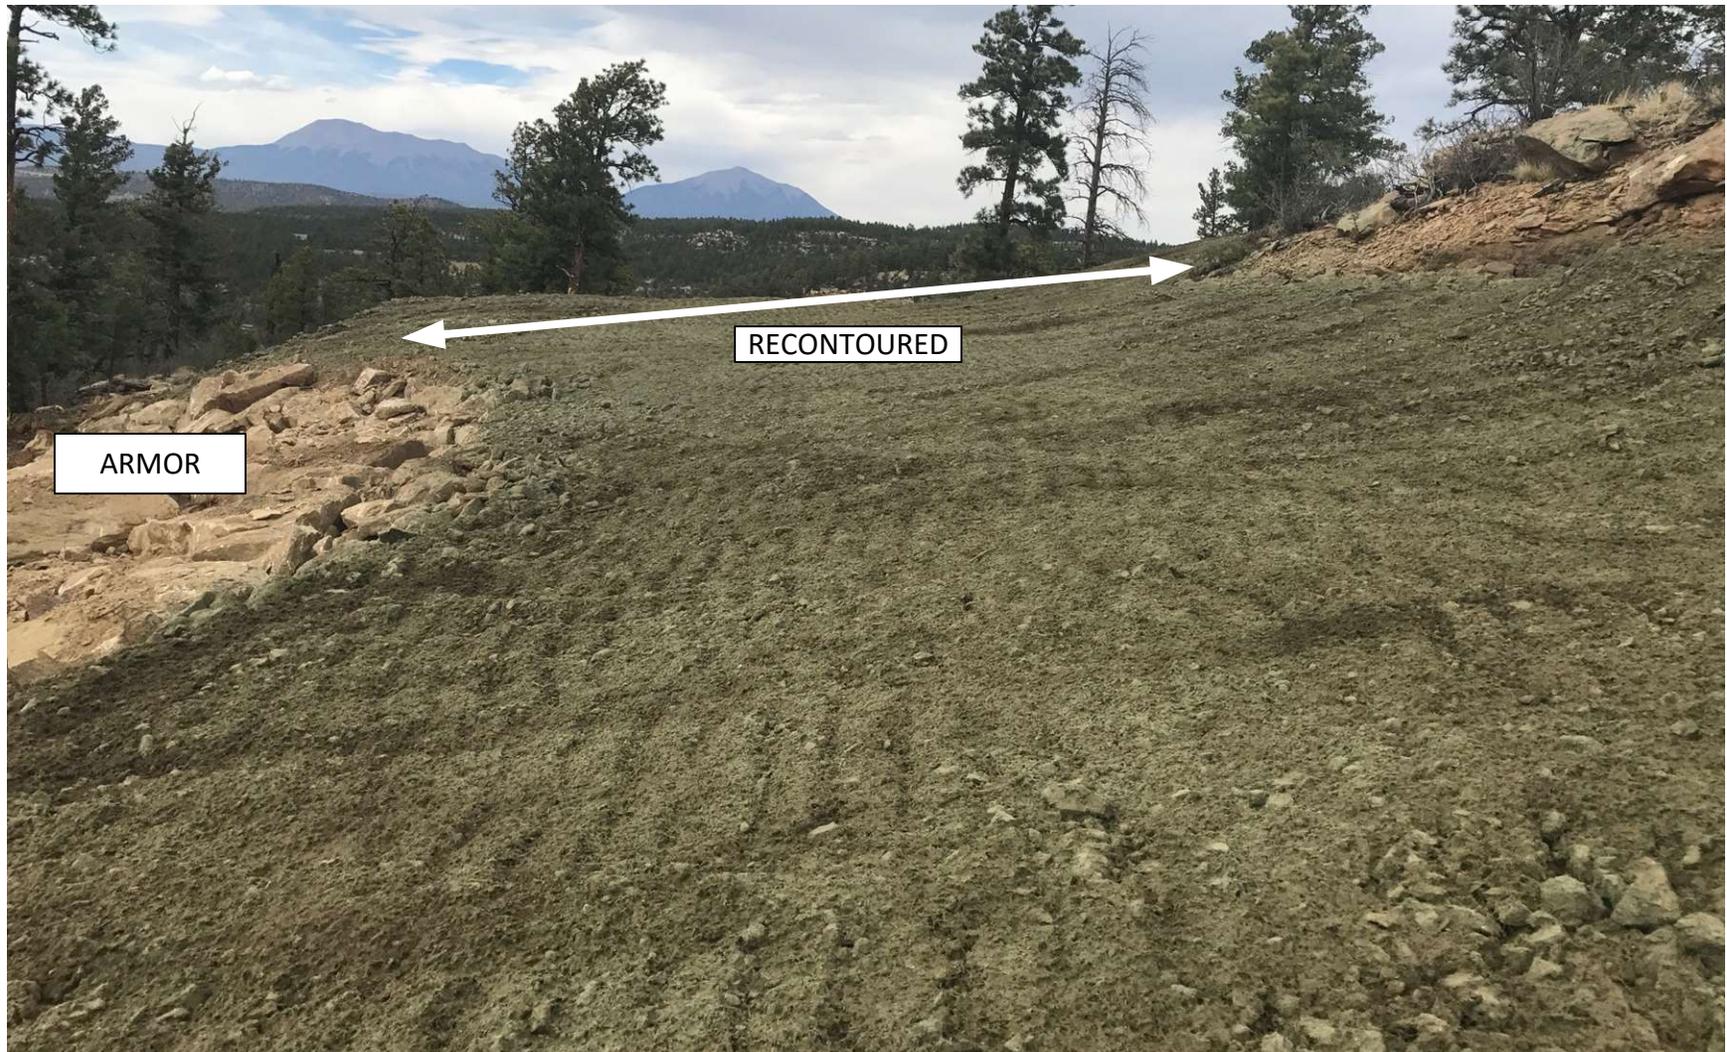
PHOTO 1: OVERVIEW OF LOCATION TO NORTH. THE WELL PAD AND ACCESS ROAD WERE RECONTOURED TO MATCH THE SURROUNDING TERRAIN, THIS PROVIDES SOIL DECOMPACTION. THE ROCK ON THE FILL SLOPE WAS PULLED UP TO STABILIZE THE SLOPE. GRADING TECHNIQUES WERE INSTALLED ON THE CONTOUR TO PROVIDE SOIL STABILIZATION, PROMOTE GROUND INFILTRATION AND TO PREPARE THE SOIL FOR SEEDING. THE EARTH DISTURBANCE ON THE WELL PAD WAS STABILIZED BY HYDRO-SEEDING USING AN APPROVED HILL RANCH SEED MIX TO PROMOTE THE ESTABLISHMENT OF VEGETATION.

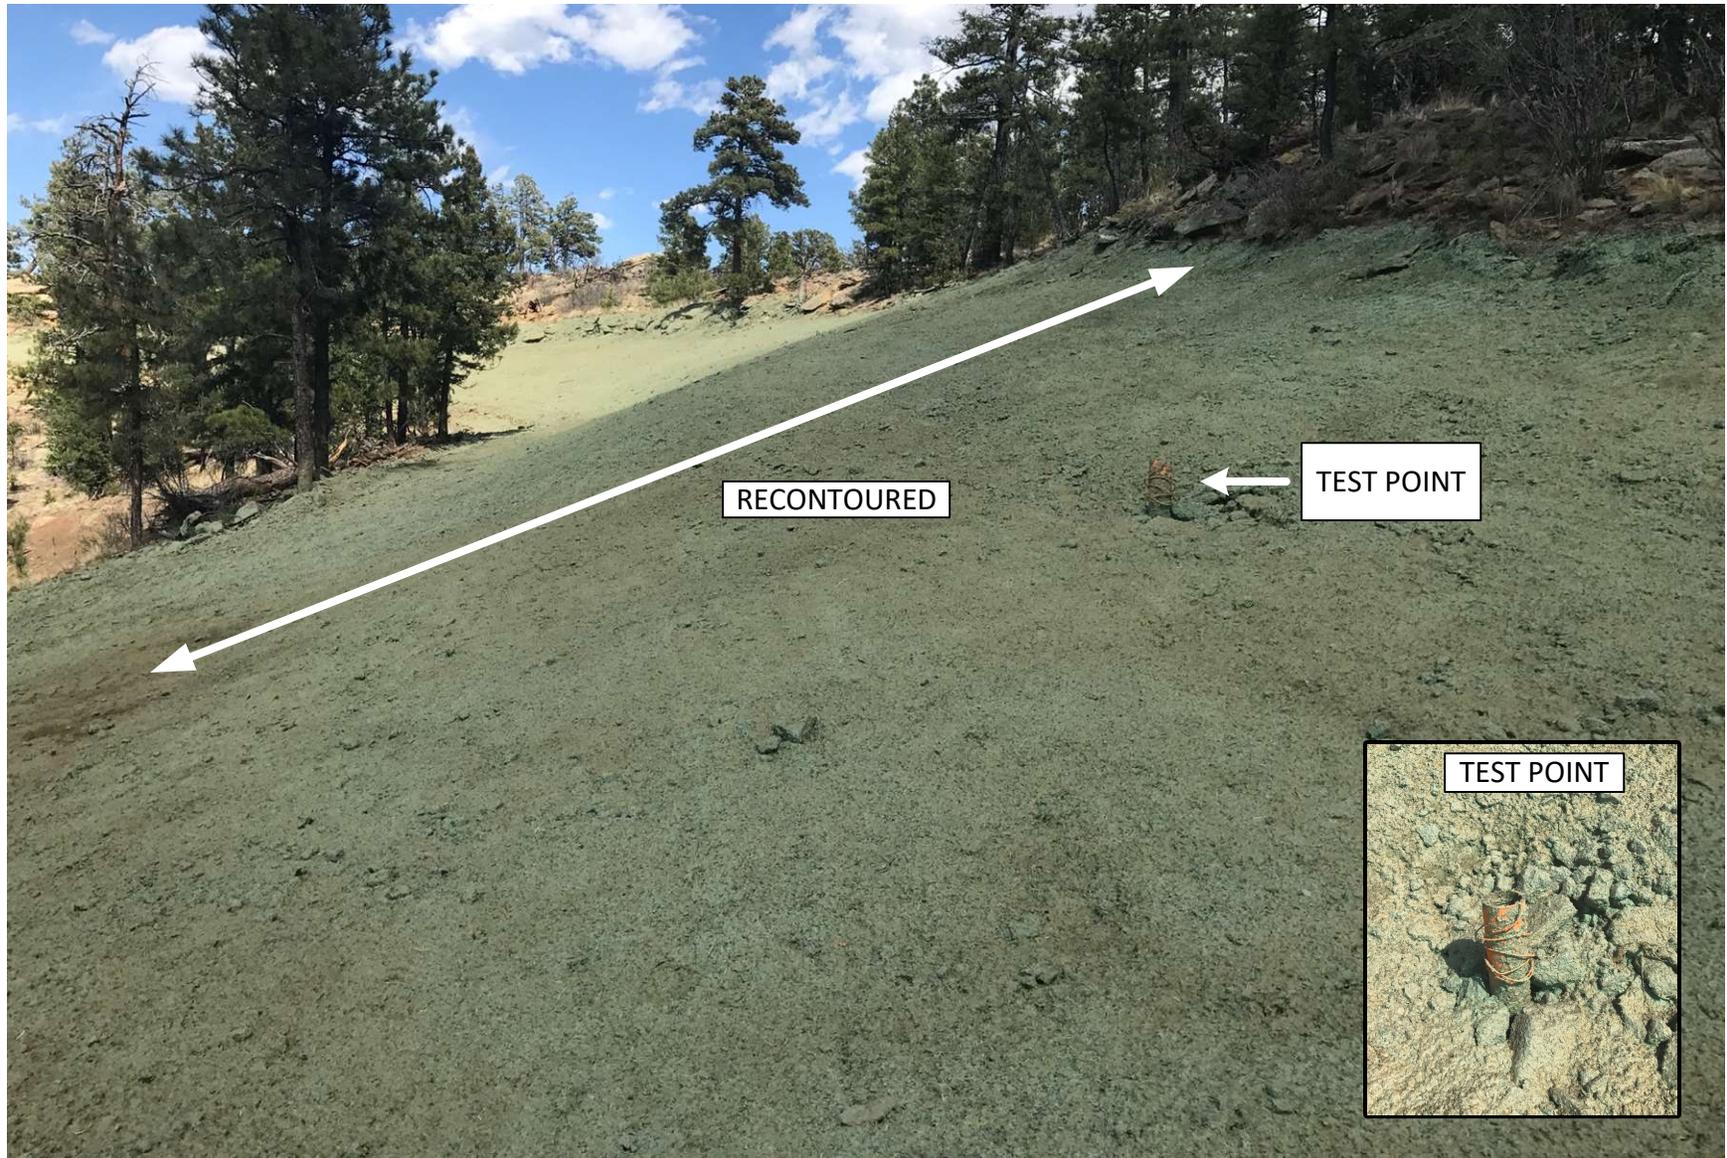
PHOTO 2: VIEW NORTH ALONG RECLAIMED ACCESS ROAD LEADING INTO LOCATION. THERE IS AN ACTIVE PIPELINE RUNNING THROUGH THE RECLAMATION. THERE IS A PIPELINE LOCATE TEST POINT AT THE SOUTH END OF LOCATION THAT WILL NEED TO STAY OPERATIONAL.

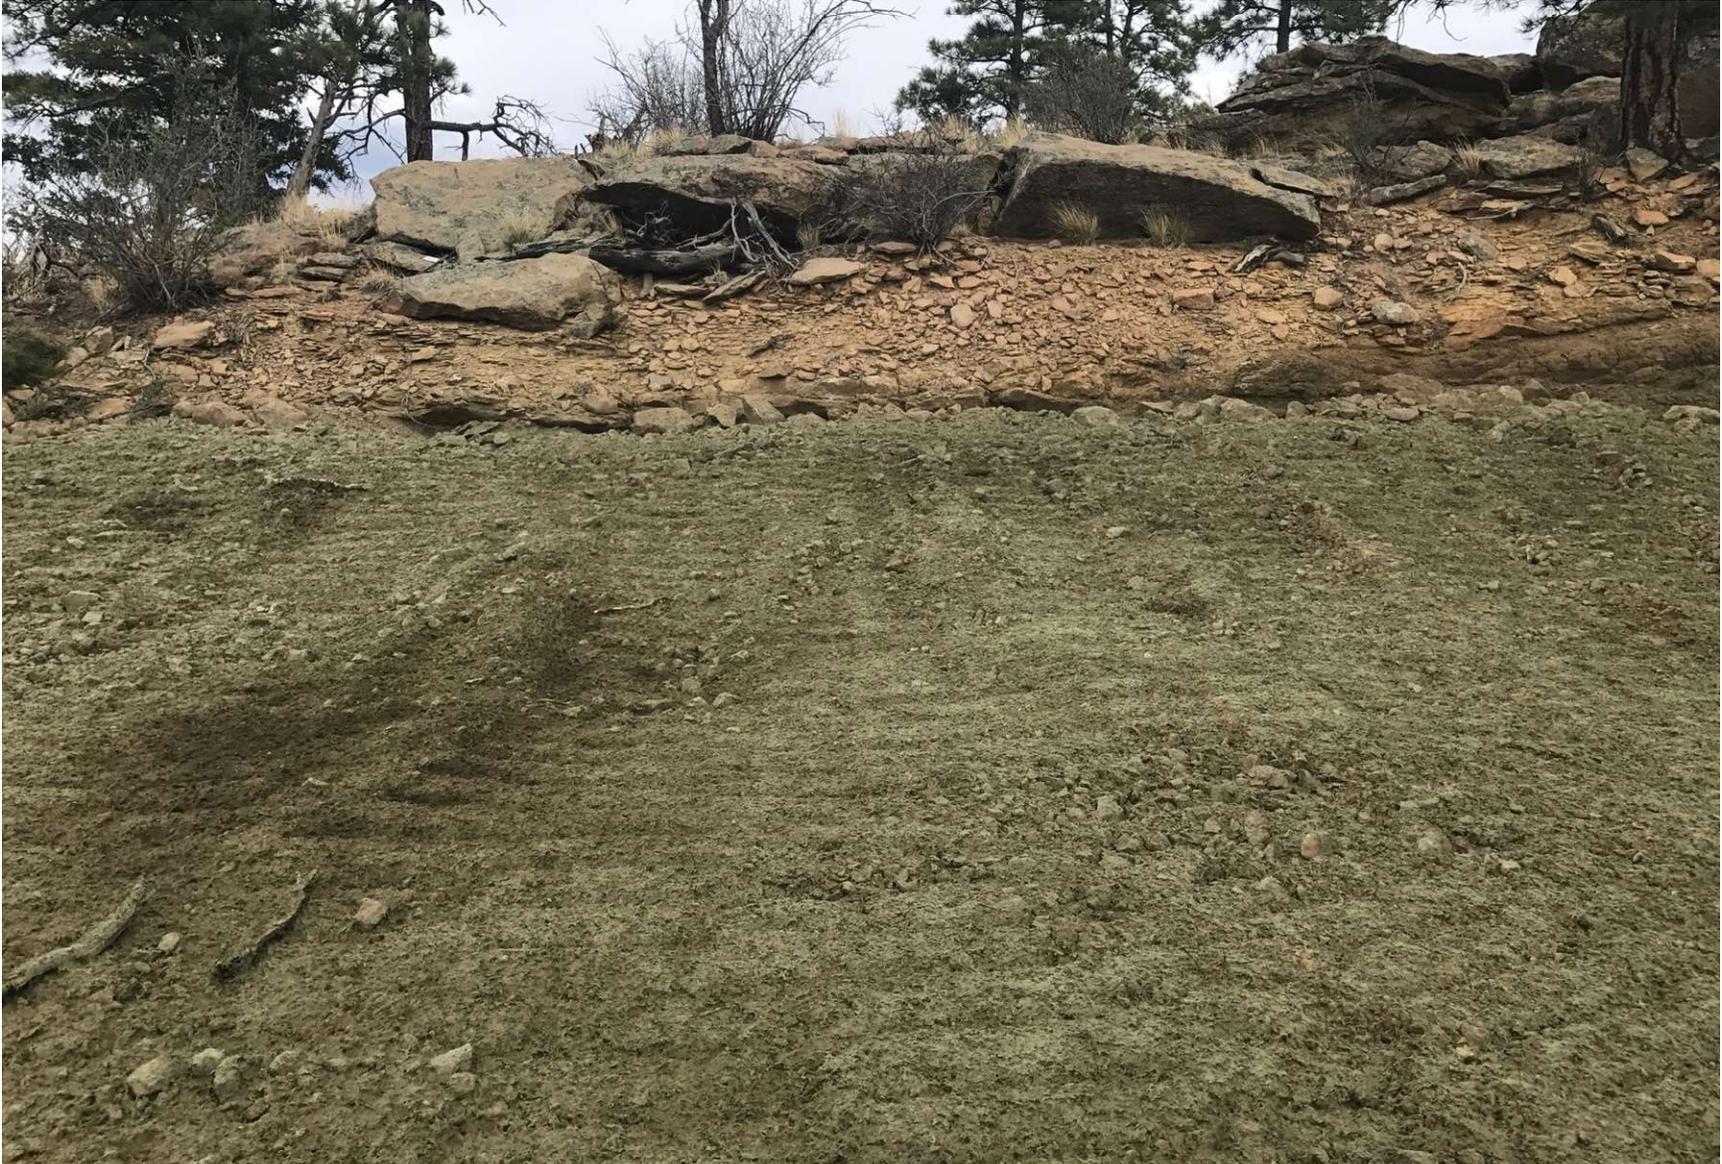
PHOTO 3: VIEW OF CUT SLOPE ALONG EAST SIDE OF LOCATION.

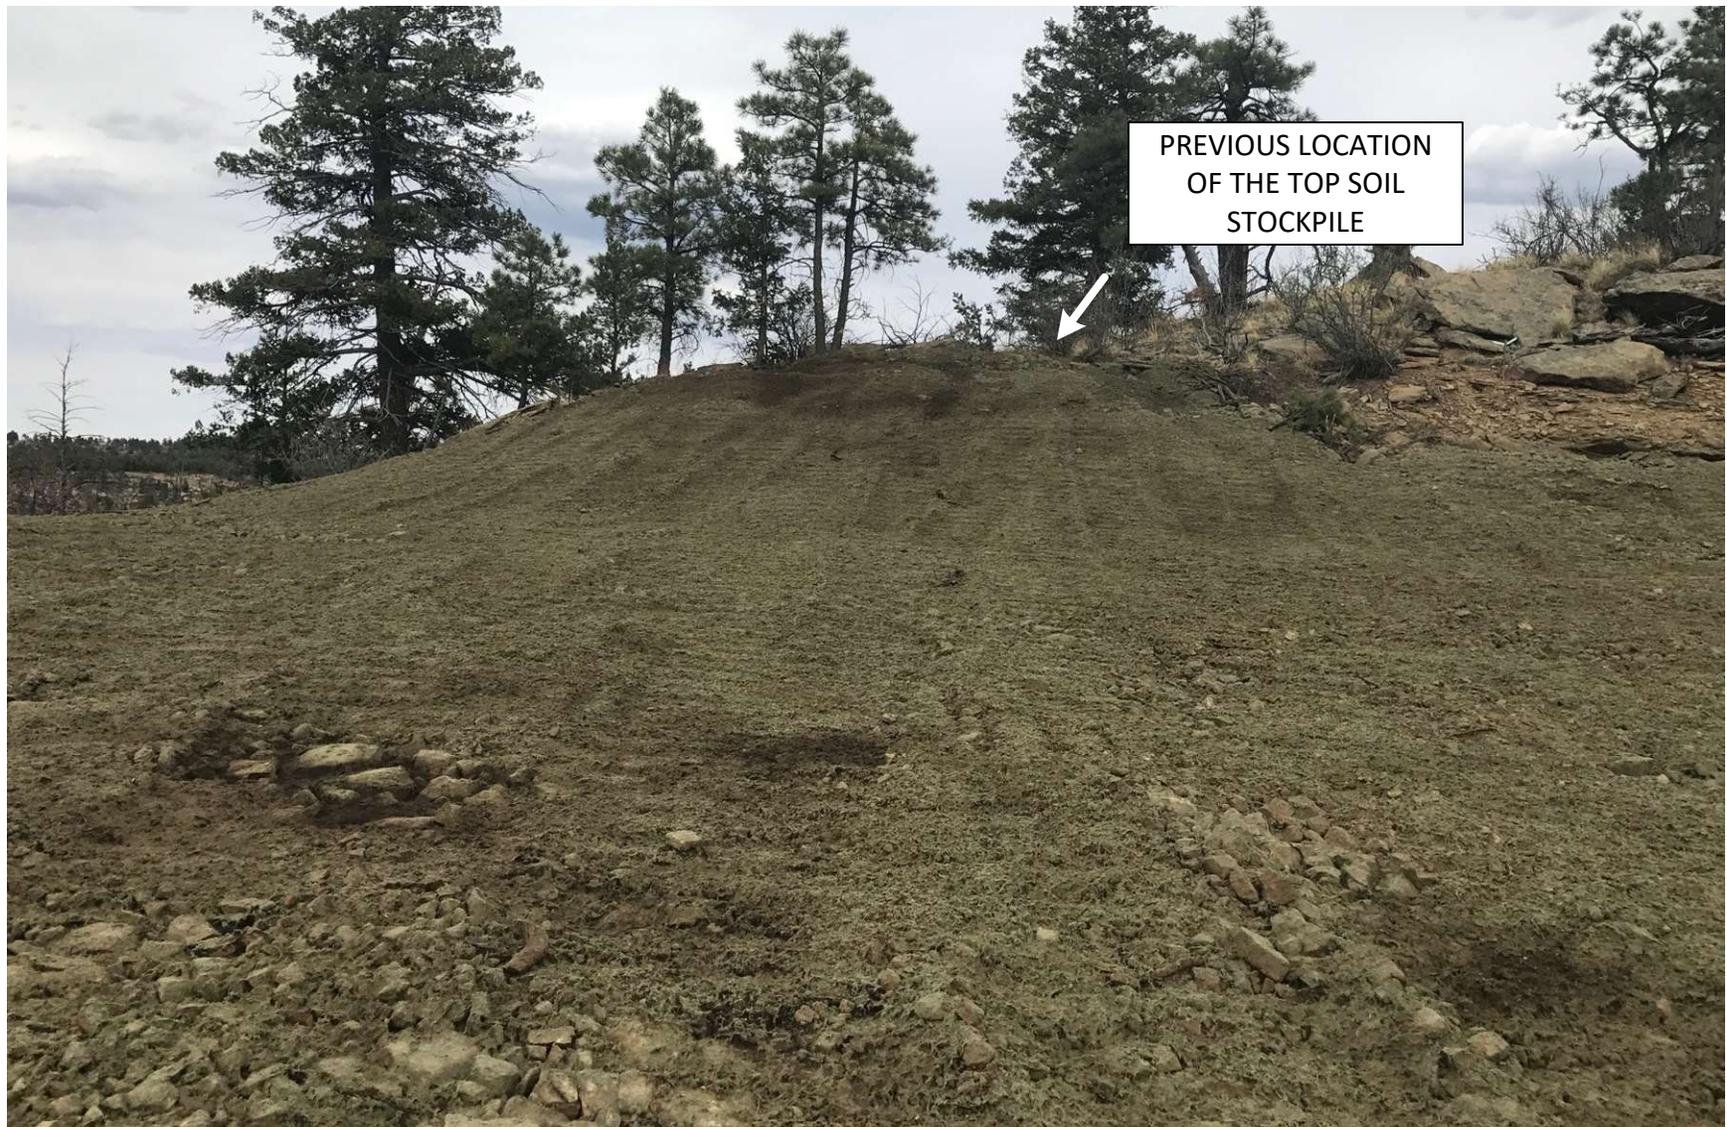
PHOTO 4: THE TOP SOIL STOCKPILE WAS SPREAD ACROSS LOCATION DURING THE RECLAMATION ACTIVITIES. THE SIGNAGE WAS REMOVED FROM LOCATION.

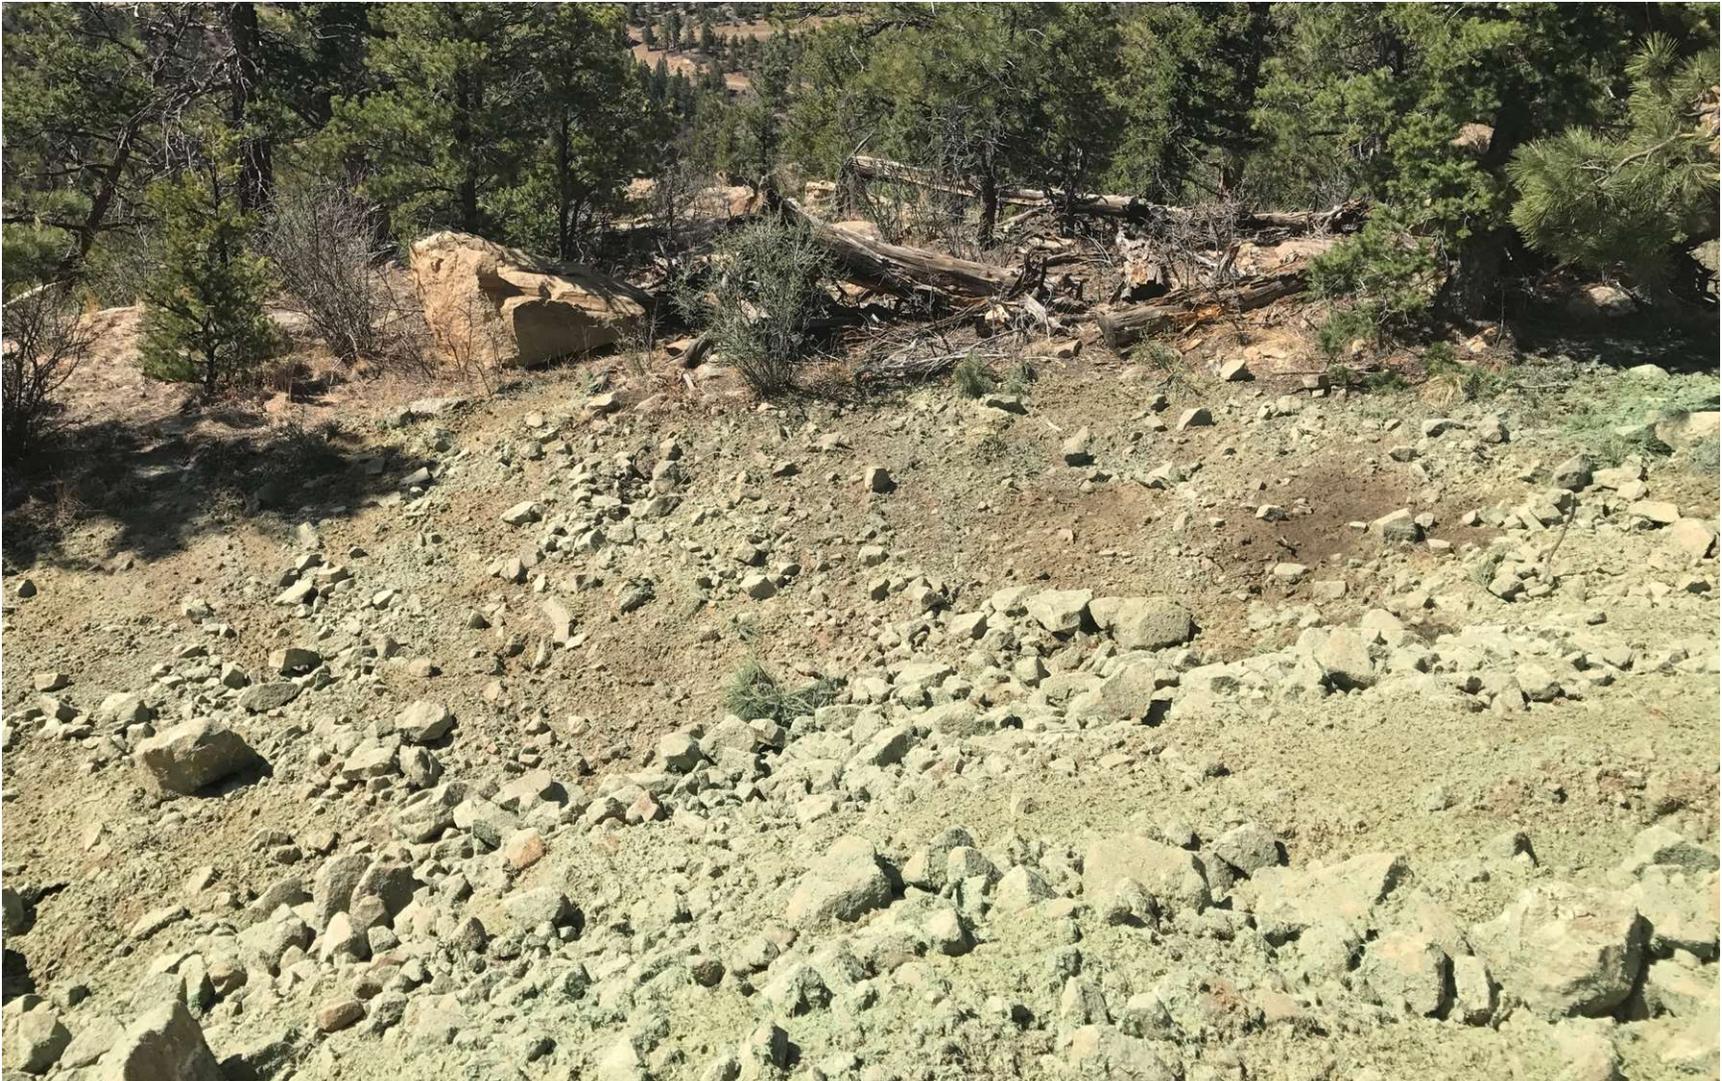
PHOTO 5: THE SILT FENCE AT THE BASE OF THE FILL SLOPE HAS BEEN REMOVED.

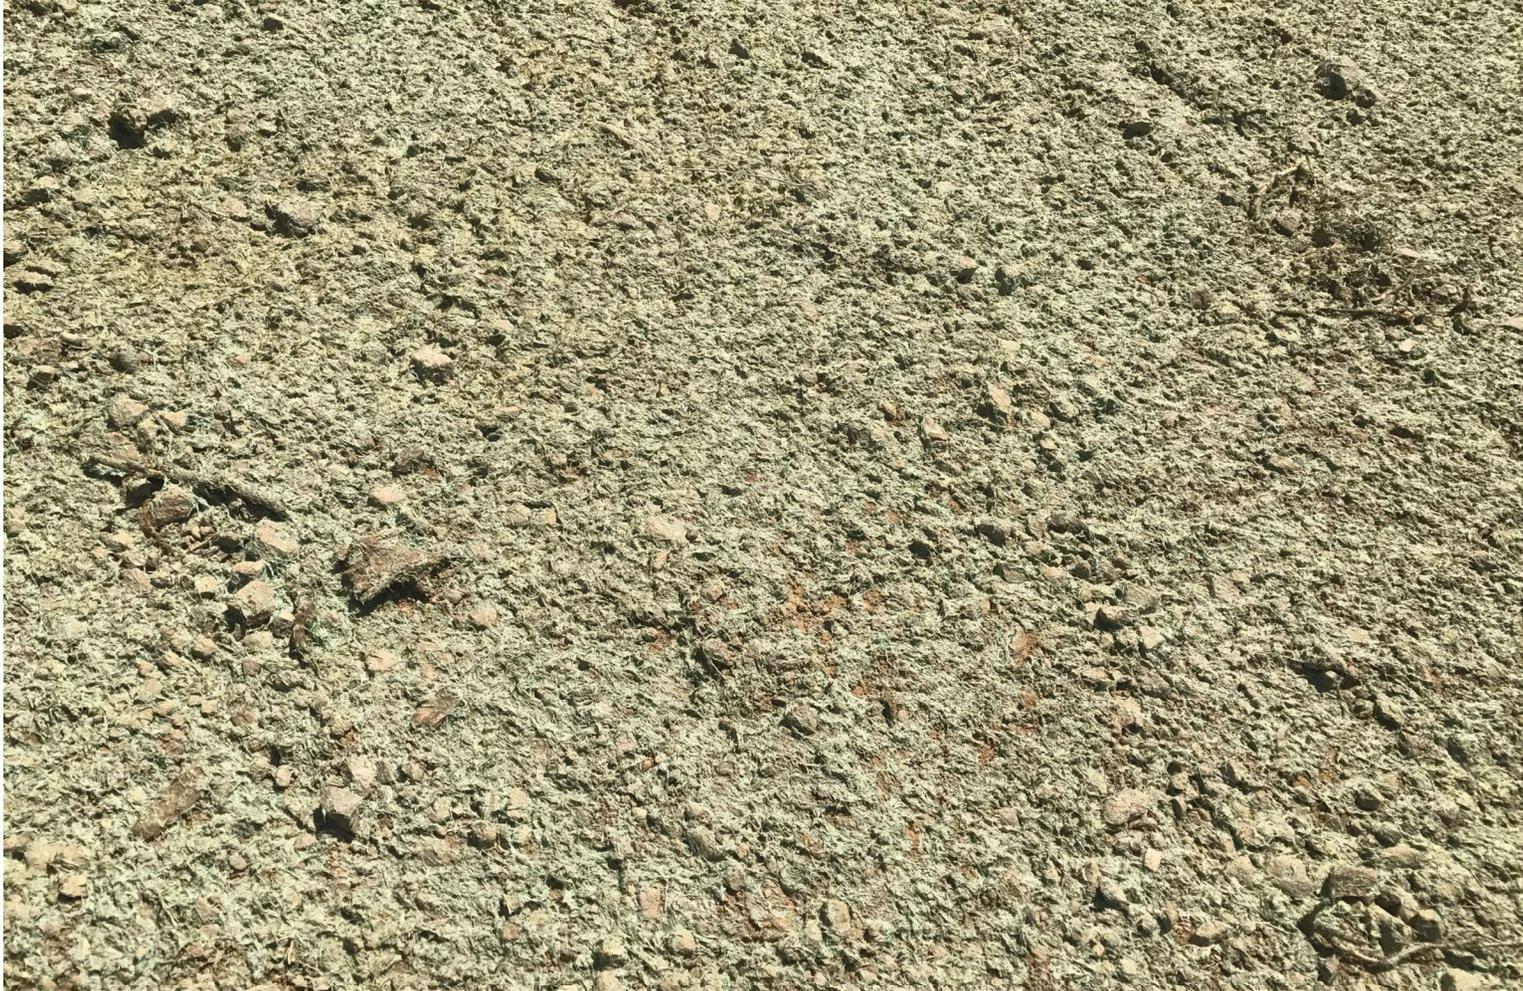
PHOTO 6: CLOSE UP OF GROUND CONDITIONS ON PAD SURFACE.

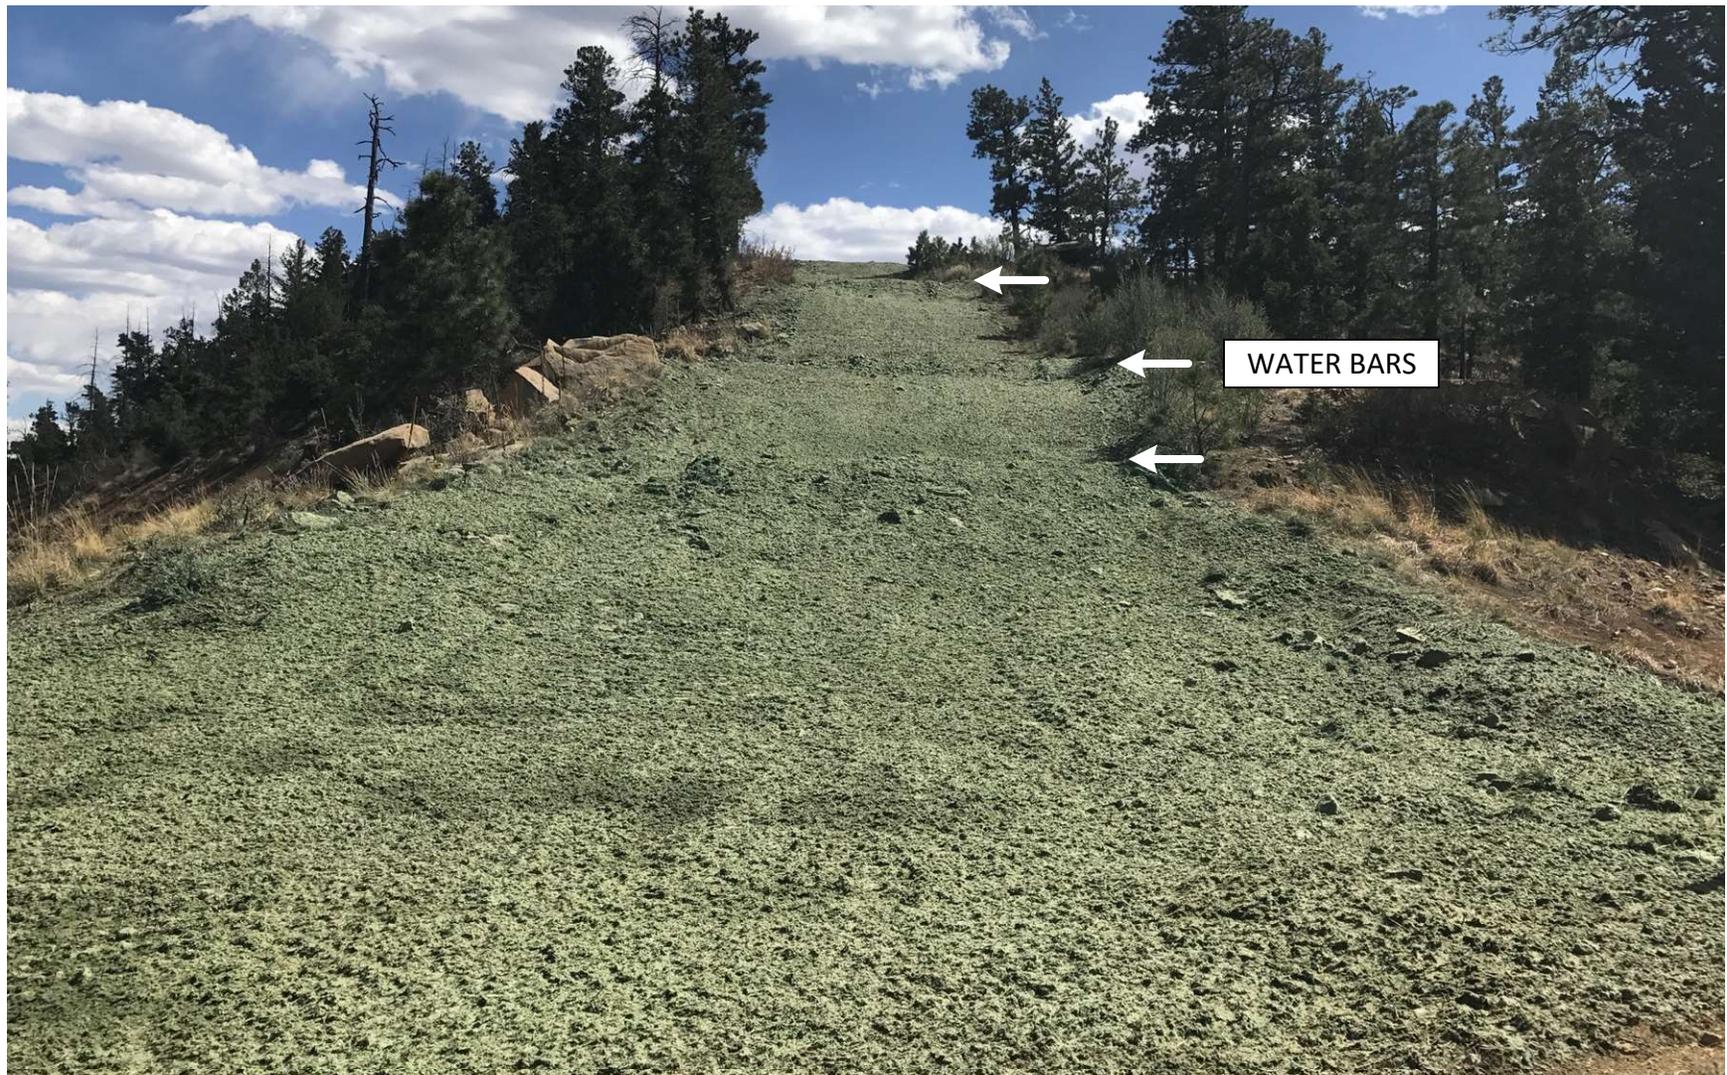
PHOTO 7: NORTH OF LOCATION ON THE MAIN ROAD FACING THE PIPELIN R.O.W. RECLAMATION. (3) WATER BARS WERE INSTALLED TO REDUCE RUN OFF VELOCITY. THE EARTH DISTURBANCE WAS STABILIZED BY HYDRO-SEEDING USING AN APPROVED HILL RANCH SEED MIX TO PROMOTE THE ESTABLISHMENT OF VEGETATION.

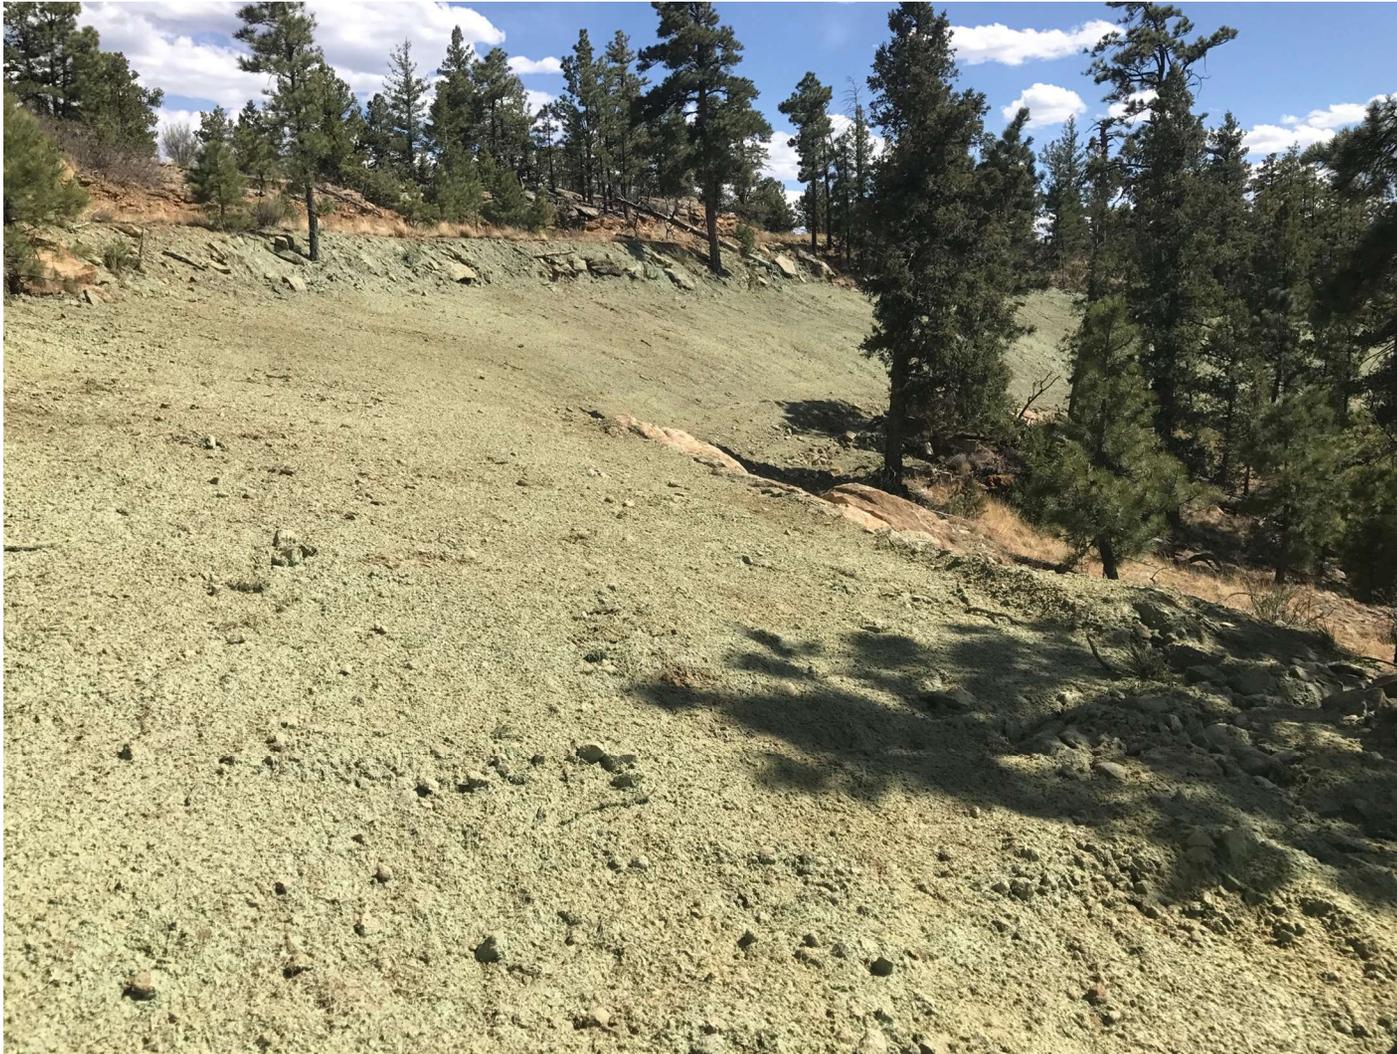
PHOTO 8: FACING SOUTH ALONG THE ACCESS ROAD RECLAMATION.
