Inspection Photos

API: 05-083-06538

Operator: QEP

Inspection Date: 4/18/2018

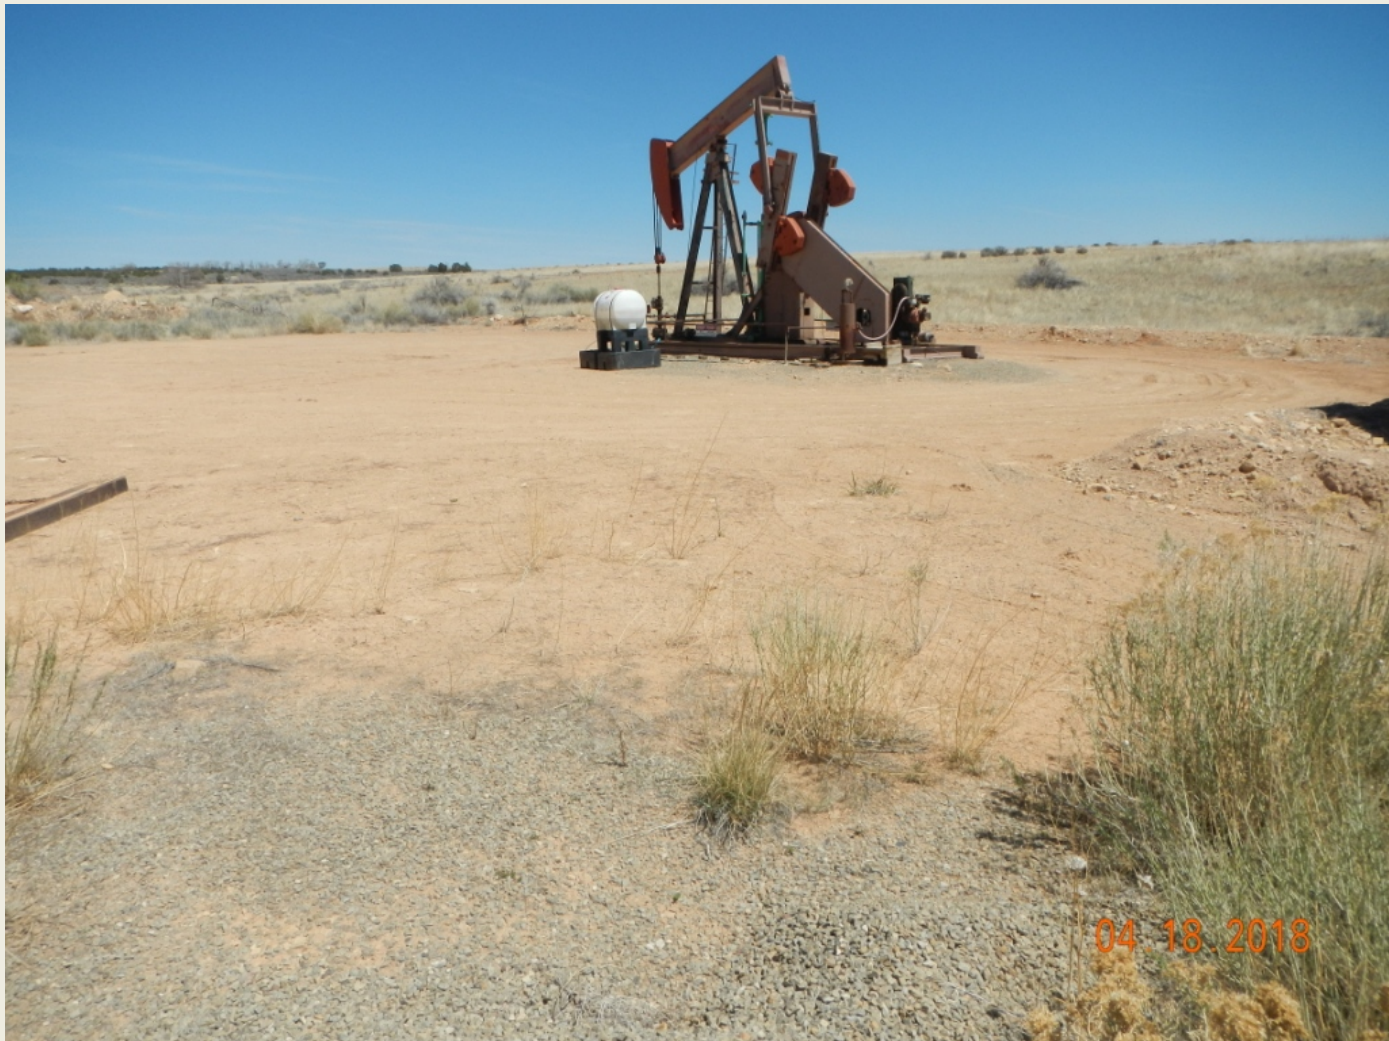
Photo 1. View of the project area from the southwestern corner facing center.

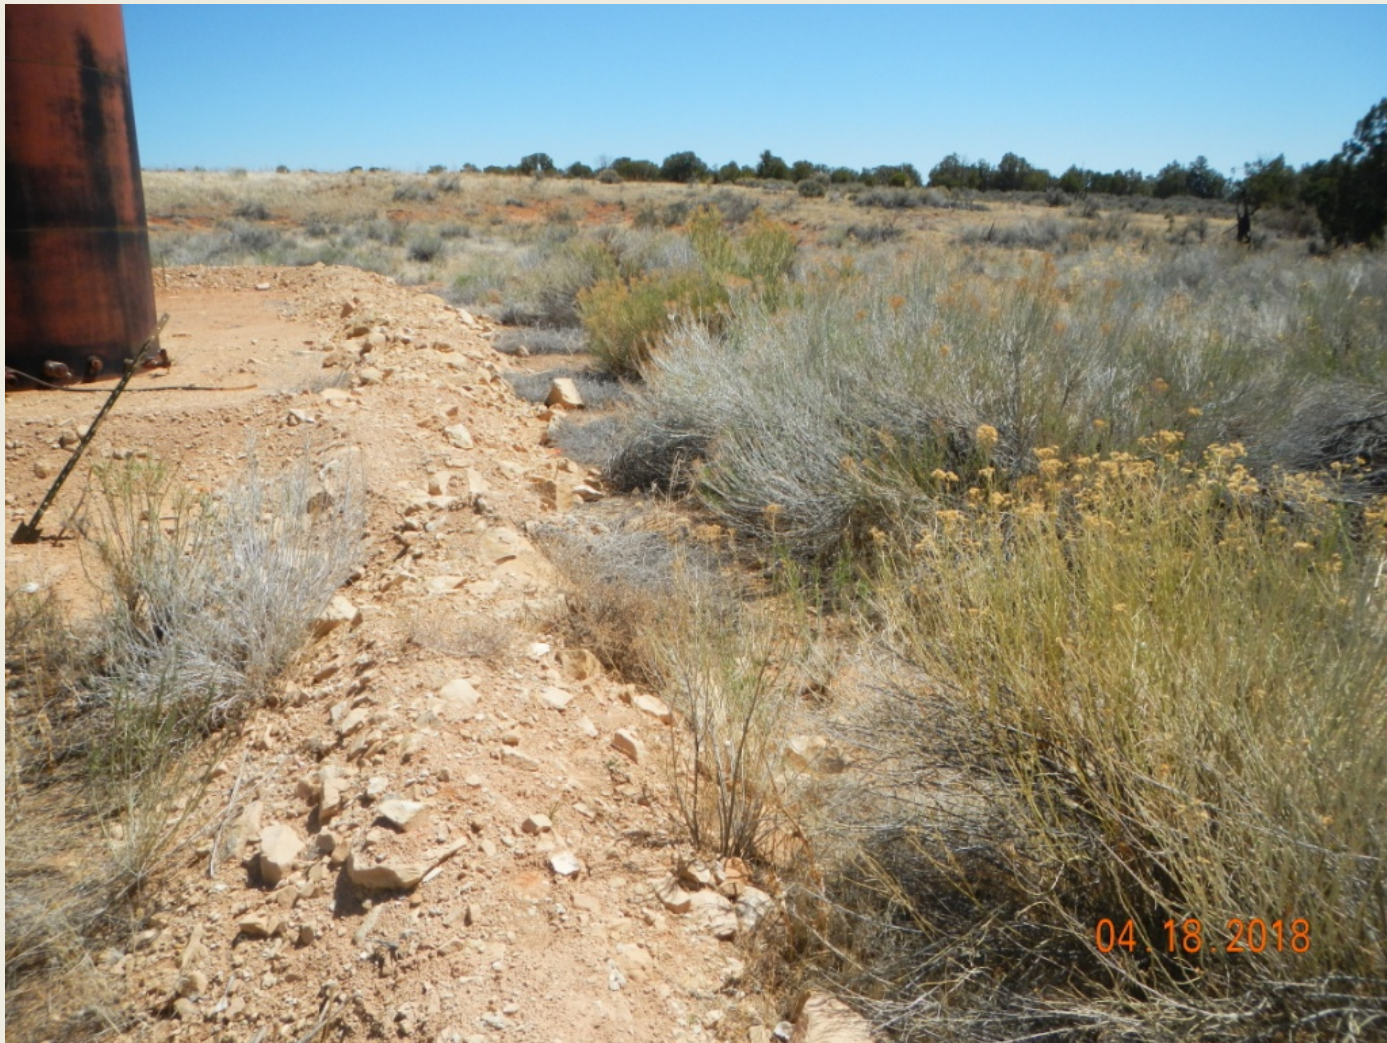
Photo 2. View of the southern edge of the working area from the southwestern corner facing eastward.

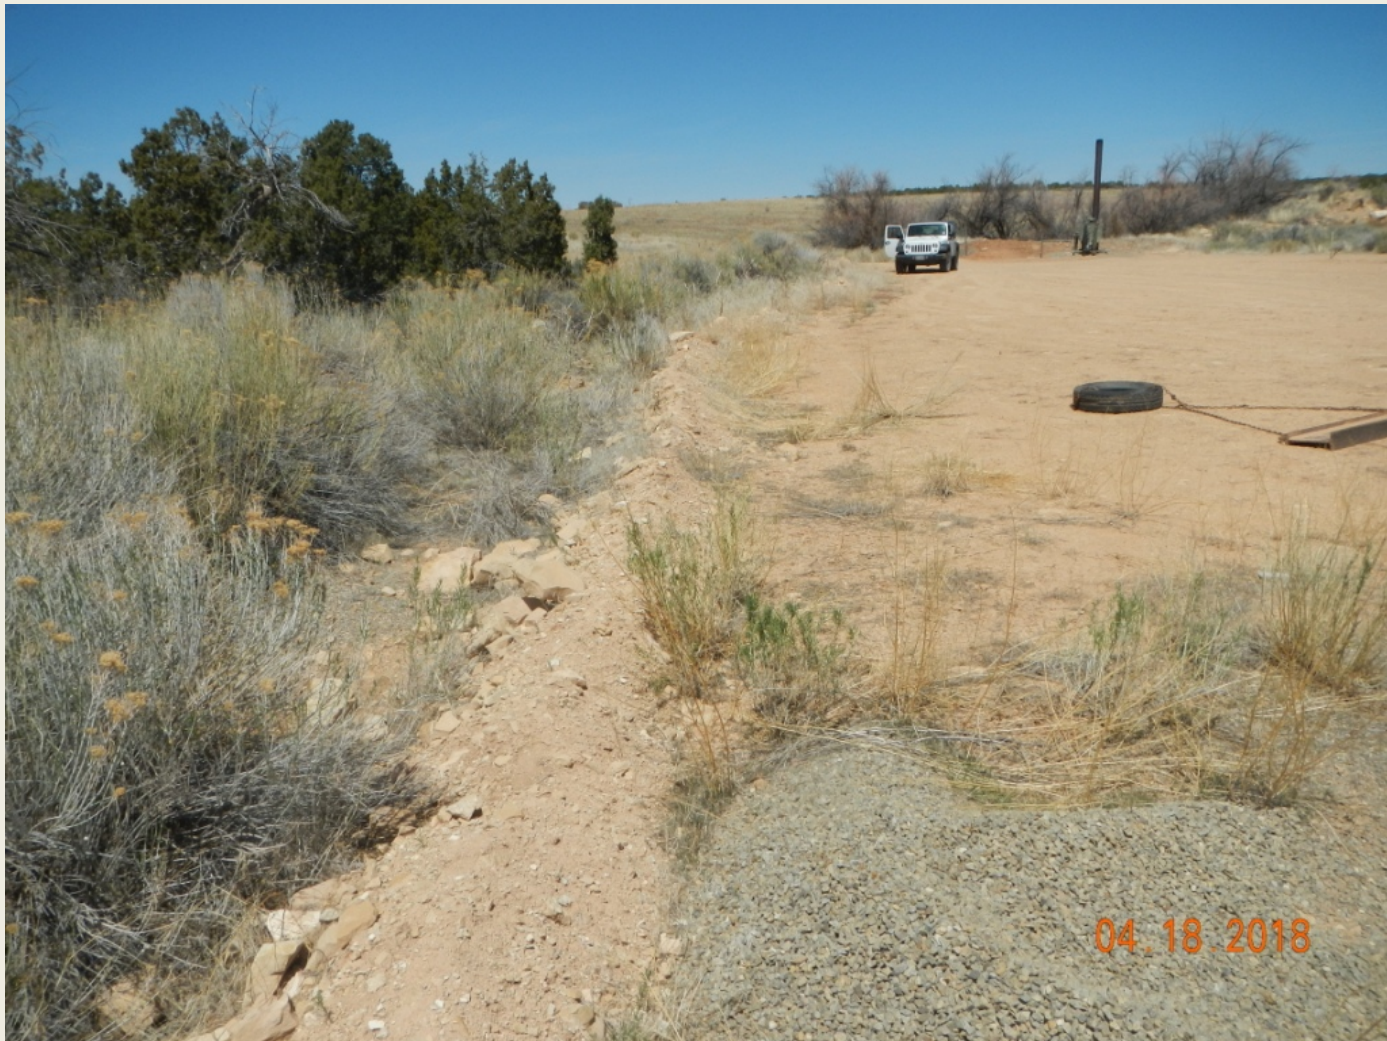
Photo 3. View of the eastern portion of the project area from the southwestern corner facing northward.

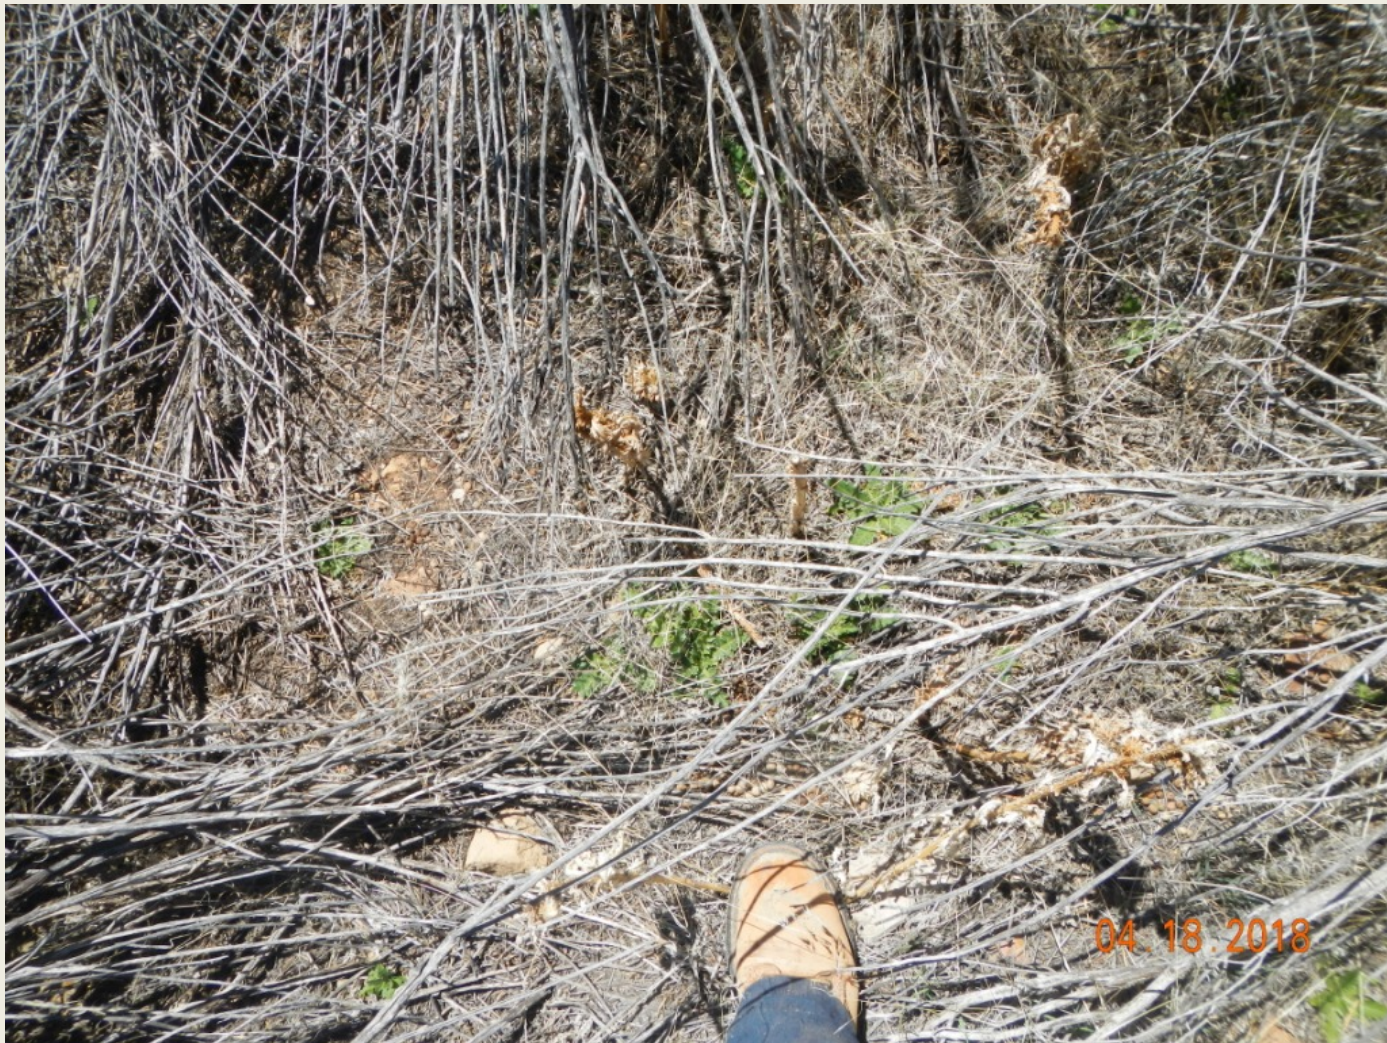
Photo 4. View of musk thistles (*Carduus nutans*) within the southern interim reclamation area.

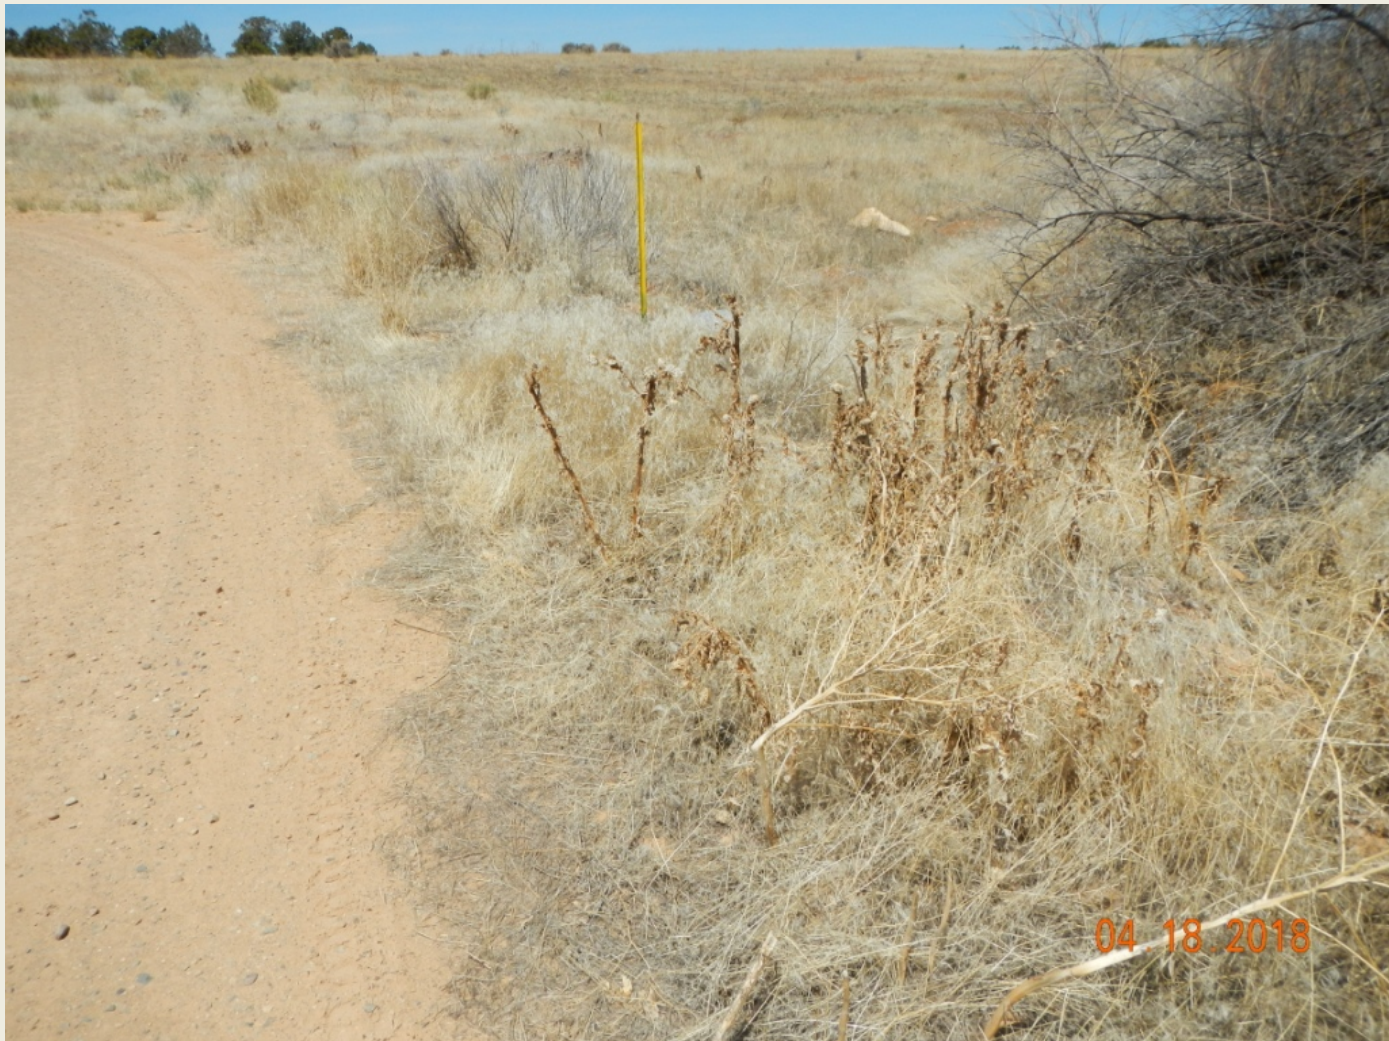
Photo 5. View of musk thistles along the access road.
