# Inspection Photos

API: 05-083-06722

Operator: QEP

Inspection Date: 4/18/2018

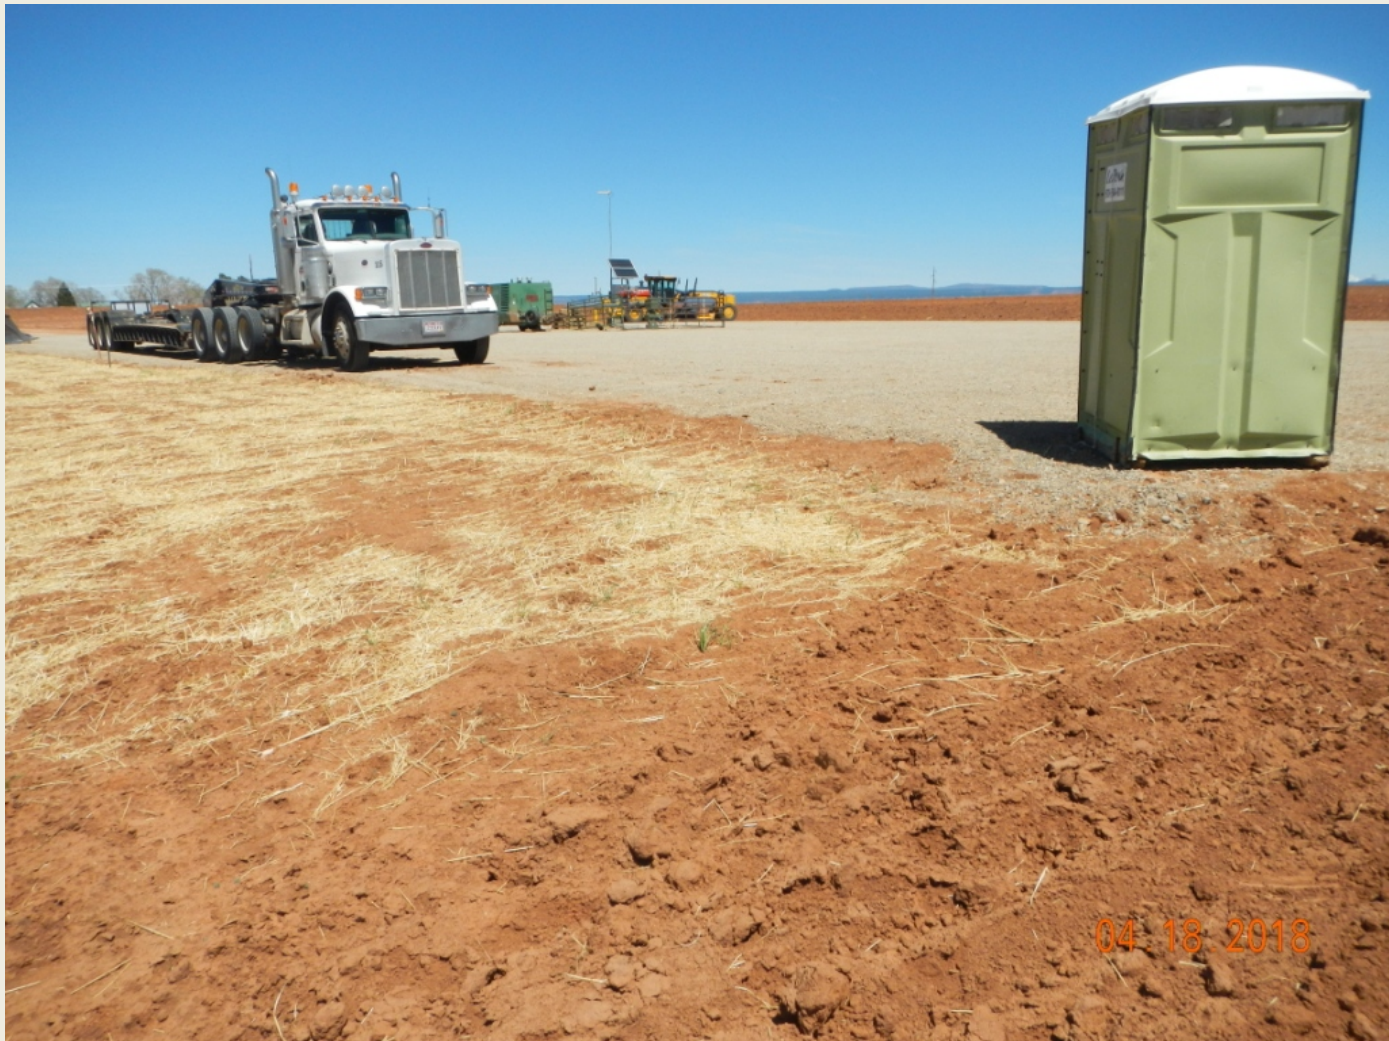
**Photo 1. View of the project area from the southwestern corner facing center.**

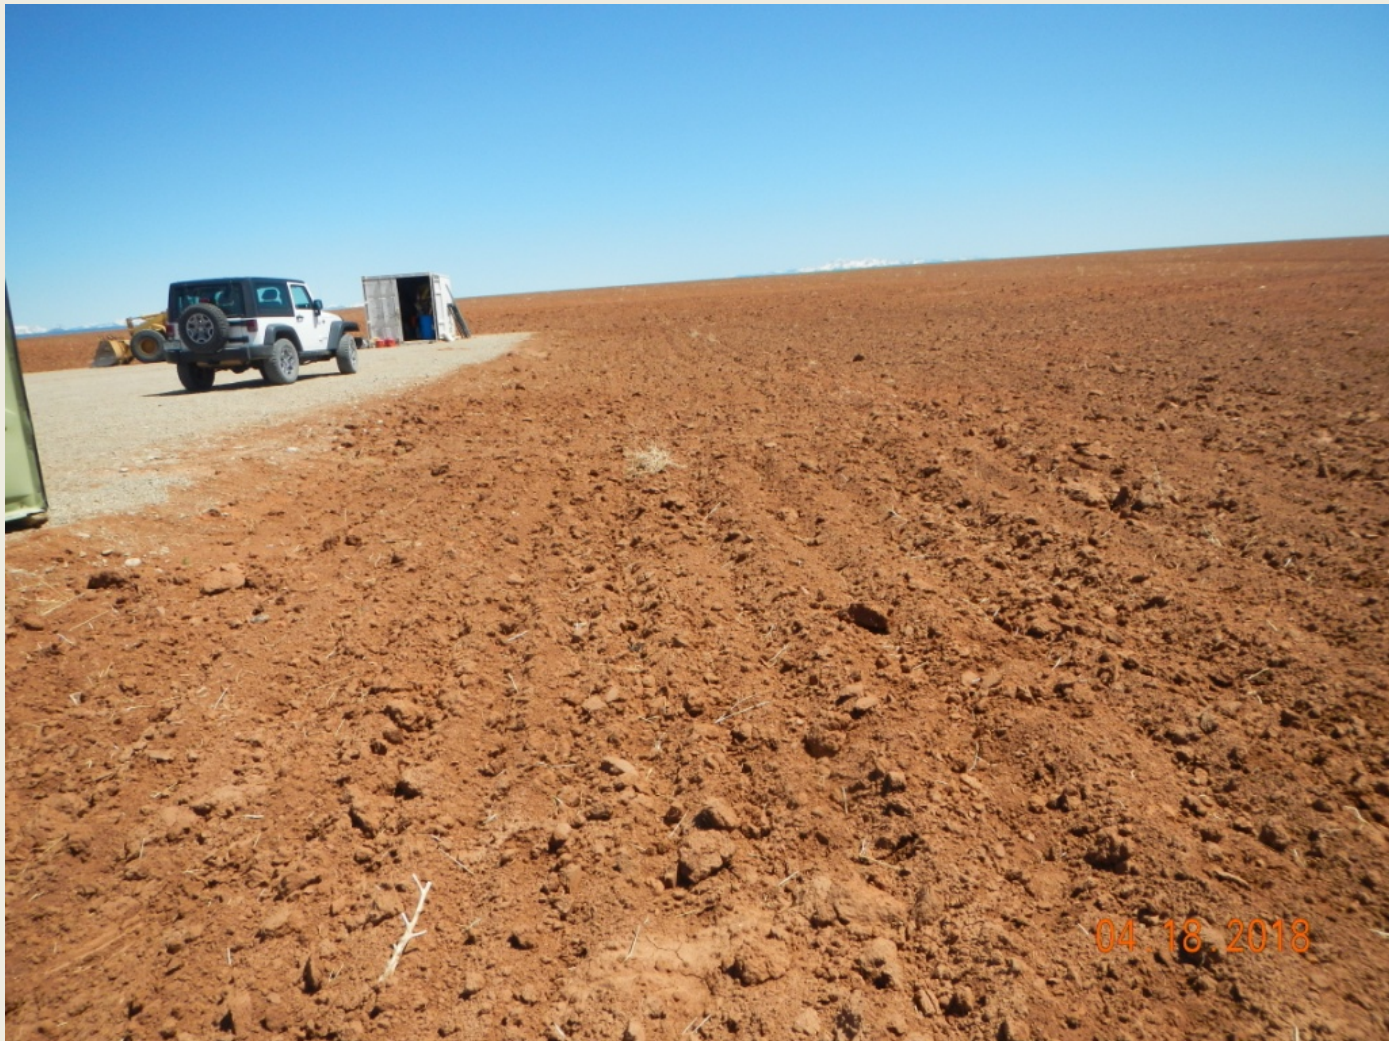
**Photo 2. View of the southern edge of the working area from the southwestern corner facing eastward. Interim reclamation is conducted and area contoured to match surrounding agricultural field.**

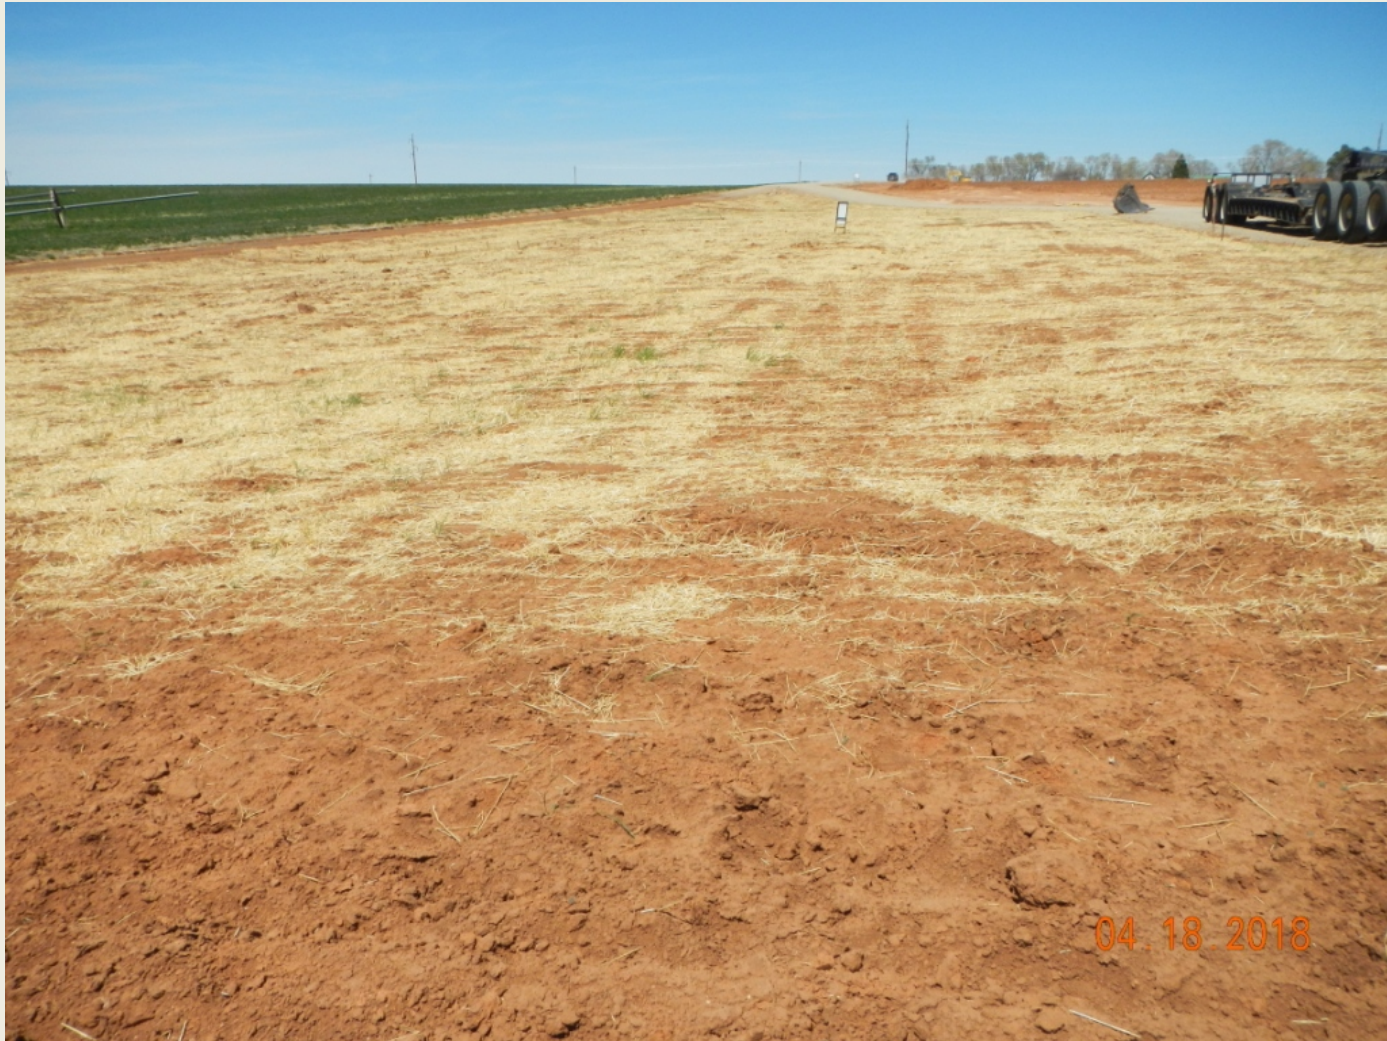
**Photo 3. View of the western portion of the project area from the southwestern corner facing northward. Western portion of project area is in process of being revegetated. Straw mulch and seedlings observed.**

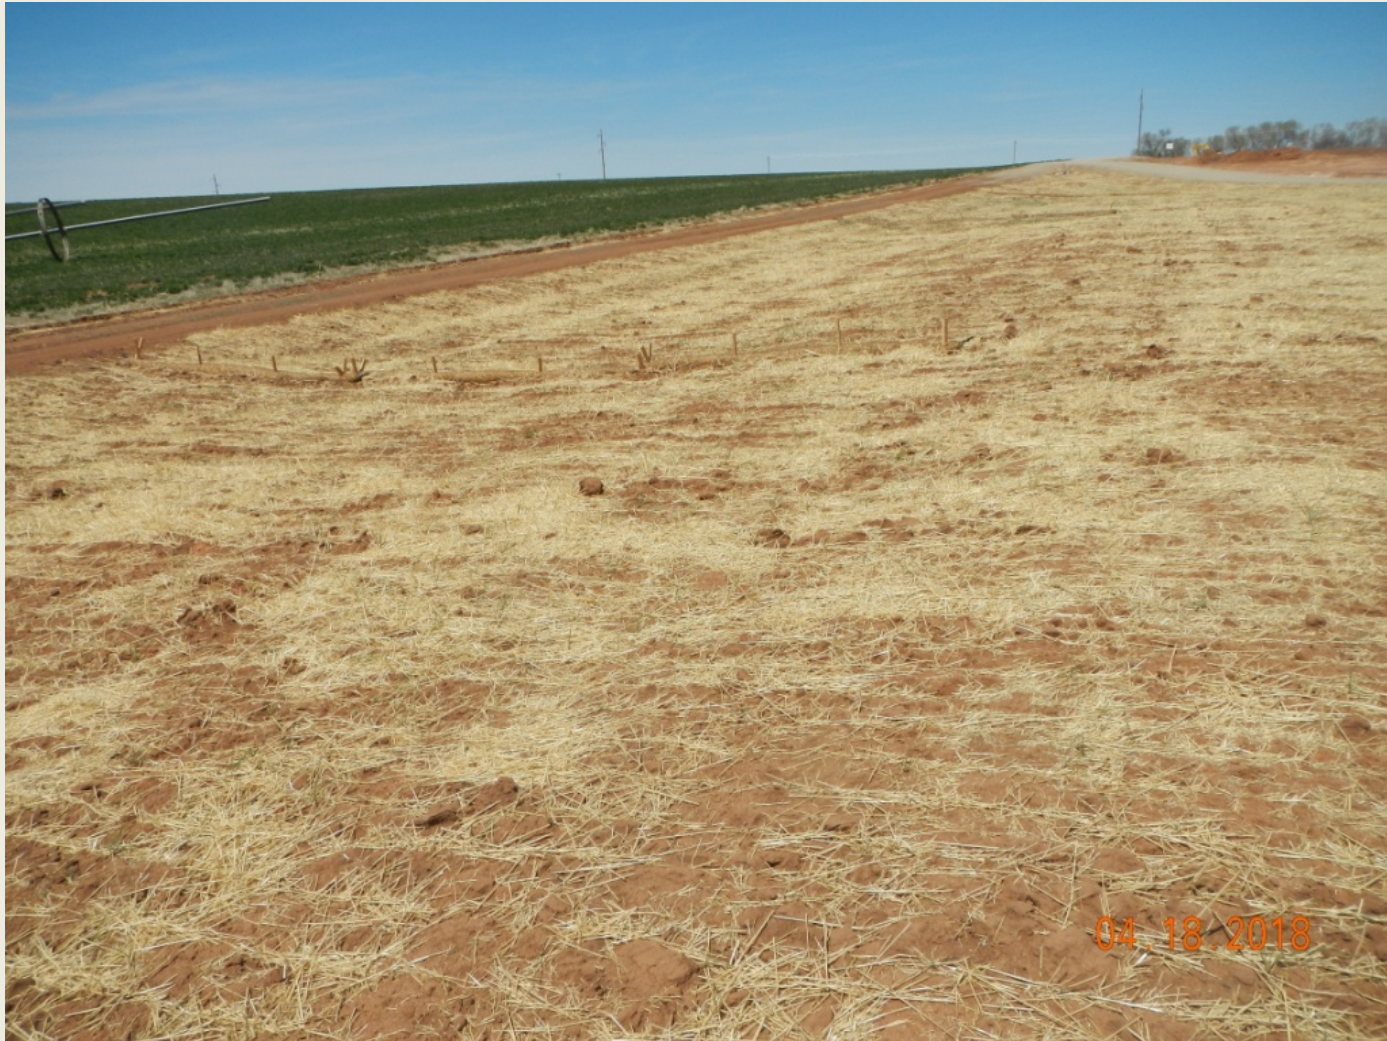
**Photo 4. Another view of western interim reclamation area and straw wattles in shallow swale along the western edge of the project area. Appear to be functioning.**

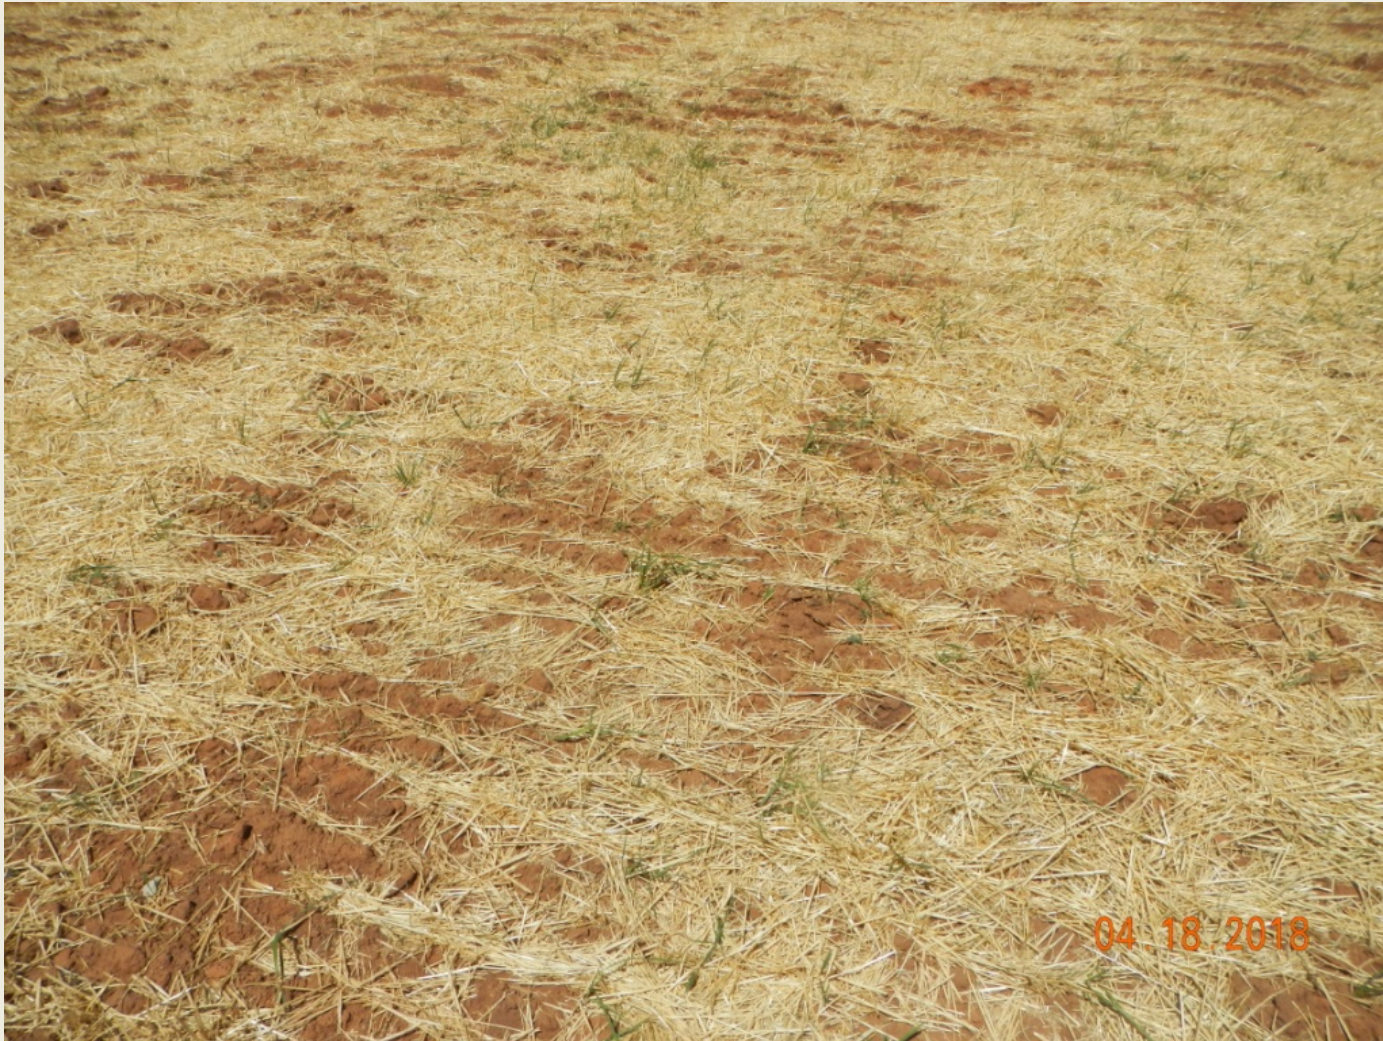
**Photo 5. View of young seedlings observed within the newly planted areas.**
