# Construction and Stormwater Inspection

May 14, 2018

Operator: EXTRACTION OIL & GAS INC - #10459

Location ID: 454492

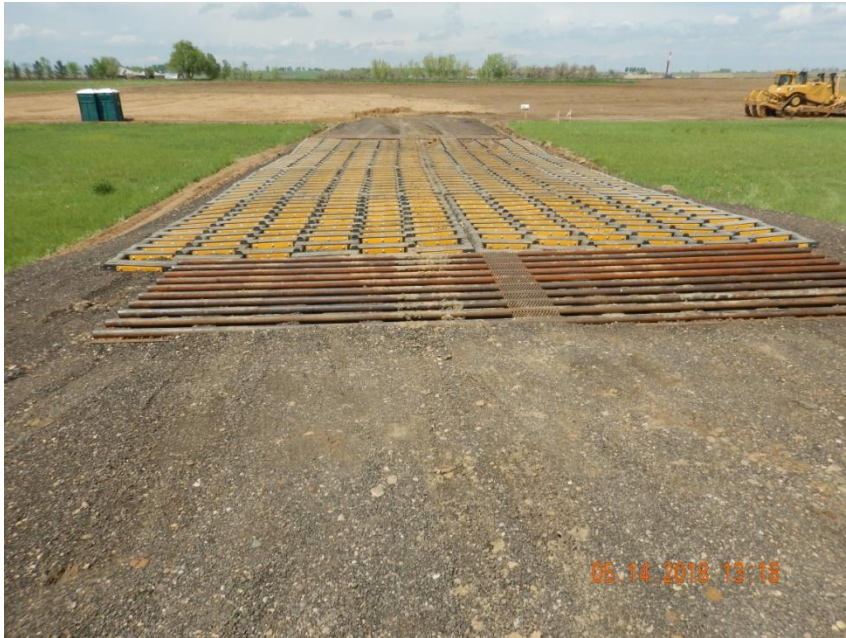
**Photo 1.** Photo taken from the entrance of location, facing North. Operator has installed tracking device BMPs. Based off the location file, Operator is not using the proposed access road. This access road is east of the proposed access road.

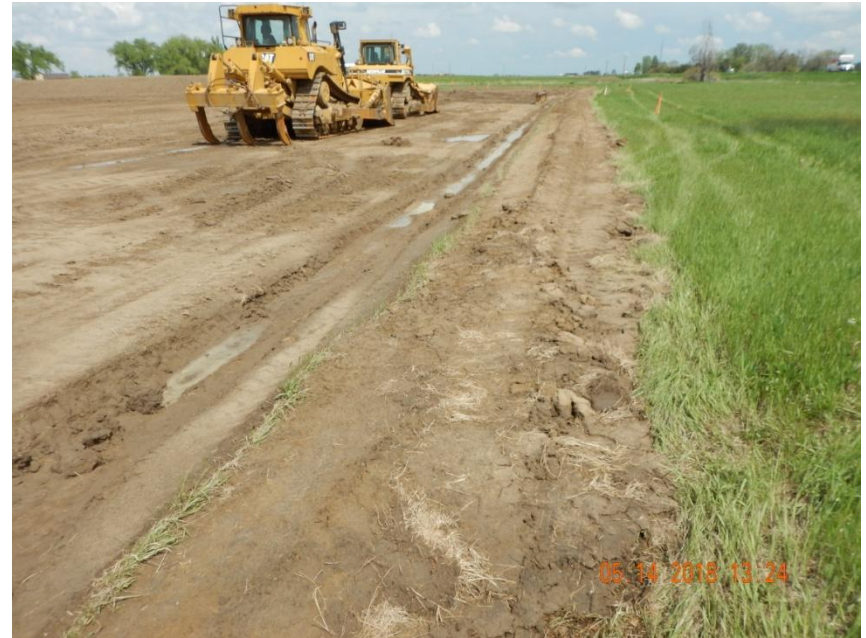
**Photo 2.** Photo taken from the entrance of location, facing East. Ditch and berm BMP has been installed around the entire perimeter of the location. Portions of the berm BMP are unconsolidated. An unconsolidated berm is not a proper functioning BMP.

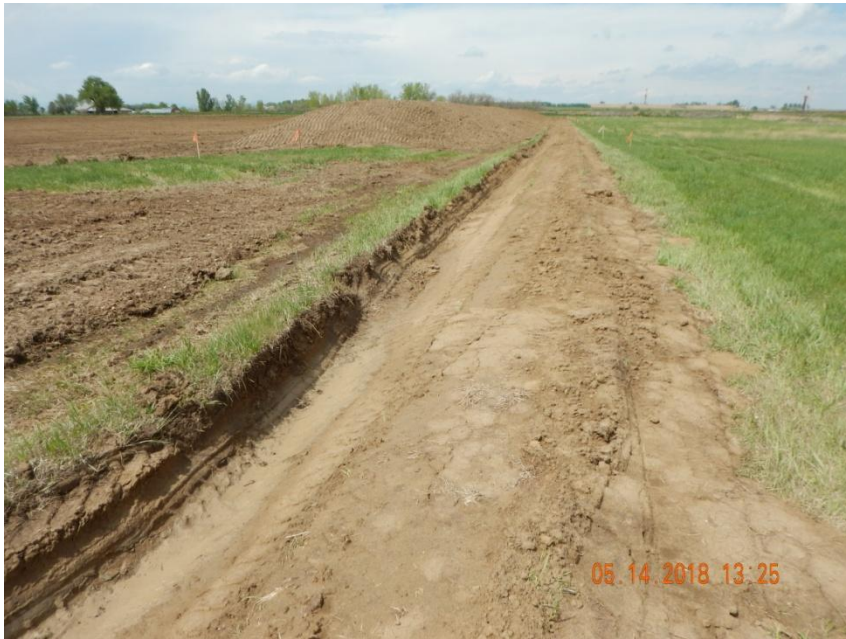
**Photo 3.** Photo taken from the southeast perimeter of the location, facing North. See comments under Photo 2.

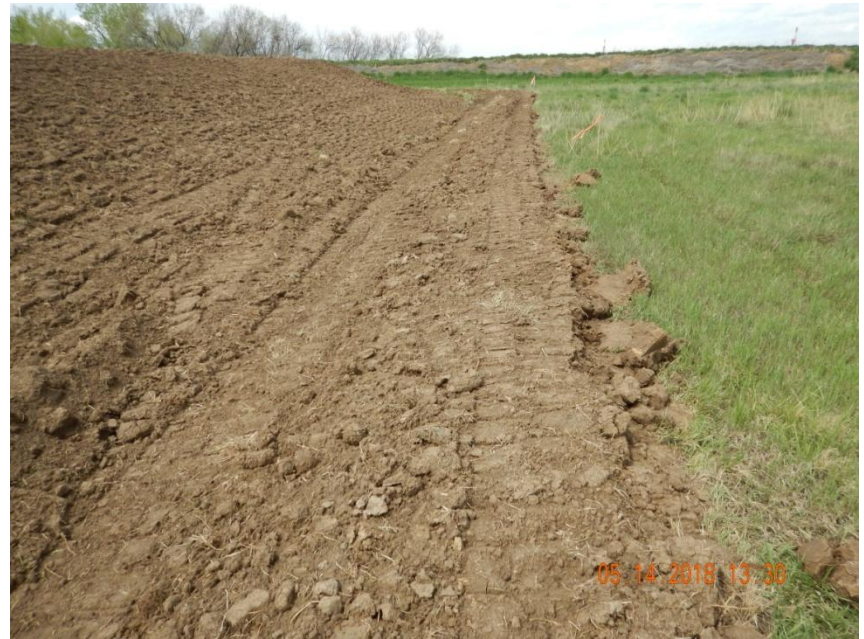
**Photo 4.** Photo taken from the northeast perimeter of the location, facing North. Ditch BMP has been filled in from construction operations and needs maintenance. Topsoil has been stockpiled and temporarily stabilized with equipment tracking along the eastern perimeter of the location.

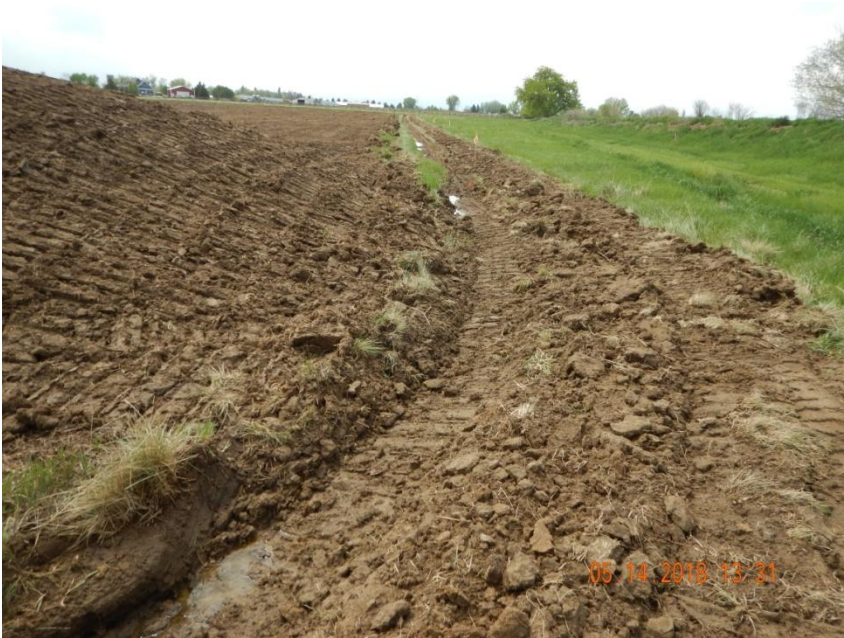
**Photo 5.** Photo taken from the northeast perimeter of the location, facing West. Photo illustrates a portion of the unconsolidated berm BMP and ditch BMP that need maintenance.

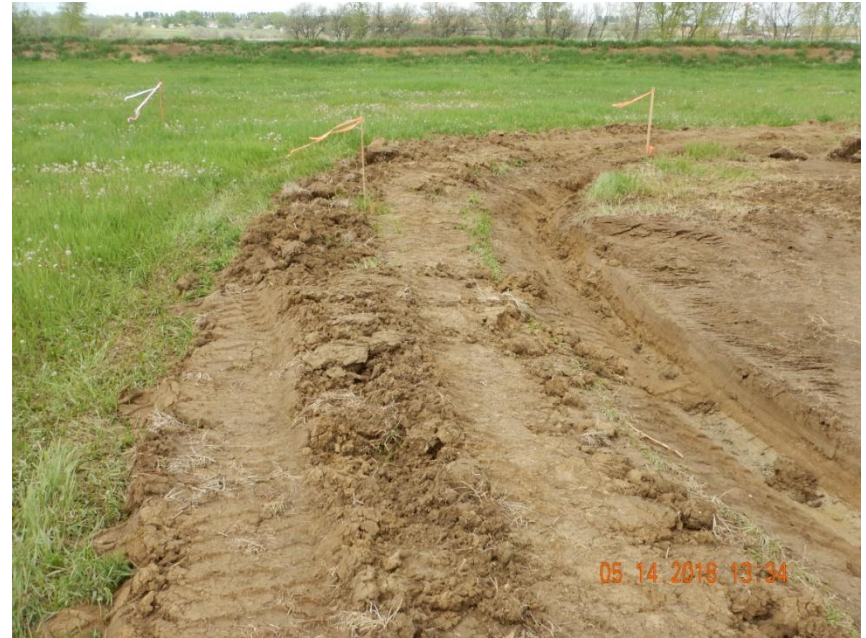
**Photo 6.** Photo taken from the northwest perimeter of the location, facing North. See comments under Photo 5.

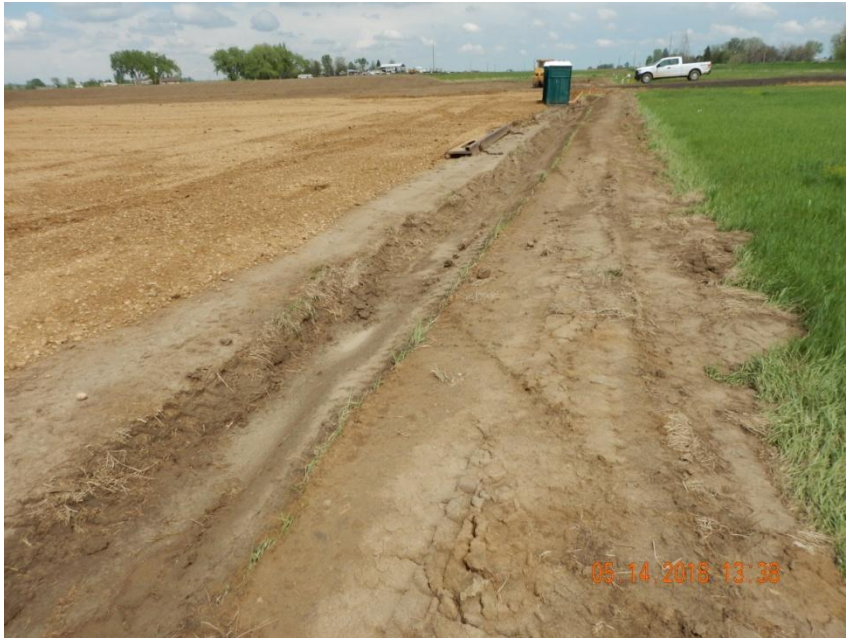
**Photo 7.** Photo taken from the southwest perimeter of the location, facing East. See comments under Photo 2.

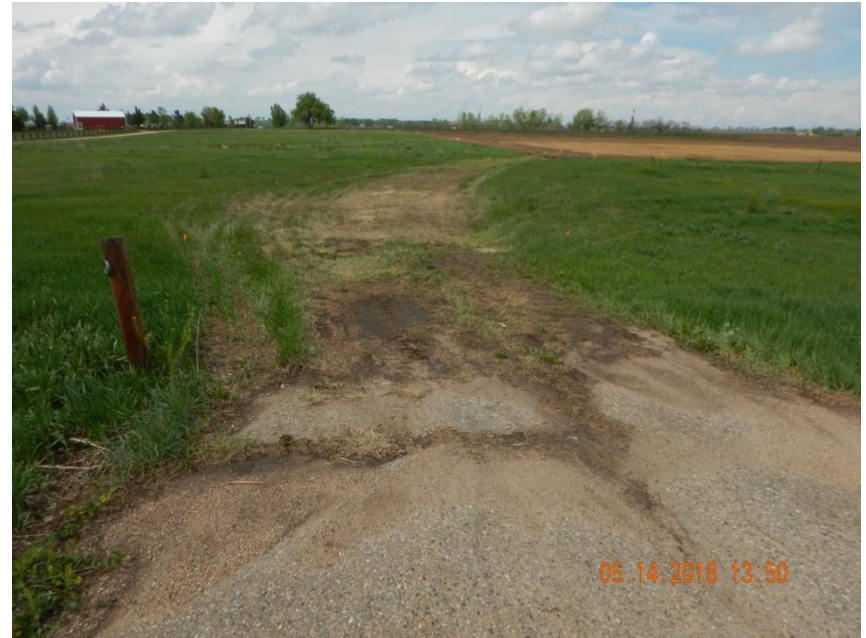
**Photo 8.** Photo taken from the proposed access road area, facing North. The proposed access road has been flagged and appears some traffic used this area, but this is not the current access road being used- see Photo 1.
