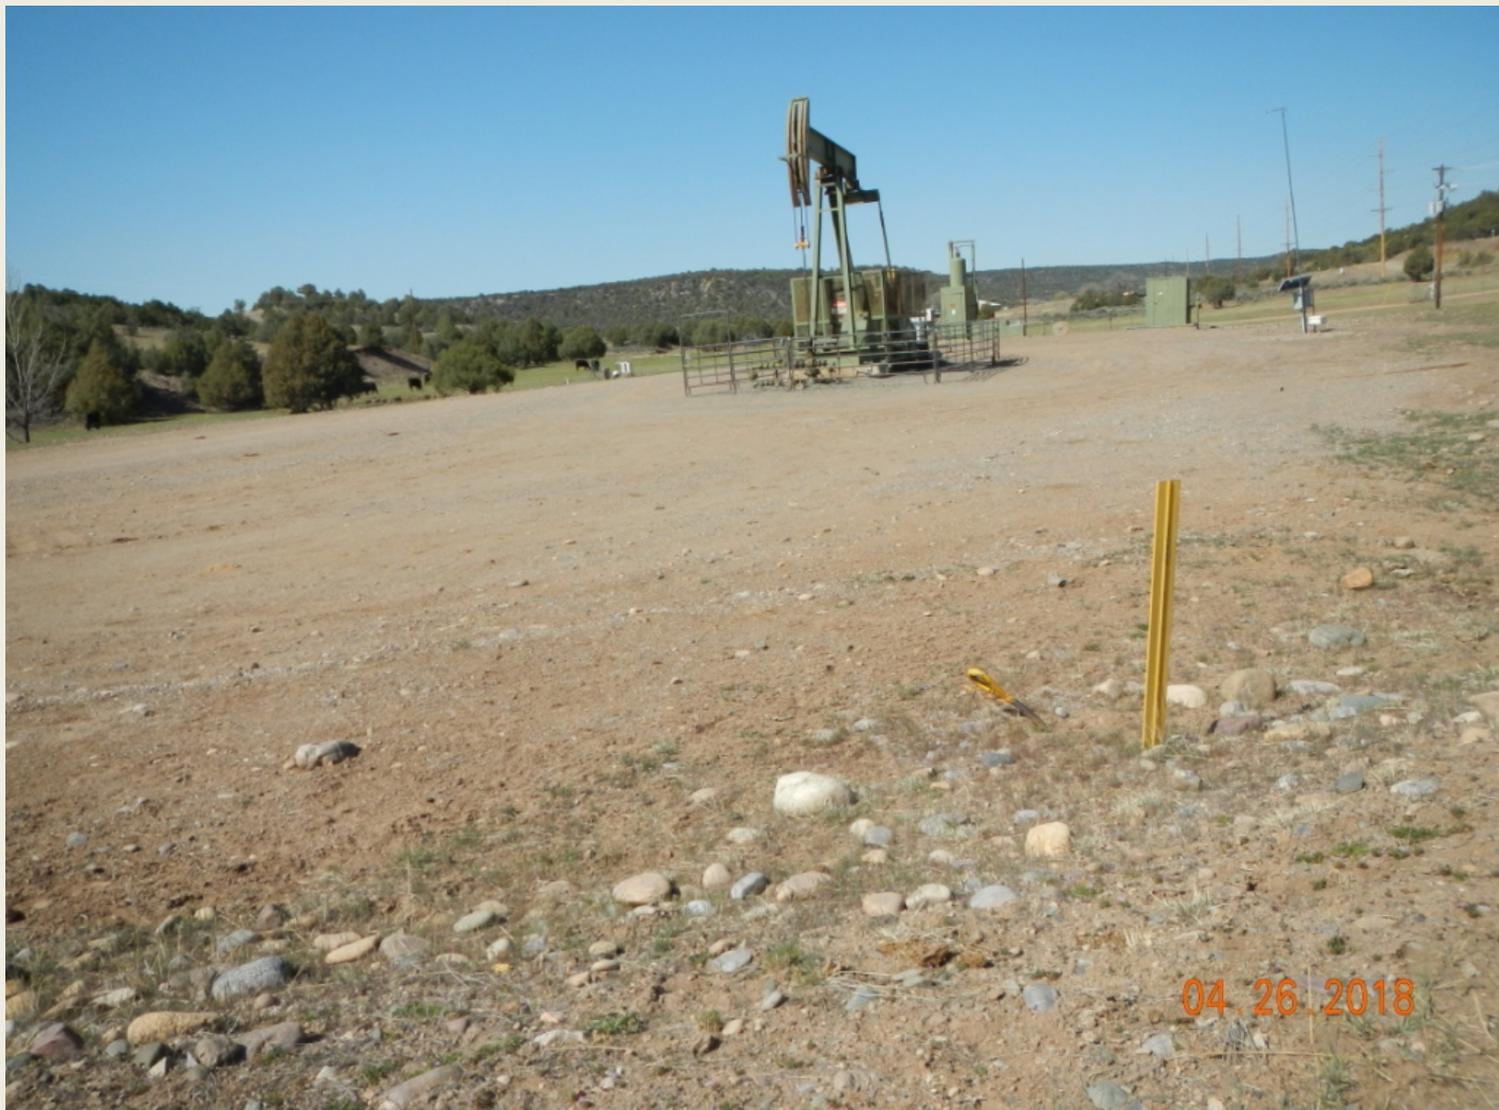
Photo 1. View of the project area from the northeastern corner facing center.

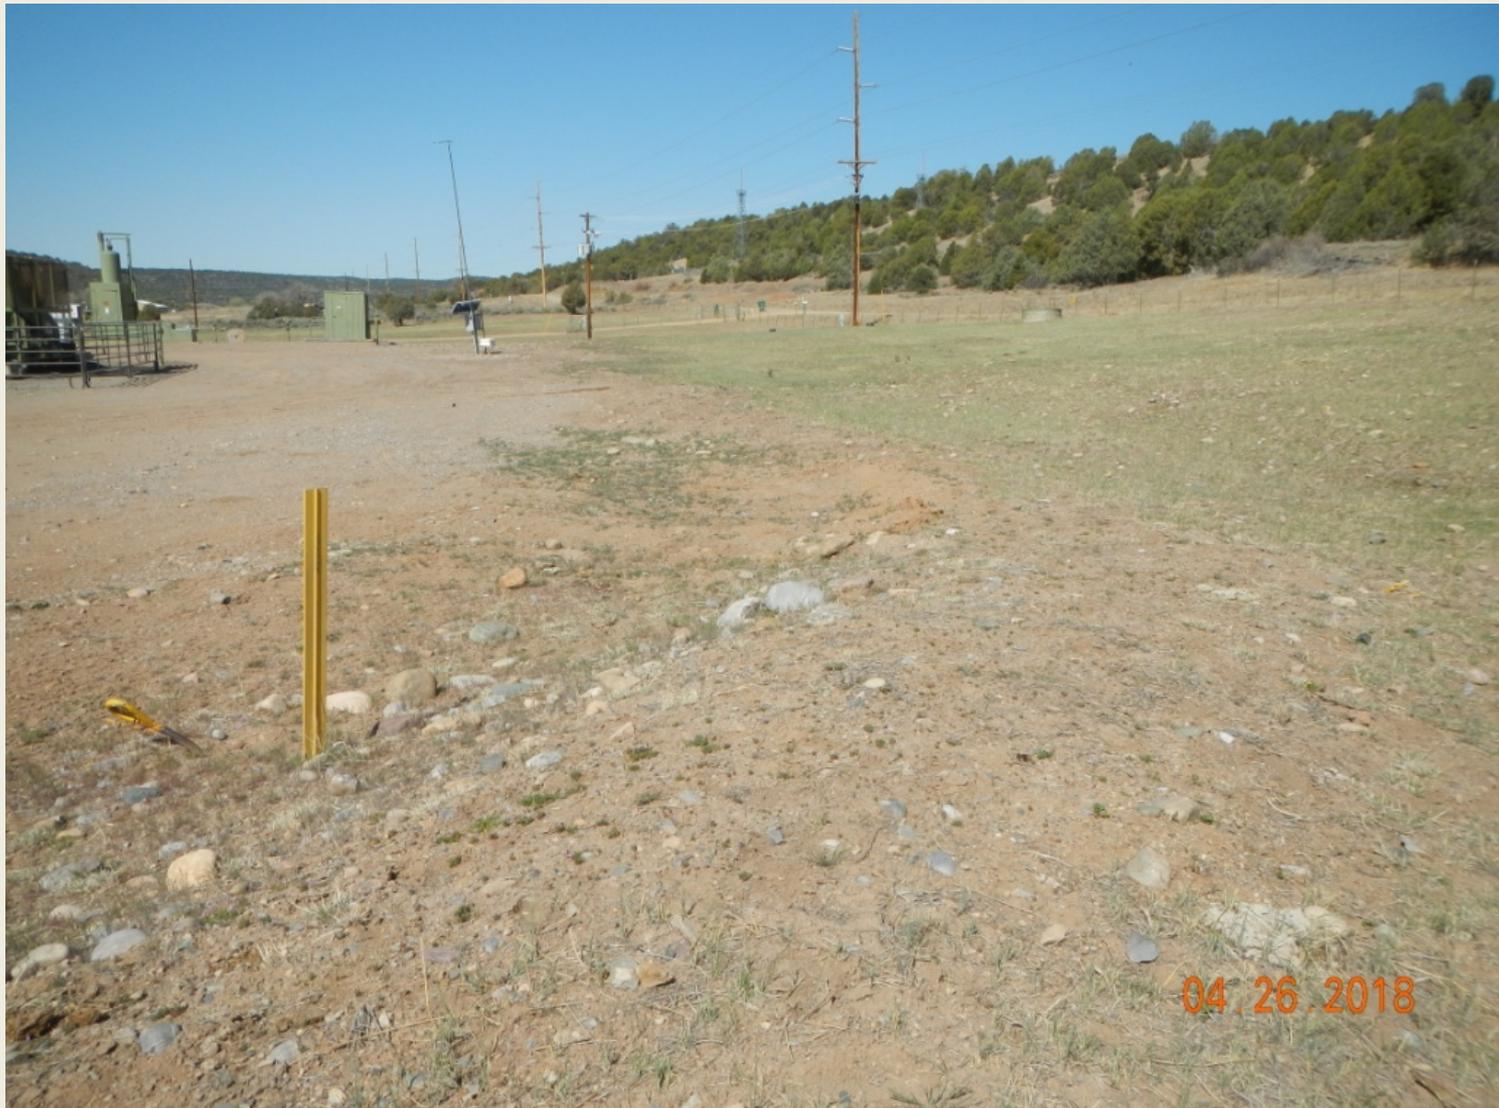
Photo 2. View of the northern portion of the project area from the northeastern corner of the working area facing westward. Revegetation is progressing with grazed grasses such as western wheatgrass (*Pascopyrum smithii*).

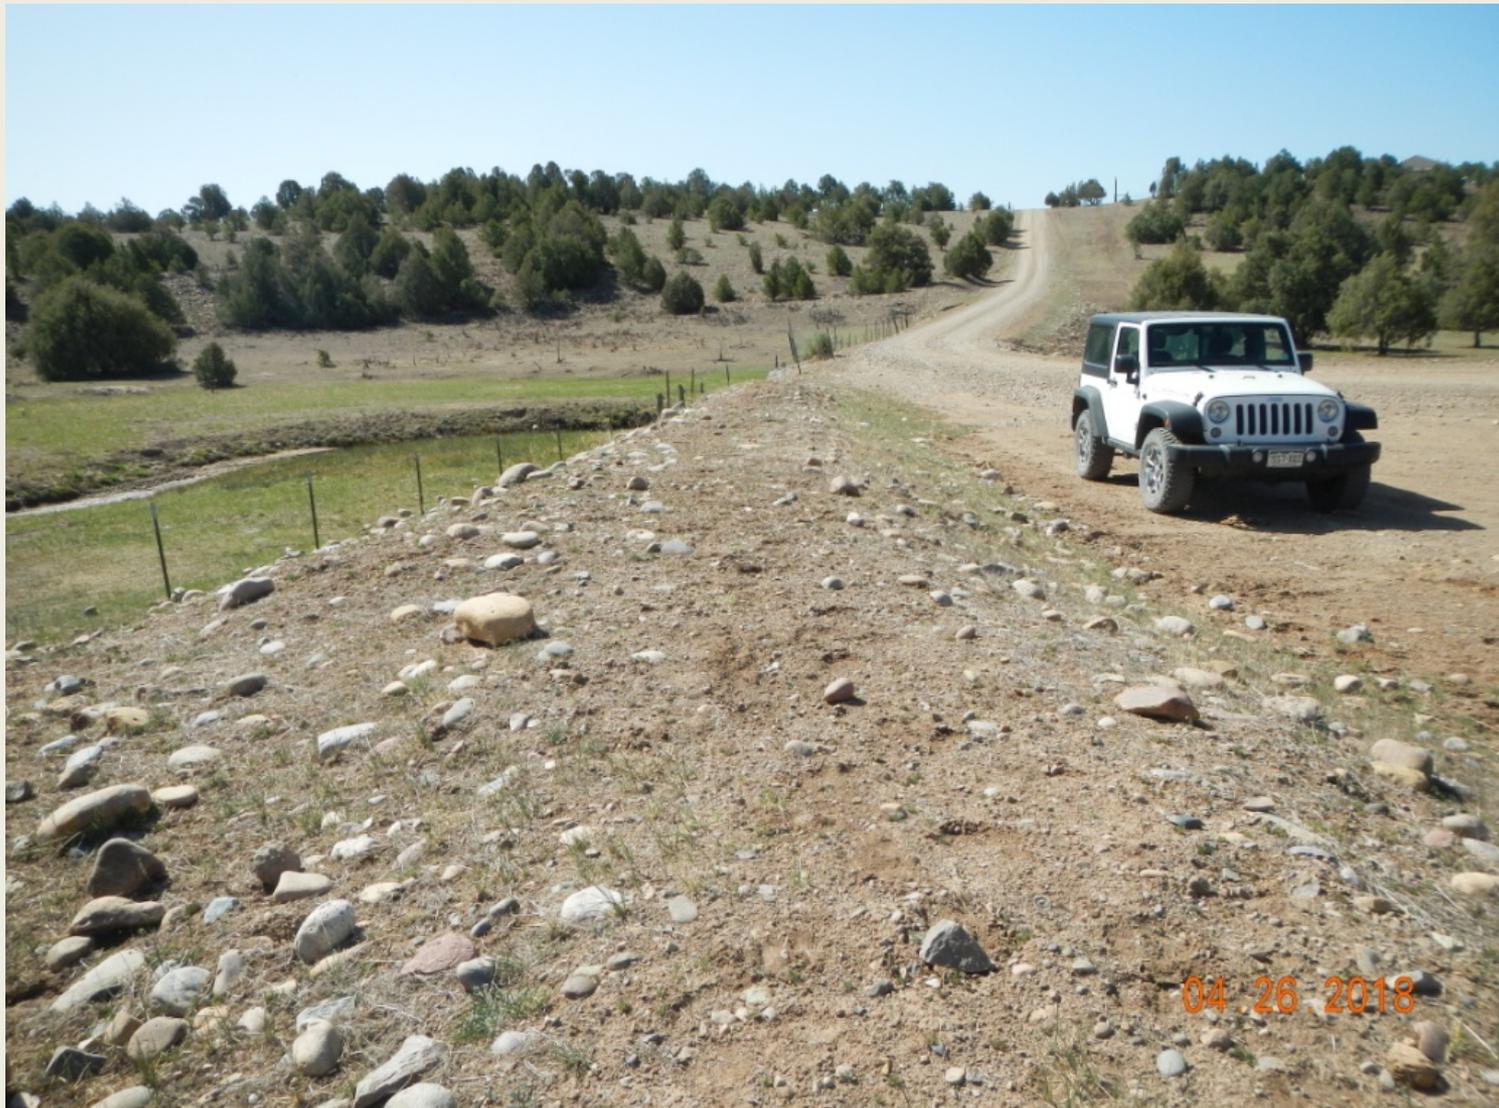
Photo 3. View of the eastern portion of the project area from the northeastern corner of the working area facing southward.

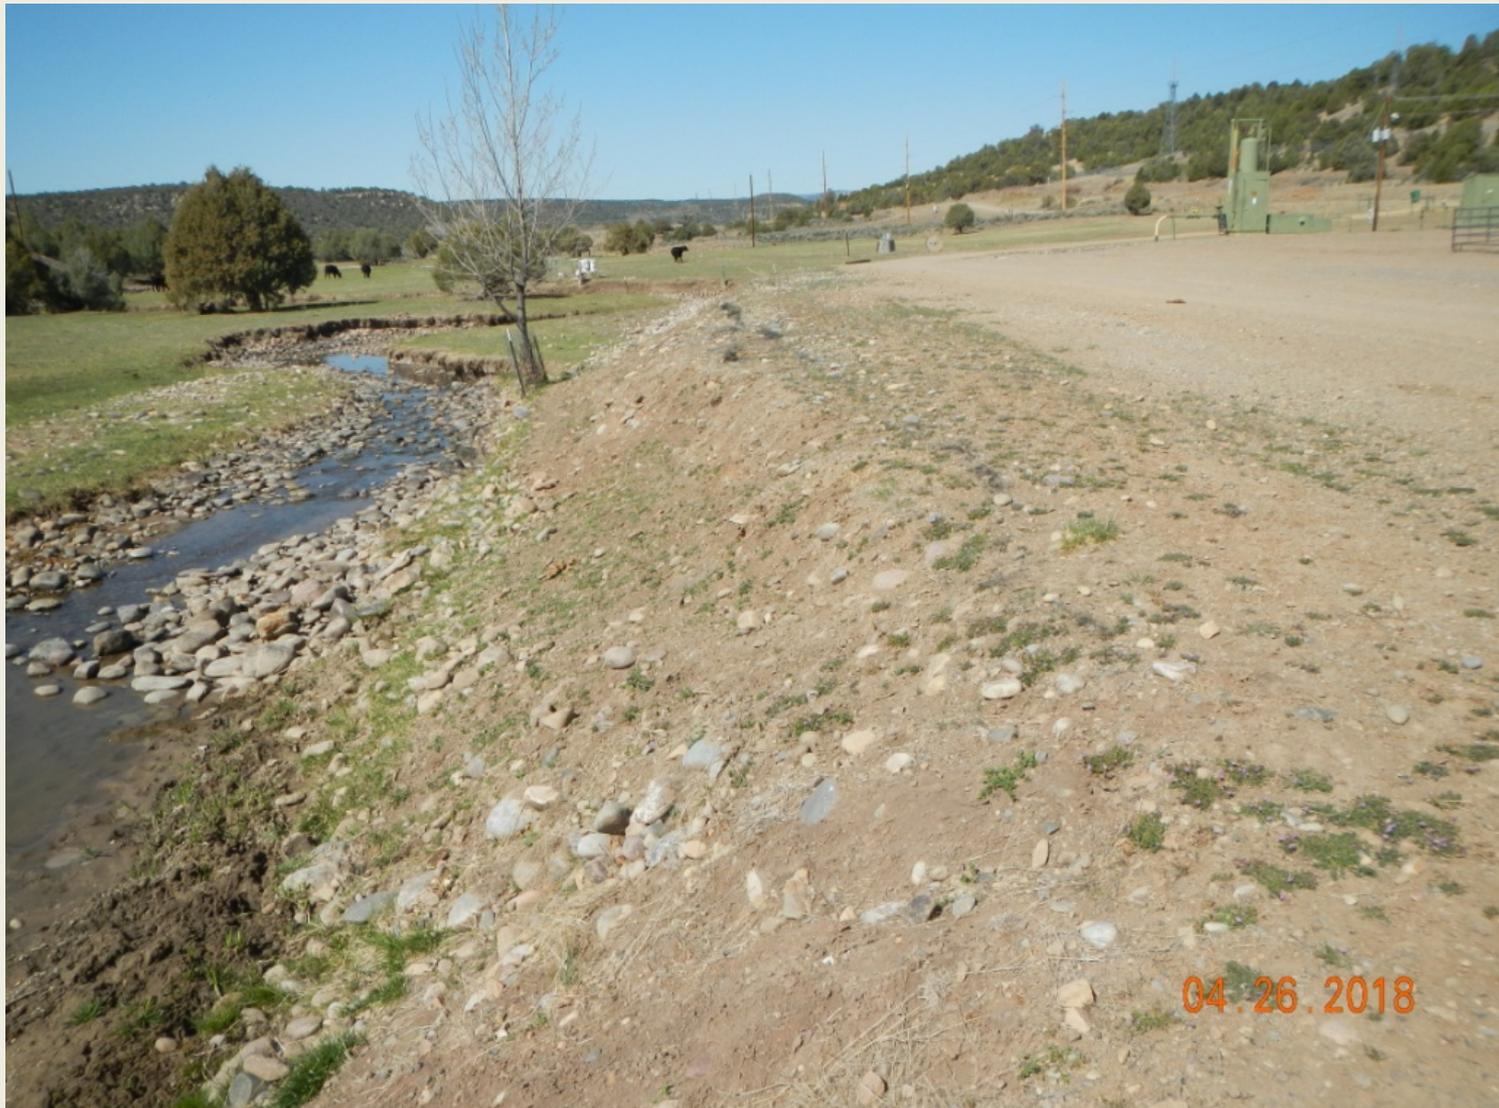
Photo 4. View of the southern portion of the project area from the southeastern corner facing westward. No significant erosion observed; however, this area needs to be carefully monitored or more robust stormwater controls installed.

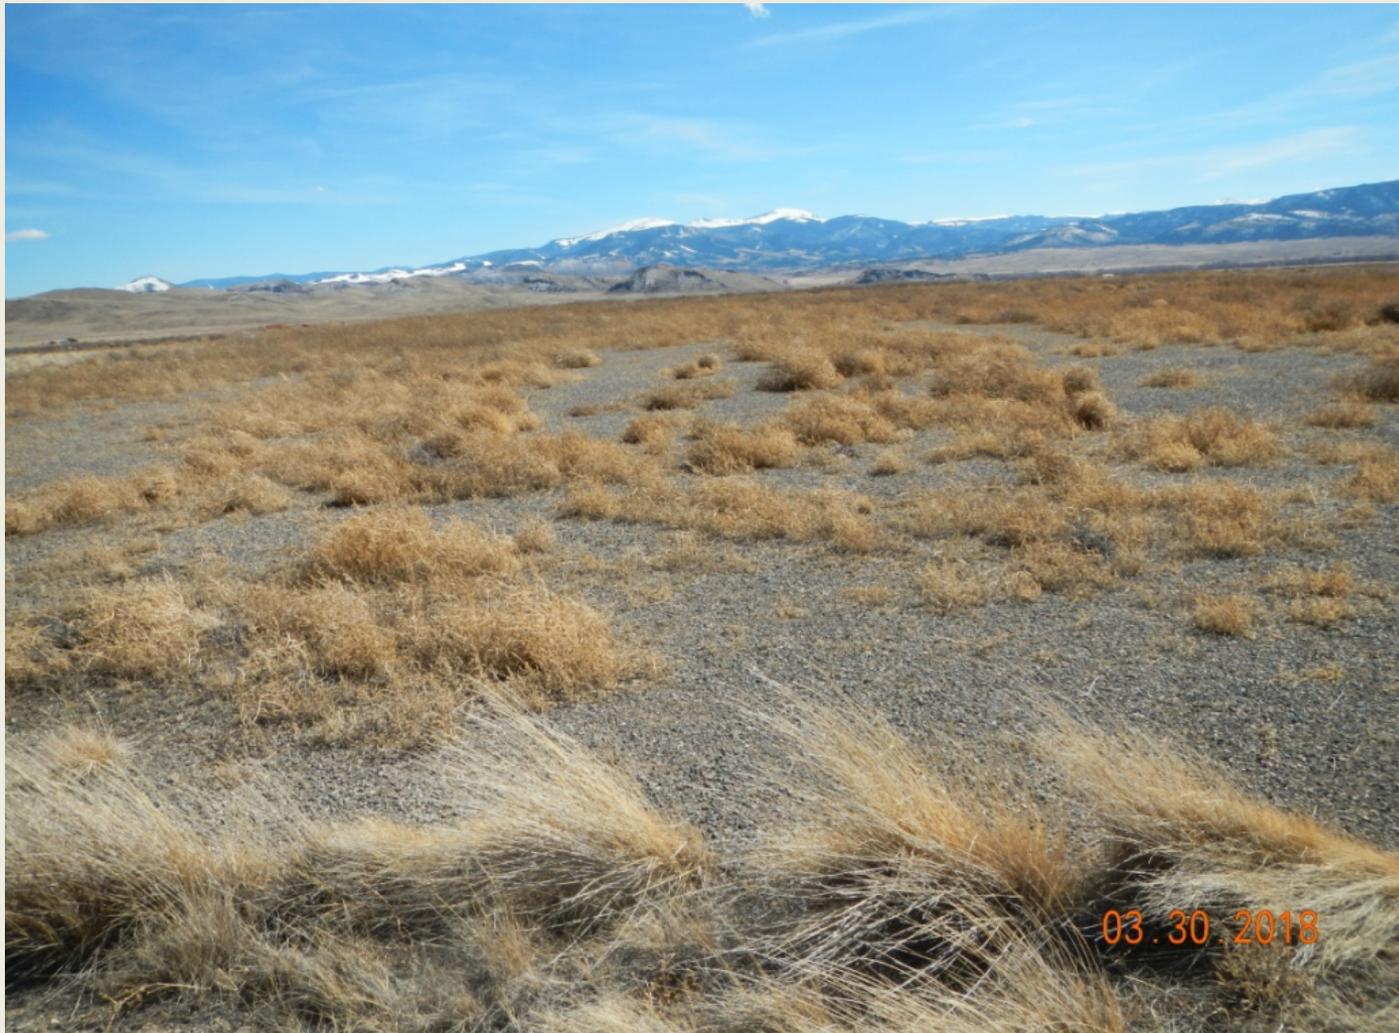
Photo 2. View of the eastern portion of the project area from the northeastern edge facing southward. Vegetation on flat, graveled portion of the well pad is dense Russian thistle (*Salsola tragus*).

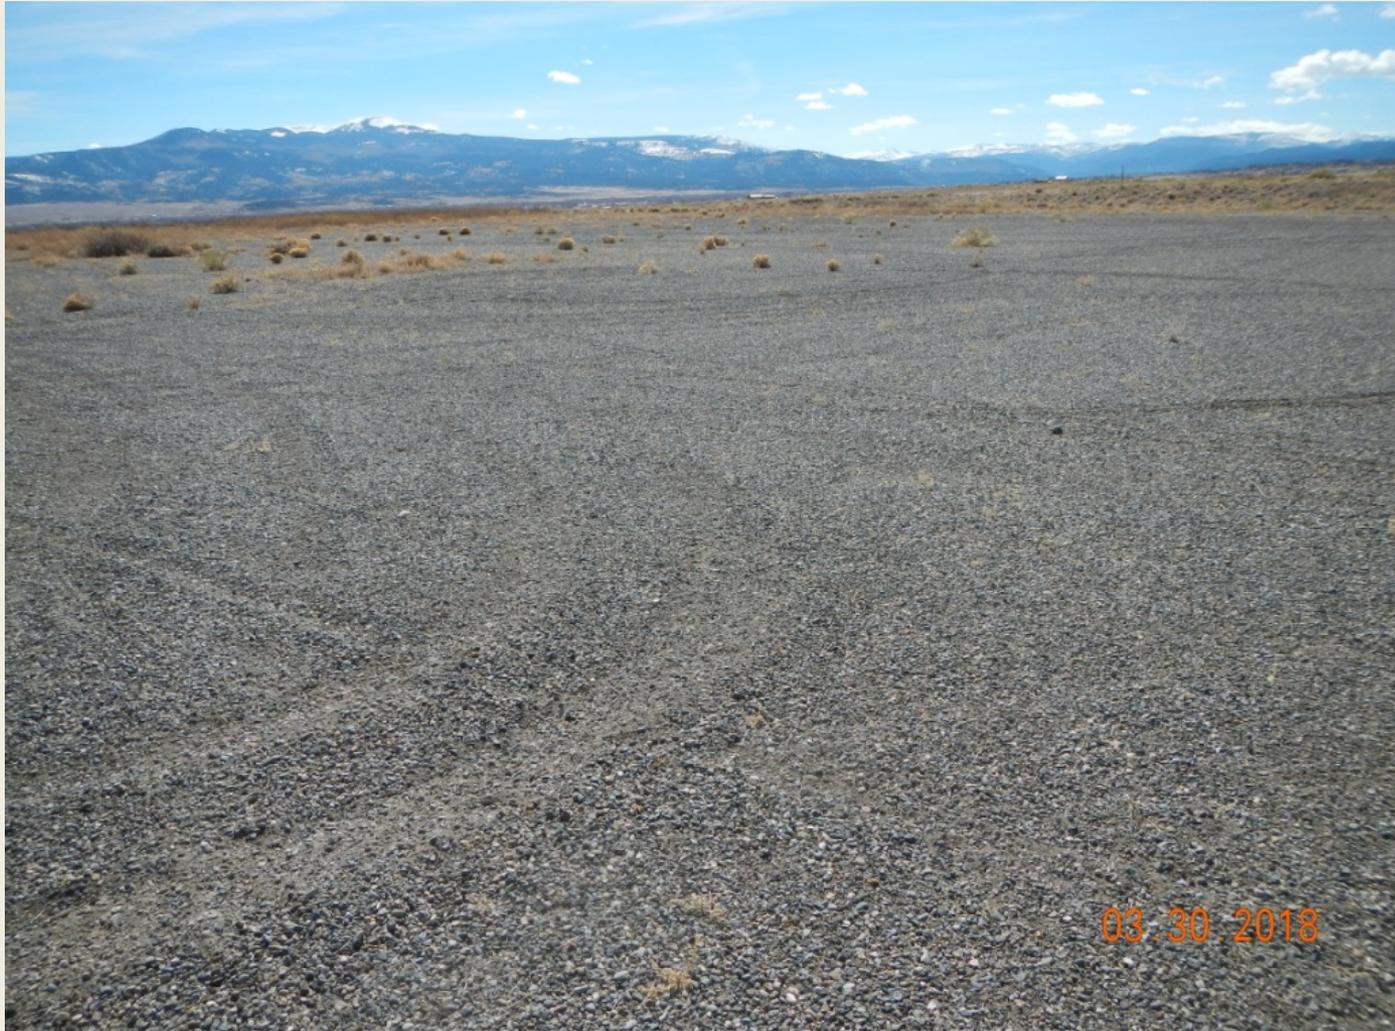
Photo 3. View of the western portion of the project area from the northeastern edge facing southwestward.

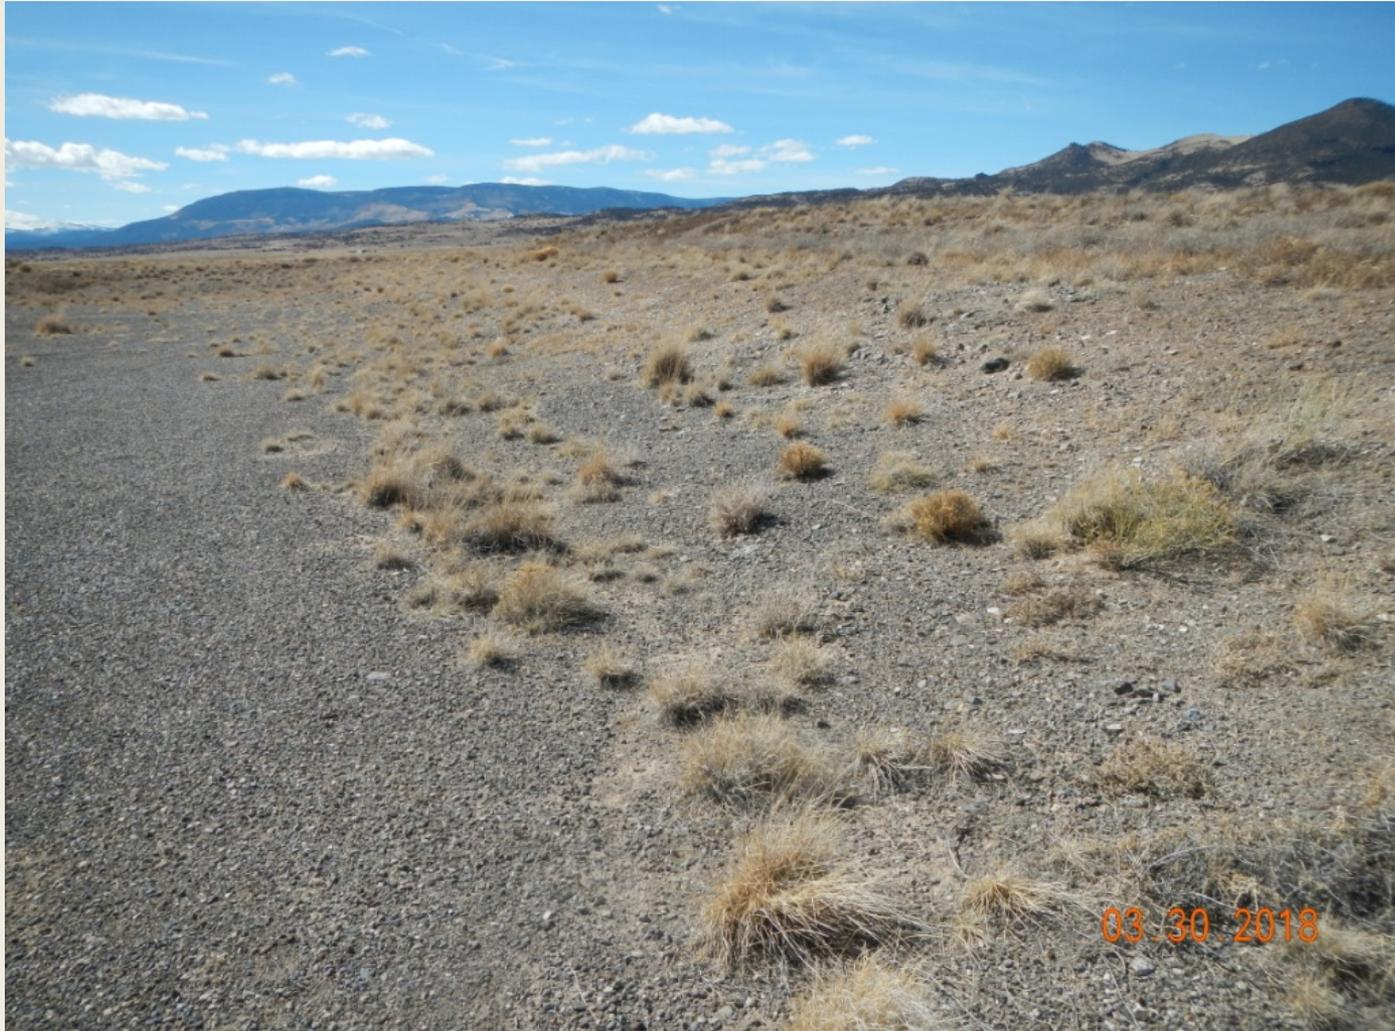
Photo 4. View of the northern cut-slope facing westward from northern edge.
