Interim Reclamation Inspection

Operator: KERR MCGEE OIL & GAS ONSHORE LP- #47120

Location ID: 159823

Inspection Photos
Location Name: WILSON RANCH /34N-
27HZ
Location ID: 159823

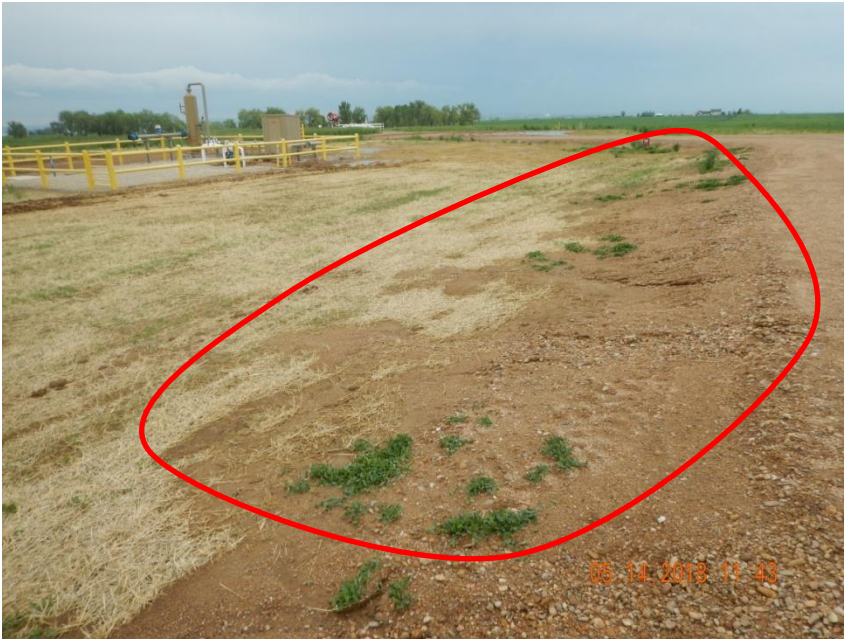
Photo 1. Photo taken of the eastern battery location, facing South. Appears the Operator has performed interim reclamation activities to reduce disturbance areas only needed for production operations, with the evidence of drilling rows and straw crimped mulch. Germination was apparent throughout the interim areas. Operator shall continue to monitor and manage this site until the location meets Rule 1003 standards. Rill erosion was observed along the eastern location- red circle.

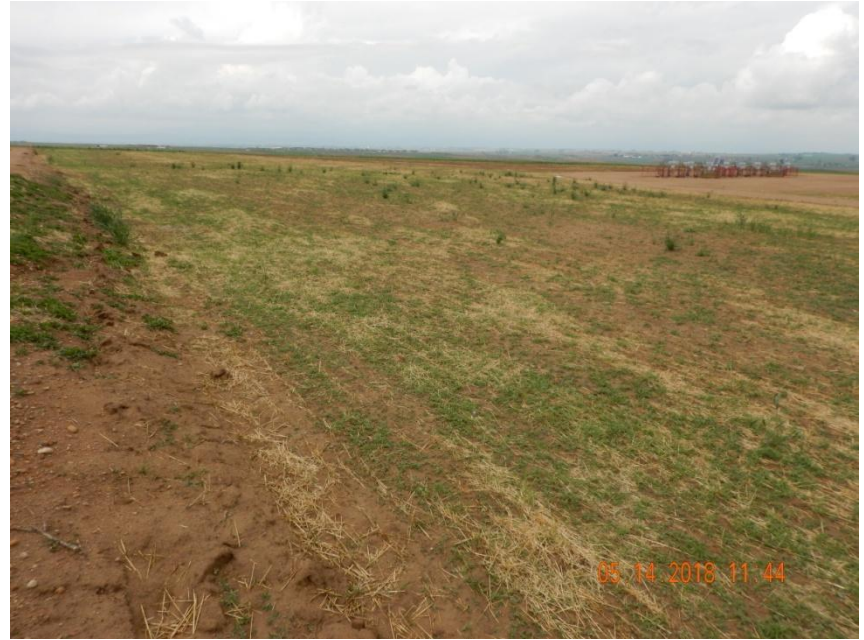
Photo 2. Photo taken of the northeastern battery location, facing West. See comments under Photo 1. In addition, Kochia rosettes were also observed throughout interim areas.

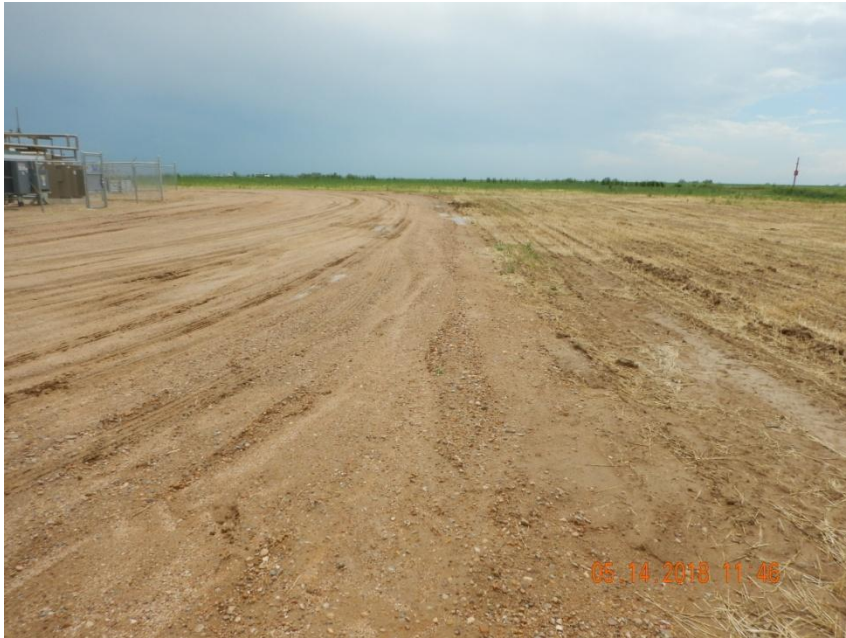
Photo 3. Photo taken of the northwest battery location, facing South. See comments under Photo 1 and 2.

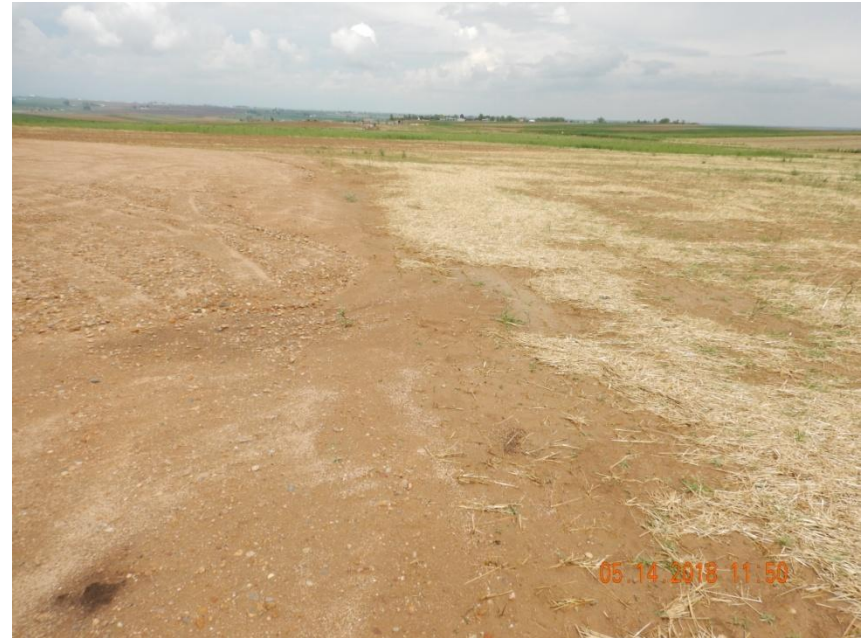
Photo 4. Photo taken of the eastern well location, facing North- see comments under Photo 6.

Photo 6. Photo taken of the northeast well location, facing South. Appears portions of the eastern well location are not needed for production operations. Operator shall comply with Rule 1003 standards if these areas are no longer needed.

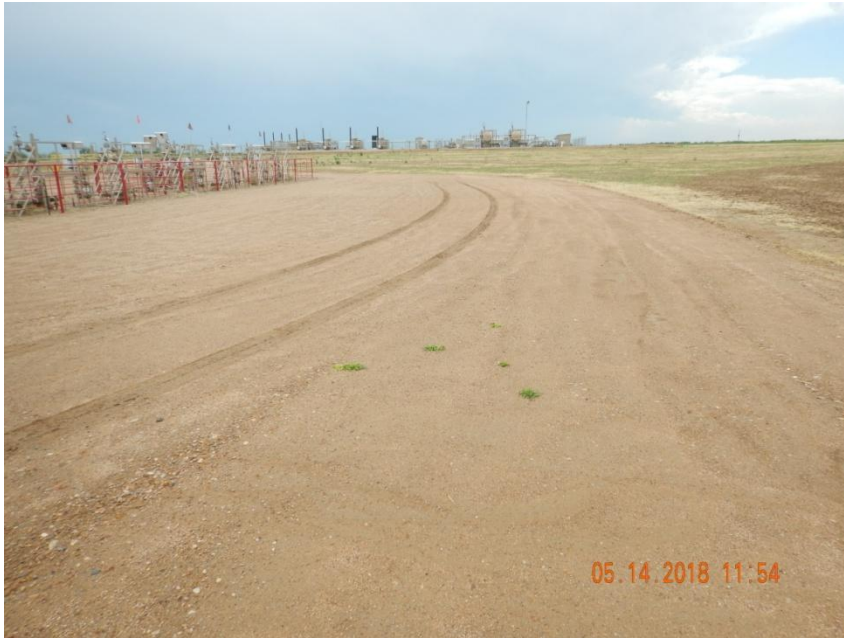
Photo 5. Photo taken of the northwest well location, facing South. See comments under Photo 1 and 2.
