Inspection Photos

Operator: WIEPKING-FULLERTON ENERGY LLC -
96340

Location ID: 321883

Inspection Doc. Number: 682503357
Cheyenne County, CO

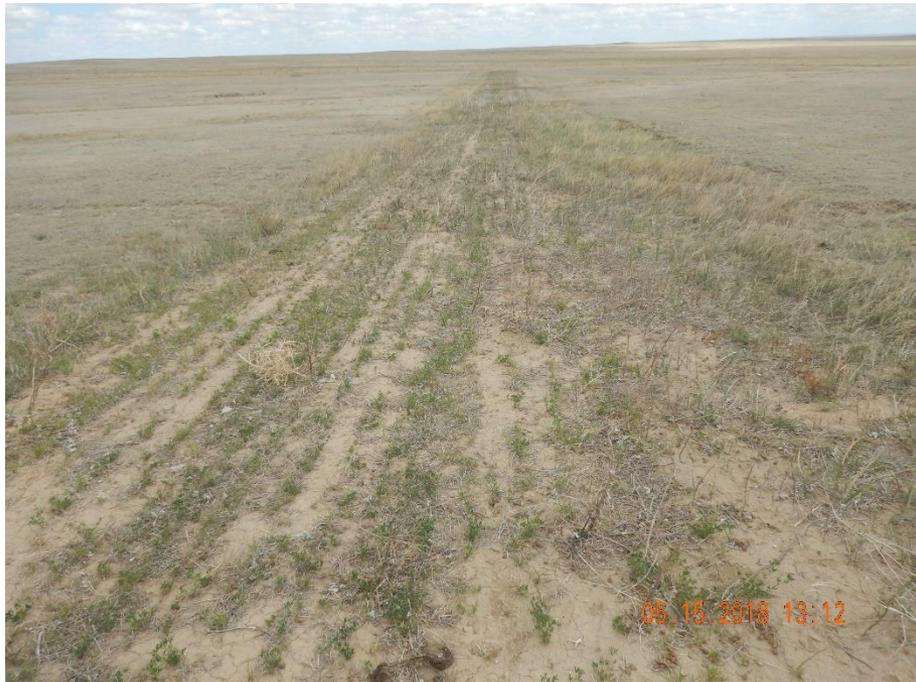
Photo 1: Photo taken from the east end of the location, facing east. Photo shows section of the access road NOT included in the variance request appears to have had reclamation work conducted.

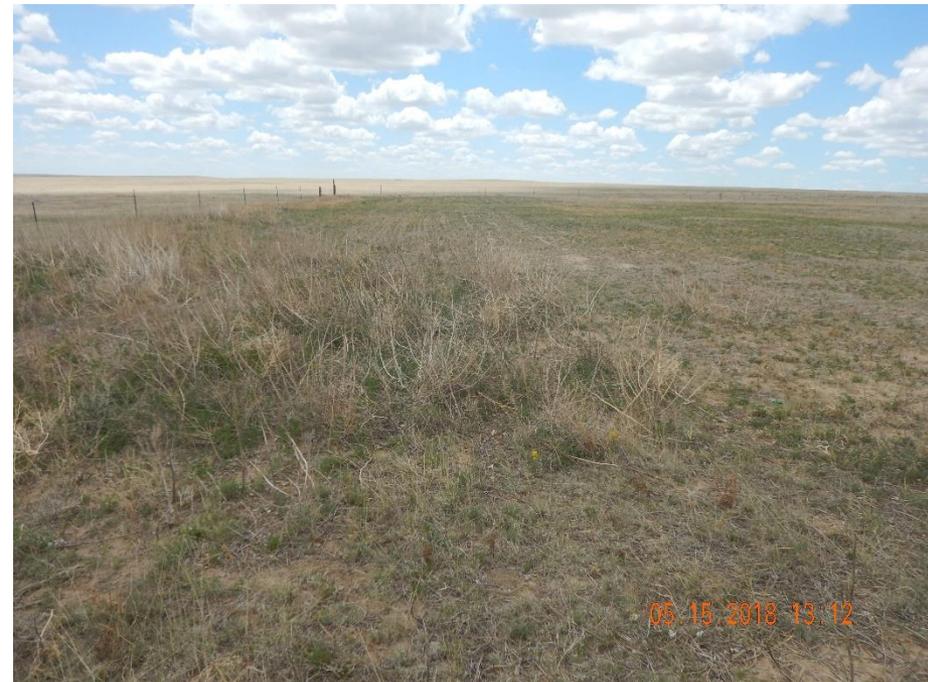
Photo 2: Photo taken from the southeast end of the location, facing west. Photo shows overview of the location. Recent reclamation work evident.

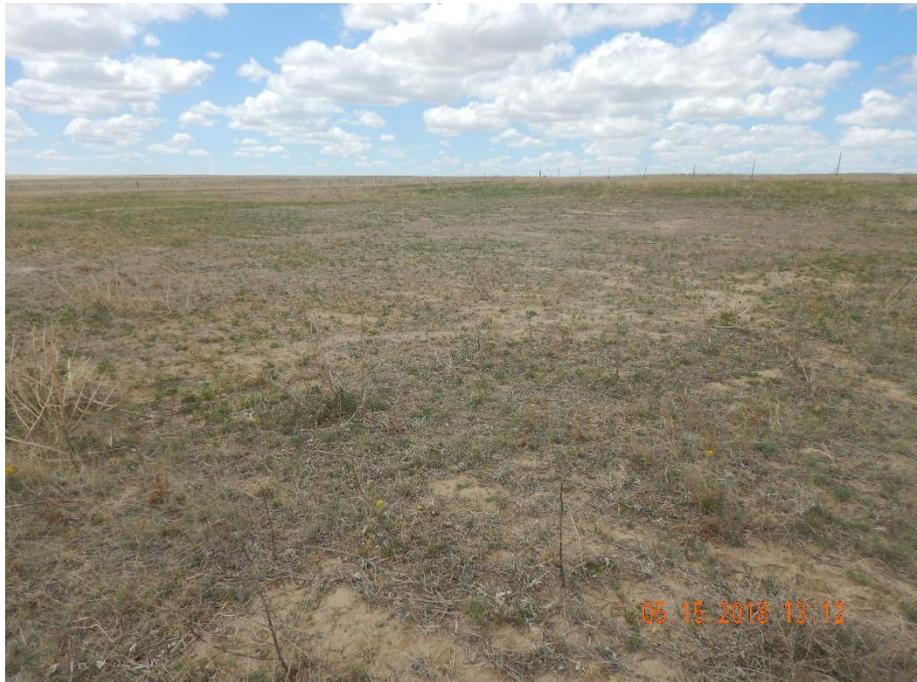
Photo 3: Photo taken from the southeast end of the location, facing northwest. Photo shows overview of the location. Recent reclamation work evident.

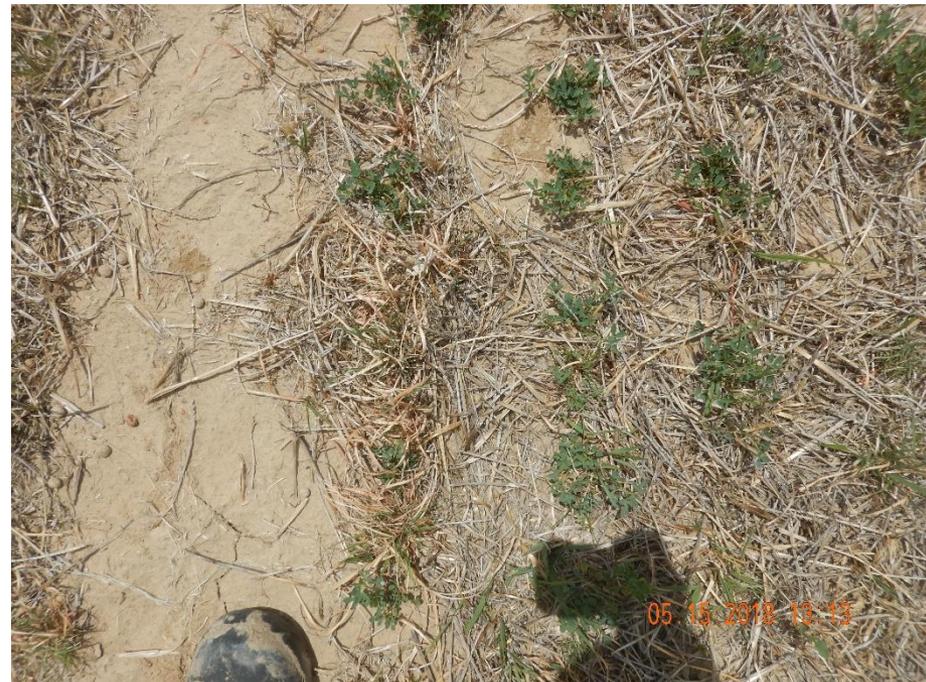
Photo 4: Photo taken from the location. Inspector found evidence of desirable perennial vegetation throughout location. Inspector also found germination of undesirable weedy plant species such as kochia. Continue performing weed management.

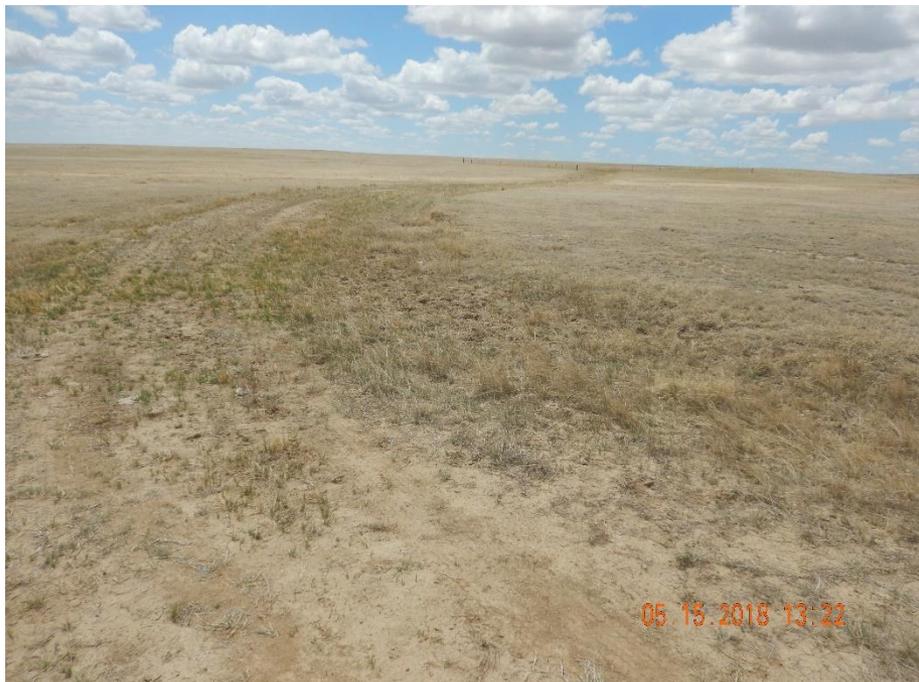
Photo 5: Photo taken from the access road, east of the location, facing west. Photo shows section of the access road NOT included in the variance request appears to have had reclamation work conducted.

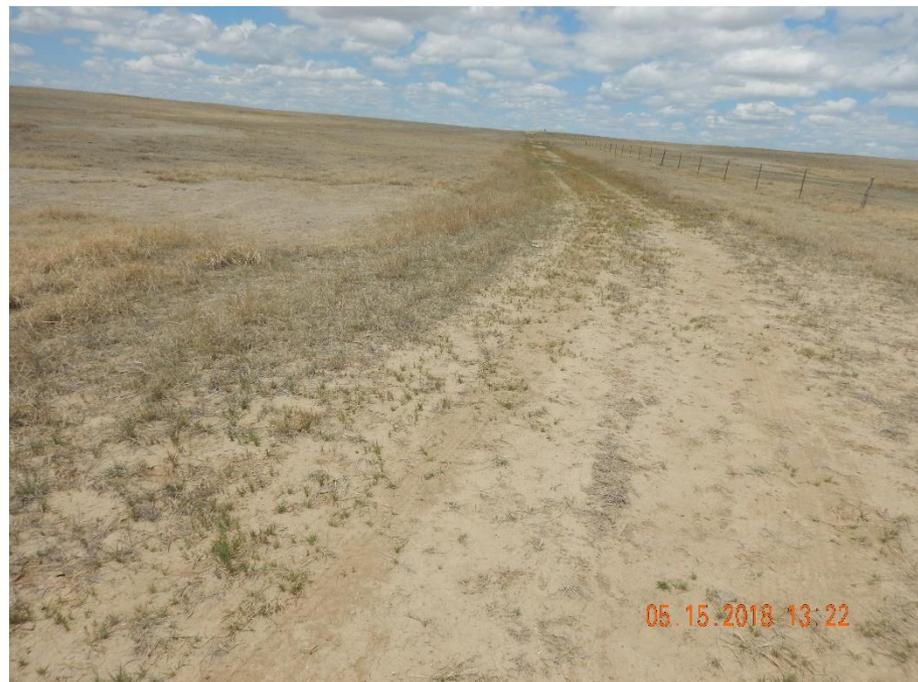
Photo 6: Photo taken from the access road, east of the location, facing west. Photo shows the north/south section of the access road that is included in the variance request.

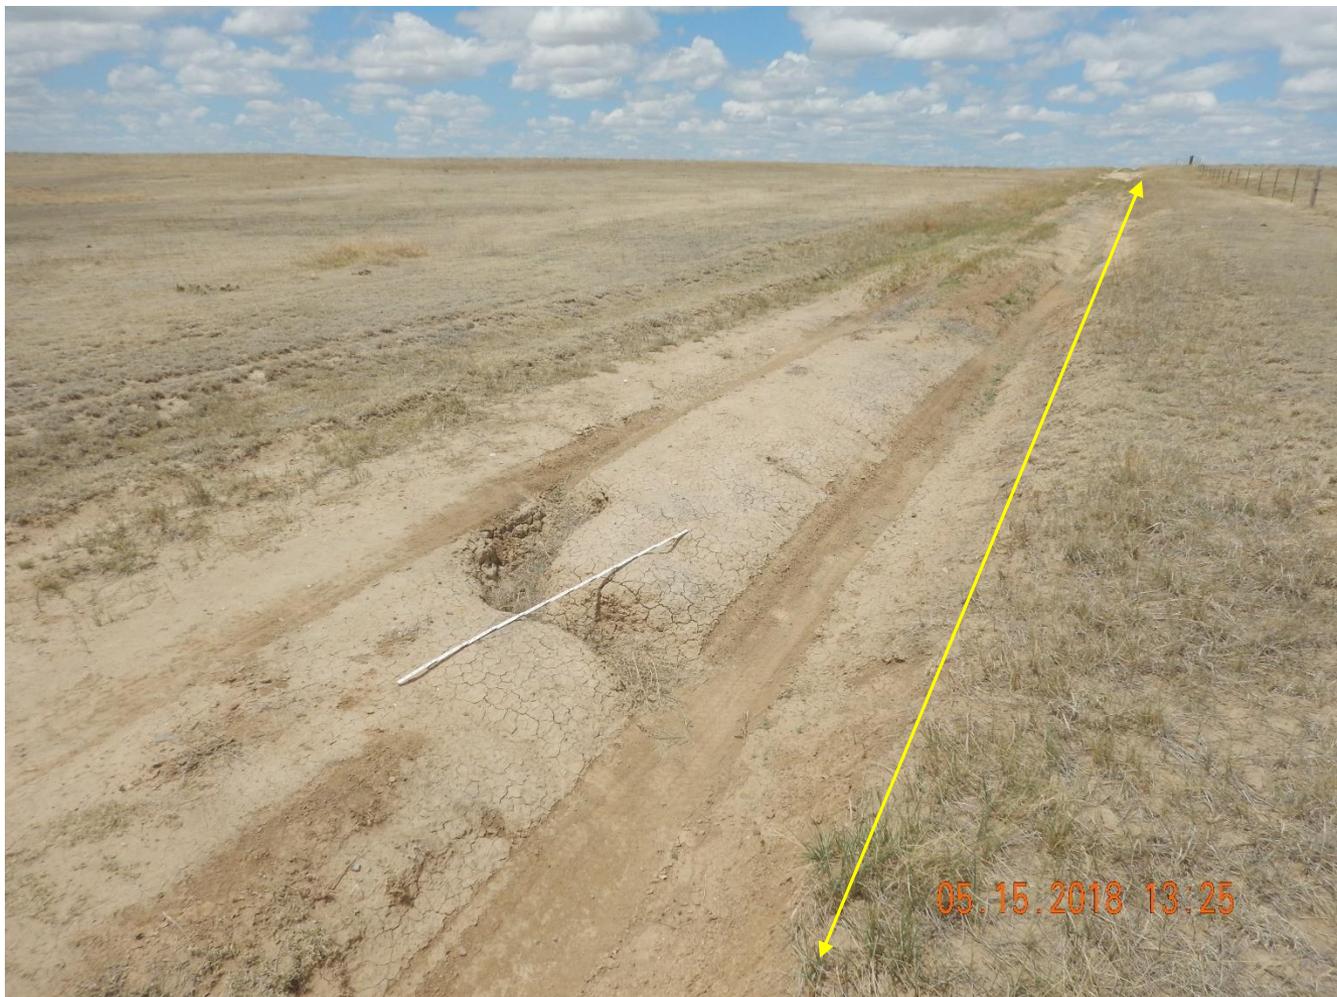
Photo 7: Photo taken from the southern end, of the north/south traveling section of the access road included in the variance request. Photo shows section of access road where degradation is evident. The north/south traveling section of the access road is on a slope and stormwater and vehicular appears to have deepened vehicle ruts in areas as. Stormwater also appears to have “cut”, or washed out, areas of the access road creating gully formations. 6 foot measuring stick for reference.

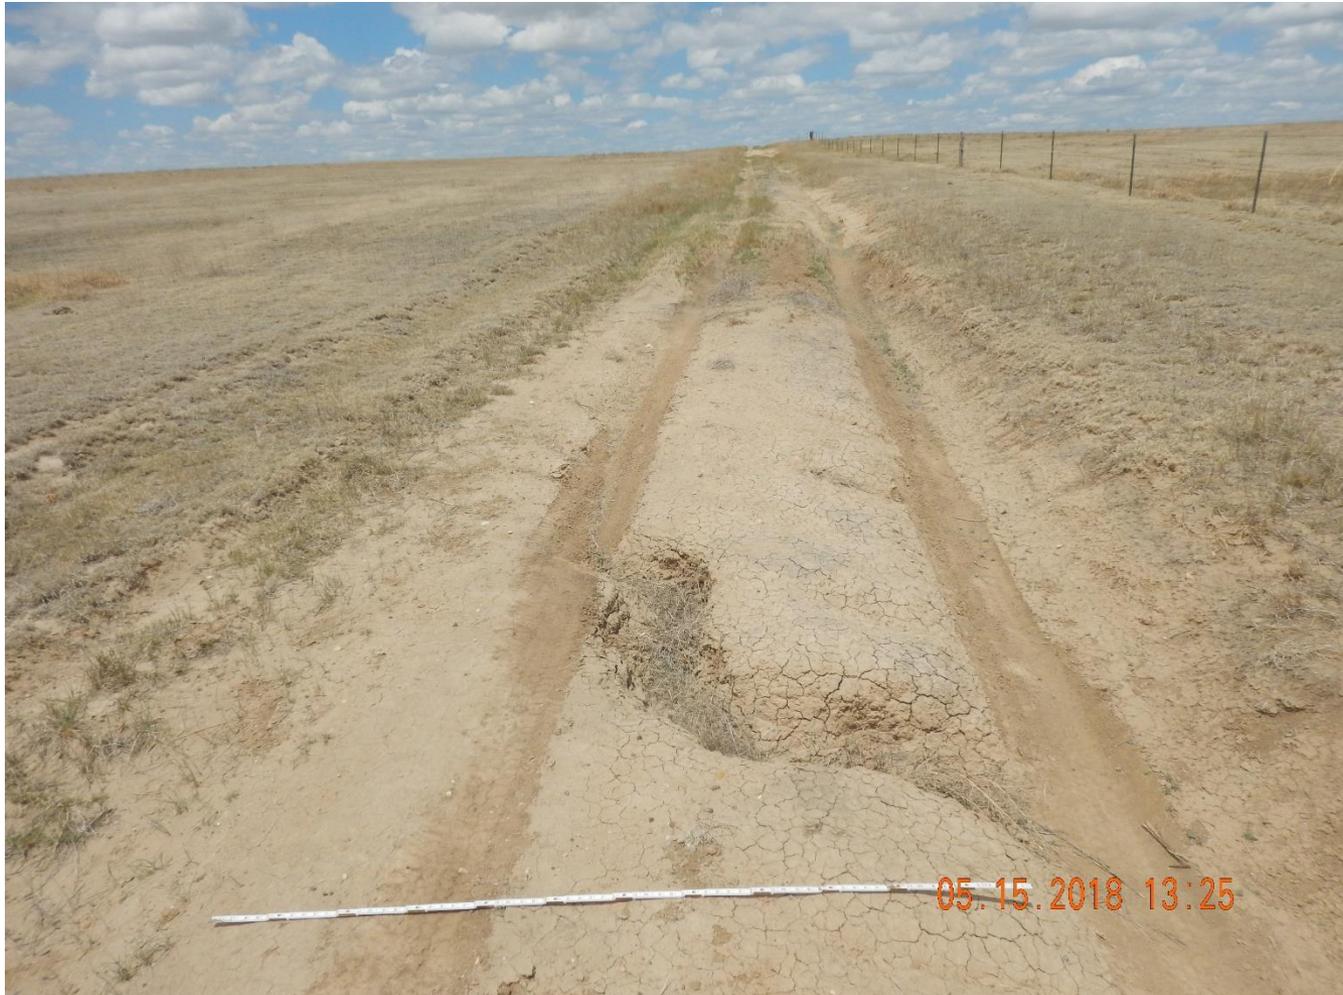
Photo 8: Continued from photo 7.

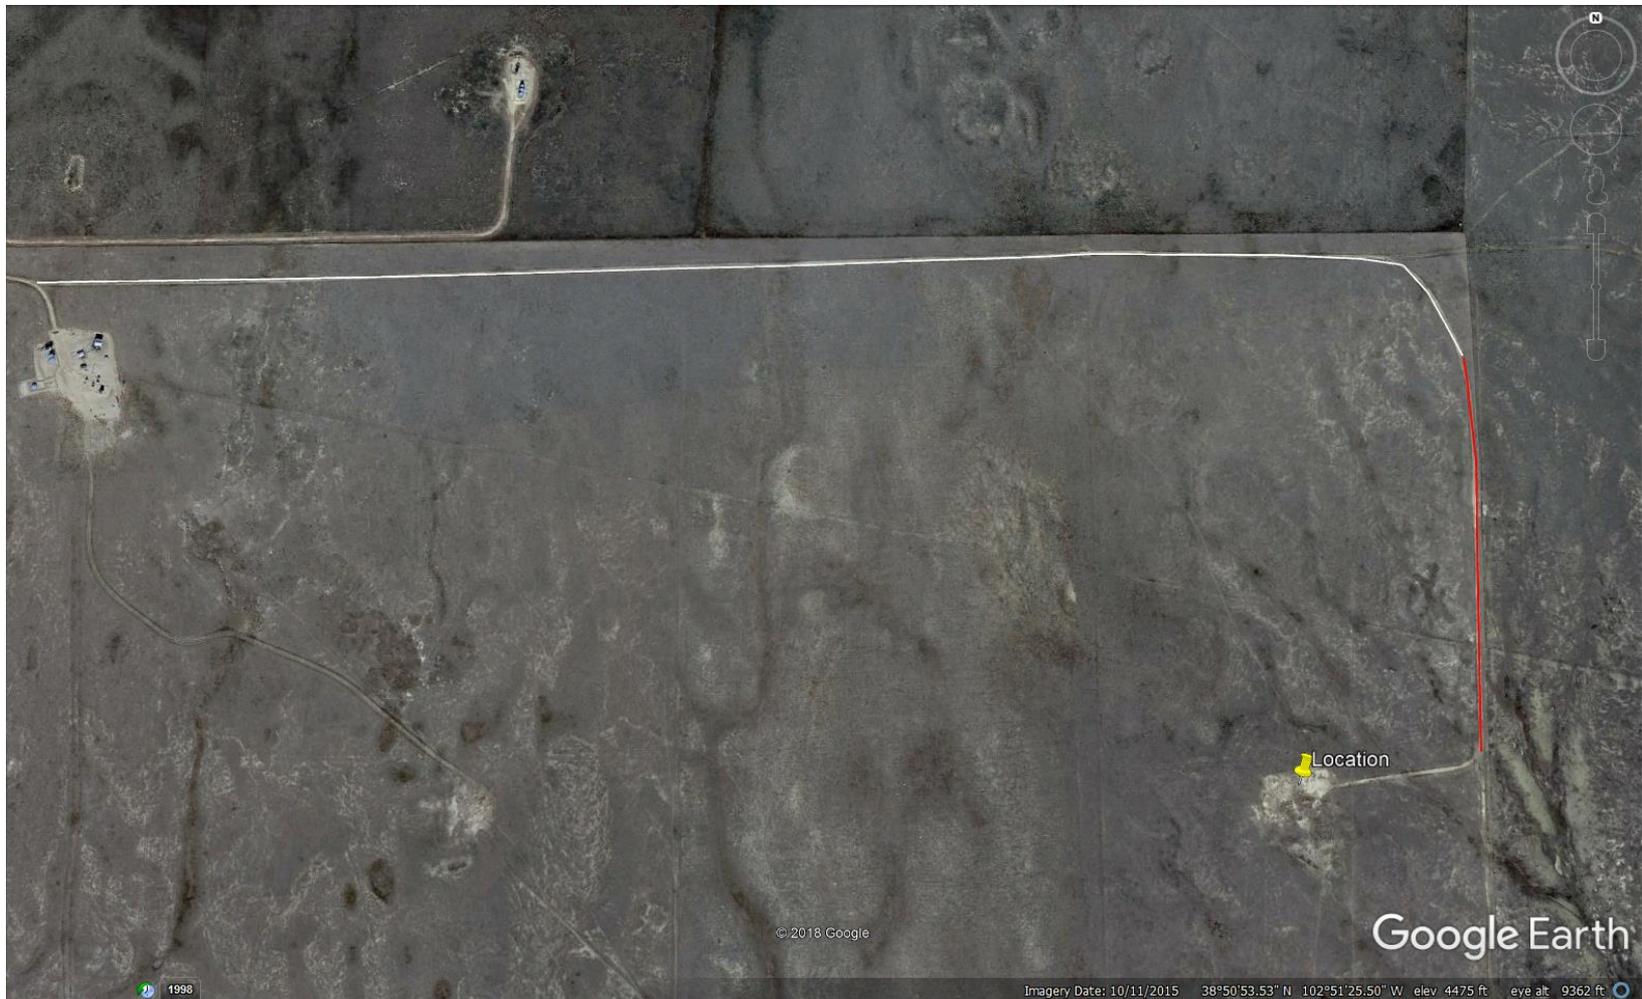
Photo 9: 2015 aerial imagery. Photo shows the access road outlined in the variance request. The section of access road in red outlines areas where degradation is evident.
