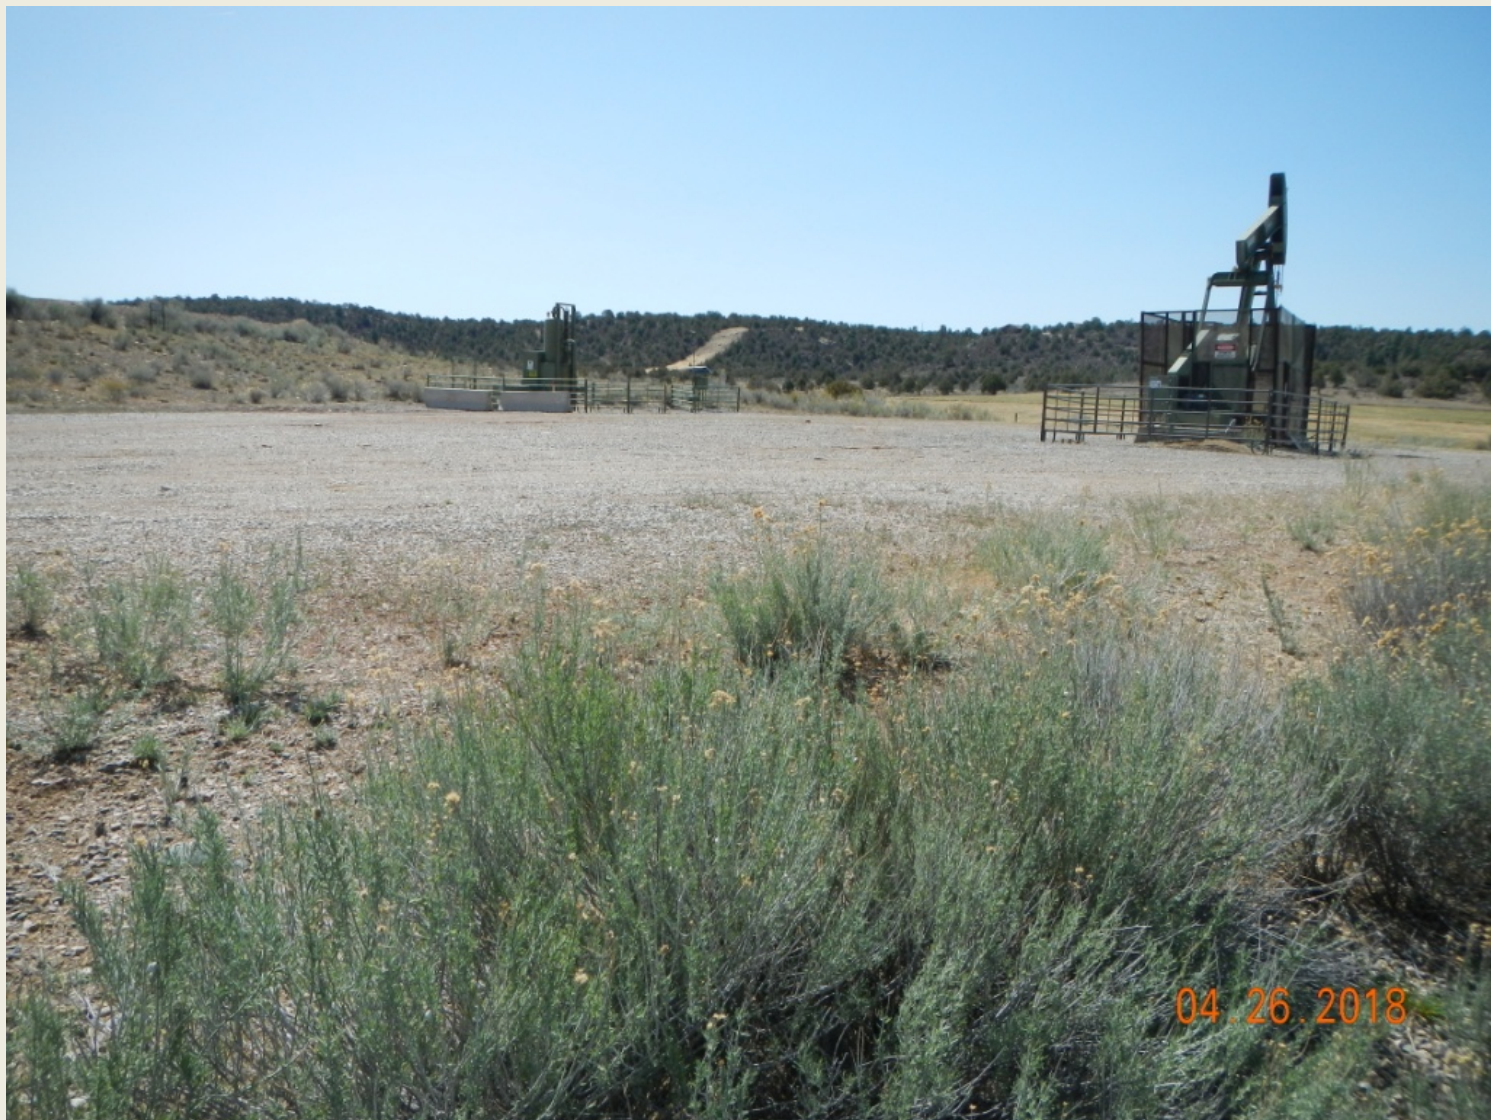
Photo 1. View of the project area from the southeastern corner facing center.

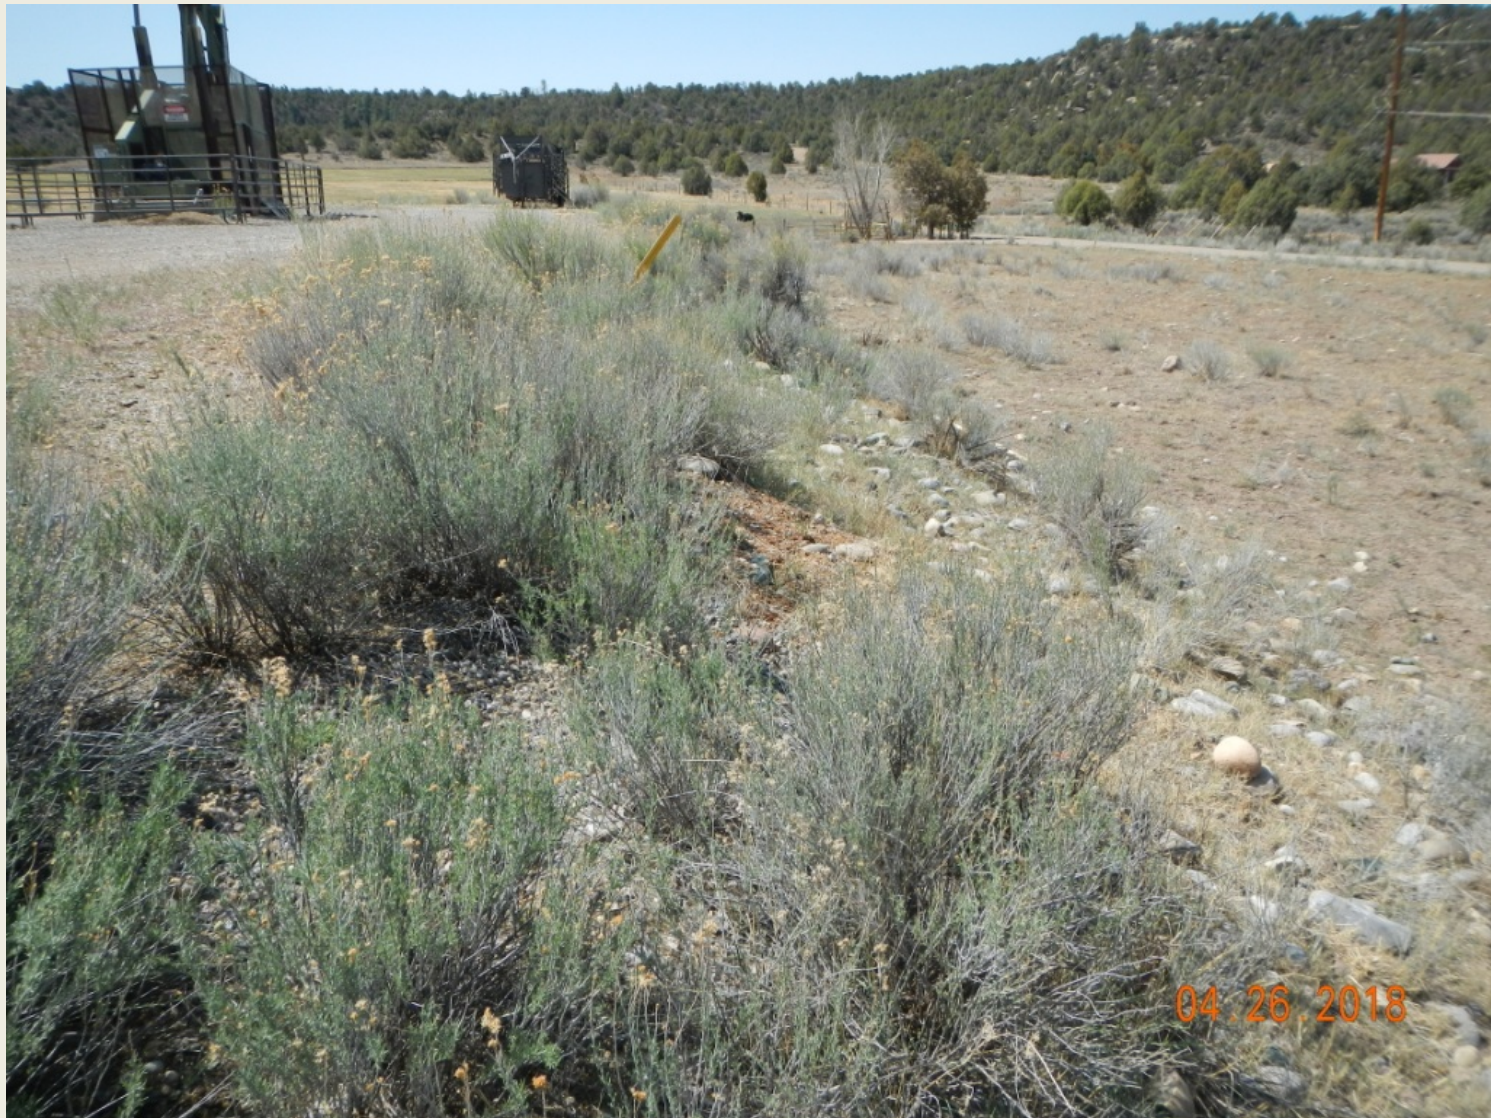
Photo 2. View of the western portion of the project area from the northwestern corner facing southward. Revegetation is progressing on fill slope with rubber rabbitbrush (*Chrysothamnus nauseosus*) and western wheatgrass (*Pascopyrum smithii*).

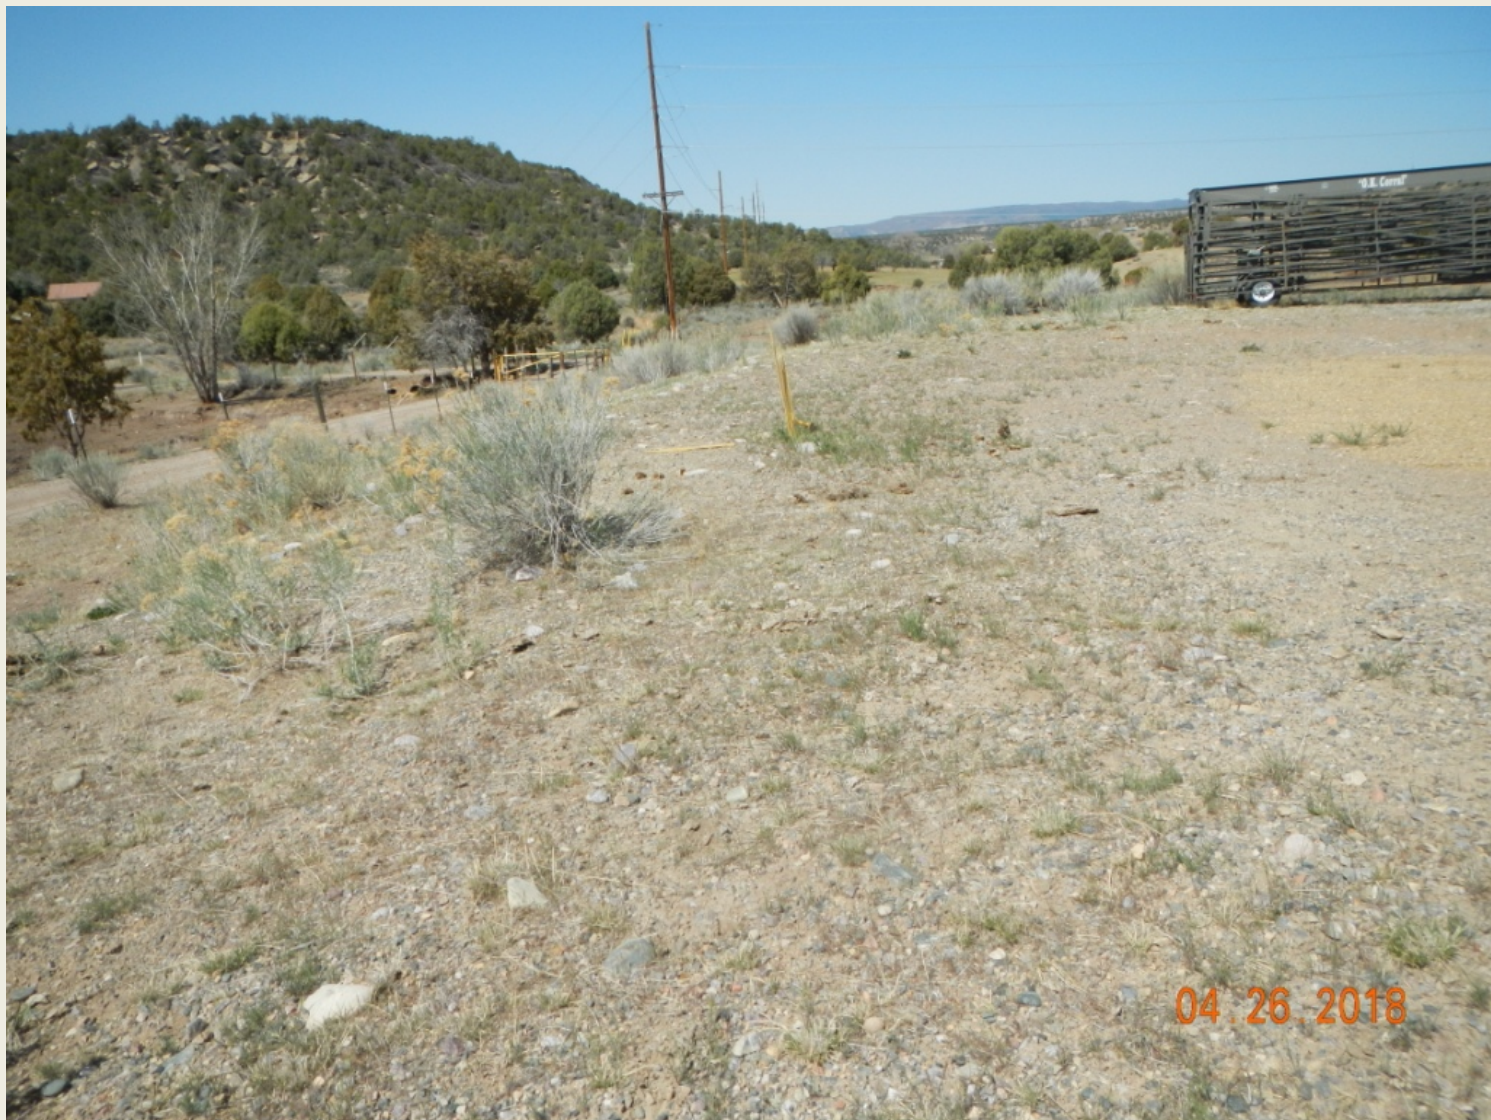
Photo 3. View of the southern portion of the project area from the southeastern corner of the working area facing westward.

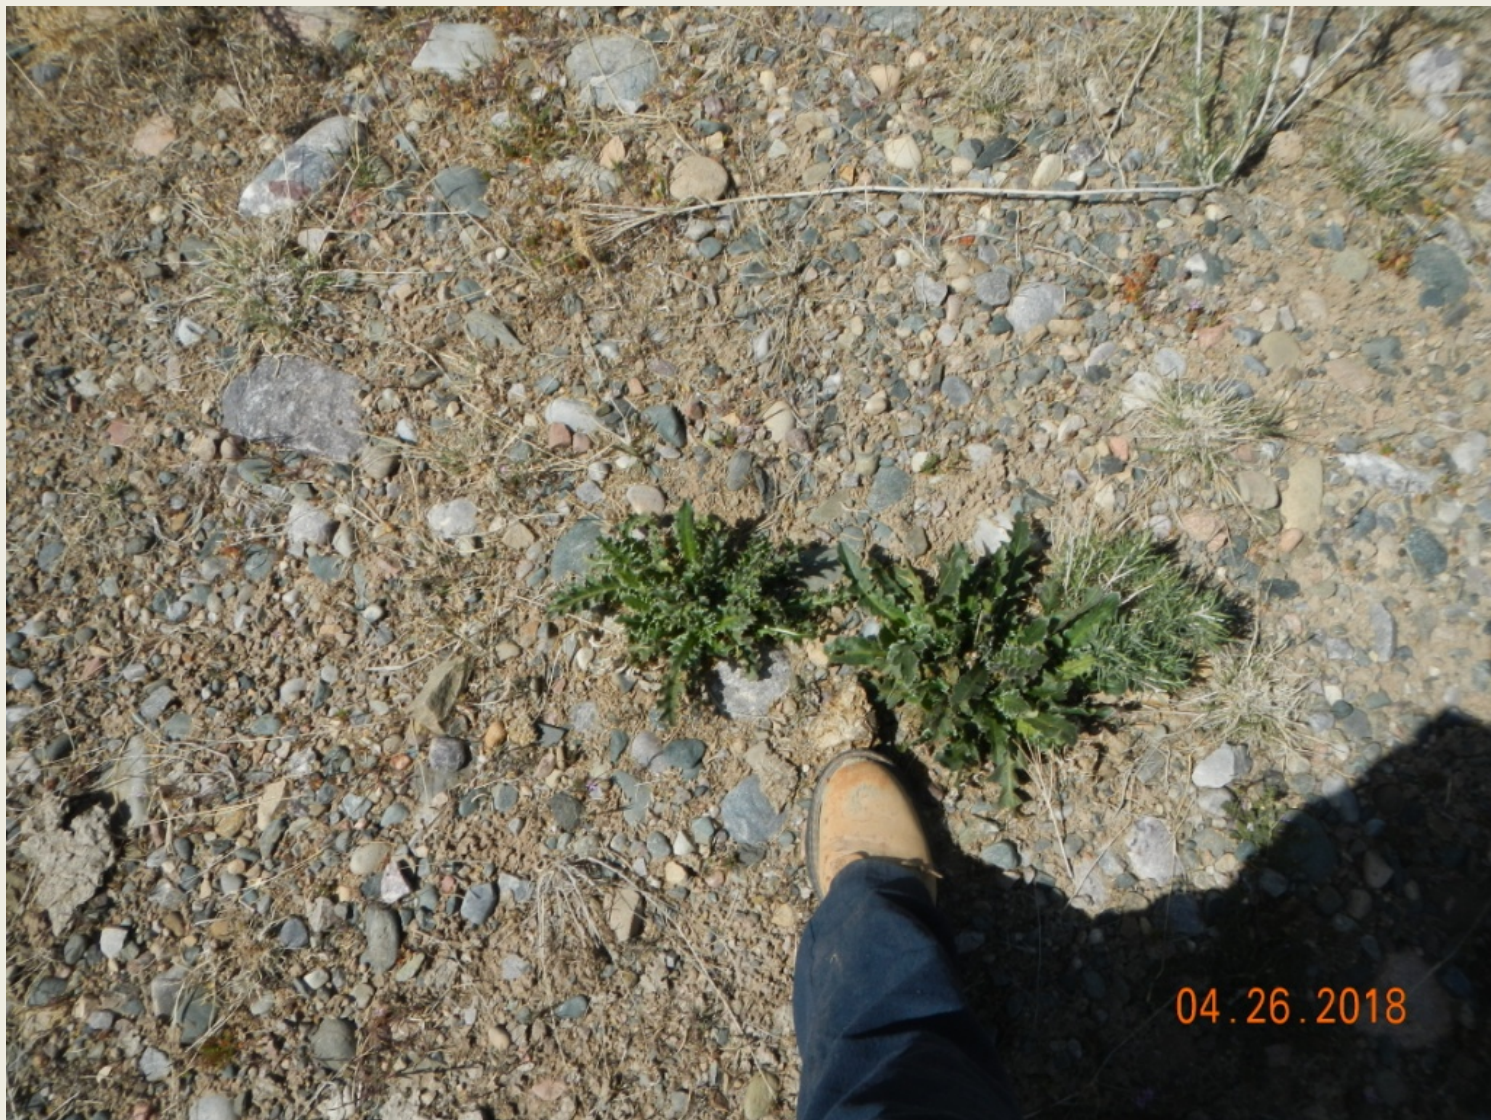
Photo 4. View of musk thistles (*Carduus nutans*) in the southern project area.

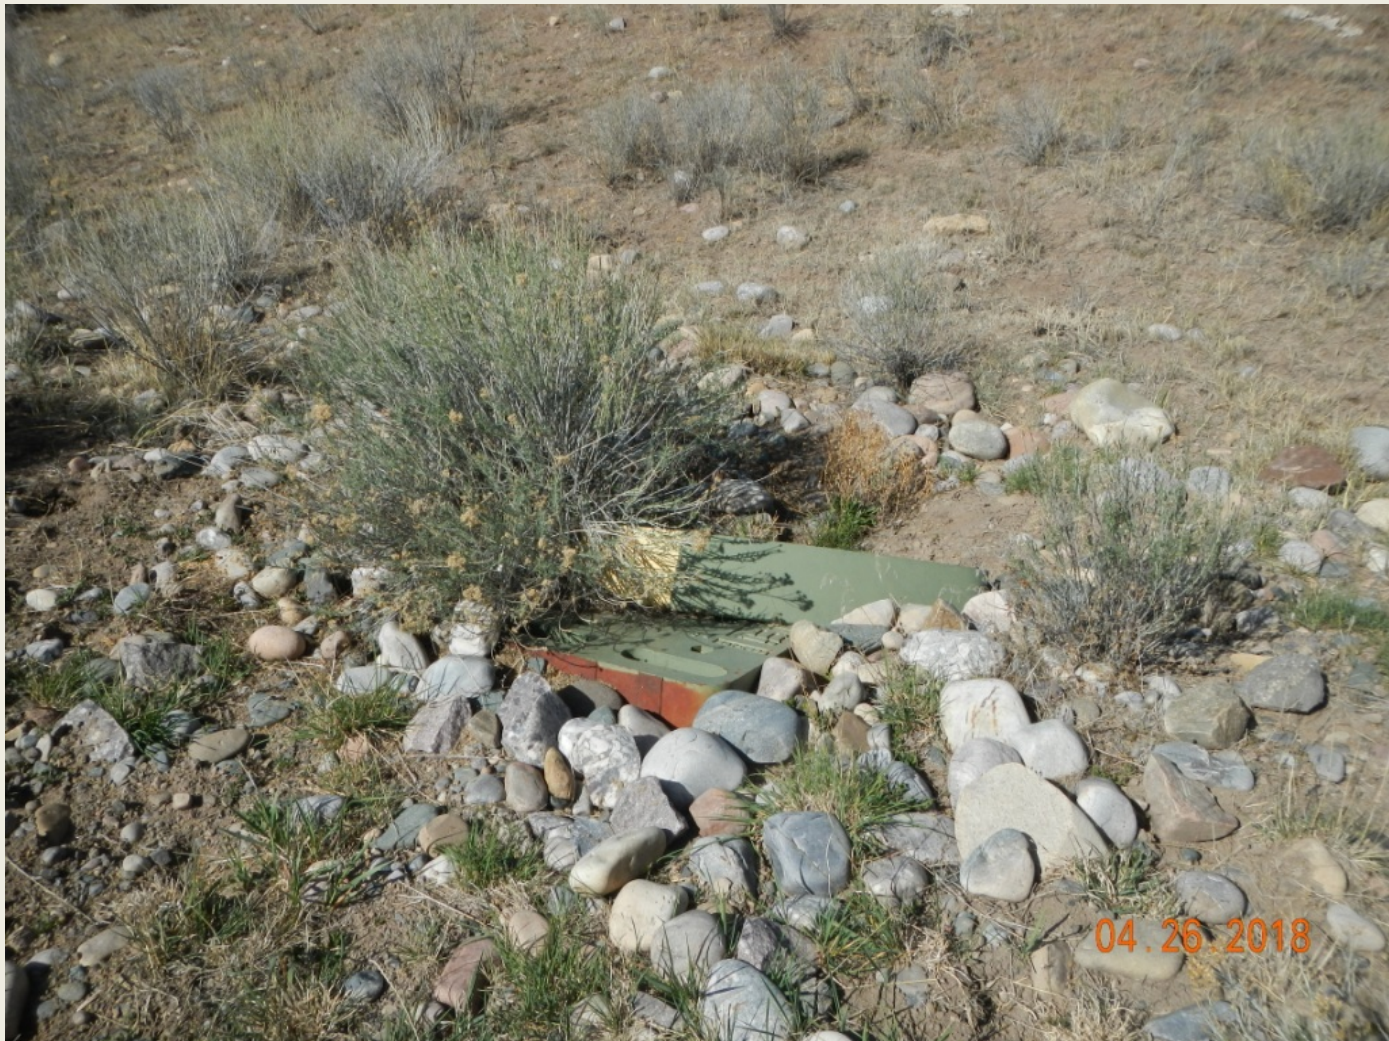
Photo 5. View of unused equipment within the western interim reclamation area.

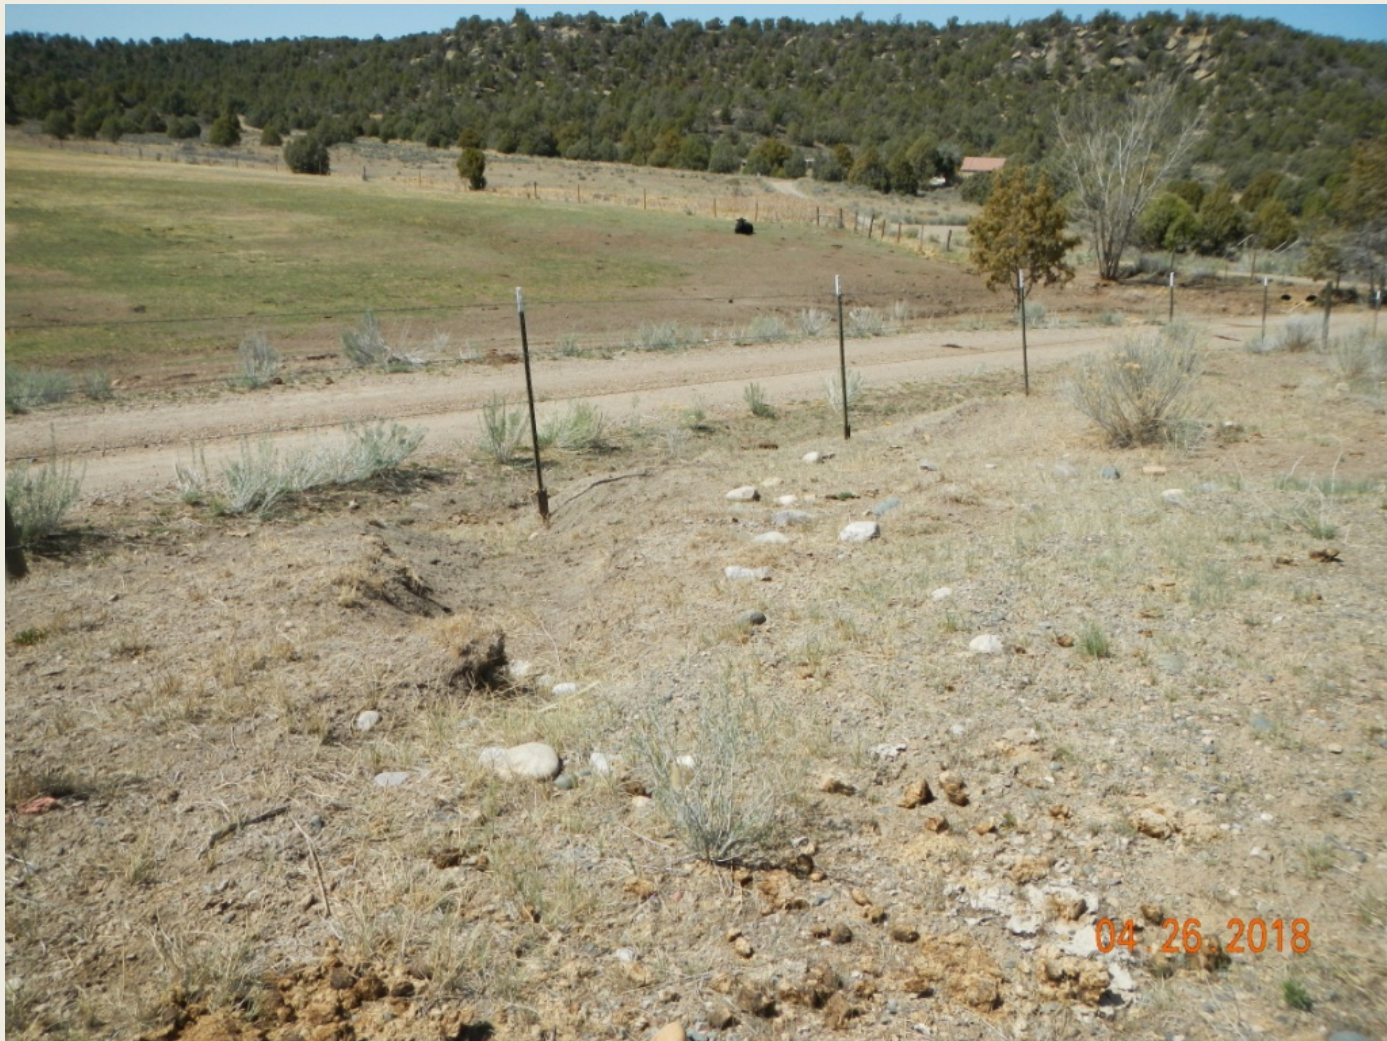
Photo 6. View of erosional channel forming within the southern portion of the project area.
