Inspection Photo
ALP 24-16B1 (J24NW)
API# 045-08105
Inspection # 689301146

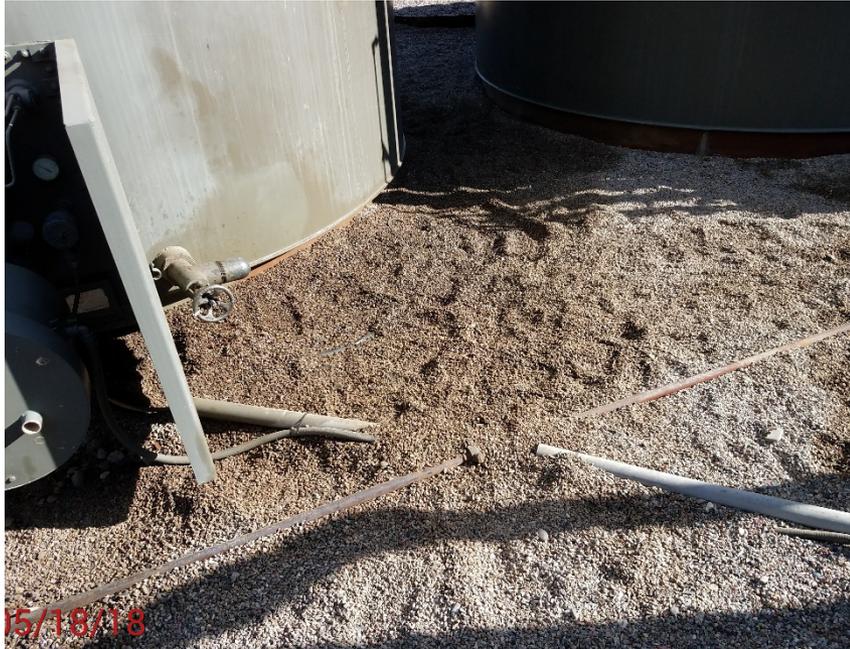
Location Photo # 3, Staining in Tank Battery containment

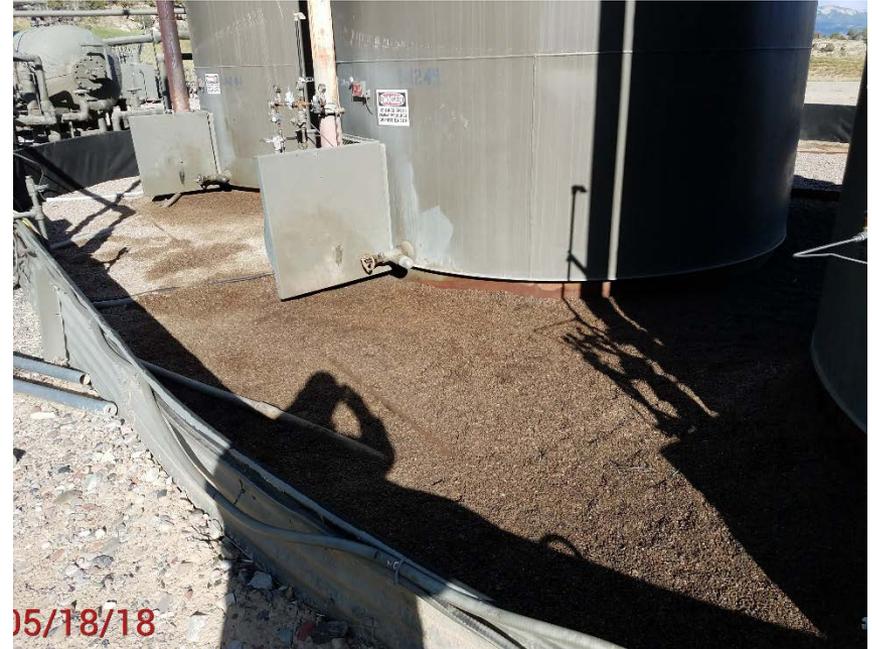
Location Photo # 4, Staining in Tank Battery containment

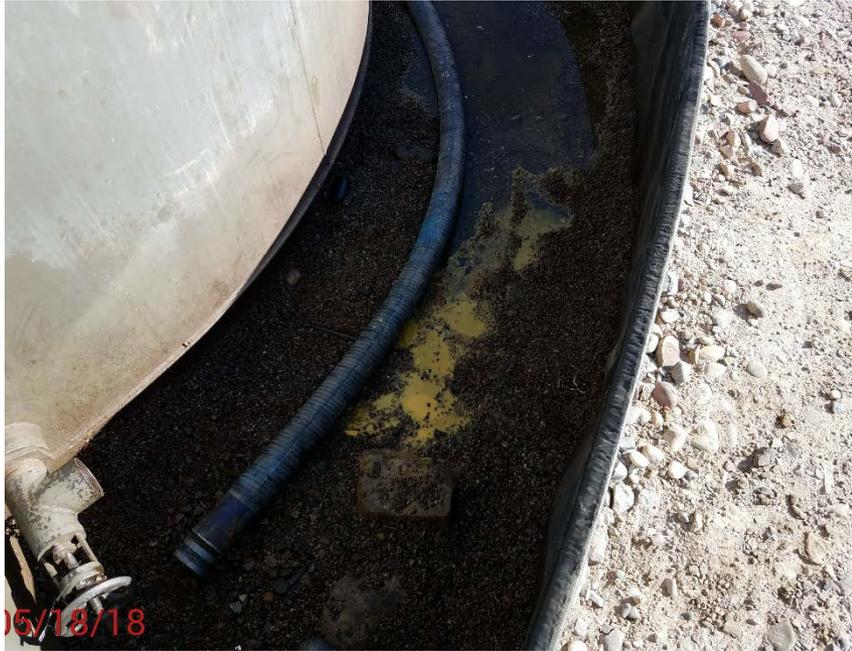
Location Photo #5, Condensate spilled in containment

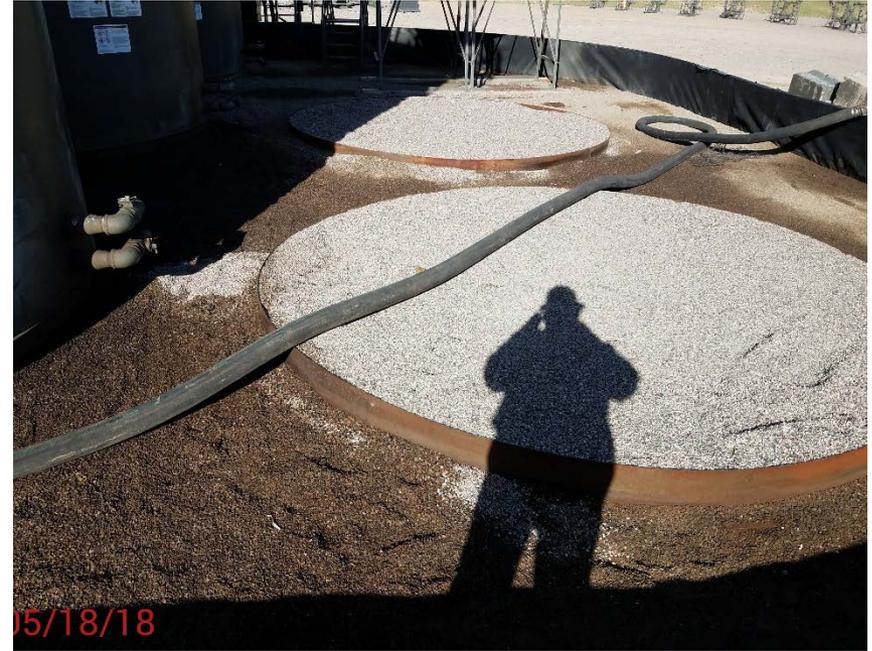
Location Photo # 6, Staining in Tank Battery containment

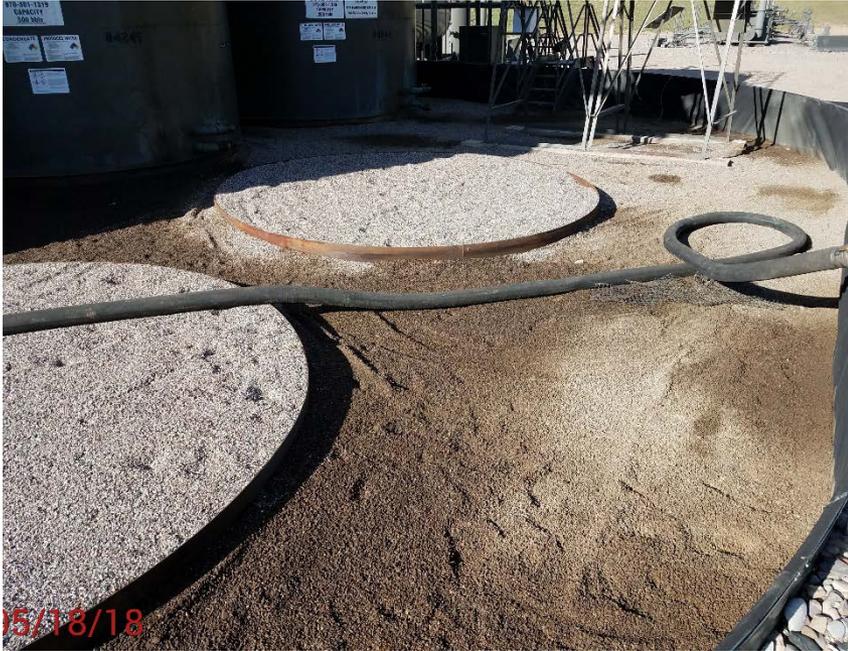
Location Photo #7, Staining in Tank Battery containment

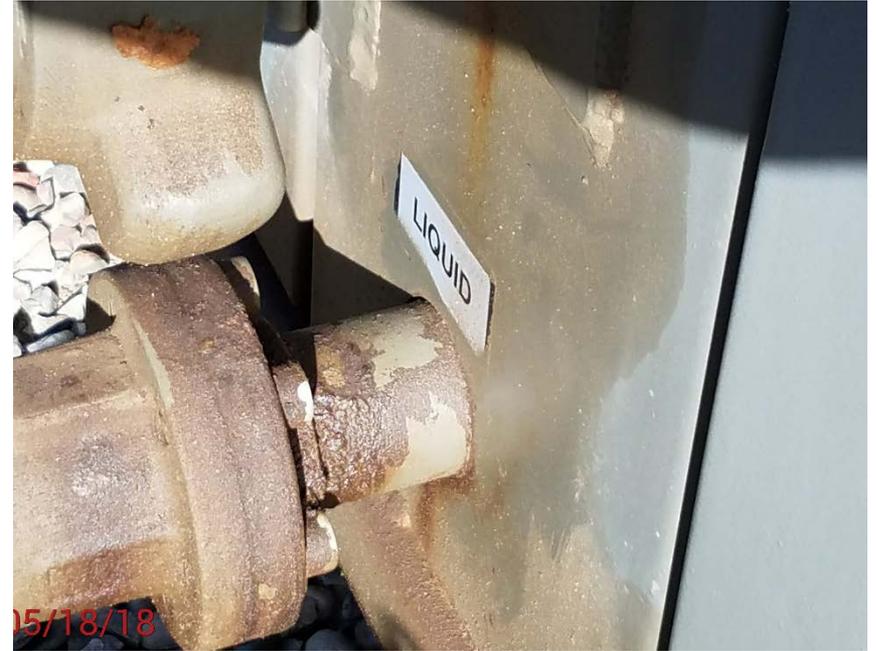
Location Photo #8, Leaking liquid line from back of separator

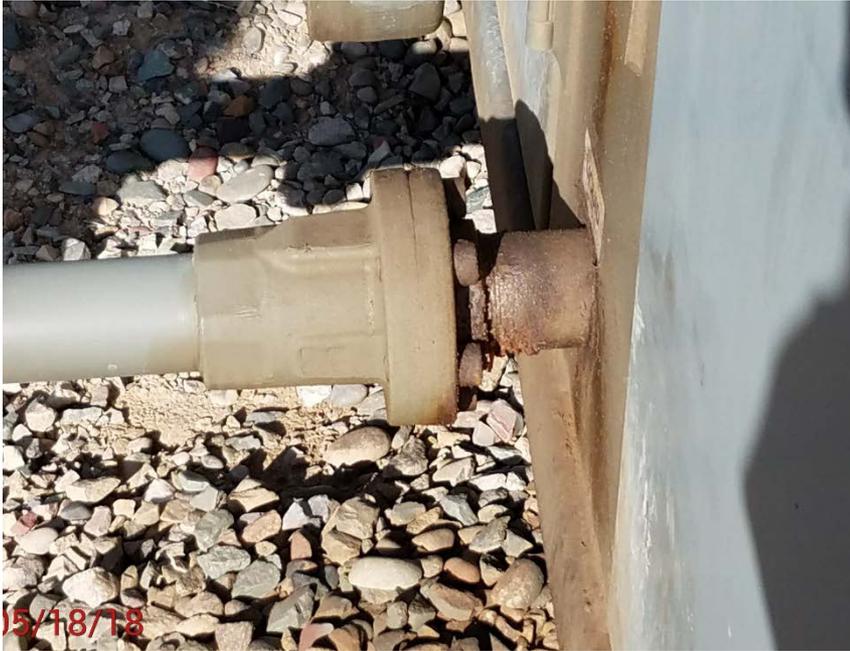
Location Photo #9, Leaking liquid line from back of separator

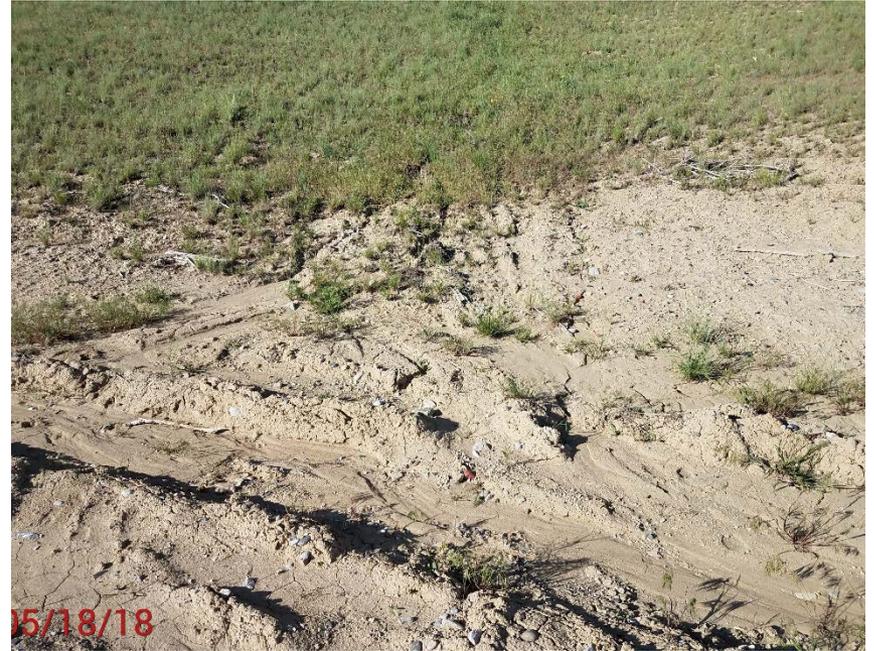
Location Photo # 10, Slope erosion on south slope

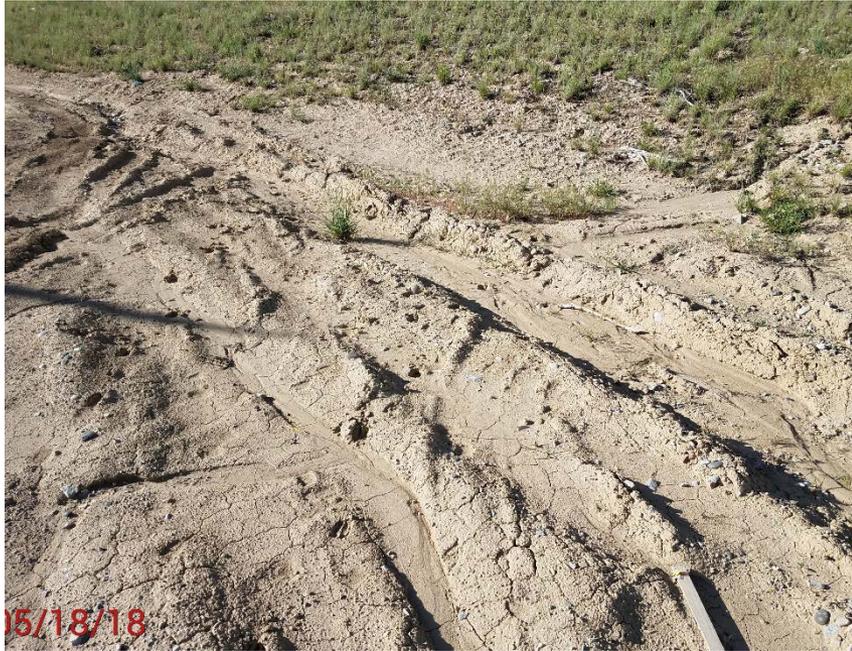
Location Photo #11, Slope erosion on south slope

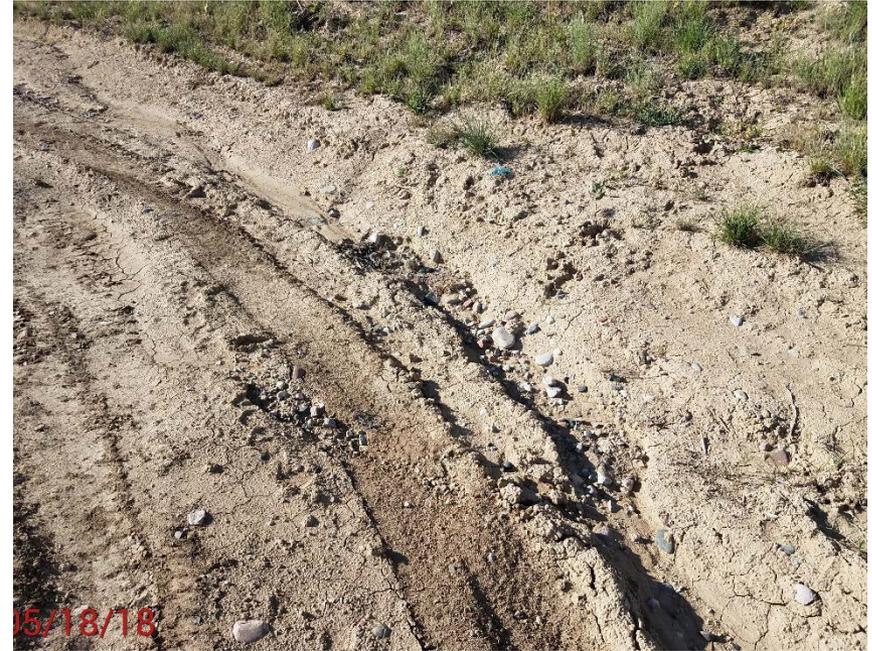
Location Photo # 12, Slope erosion on south slope

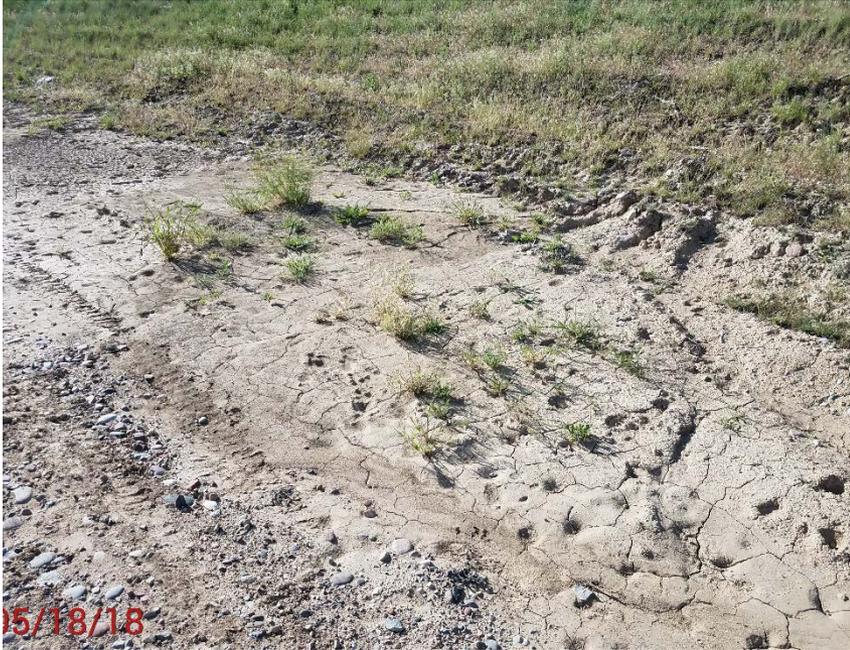
Location Photo #13, Slope erosion on south slope

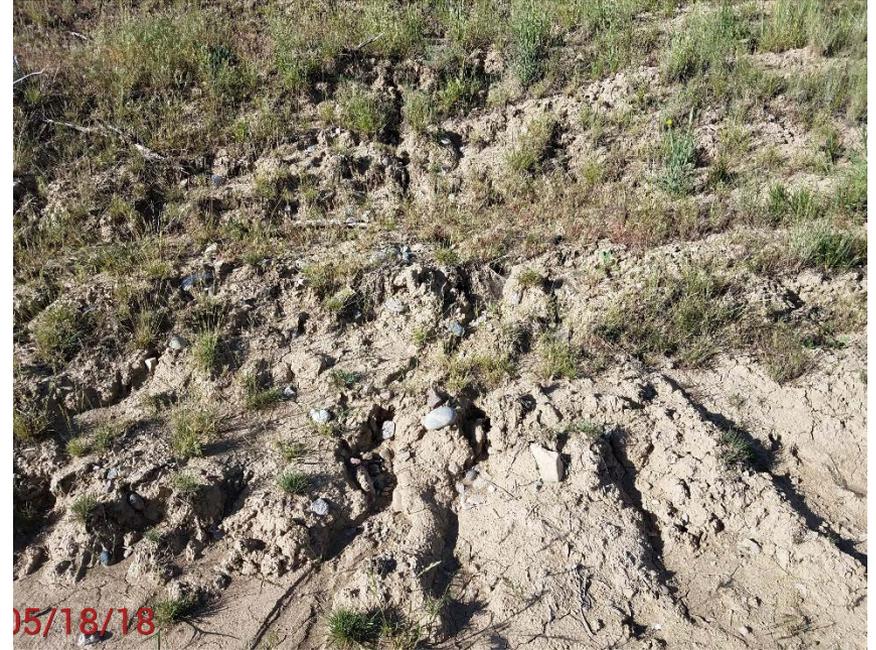
Location Photo # 14, Slope erosion on south slope

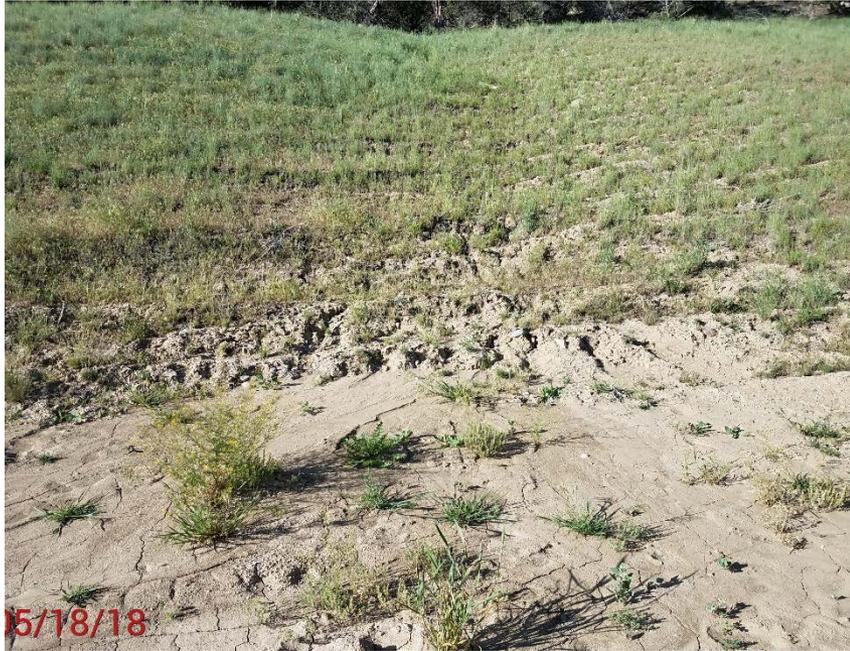
Location Photo #15, Slope erosion on south slope

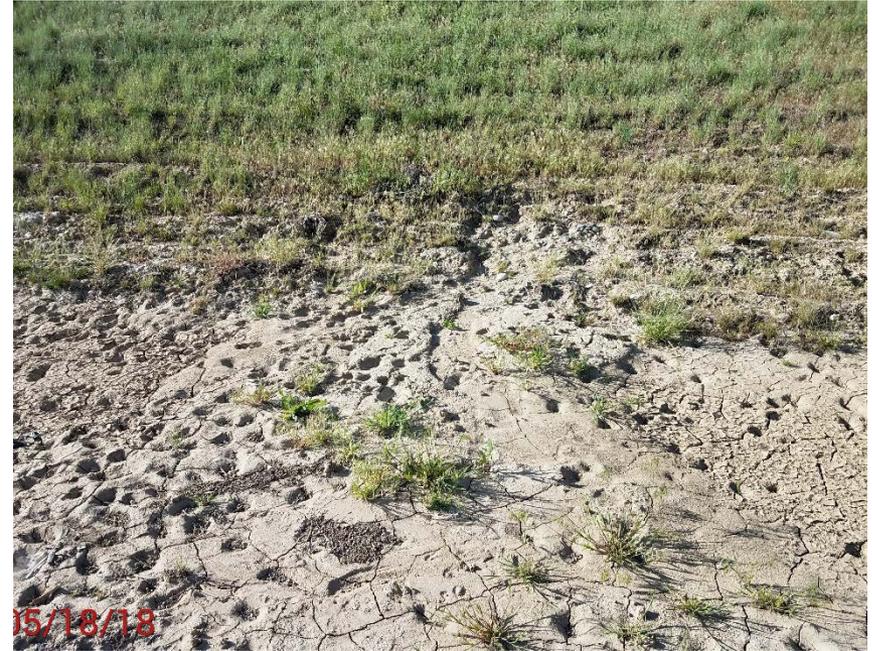
Location Photo # 16, Slope erosion on south slope

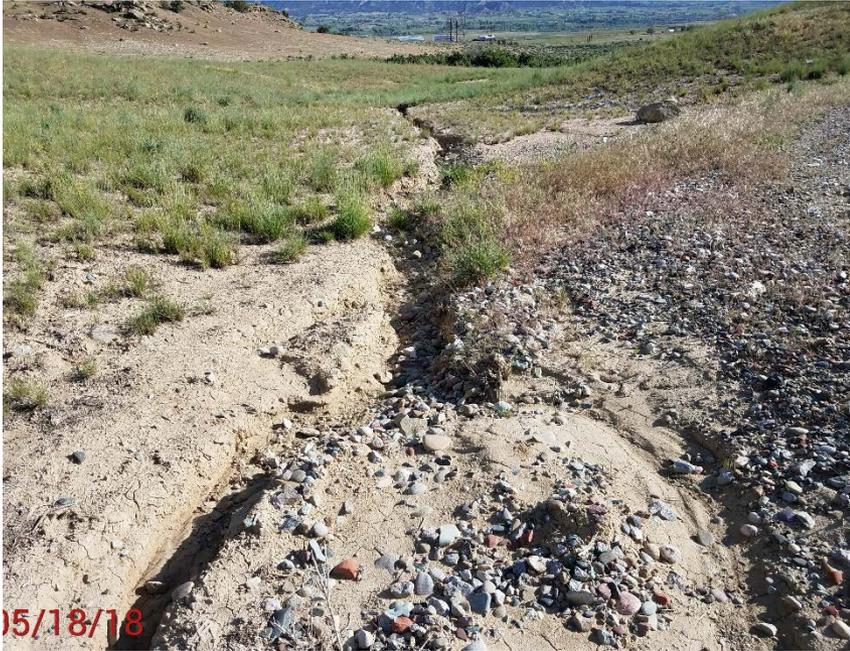
Location Photo #17, Riling occurring on North side of location

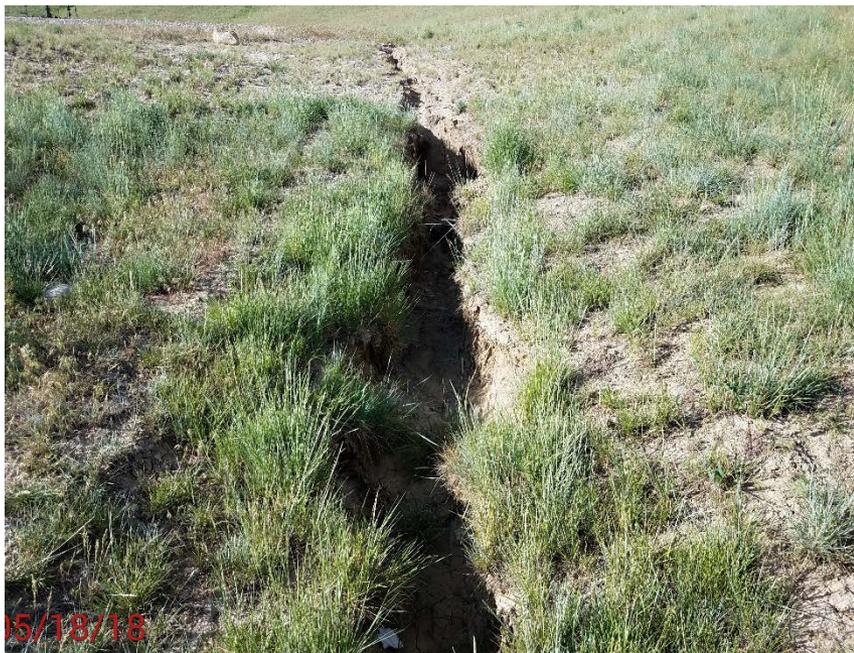
Location Photo #19, continued riling on North side of location

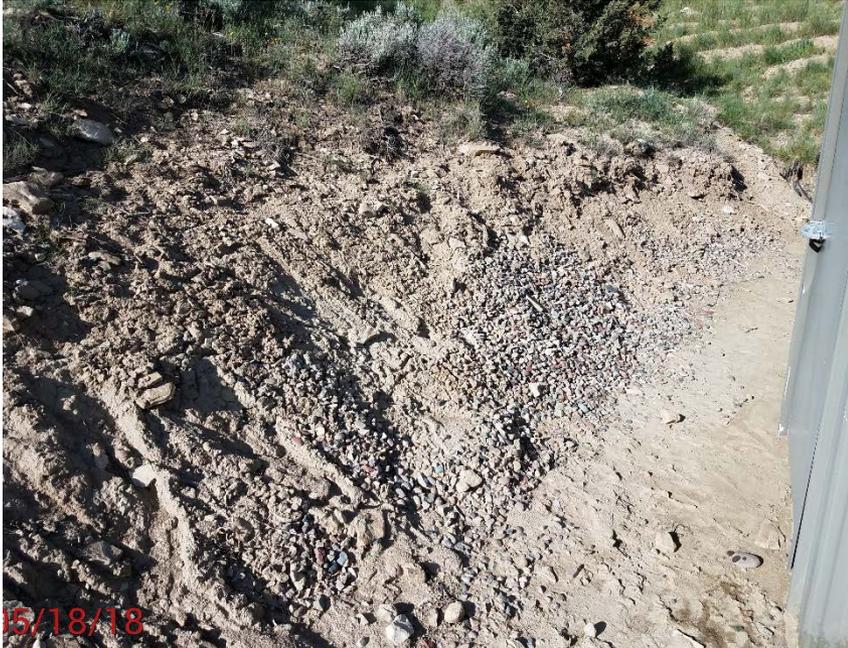
**Location Photo #21, slope erosion next to
meter run**
