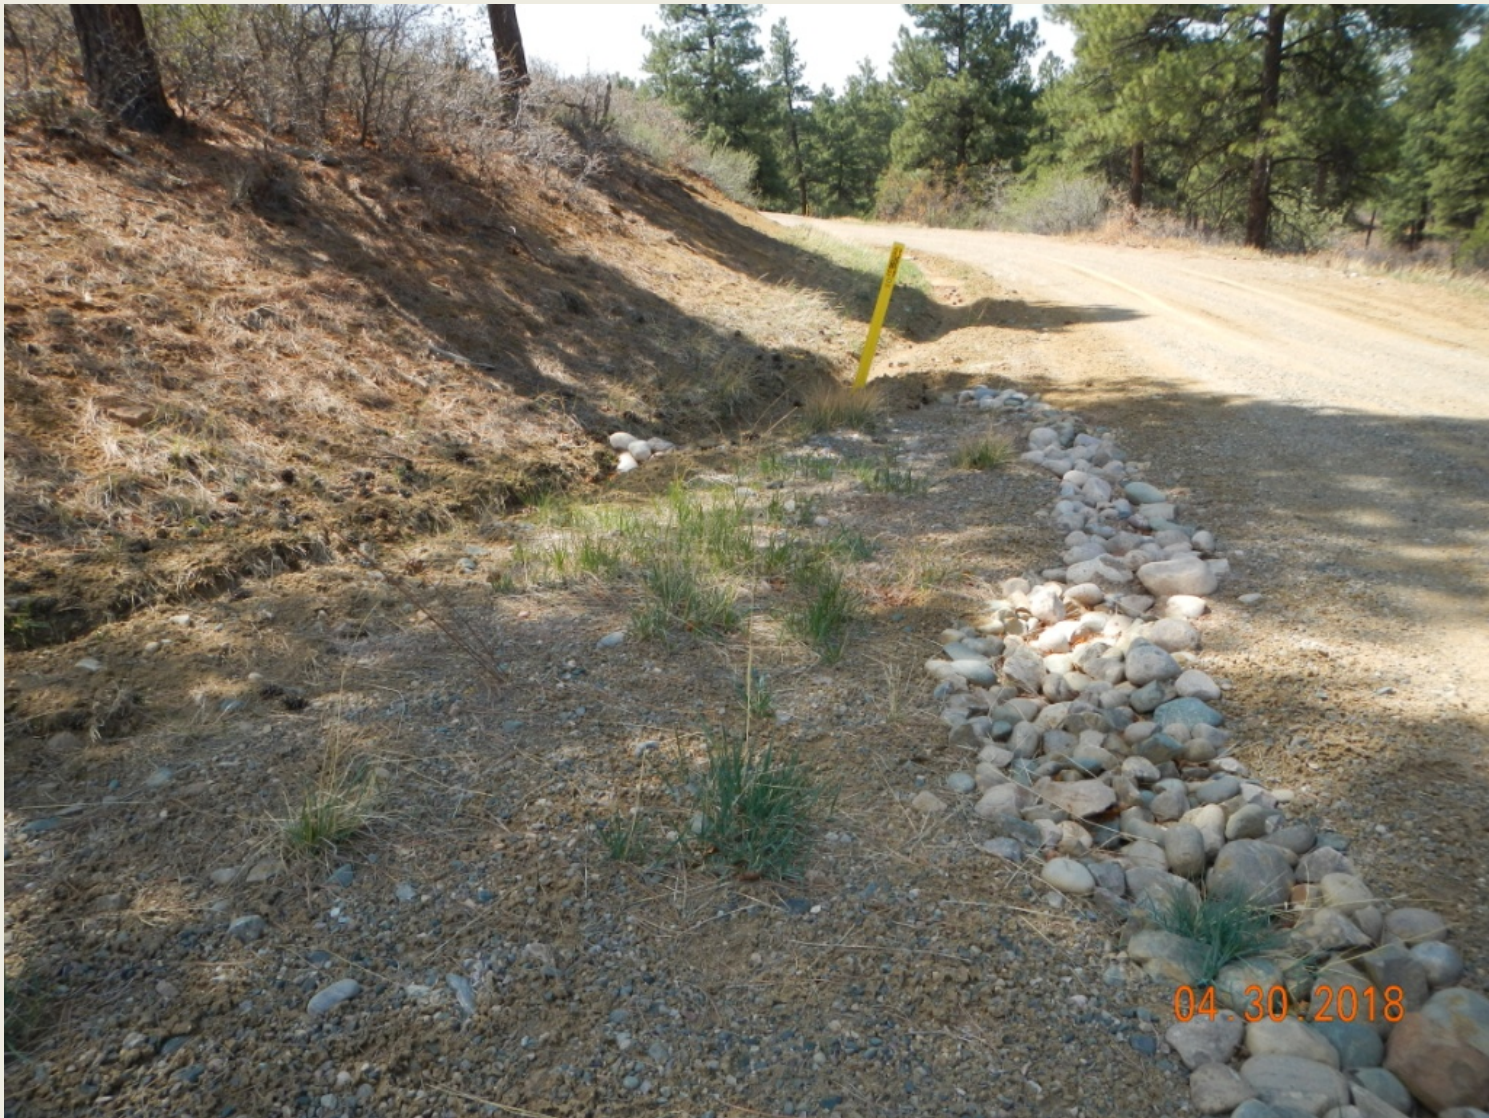
**Photo 1. View of cobble armoring and diversion in the southern portion of the project area.**

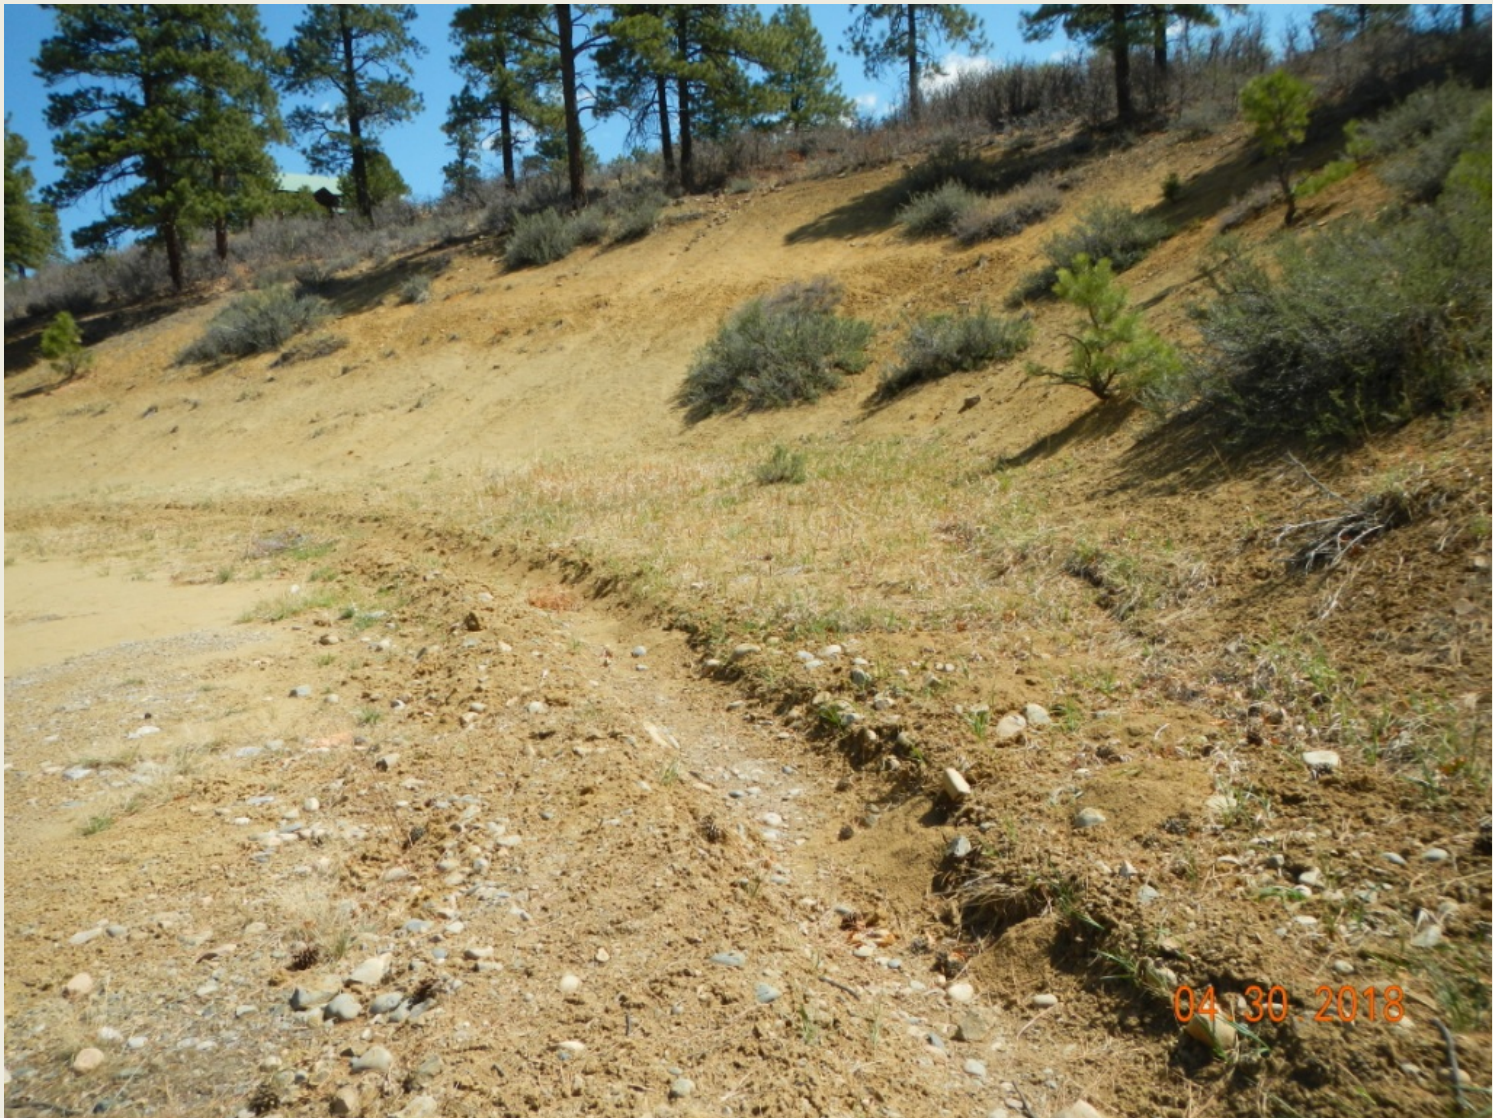
**Photo 2. View of recently graded diversion in the southeastern project area.**

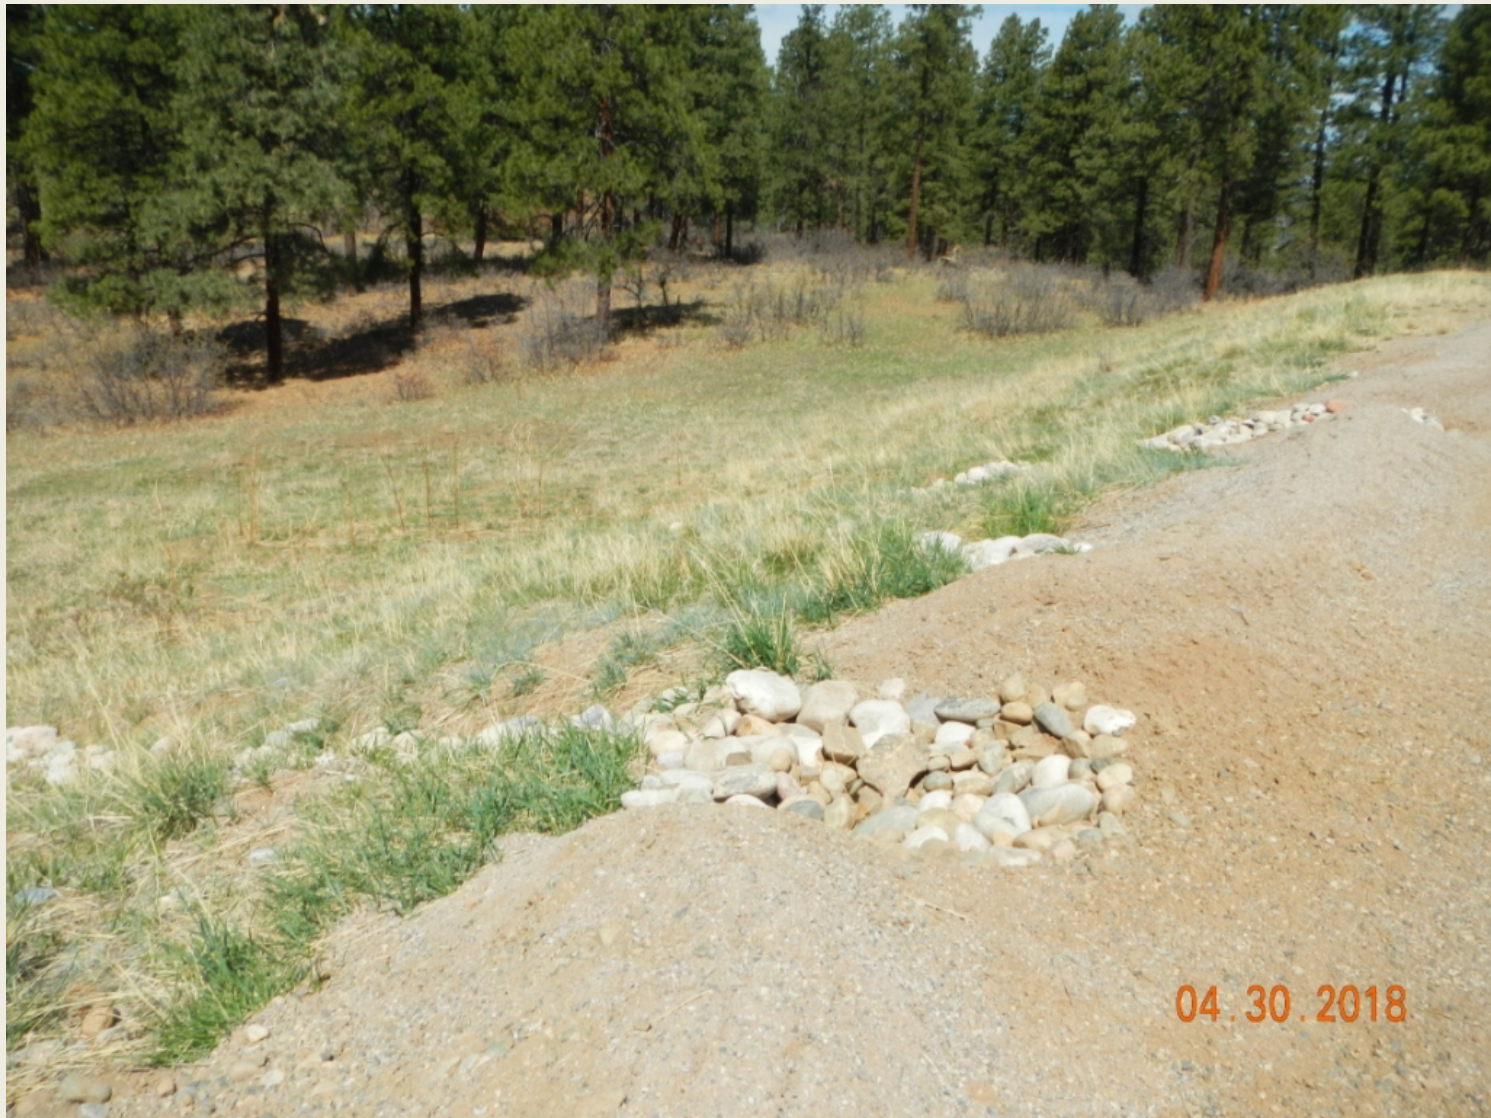
**Photo 3. View of cobble run-downs in the western portion of the project area.**

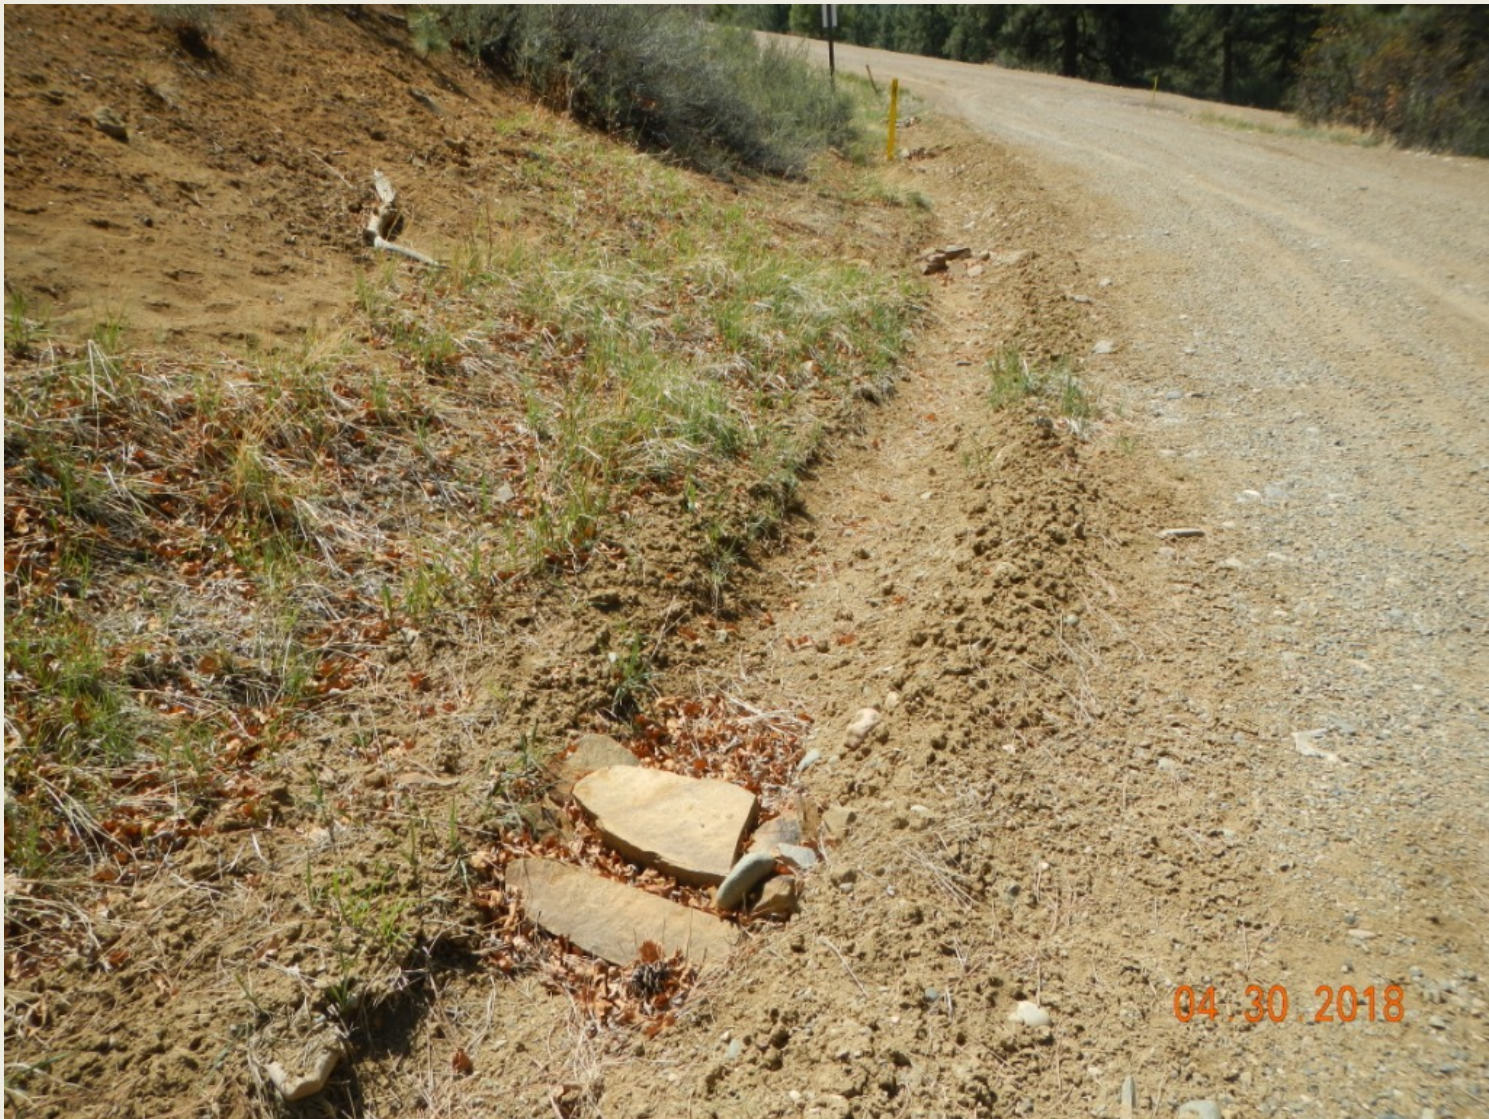
**Photo 4. View of rock checks along the access road.**
