Daily Inspection Report
Laramie Energy, LLC, Stormwater Management, 2018

Bruton Project Area

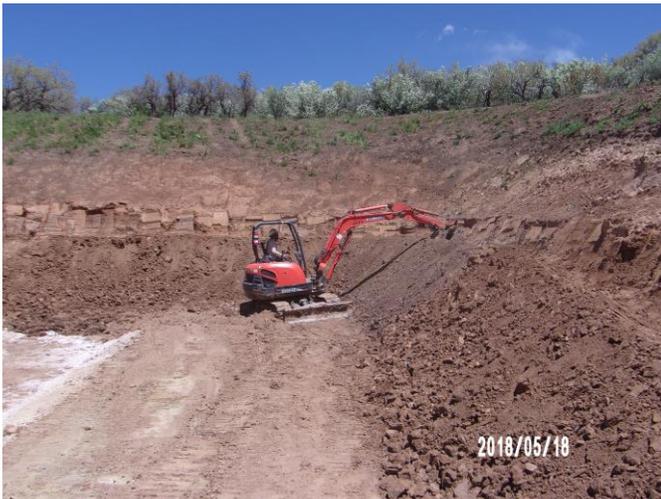
Installing Secondary Berm Mid-Slope

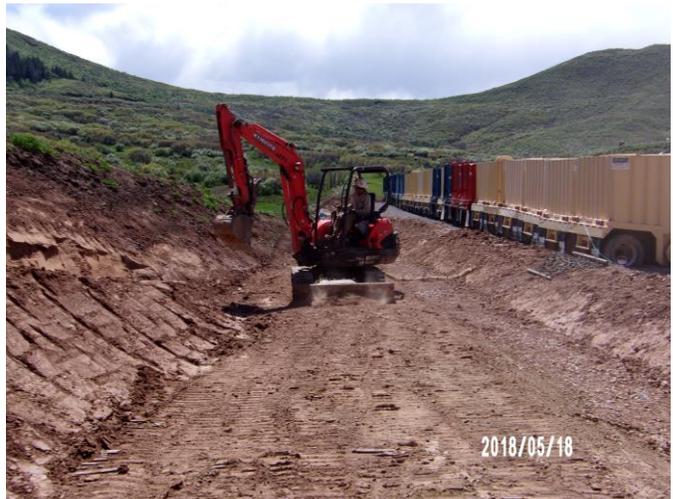
Incorporating Sediment into a Lower Bench

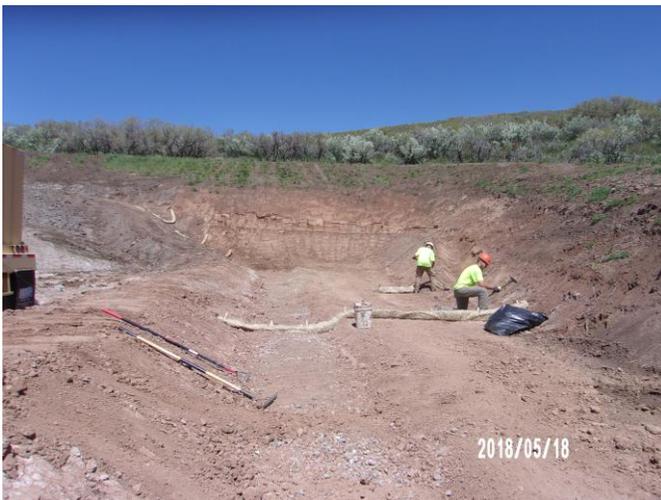
Installing Additional Excelsior Wattle

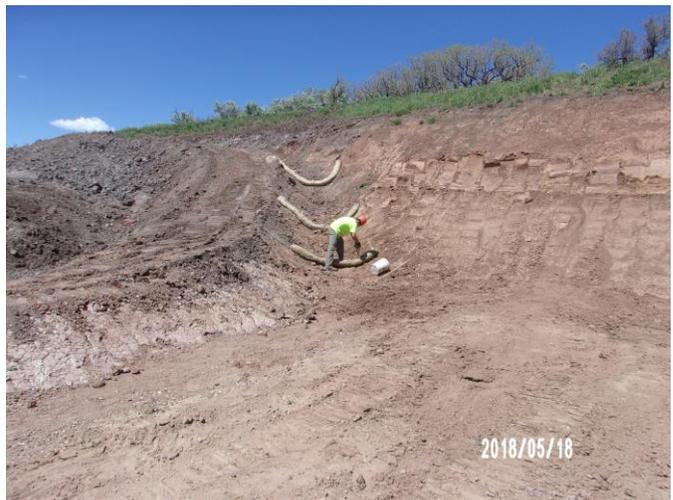
Installing Wattle Checks in Newly Formed Channel
