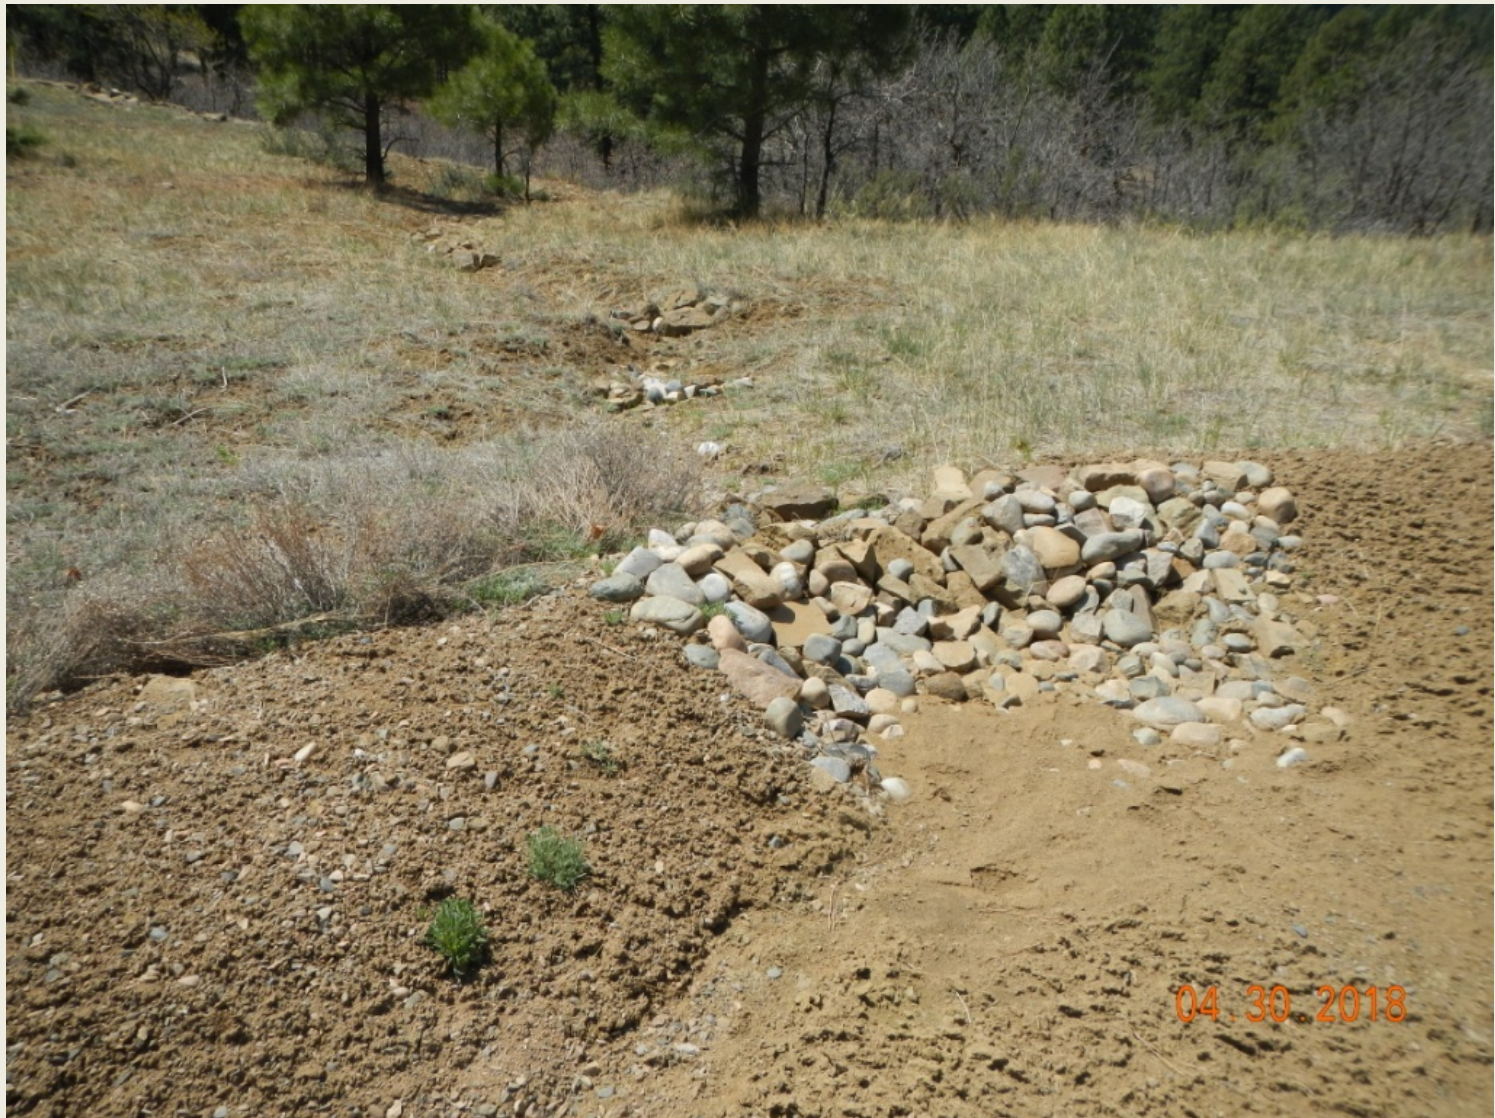
**Photo 1. View of check dams in the southern portion of the project area. Appear to be functioning.**

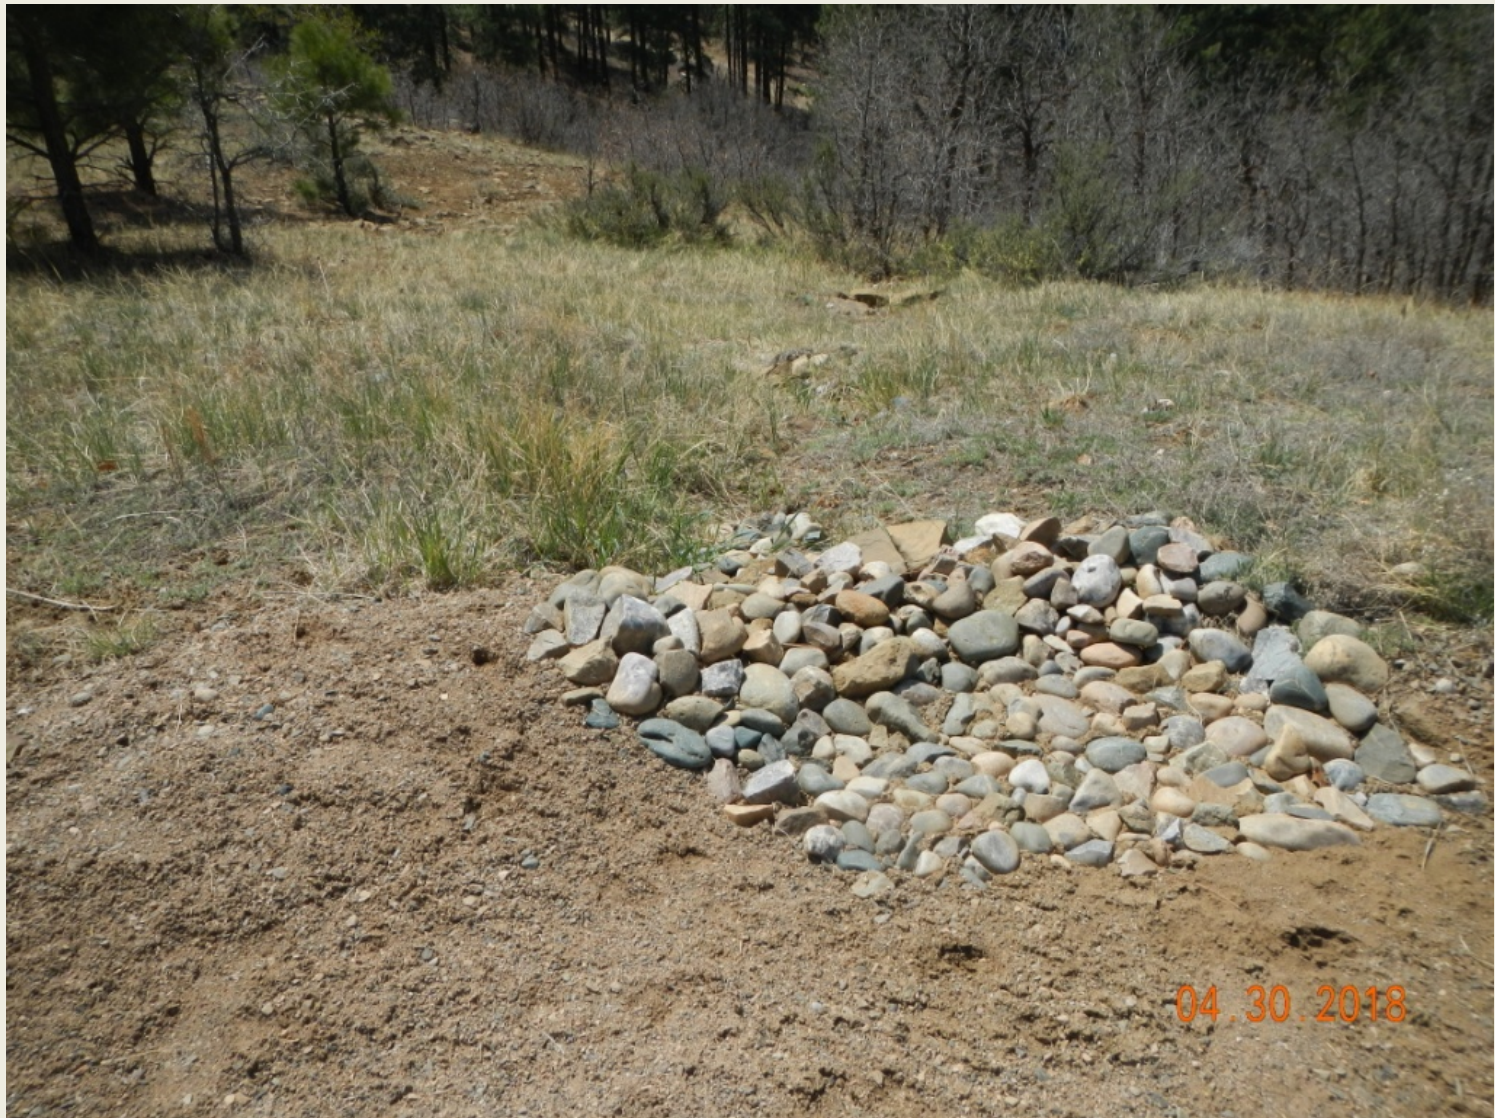
**Photo 2. View of another check dam in the southern project area.**

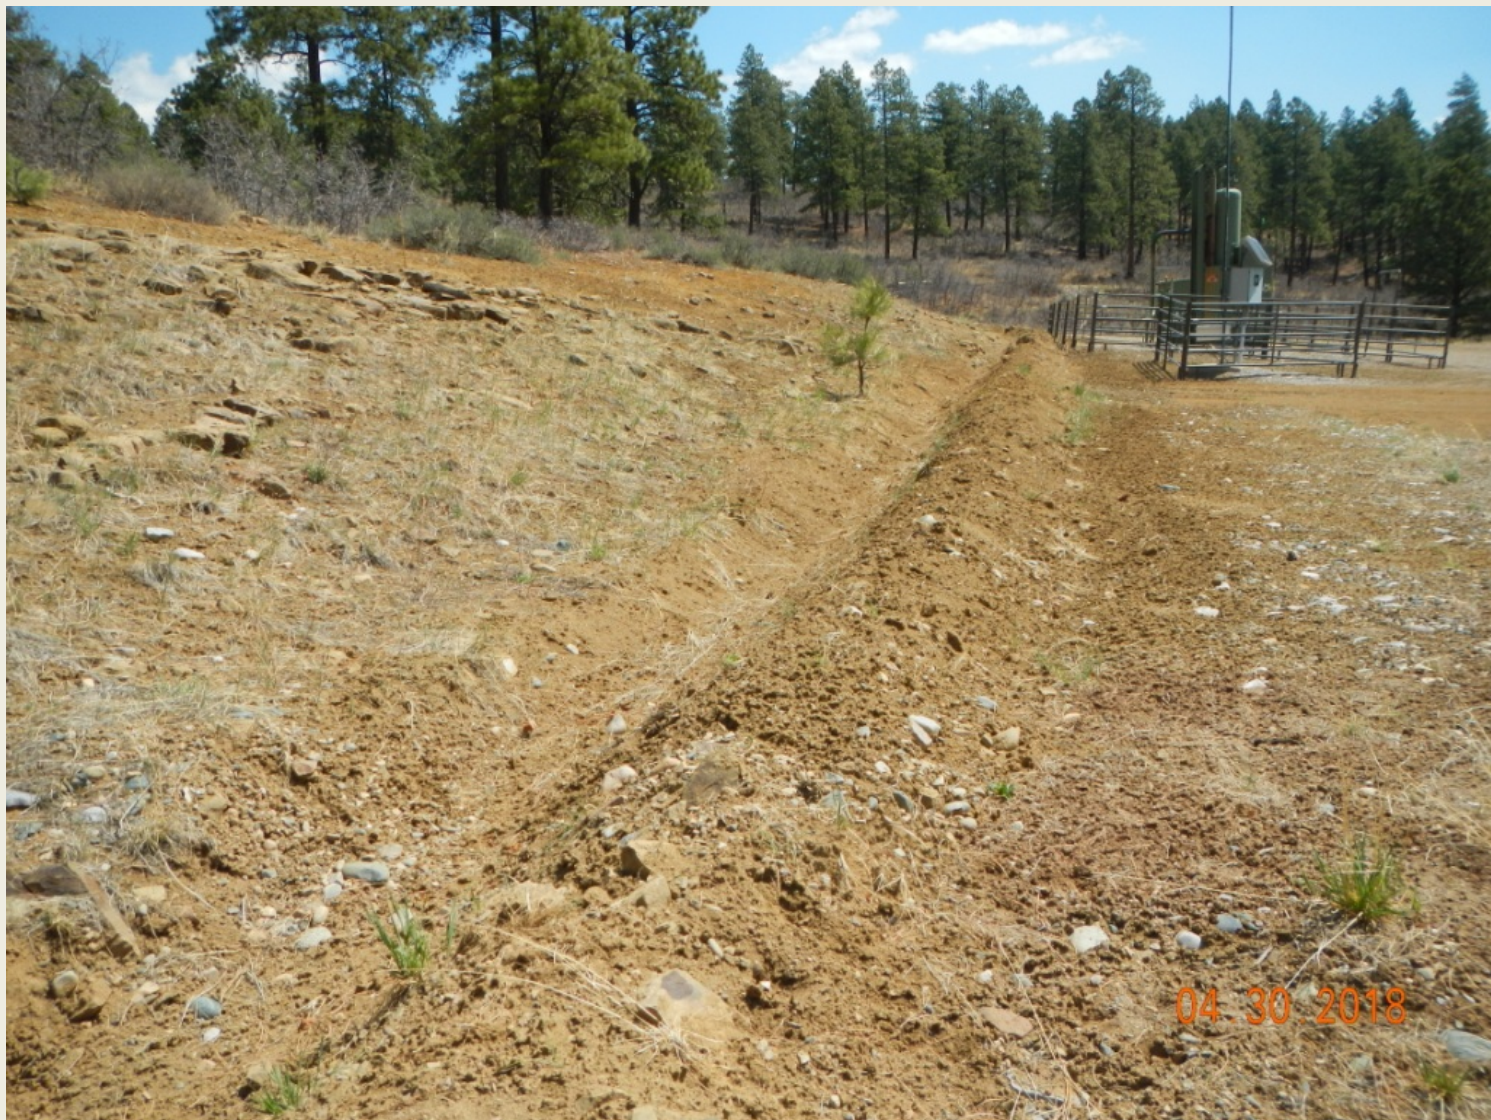
**Photo 3. View of recently graded diversion and berm. Seedlings observed on berm.**

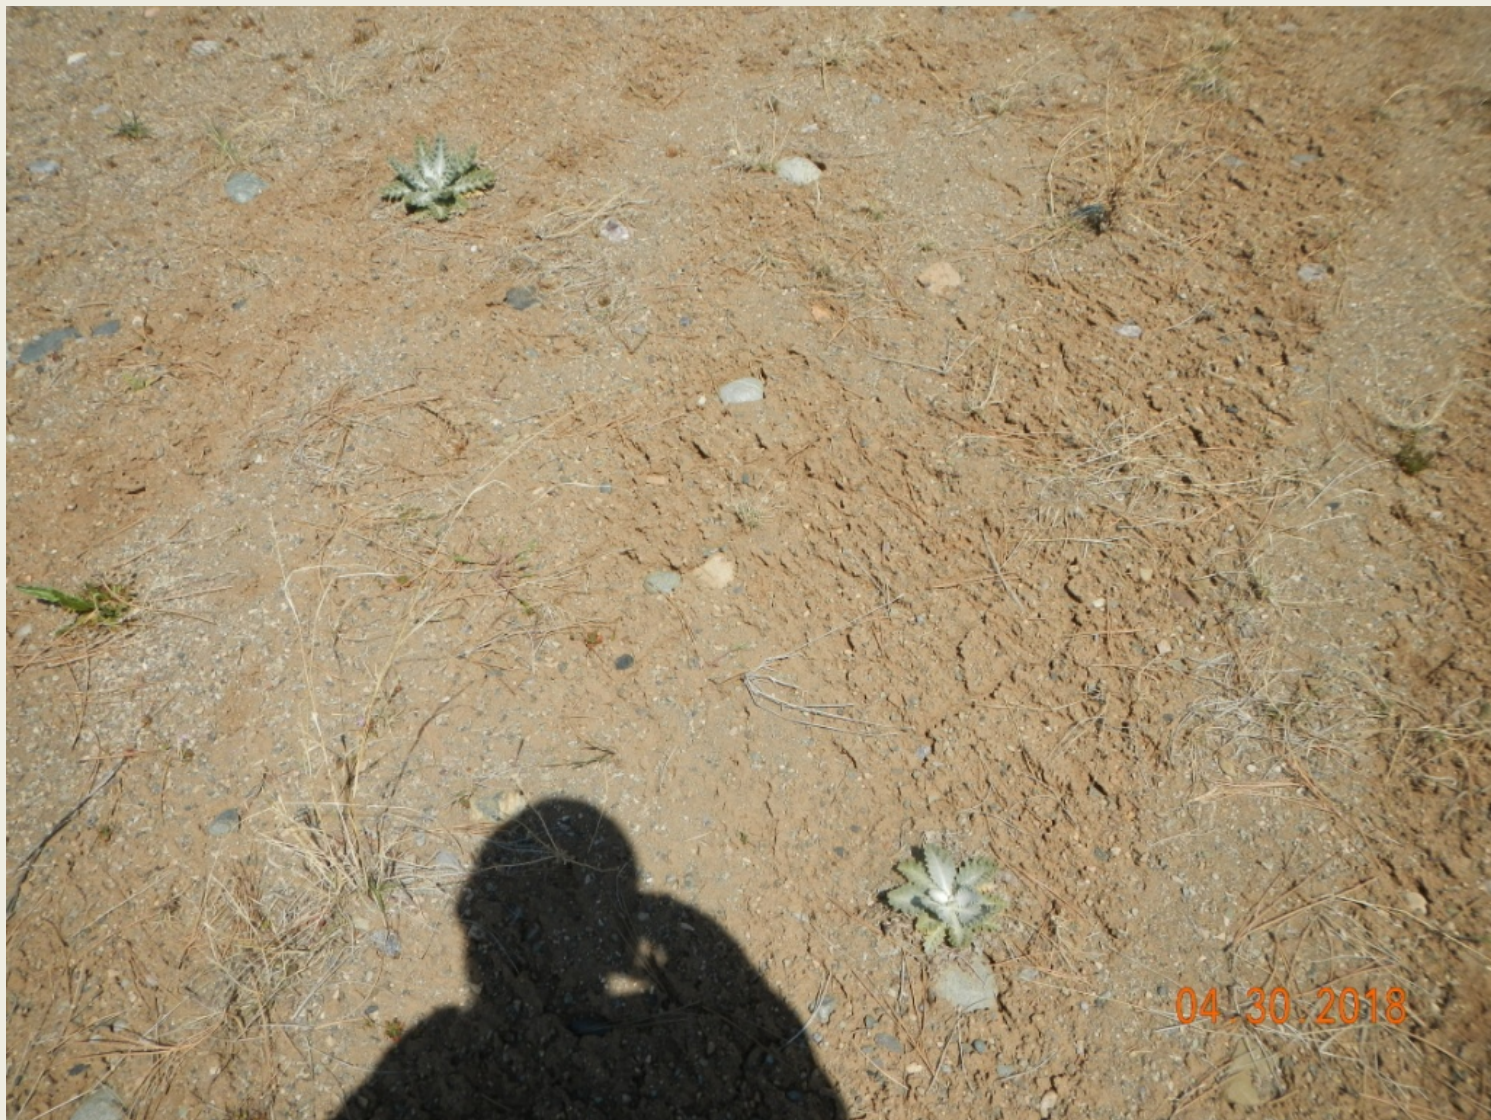
**Photo 4. View of Scotch thistles (*Onopordum acanthium*) in the western portion of the project area.**
