Inspection Photos
Location Name: MOC 32C CE&P Facility
433736

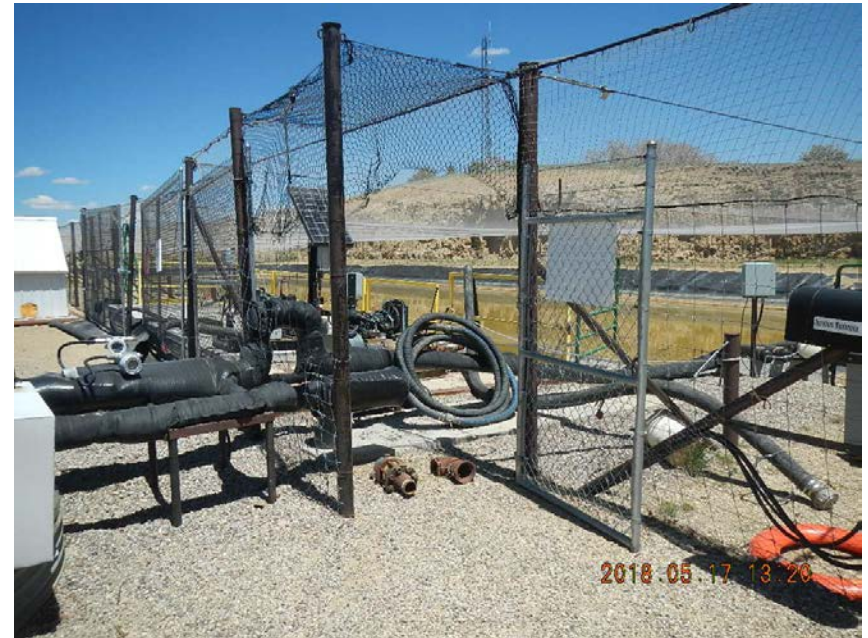
Open gate

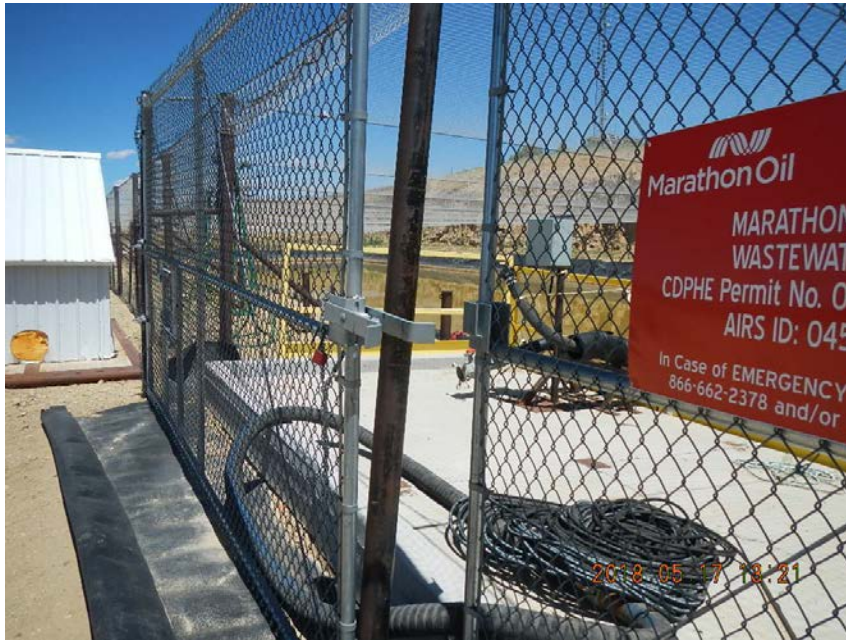
Unsecured gate

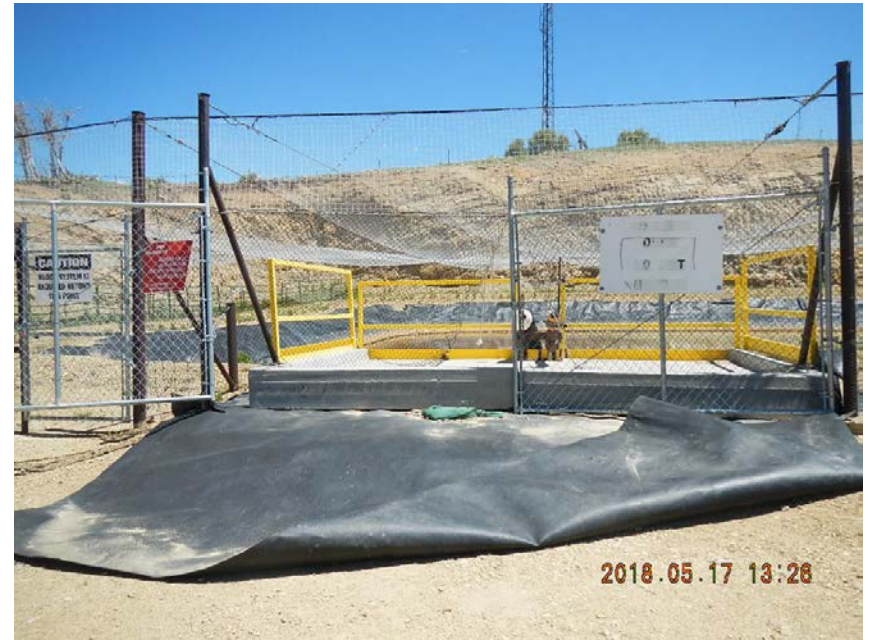
Open gate

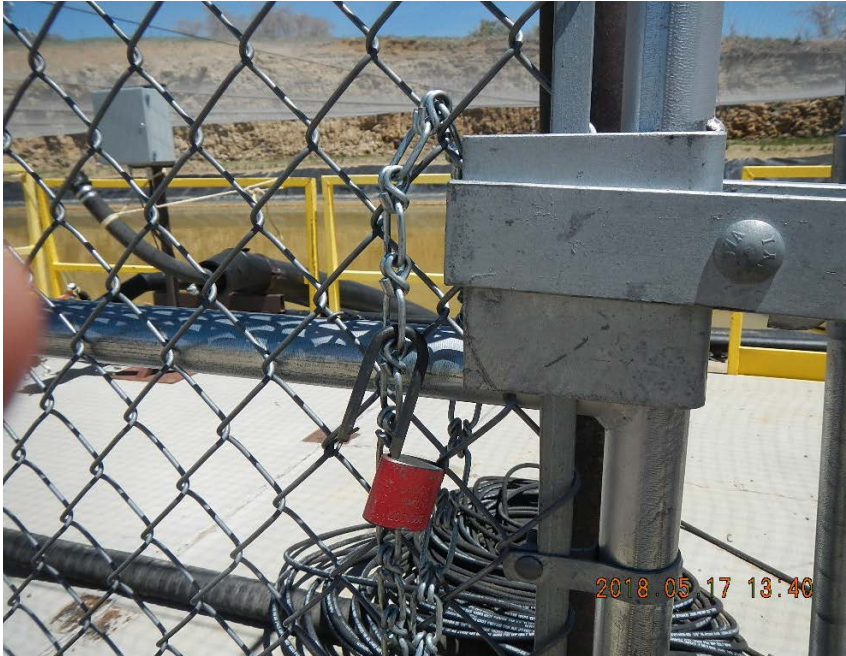
Unsecured gate

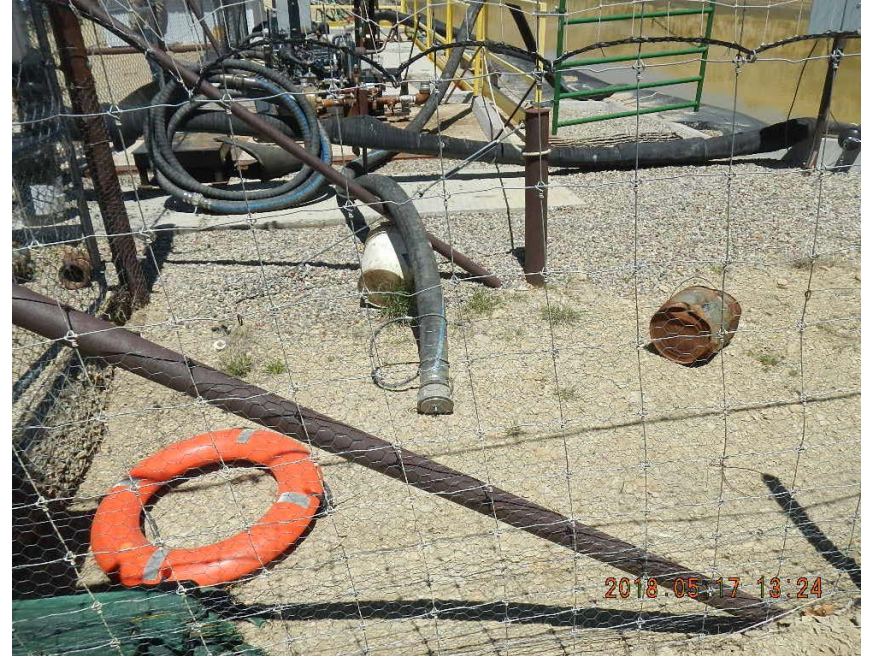
Debris (buckets), hoses on liner

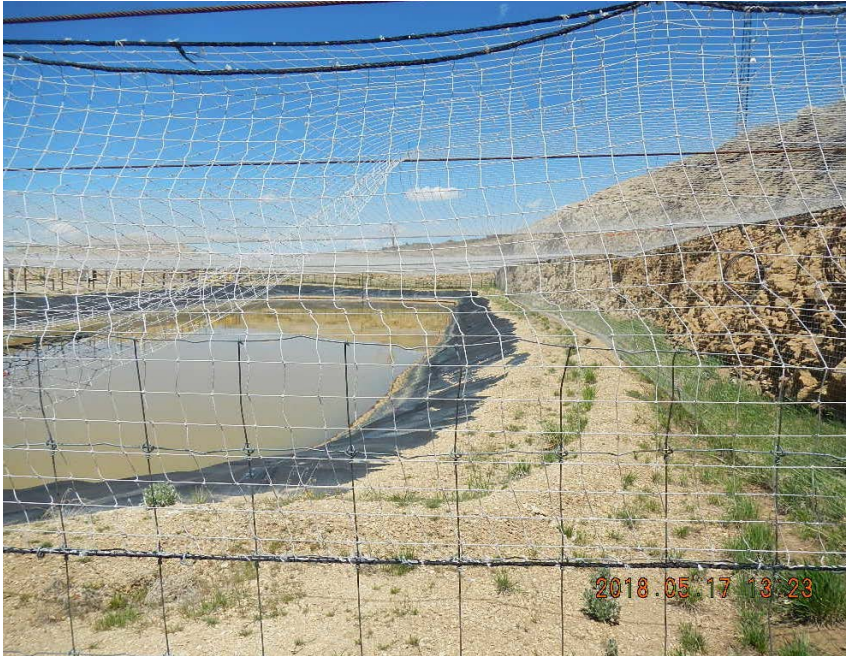
Holes in netting

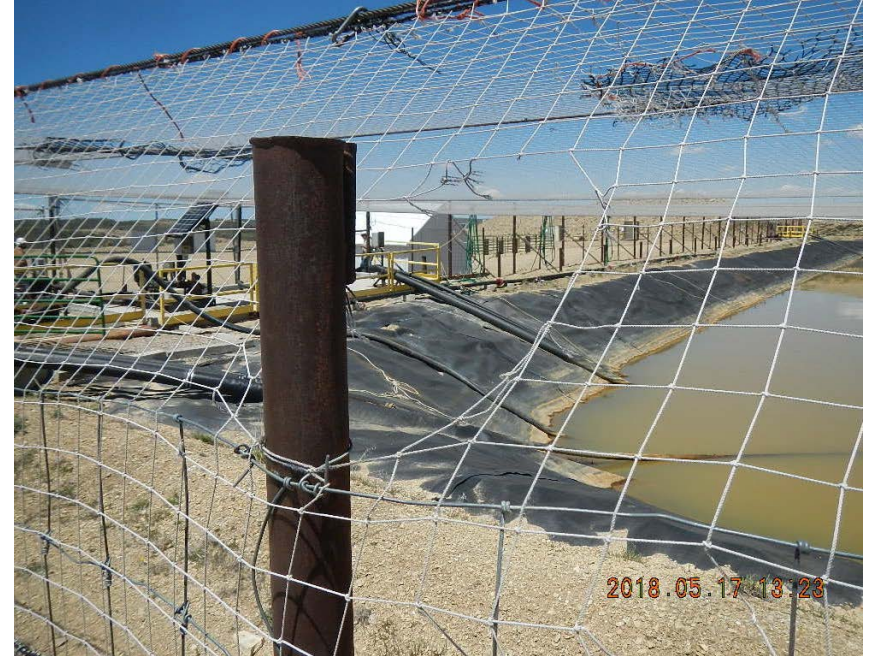
Holes in netting

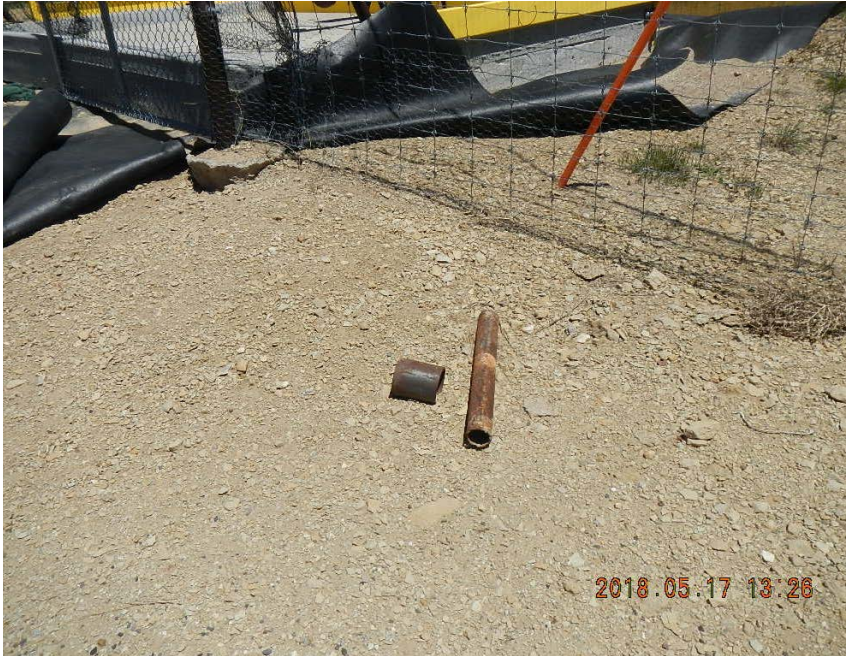
Debris

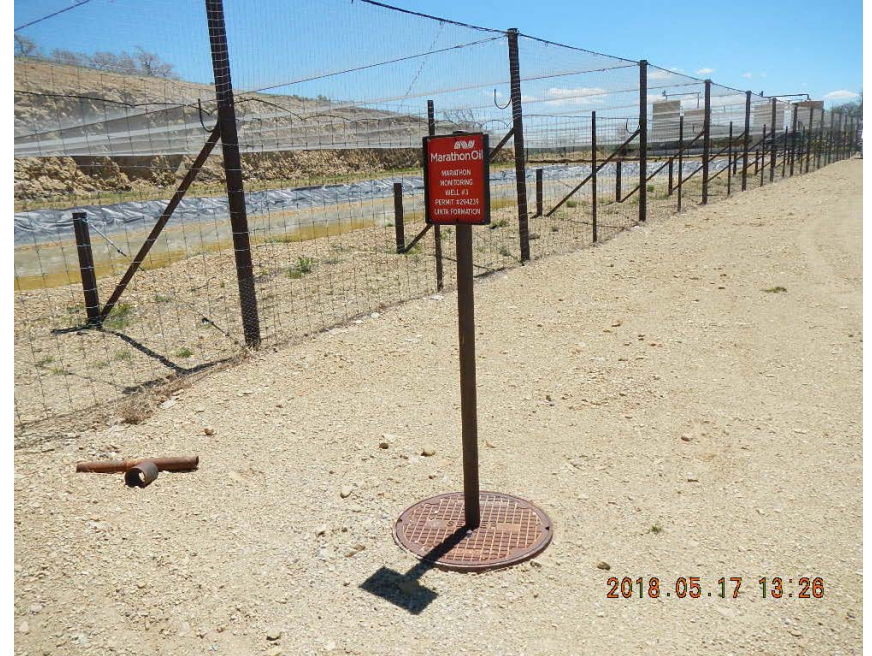
Debris
