Inspection Photos
Location Name: F.S. Duncan B 5
API: 05-081-06864

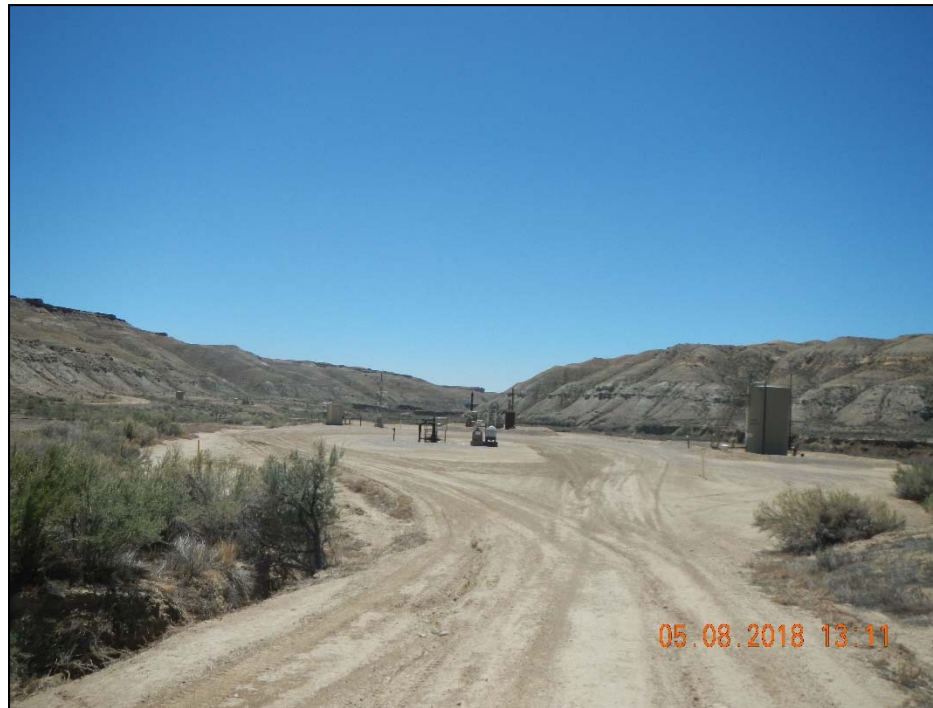
Photo 1. Overview of location taken at entrance facing southwest.

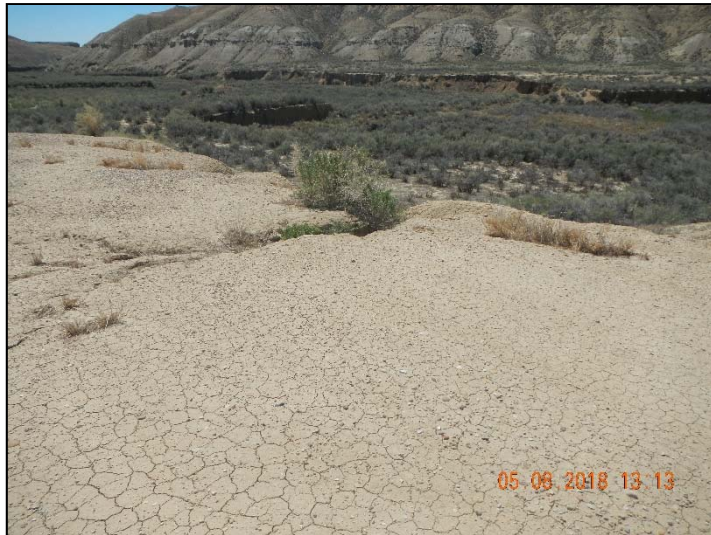
Photo 2. Erosion gully transporting sediment off location. (1 of 2)

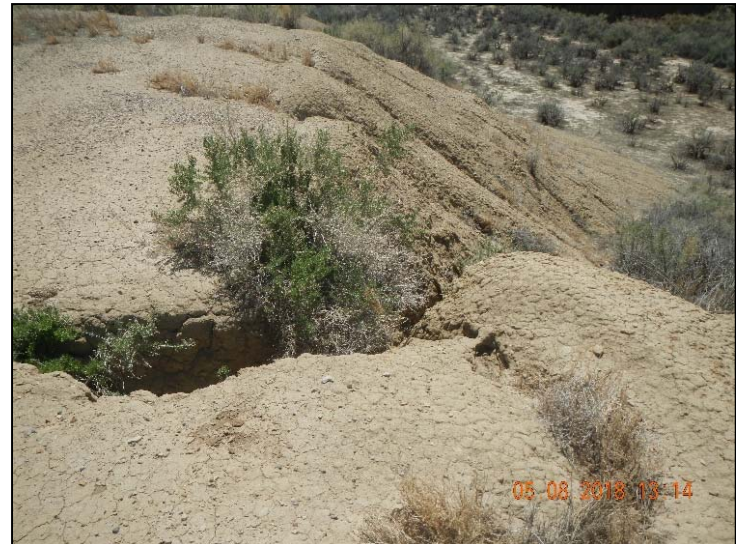
Photo 3. Erosion gully transporting sediment off location. (2 of 2)
