Inspection Photos
Location Name: Duncan Van Schaick
612N100W 29SWNW
Location ID: 333337

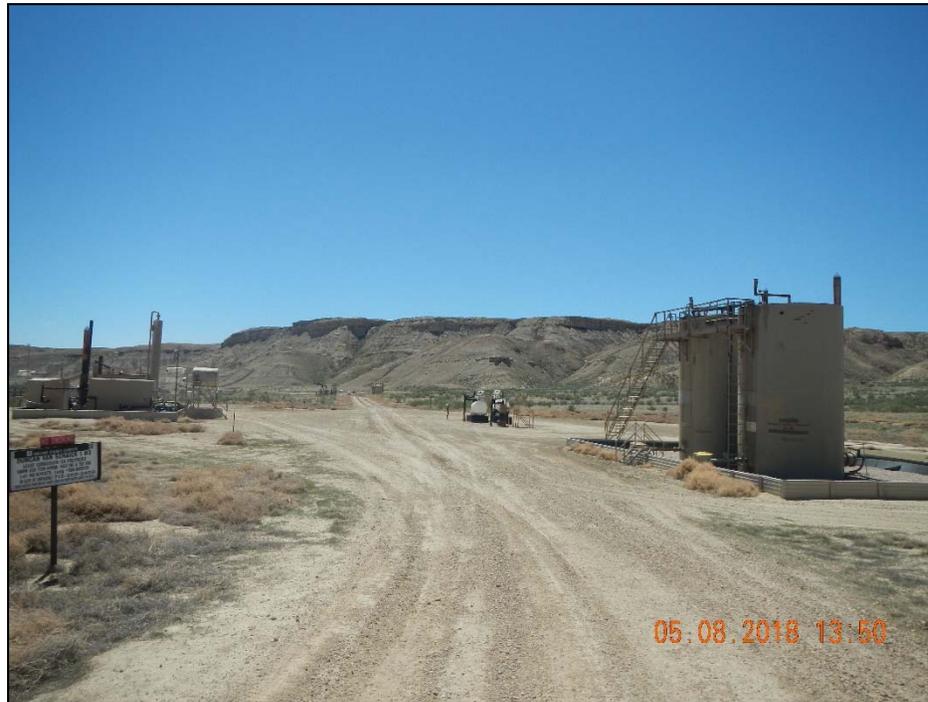
Photo 1. Overview of location taken at entrance facing south.
