Inspection Photos

Operator: CM PRODUCTION LLC - 10352

Location ID: 317120

Inspection Doc. Number: 682503375

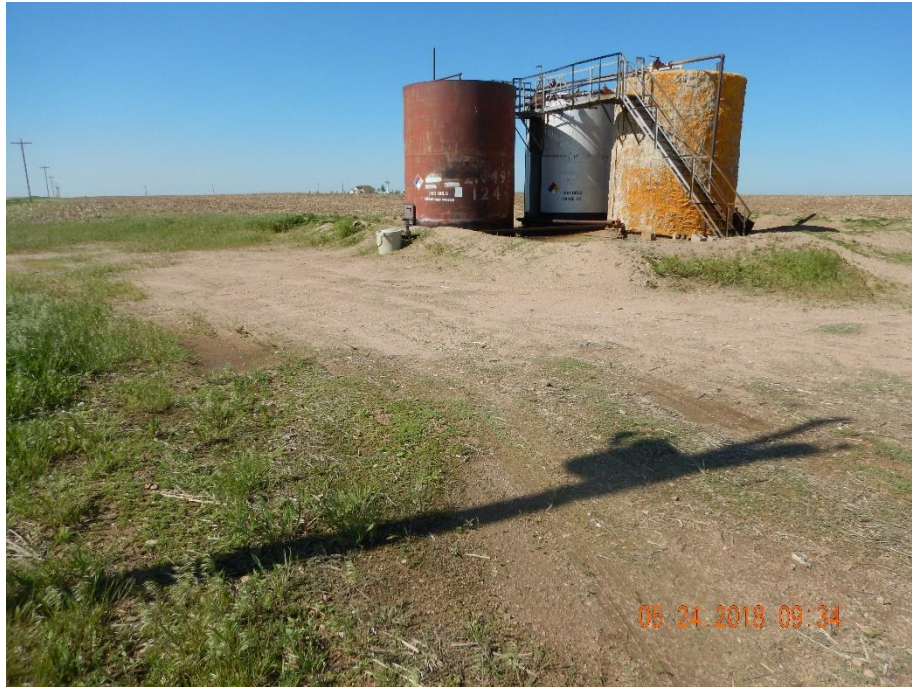
Photo 1: Photo taken east end of the tank battery facility, facing southwest. Photos 1-4 show an overview of the location, facing southwest, to west, to north.

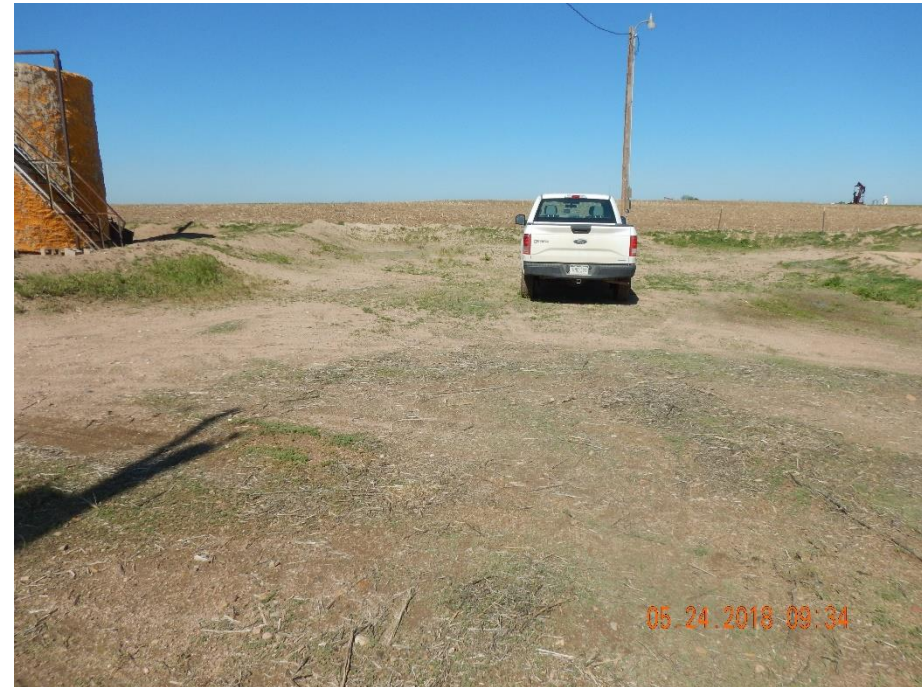
Photo 2: Photo taken east end of the tank battery facility, facing west.

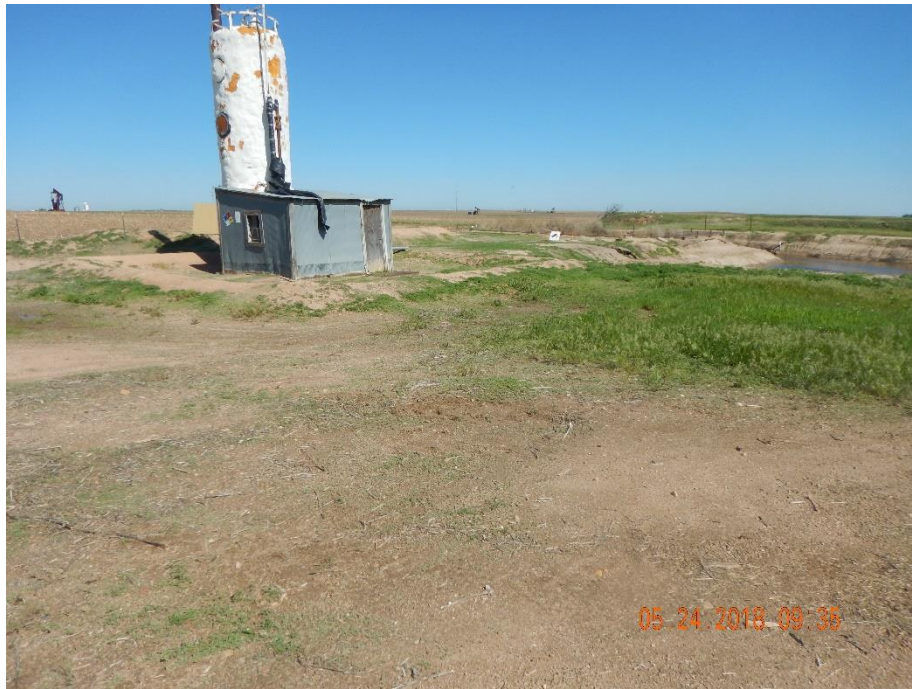
Photo 3: Photo taken east end of the tank battery facility, facing northwest.

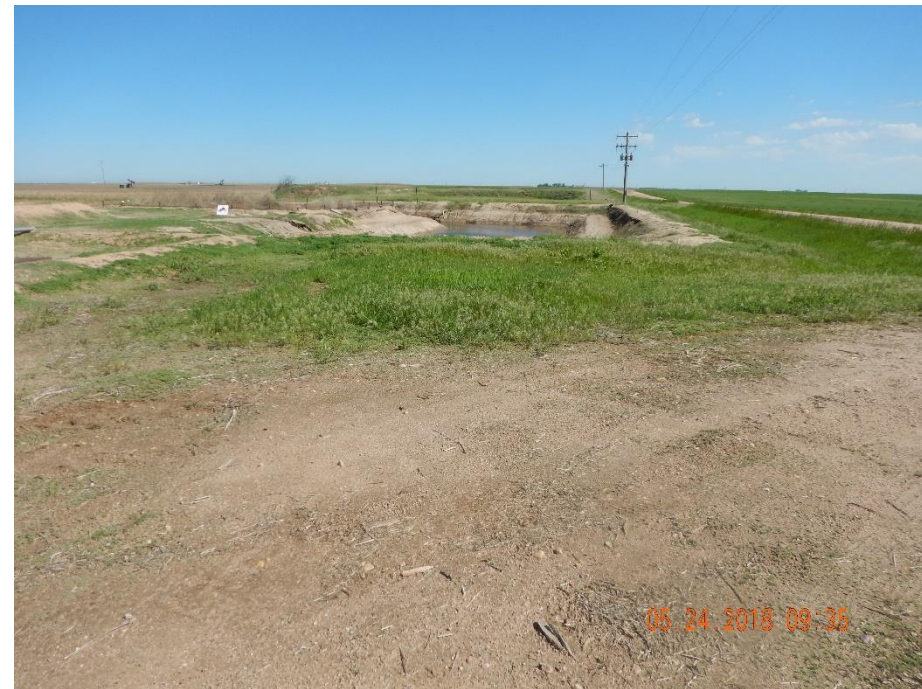
Photo 4: Photo taken east end of the tank battery facility, facing north.

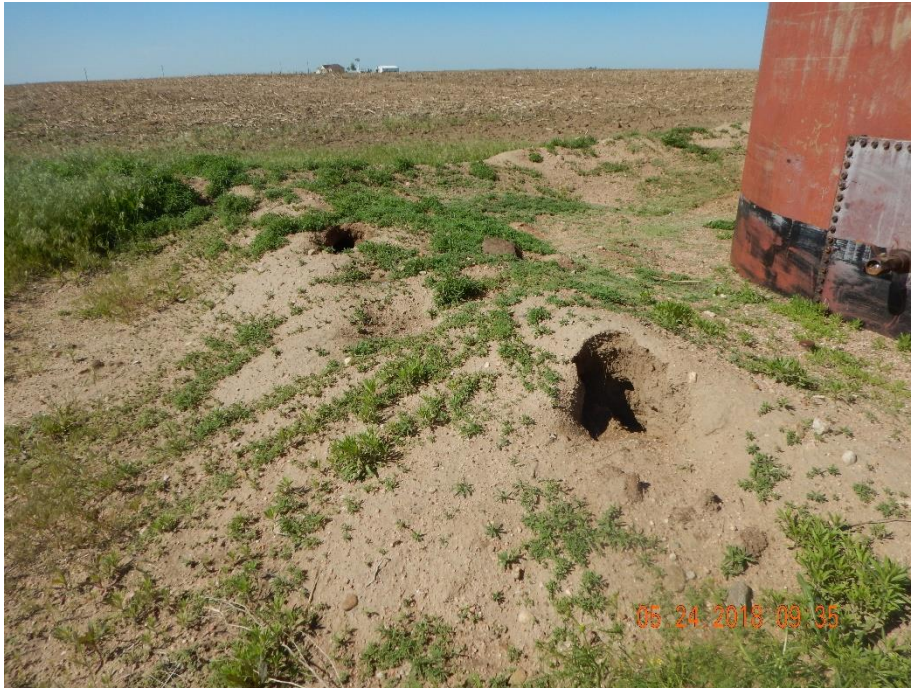
Photo 5: Photo taken from the south end of the location, at the tanks, facing southwest. Photo shows undesirable weedy plant establishment on the berms. Photo also shows wildlife appears to have created burrows/holes within the side of the berms.

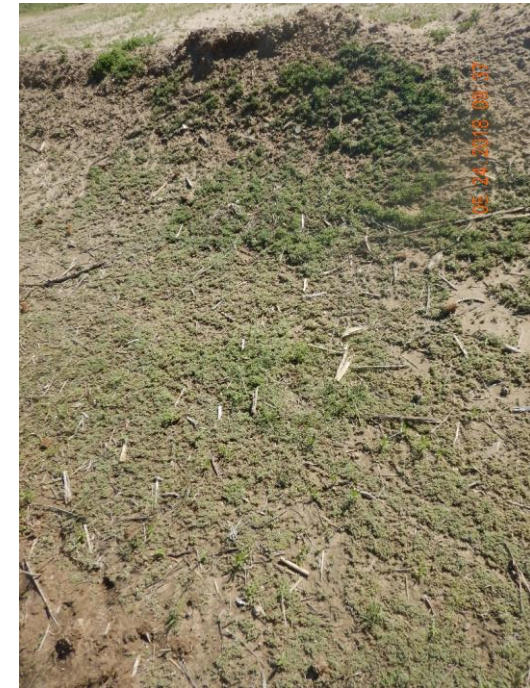
Photo 6: Photo taken from the berms on the south end of the location. Photo shows undesirable weedy plant species (Kochia) establishing on the location.

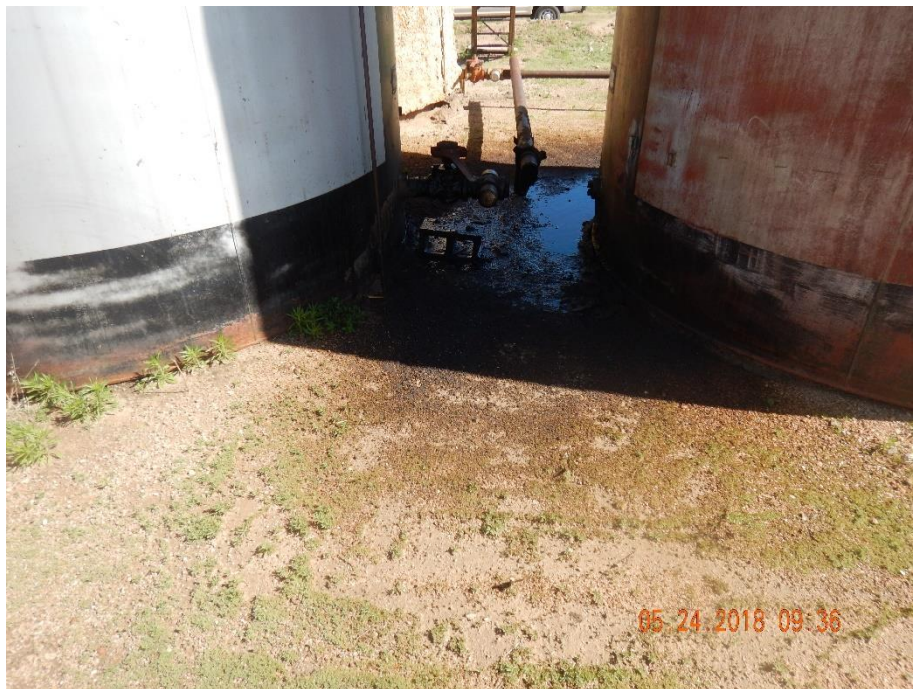
Photo 7: Photo taken from the south end of the tank battery. Photo shows what appears to be crude oil is leaking from the southwestern tank.

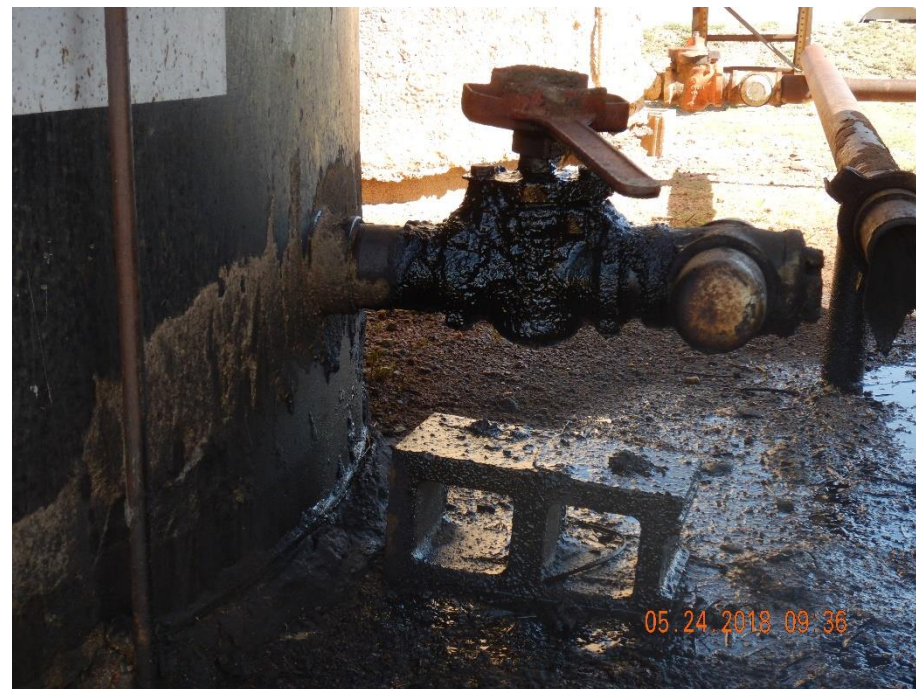
Photo 8: Photo taken from the south end of the tank battery. Photo shows what appears to be crude oil is leaking from the valve of the southwestern tank.

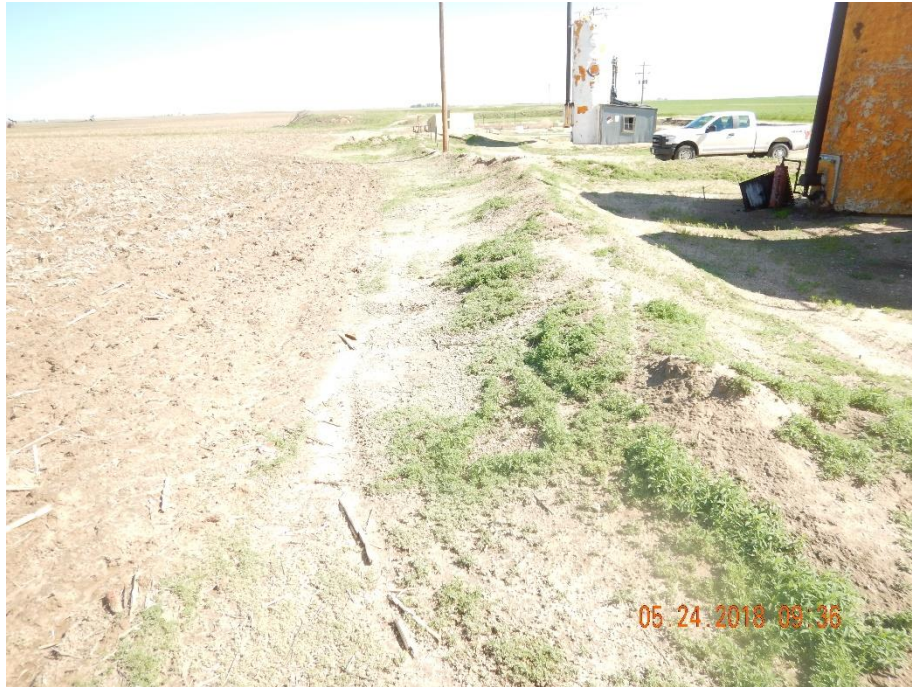
Photo 9: Photo taken from the southwest end of the location, facing north. Photo shows undesirable weedy plant species establishing on the location.

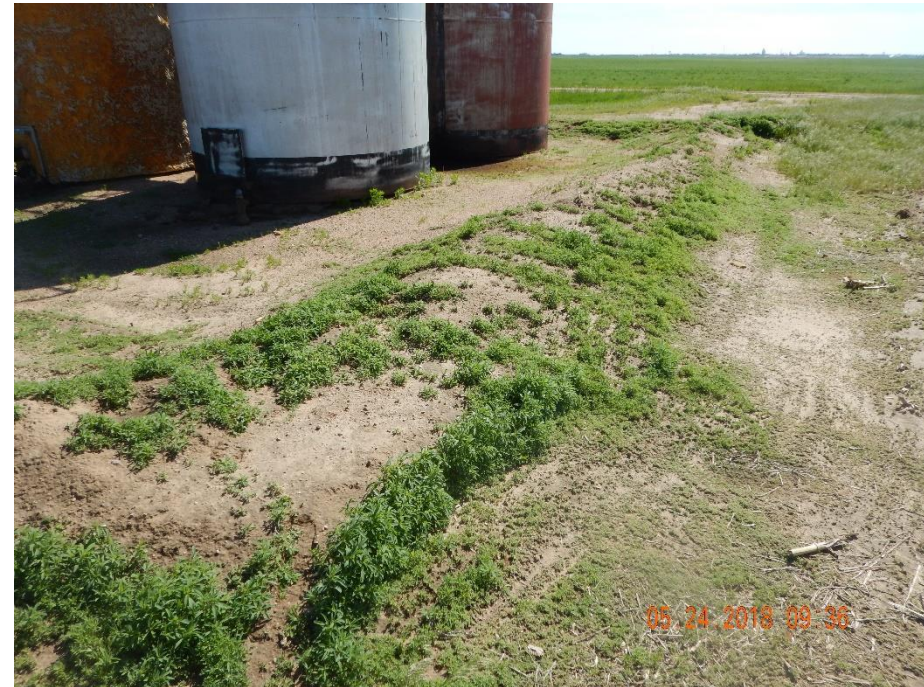
Photo 10: Photo taken from the southwest end of the location facing east. Photo shows undesirable weedy plant species establishing on the location.

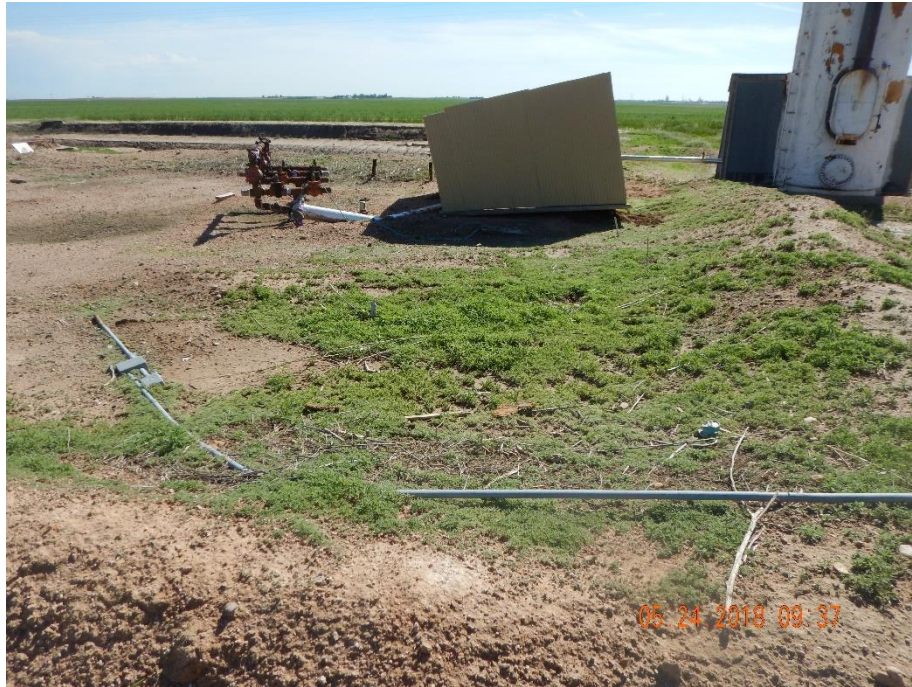
Photo 11: Photo taken from the west end of the location, facing east. Photo shows undesirable weedy plant species establishing on the location.

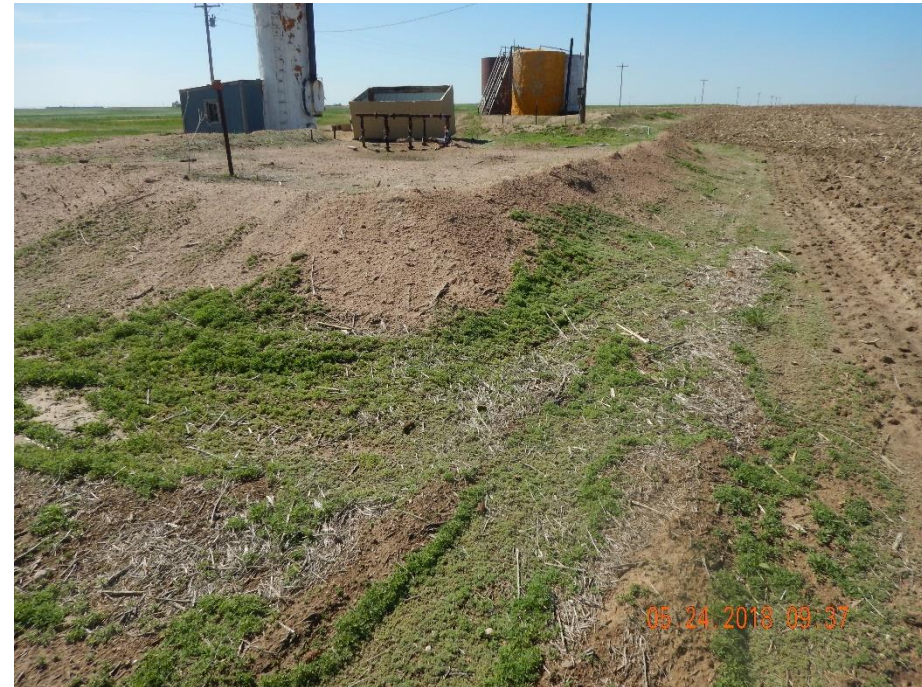
Photo 12: Photo taken from the west end of the location, facing south. Photo shows undesirable weedy plant species establishing on the location.

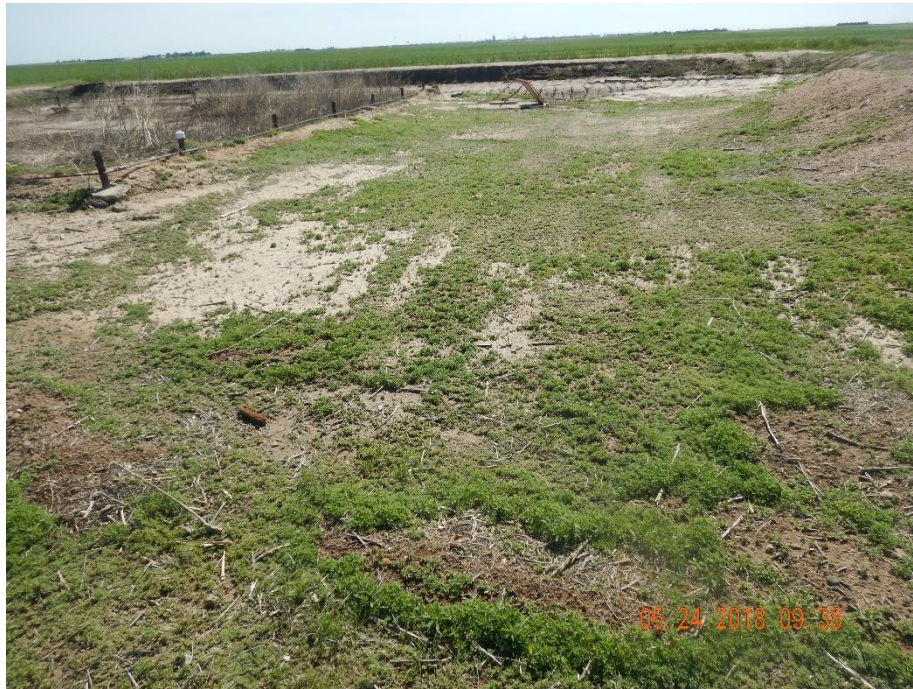
Photo 13: Photo taken from the west of the southern pit, facing east. Photo shows undesirable weedy plant species establishing on the location.

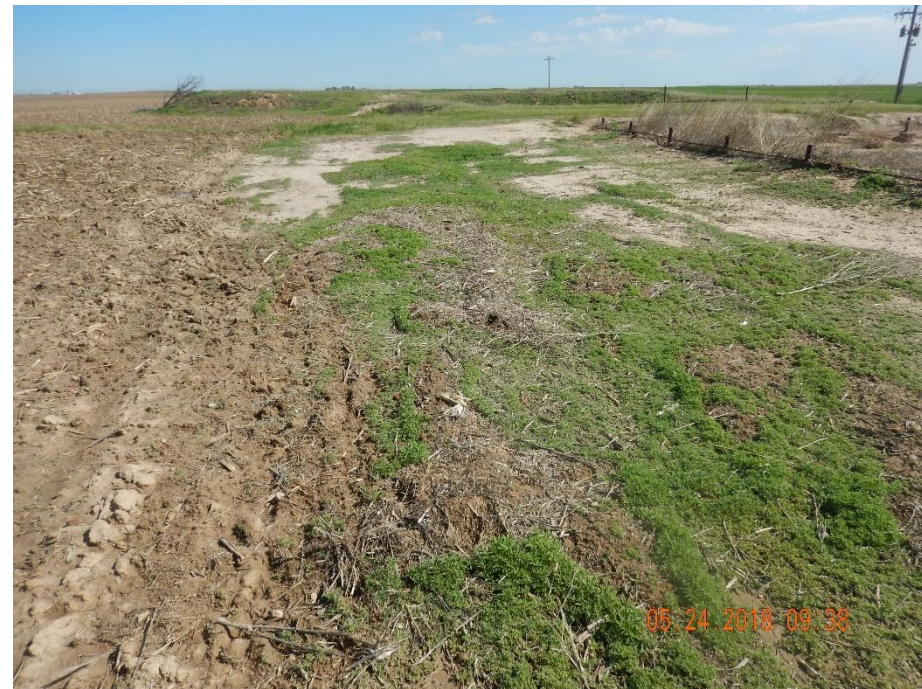
Photo 14: Photo taken from the west of the southern pit, facing north. Photo shows undesirable weedy plant species establishing on the location.

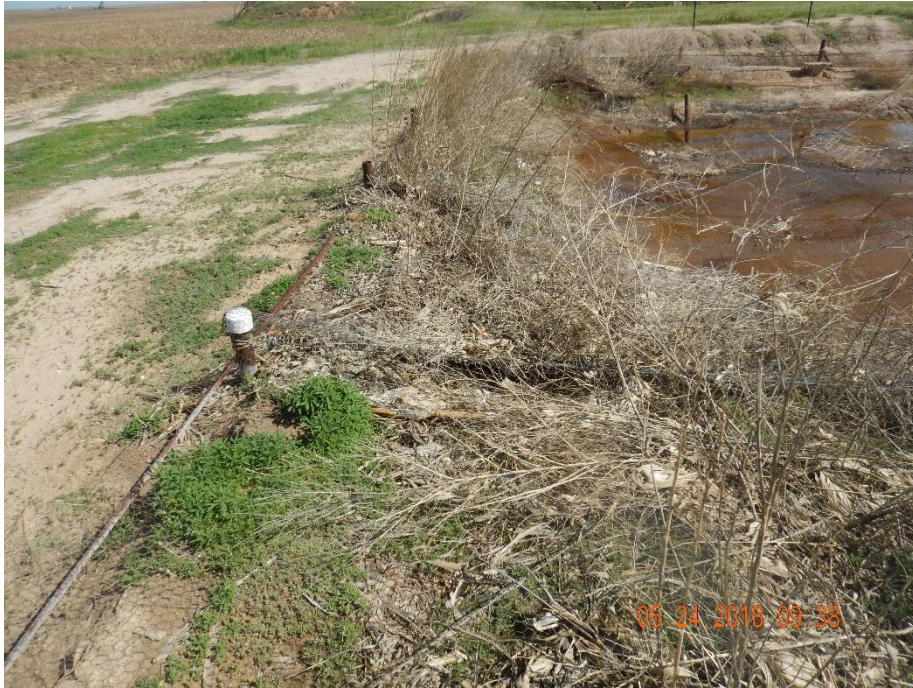
Photo 15: Photo taken from the west end of the netter-skim pit. Photo shows remaining kochia debris from the previous growing season, as well as new weed growth

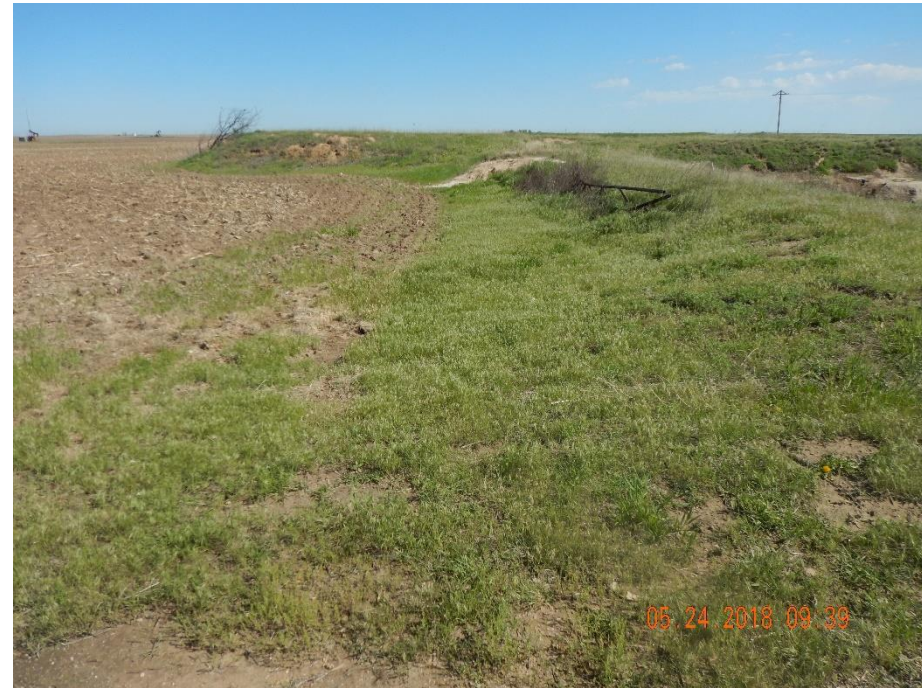
Photo 16: Photo taken from the southwest end of the central pit, facing north. Vegetation seen in this photo is predominantly undesirable cheatgrass mixed with kochia.

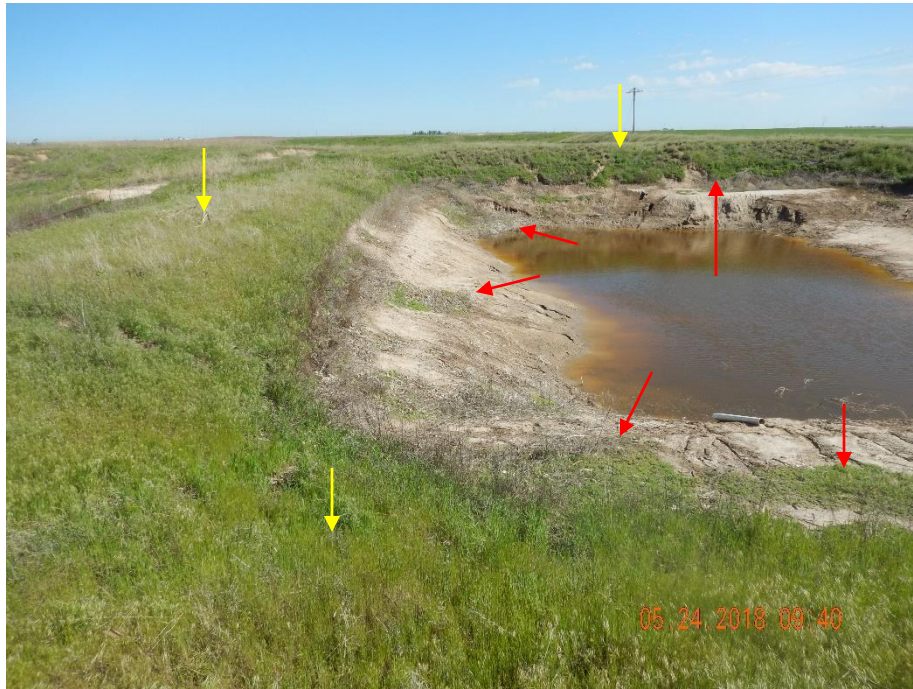
Photo 17: Photo taken from the southwest corner of the central pit, facing north. Vegetation seen in this photo is predominantly undesirable cheatgrass, though perennial grass (yellow arrow) becomes more dominant on the top of the berms, and on the eastern half of the pit.

Patches of kochia (red arrow) can be found along the inside of the pit, as well as in patches on the west end of the pit.

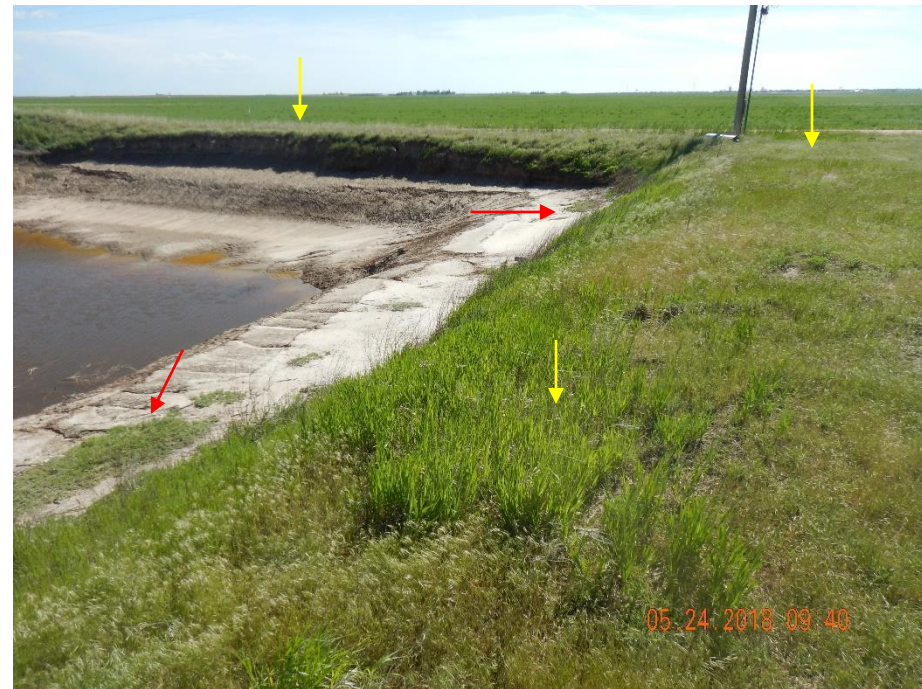
Photo 18: Photo taken from the southwest corner of the central pit, facing northeast. See comments under photo 17.

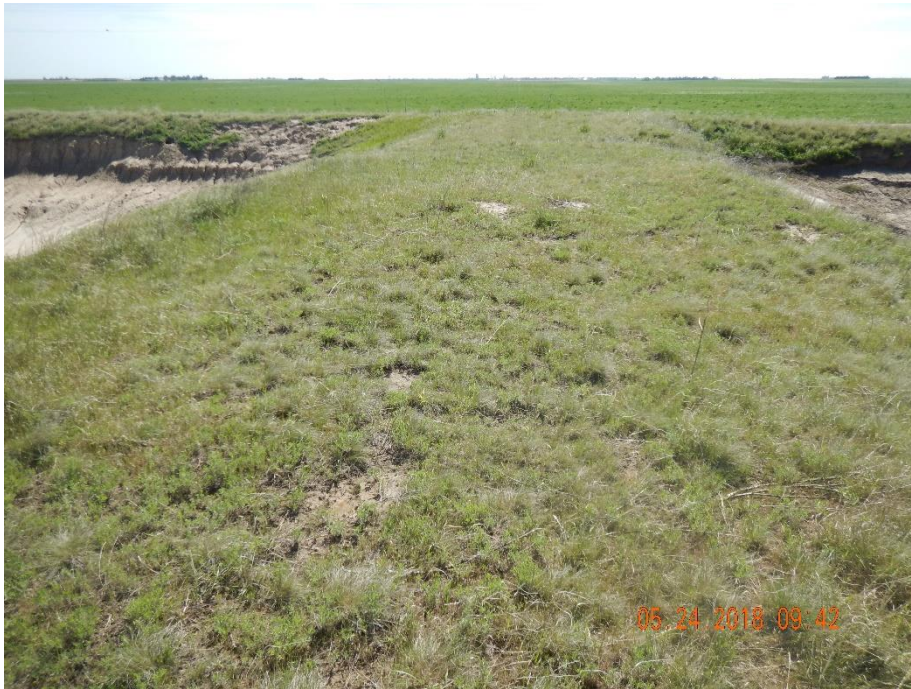
Photo 19: Photo taken from the southwest corner of the central pit, facing northeast. Photo shows perennial vegetation has established in areas between the pits.

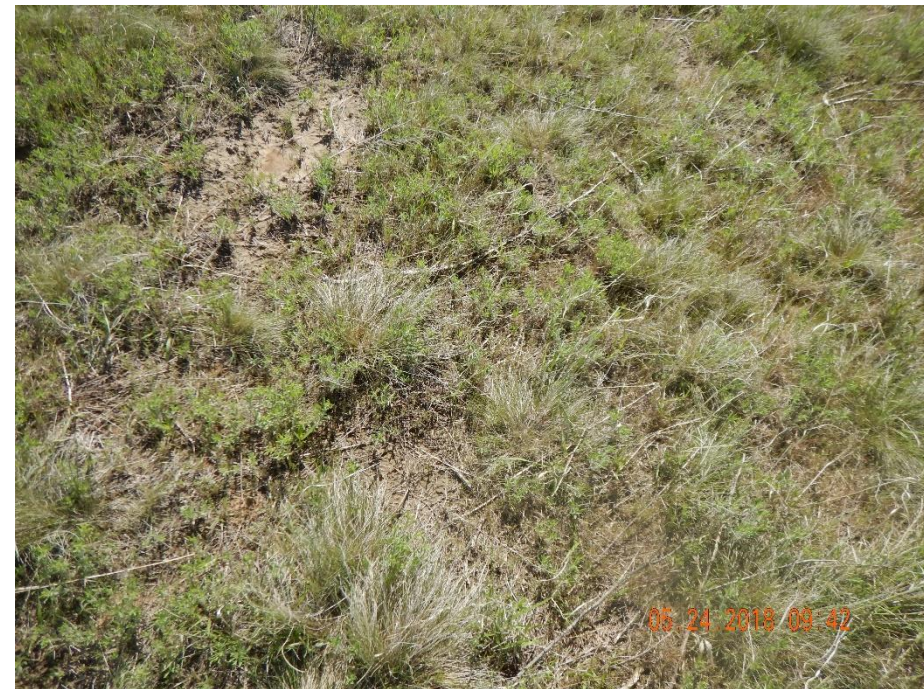
Photo 20: Photo taken from between the central and northern pits. Photo shows perennial vegetation has established in areas between the pits. Vegetation seen here is a mix of Sand dropseed, threeawn, fescue and hairy golden aster. Smooth brome can also be found in the area.

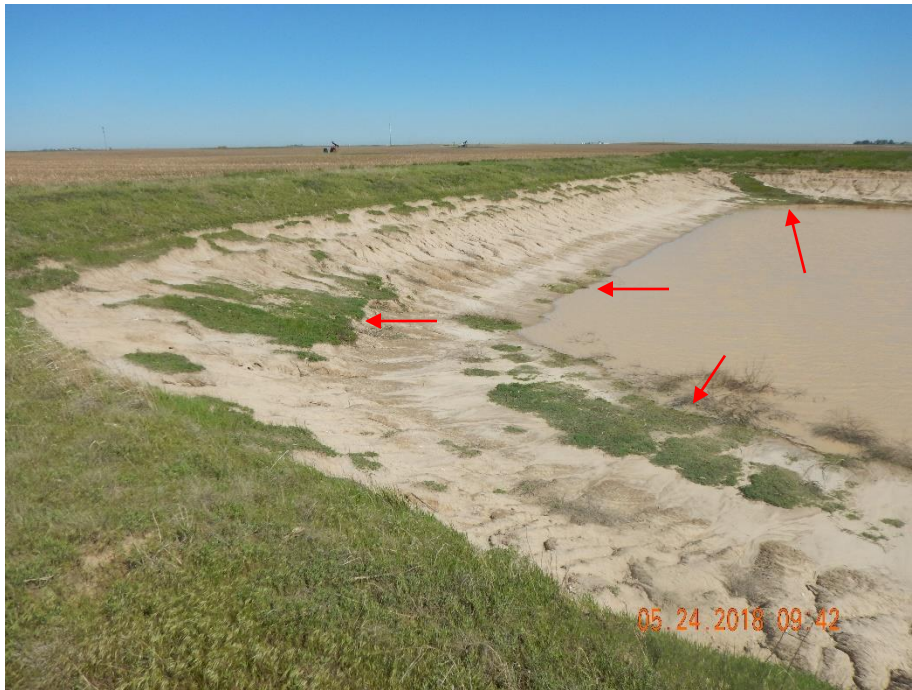
Photo 21: Photo taken from the south end of the northern pit, facing northwest. Though weedy plant species can be found within the pit (arrow), the berms of the pit has a fair amount of perennial grass establishment.

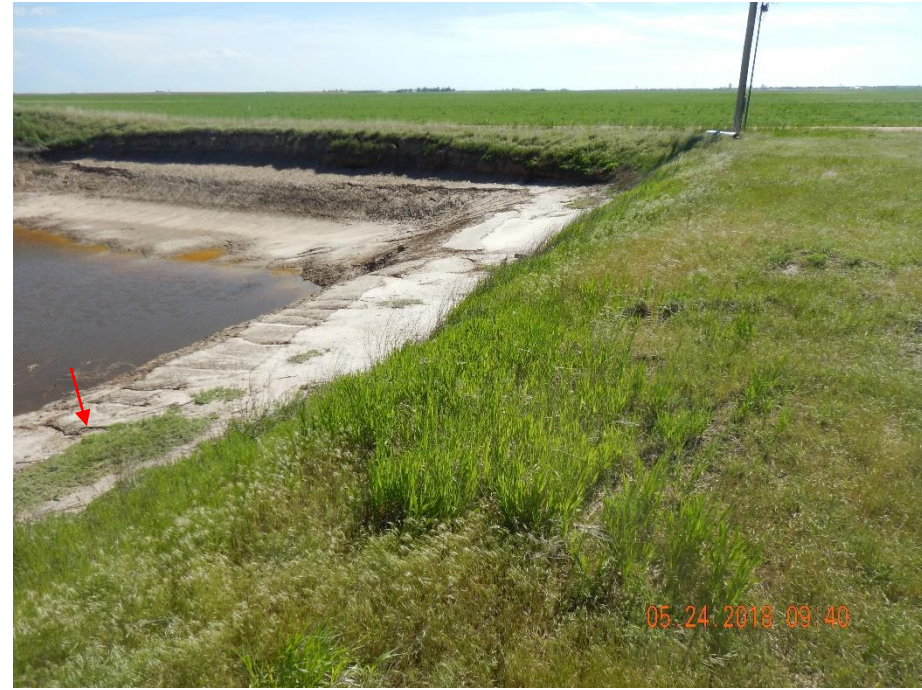
Photo 22: Photo taken from the south end of the northern pit, facing east. Though weedy plant species can be found within the pit (arrow), the berms of the pit has a fair amount of perennial grass establishment.

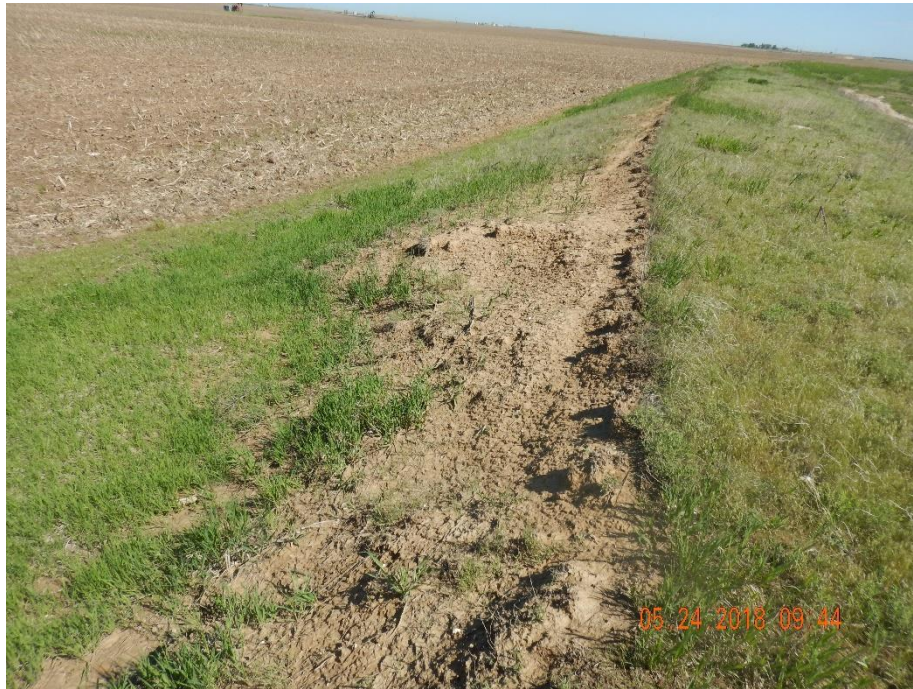
Photo 23: Photo taken from the west end of the northern pit, facing north. Photo shows perennial grass establishment. On the berms

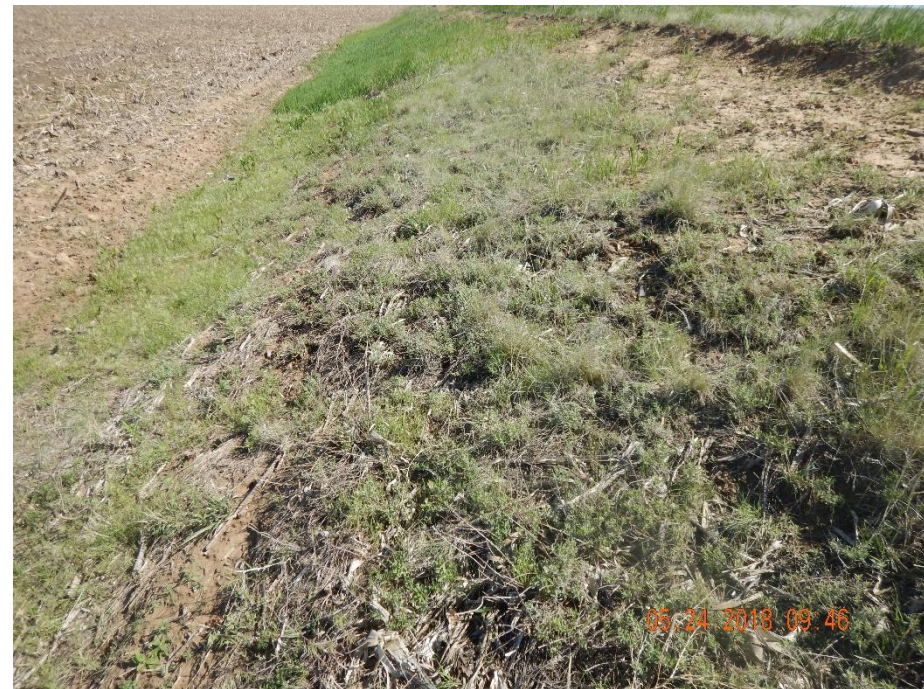
Photo 24: Photo taken from the west end of the northern pit, facing north. Photo shows perennial grass establishment. On the berms

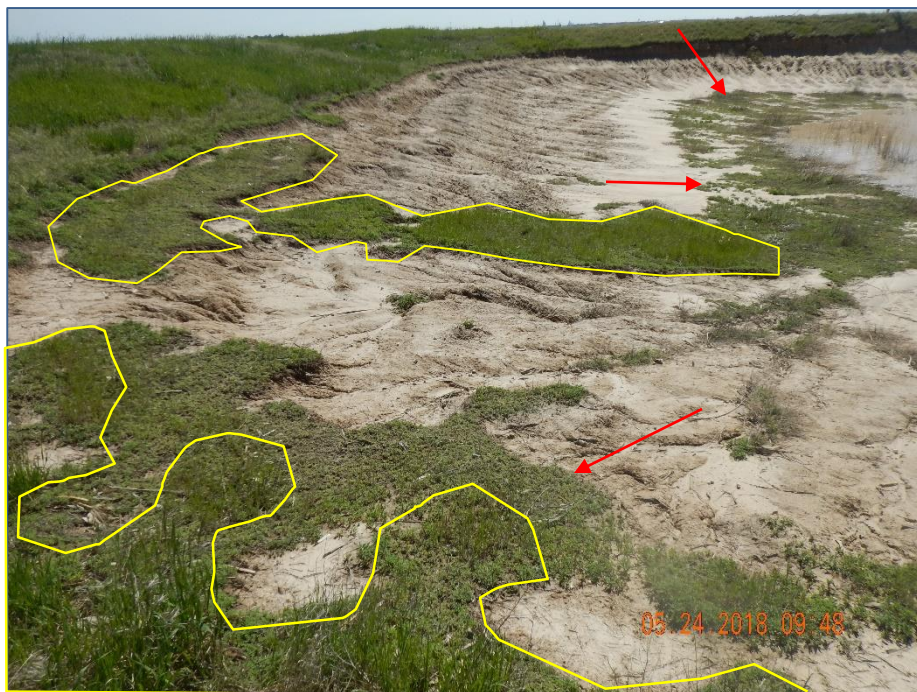
Photo 25: Photo taken from the northwest end of the northern pit, facing east. Though weedy plant species can be found within the pit (arrow), the berms of the pit has a fair amount of perennial grass establishment. Yellow polygons represent patches of grass within the pit.

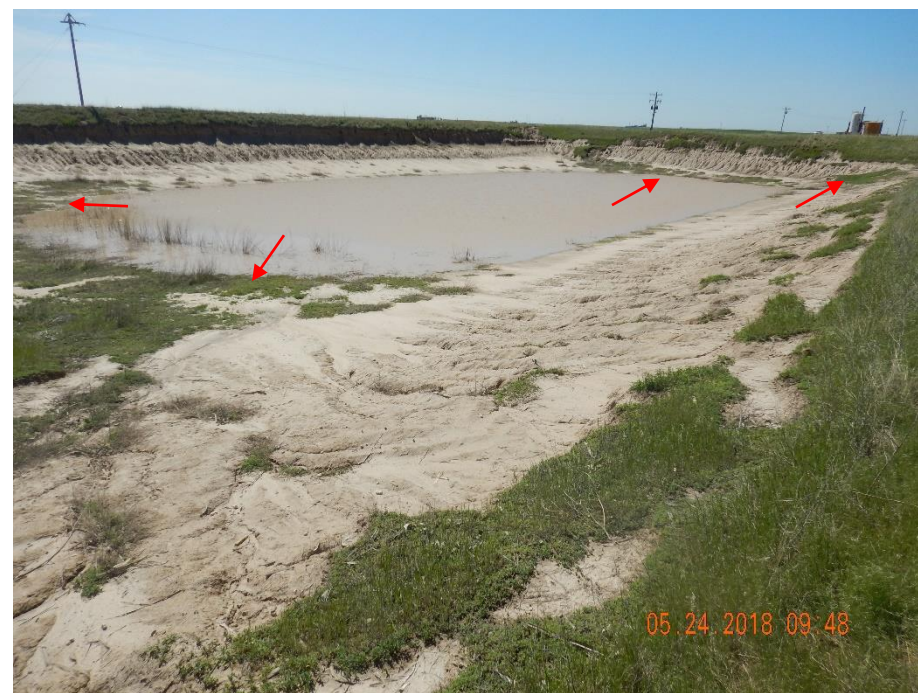
Photo 26: Photo taken from the northwest end of the northern pit, facing south. See comments under photo 25

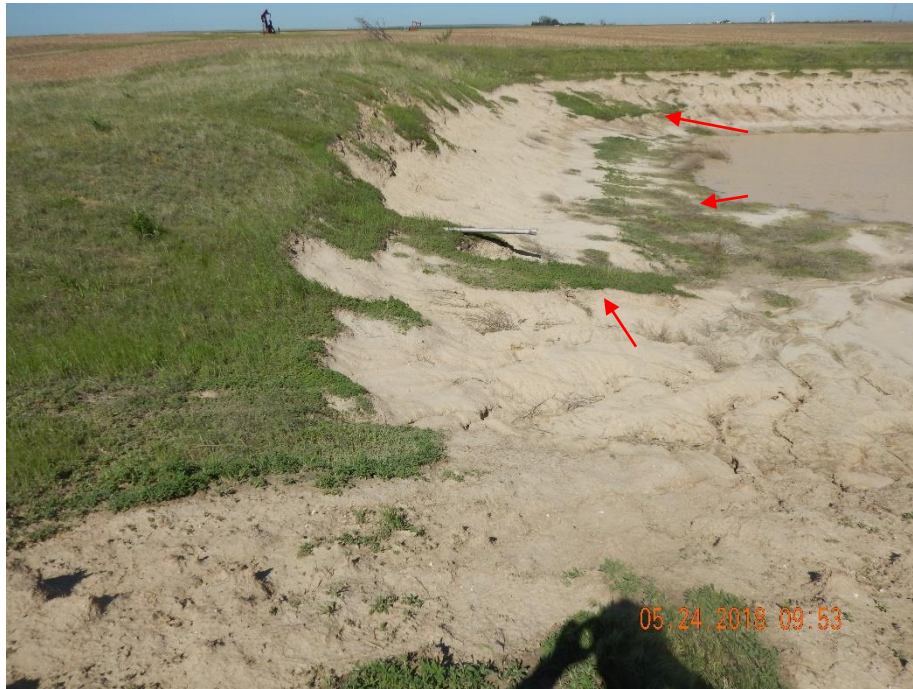
Photo 27: Photo taken from the southeast end of the northern pit, facing west. See comments under photo 25

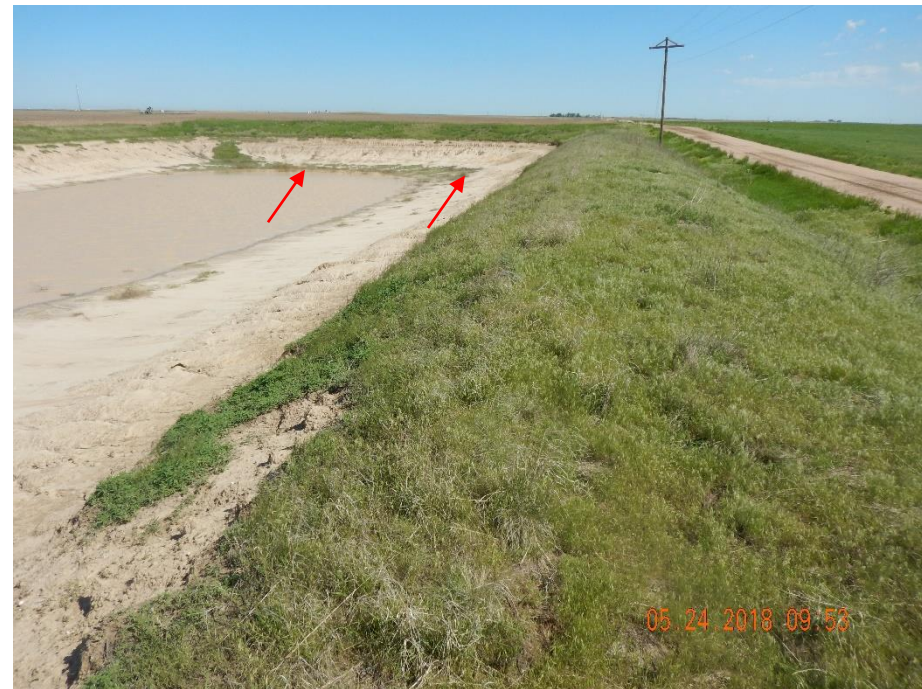
Photo 28: Photo taken from the southeast end of the northern pit, facing north. See comments under photo 25

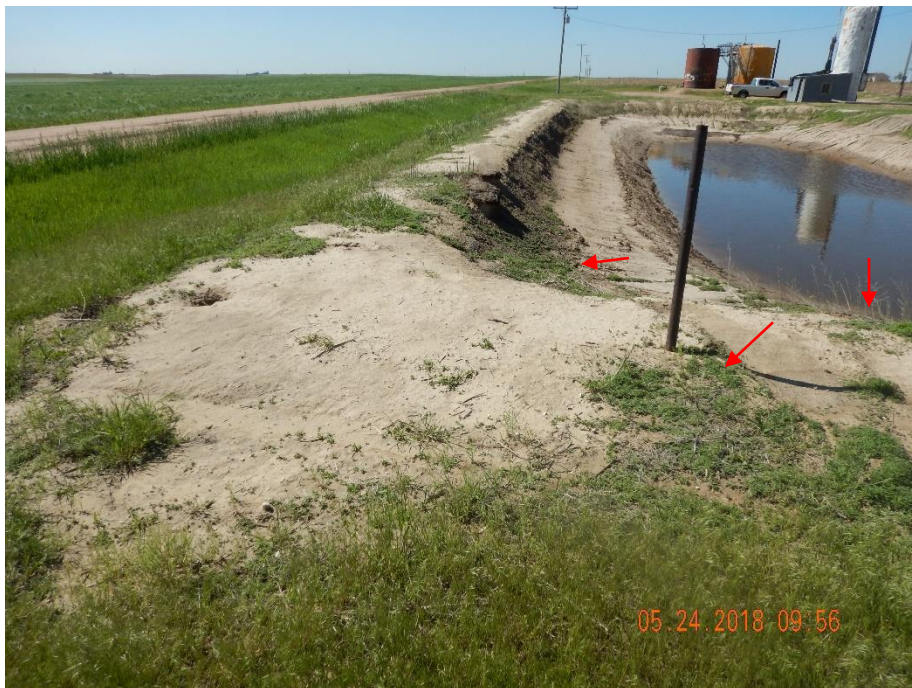
Photo 29: Photo taken from the northeast end of the central pit, facing south. Though weedy plant species can be found within the pit (arrow), the berms of the pit has a fair amount of perennial grass establishment.

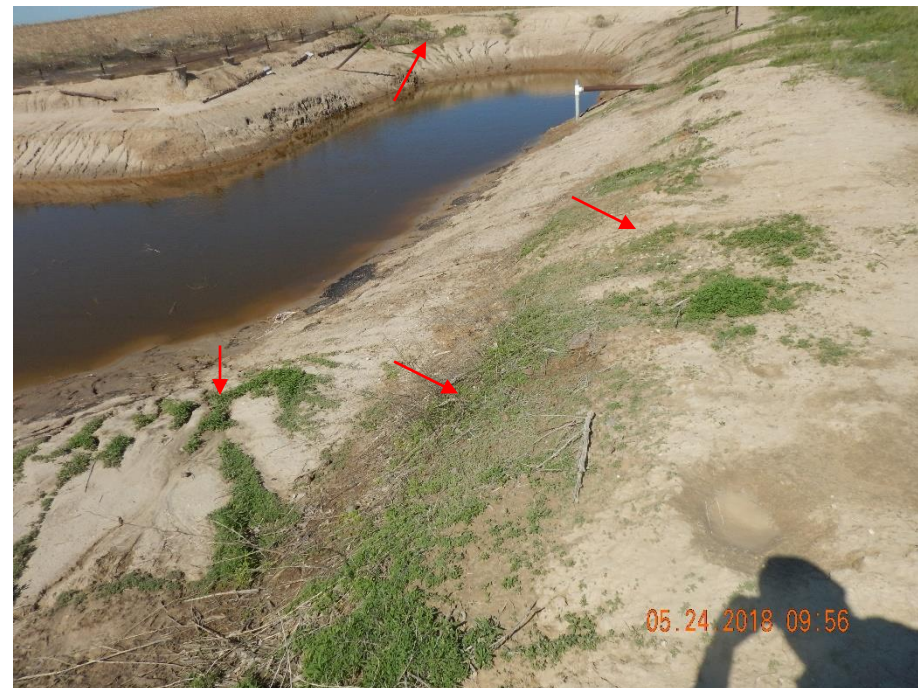
Photo 30: Photo taken from the northeast end of the central pit, facing west. See comments under photo 29.

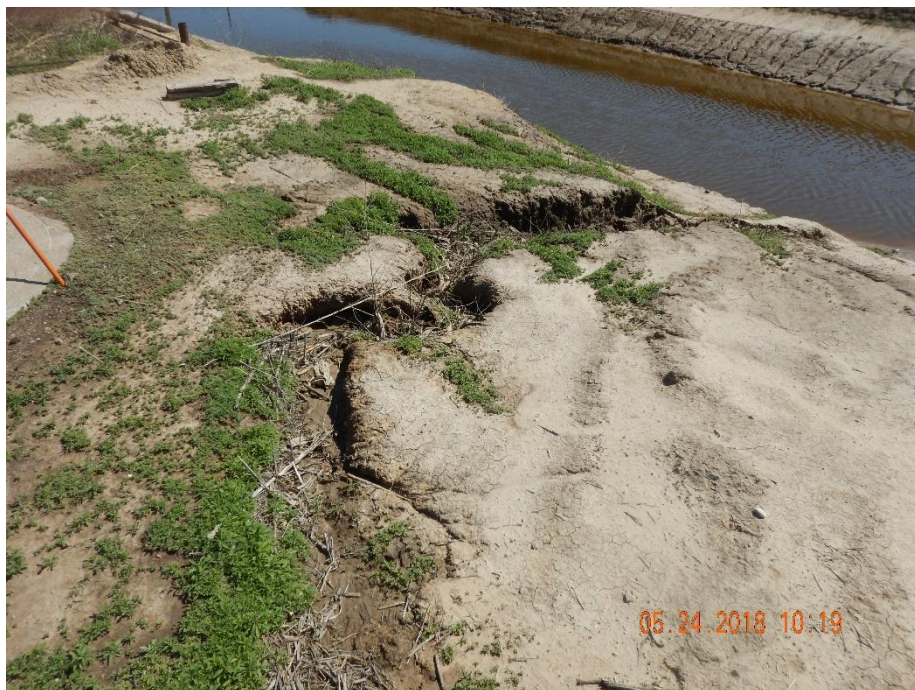
Photo 31: Photo taken from the western edge of the central pit. Photo show gully formation due to stormwater erosion.

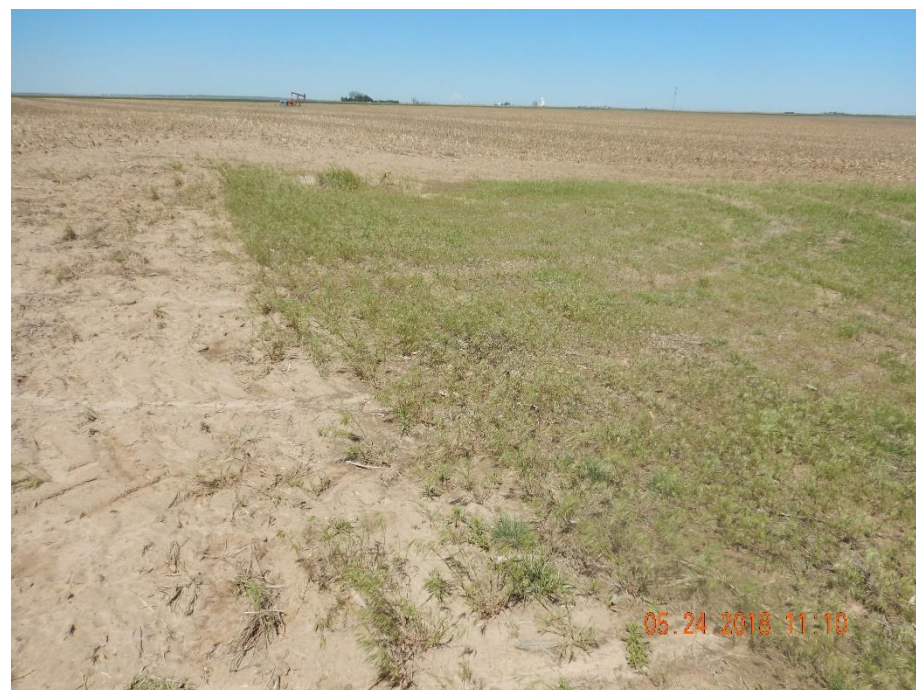
Photo 32: Photo taken from the south end of the WELL location, facing west. Photos 32- 34 shows overview of the location from west, to north, to east. Vegetation seen on location is predominantly cheatgrass mixed with perennial grasses such as sand dropseed.

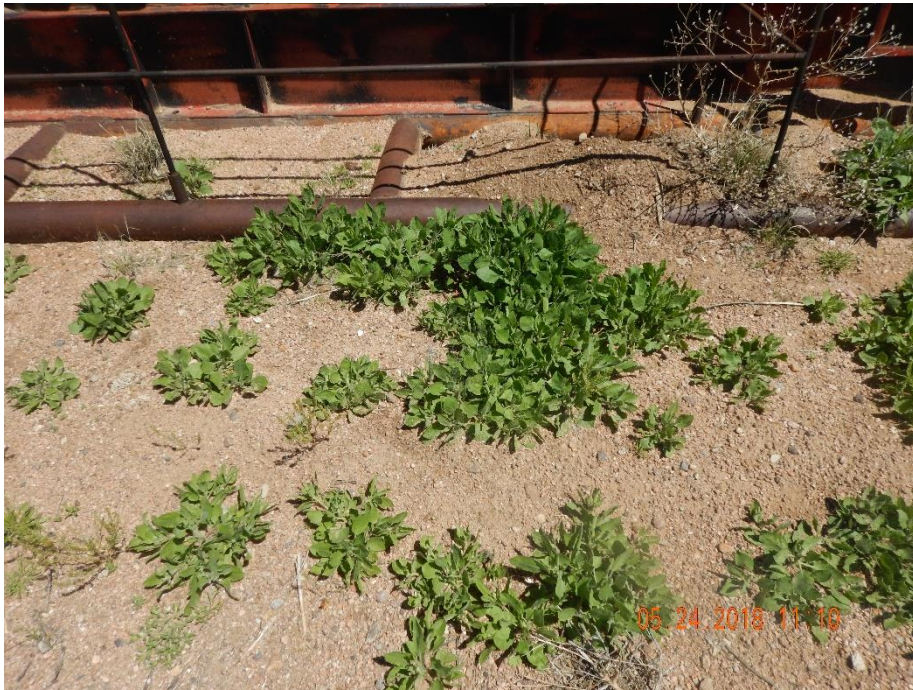
Photo 35: Photo taken at the well location. Photo shows vegetation growing at the well.

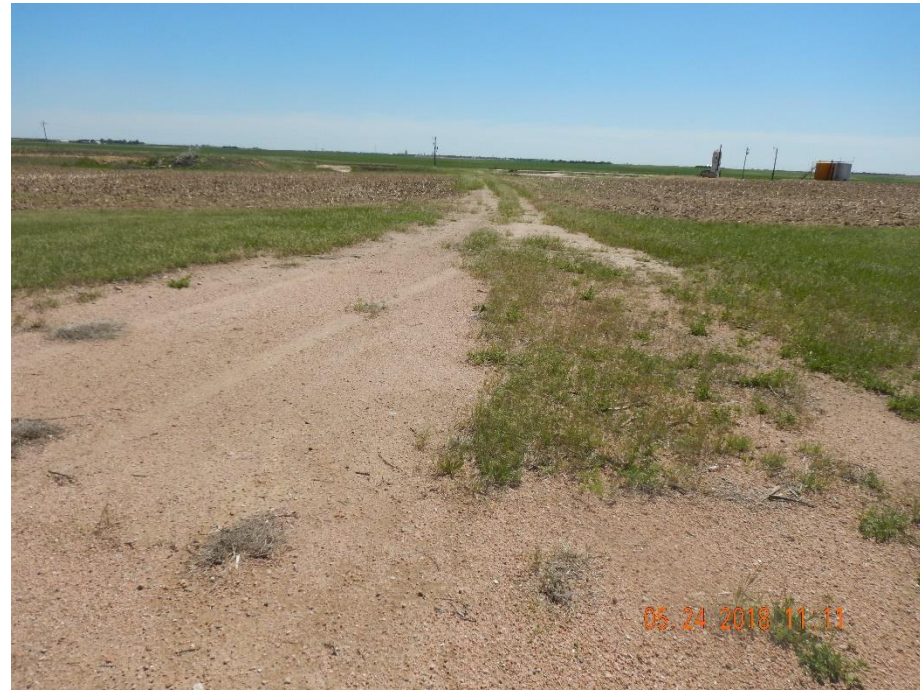
Photo 36: Photo taken from the east end of the location, facing east, photo shows access road. Road appears to be in good condition.
