Inspection Photos

Operator: CM PRODUCTION LLC - 10352

Location ID: 317120

Inspection Doc. Number: 682503375

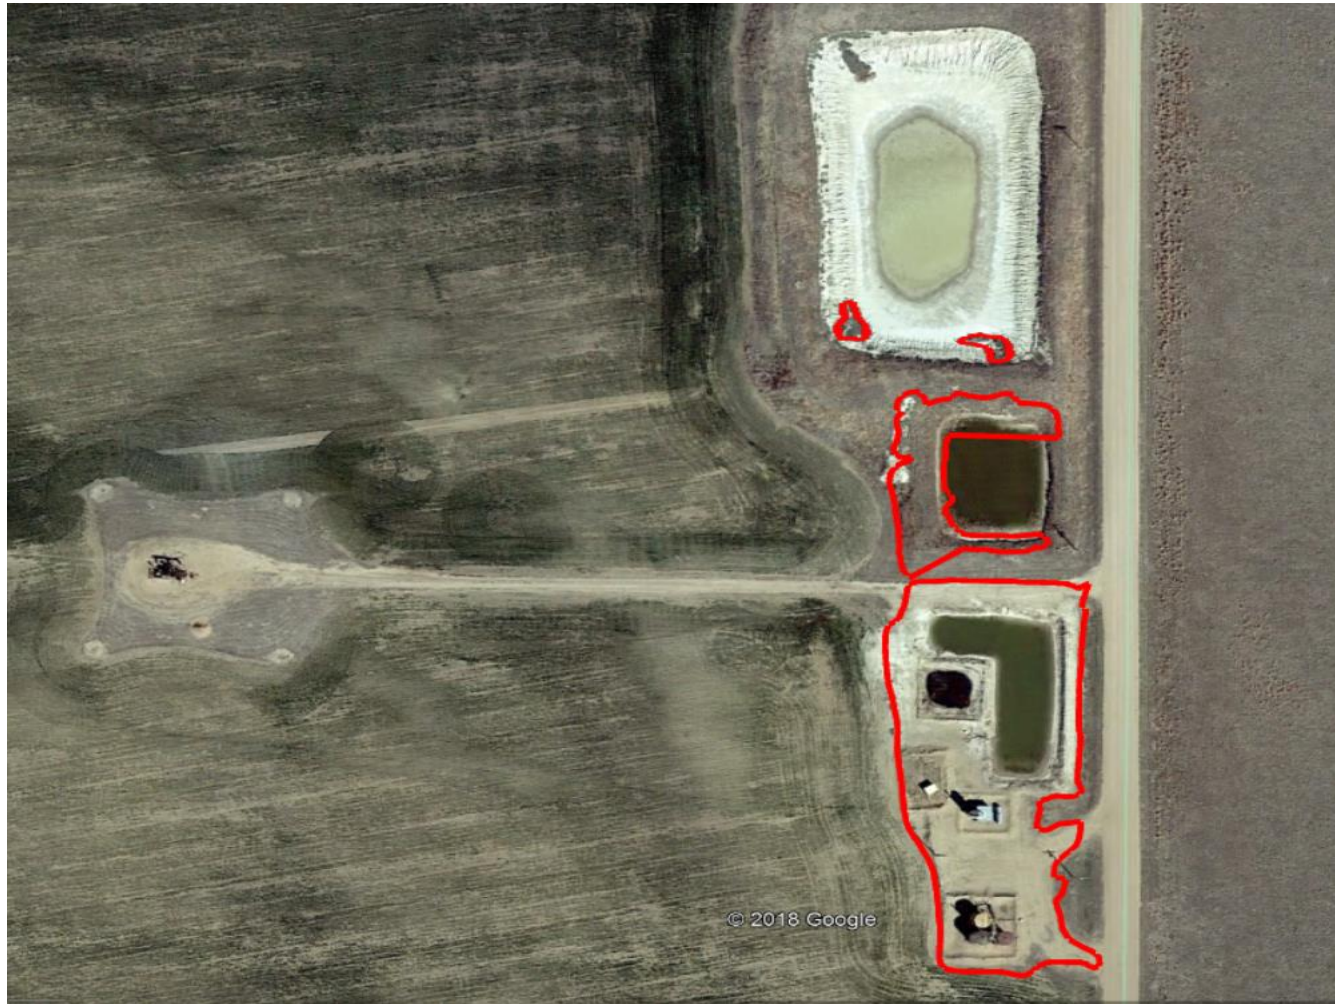
Photo 37: Aerial imagery showing the tank battery and pit facilities, as well as the well location. Areas outline in red show portions of the location where higher densities of undesirable weedy plant species such as kochia was documented. Areas are, conservatively, 1 acre in size.
