Final Reclamation and Stormwater Inspection

Operator: KERR MCGEE OIL & GAS # 47120

Location ID: 317593

Weld County, CO

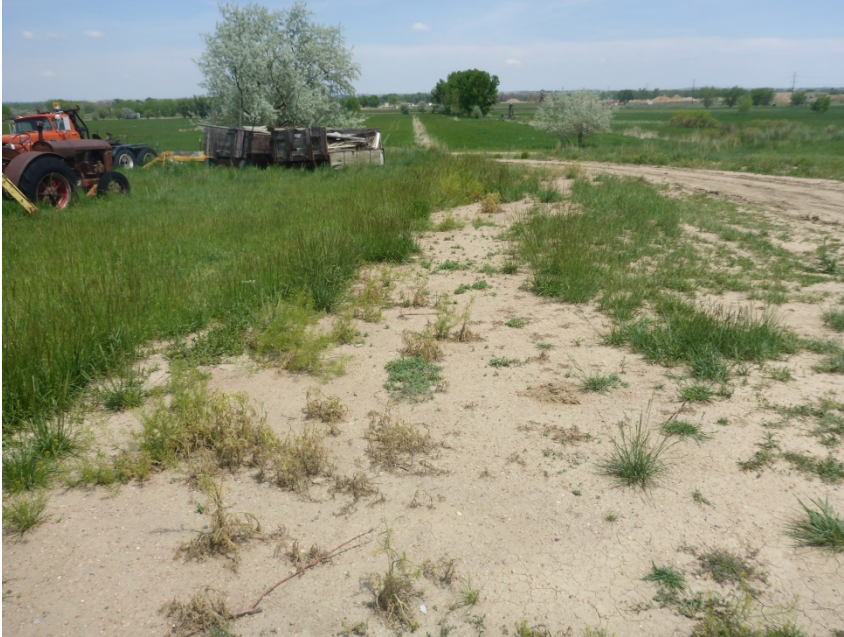
Photo 1. Photo taken from the well location looking towards the facility, facing East. Appears the Operator has not performed any reclamation activities on the well location itself but has on the facility.

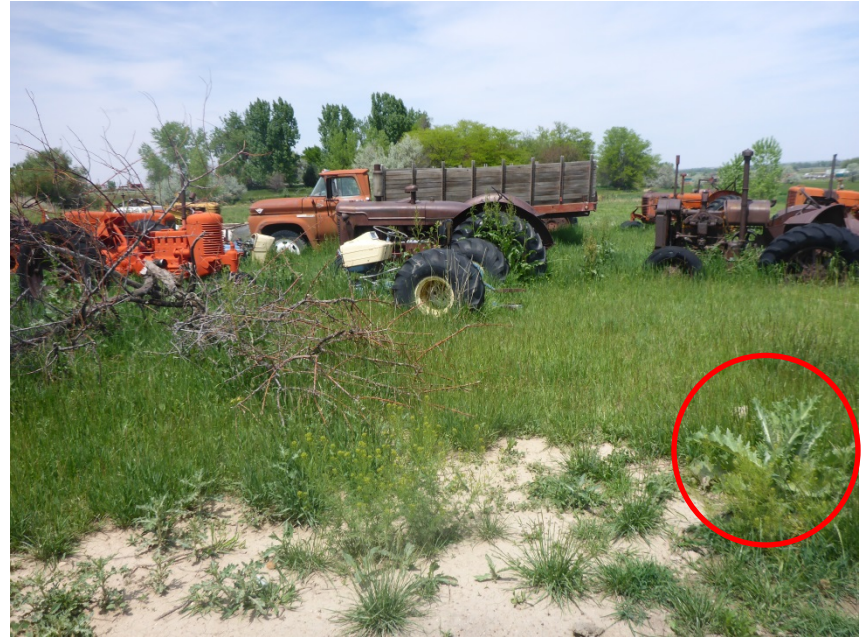
Photo 2. Photo taken from the well location, facing North. A List B Colorado Noxious weed species, musk thistle (*Carduus nutans*), is found at low densities throughout the site .

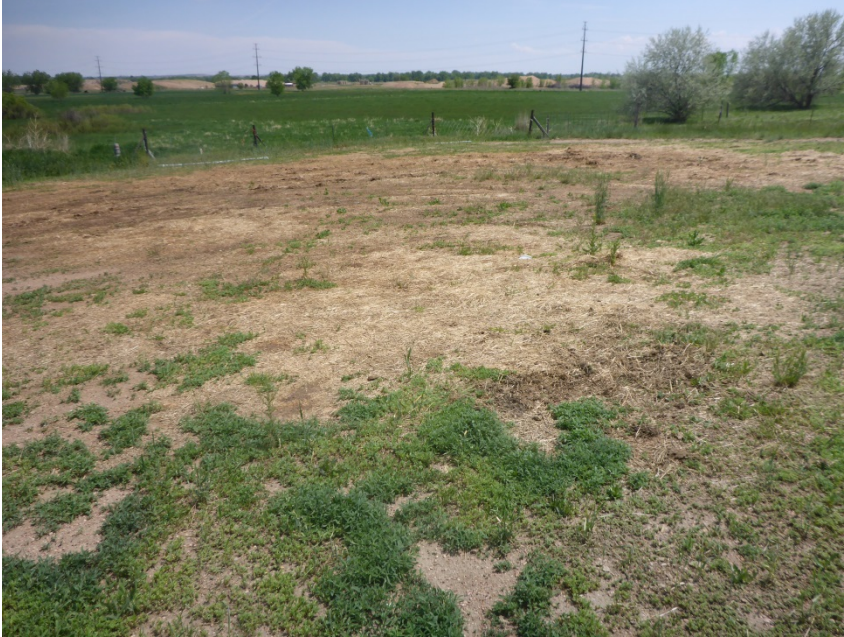
Photo 3. Photo taken from the facility, facing South. Appears the Operator has performed final reclamation activities, with the evidence of drilling rows and straw crimped mulch. However, the majority of the site is covered in weedy, annual vegetation which includes but not limited to field bindweed and kochia, with little perennial grass cover establishment. A List B Colorado Noxious weed species, musk thistle (*Carduus nutans*), is found at low densities throughout the site .

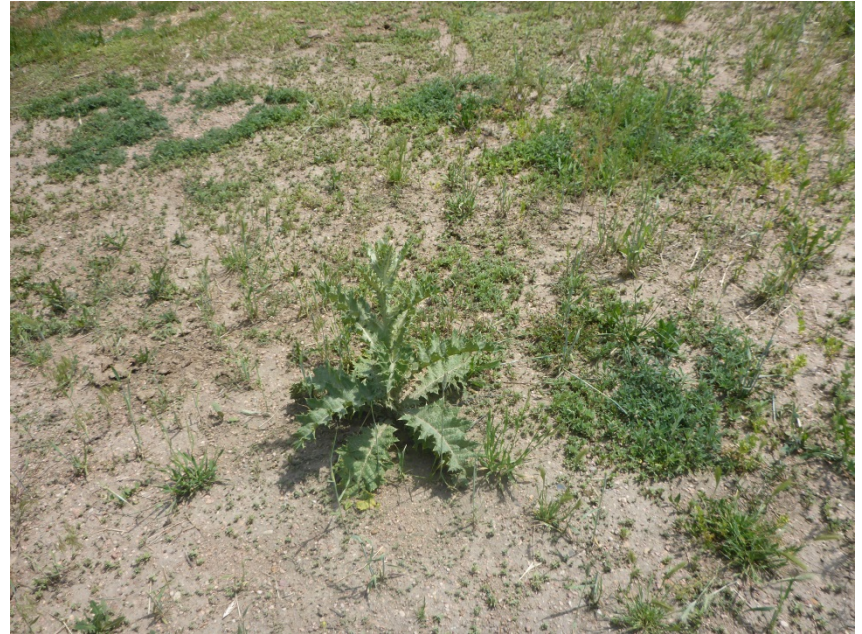
Photo 4. Photo taken within facility area. Note the musk thistle and kochia. See comments from Photo 3.

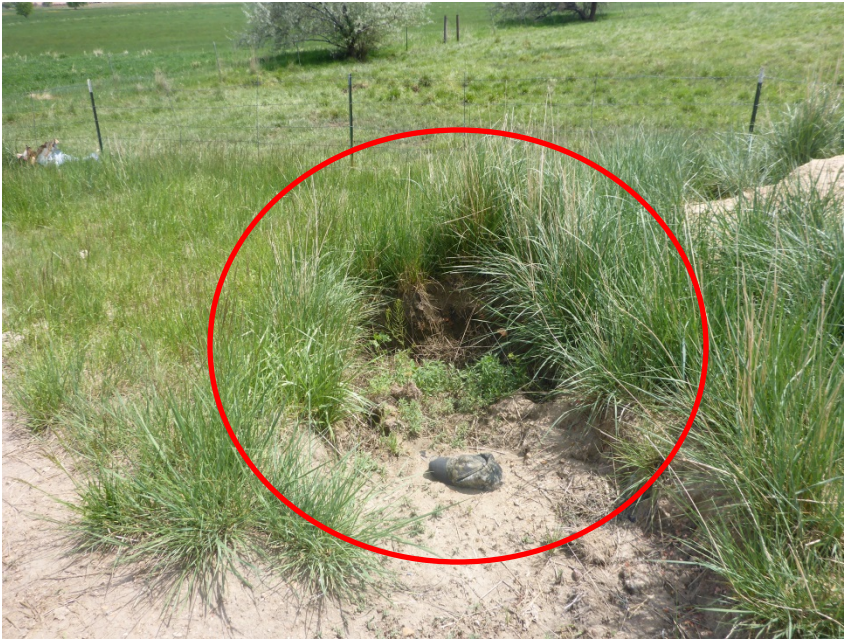
Photo 5. Photo taken from the South end of the facility. The bucket hole needs to be re-contoured and re-seeded.

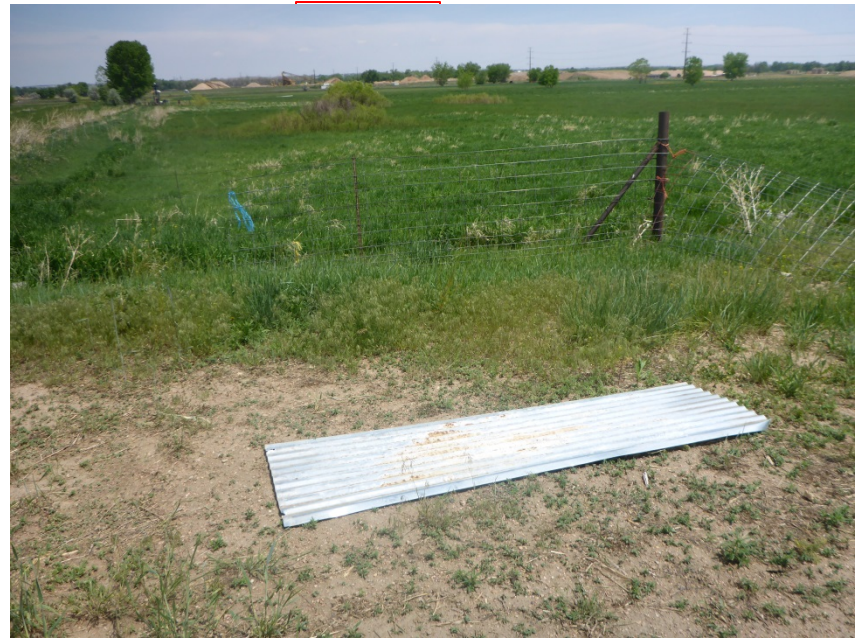
Photo 6. Photo taken from the Southeast end of the facility. Debris removal needed.

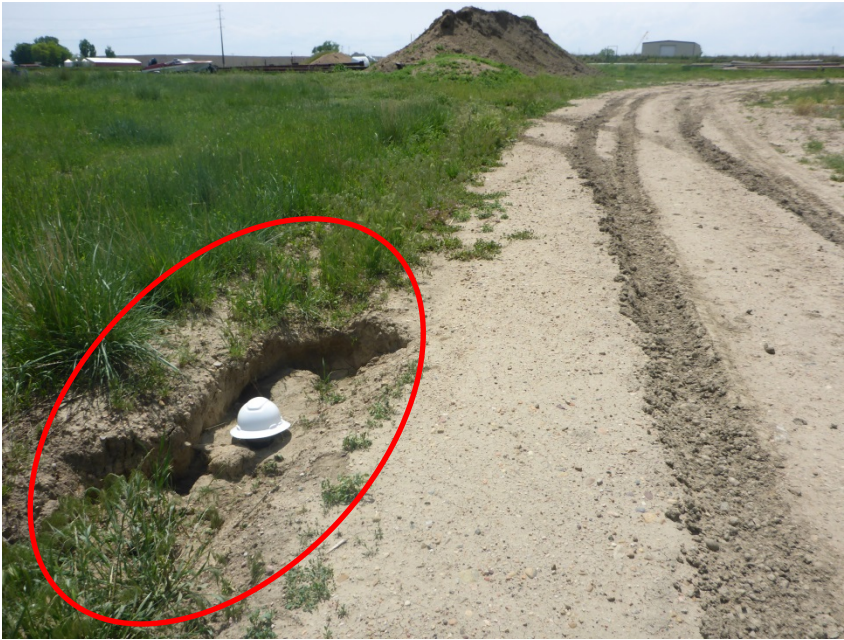
Photo 7. Photo taken from the South end of the access road between the well and the facility, facing West. Appears stormwater runoff is causing rill erosion along the remaining access road between the well and the facility.

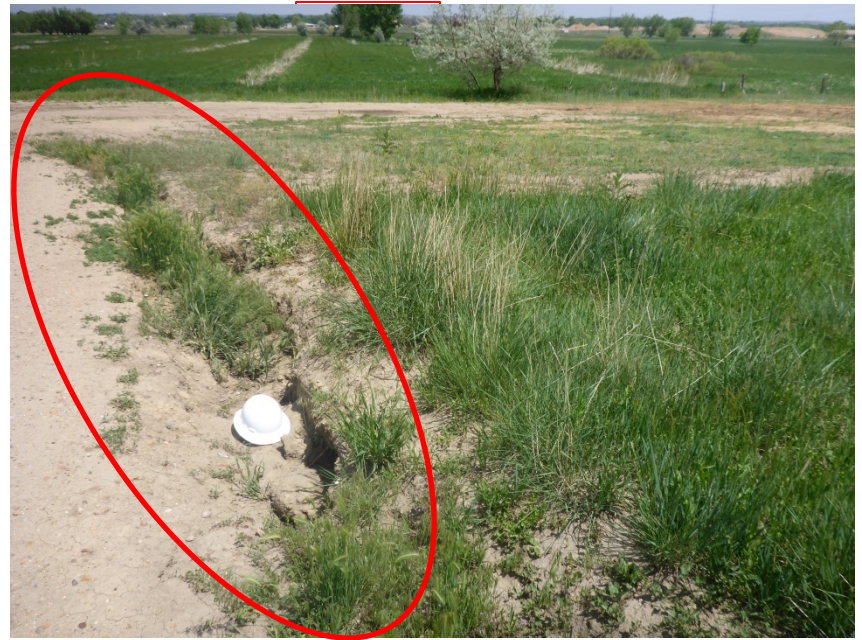
Photo 8. Photo taken from the South end of the access road between the well and the facility, facing West. See comment from Photo 7.
