Inspection Photos

Location Name: Sandy Hill Land Application Site, Facility: 448950

Inspection Date: 05/24/2018

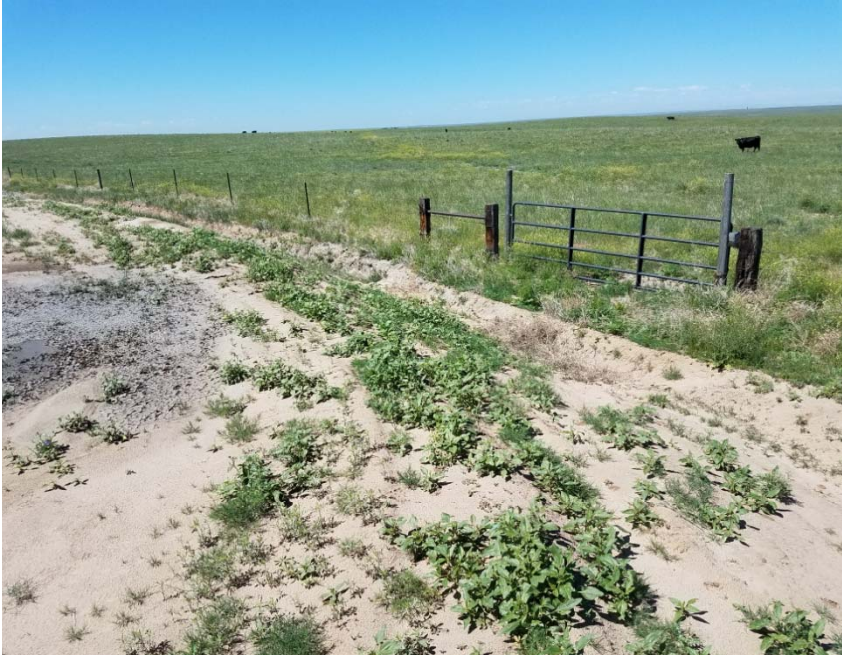
Photo 1 – Northwest corner of land application area, looking at gate onto State Landboard property.

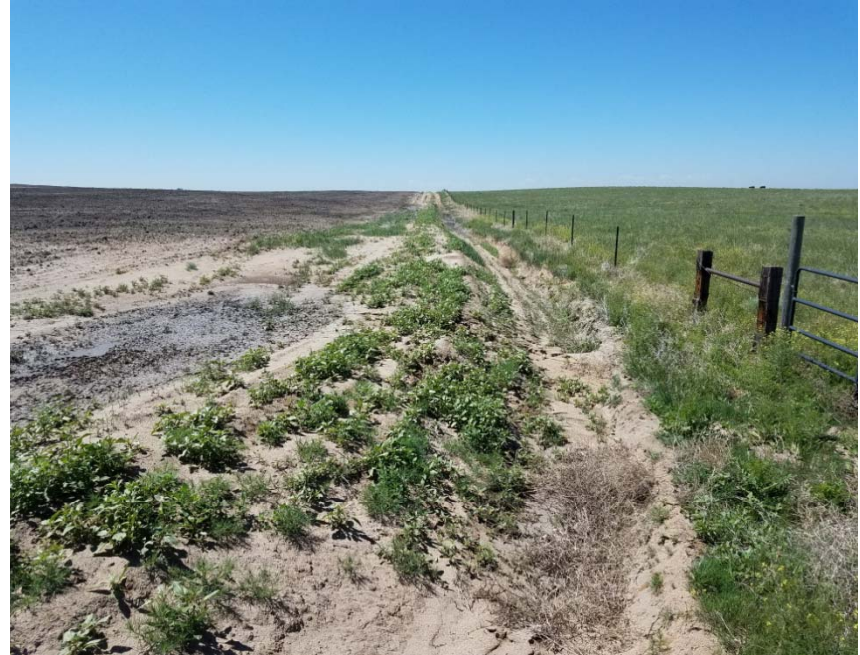
Photo 2 – From northwest corner of land application area, looking south along berm and ditch at western fenceline.

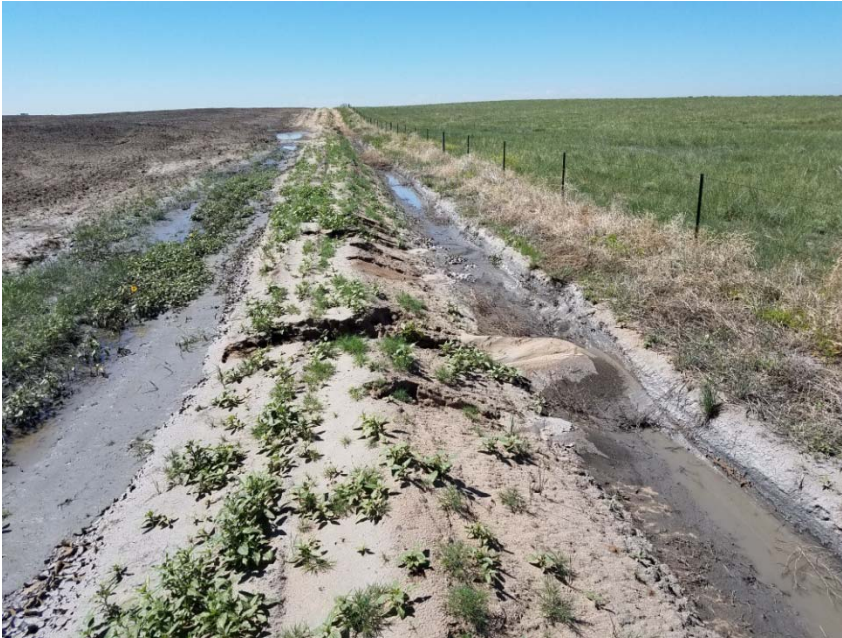
Photo 3 – Failure of berm, runoff contained in ditch on western boundary of land application area

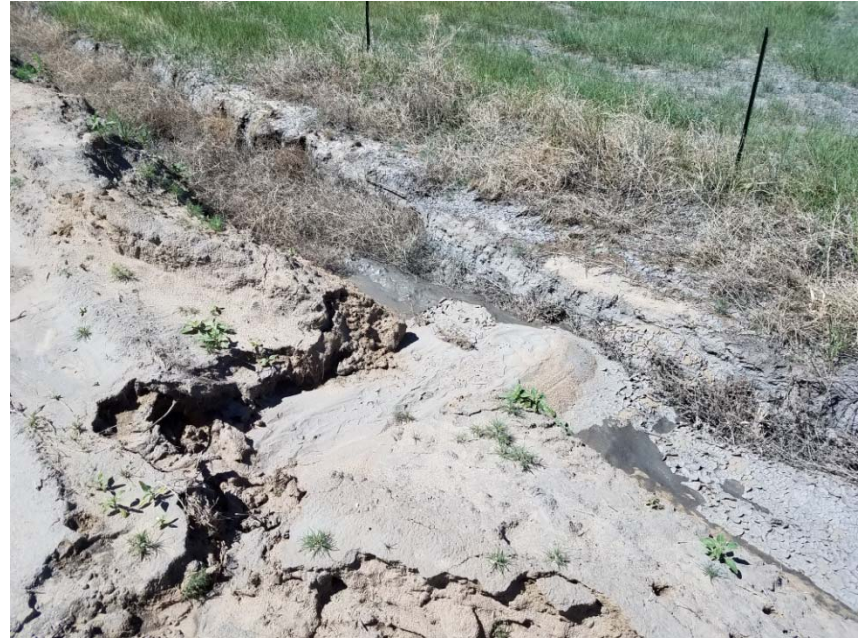
Photo 4 - Failure of berm, runoff contained in ditch on western boundary of land application area

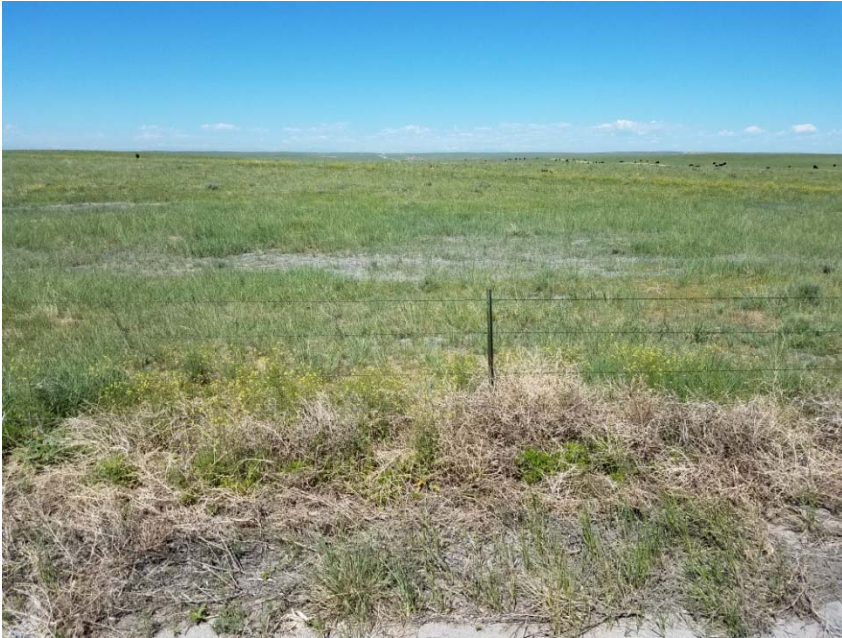
Photo 5 – Looking west onto State Landboard property at area of spill ID 452946

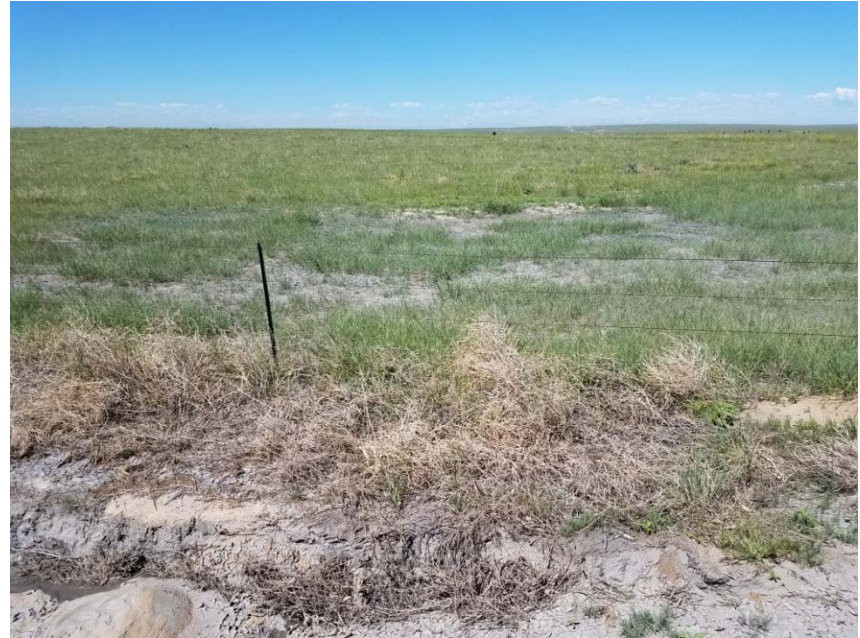
Photo 6 - Looking west onto State Landboard property at area of spill ID 452946

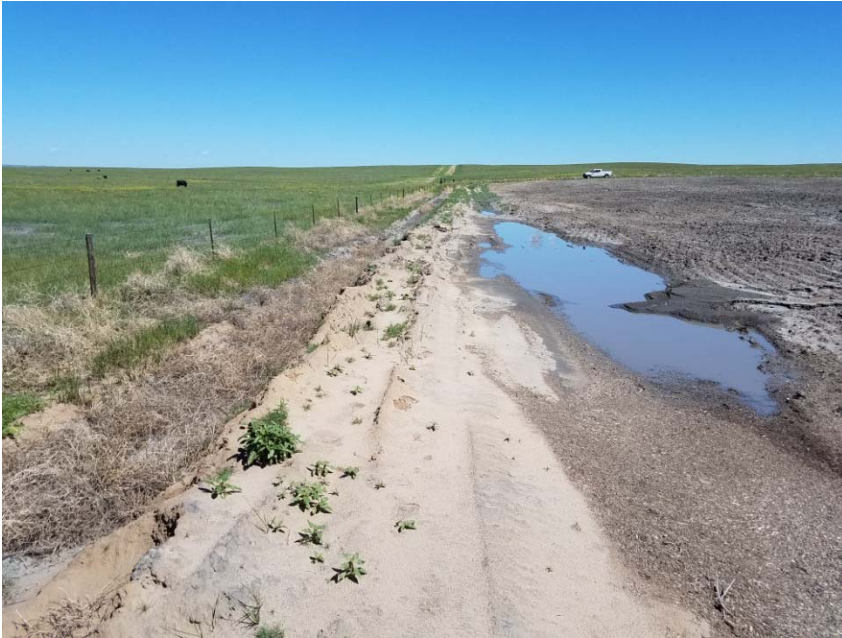
Photo 7 – From center-west edge of land application area looking north along berm and ditch on western property line.

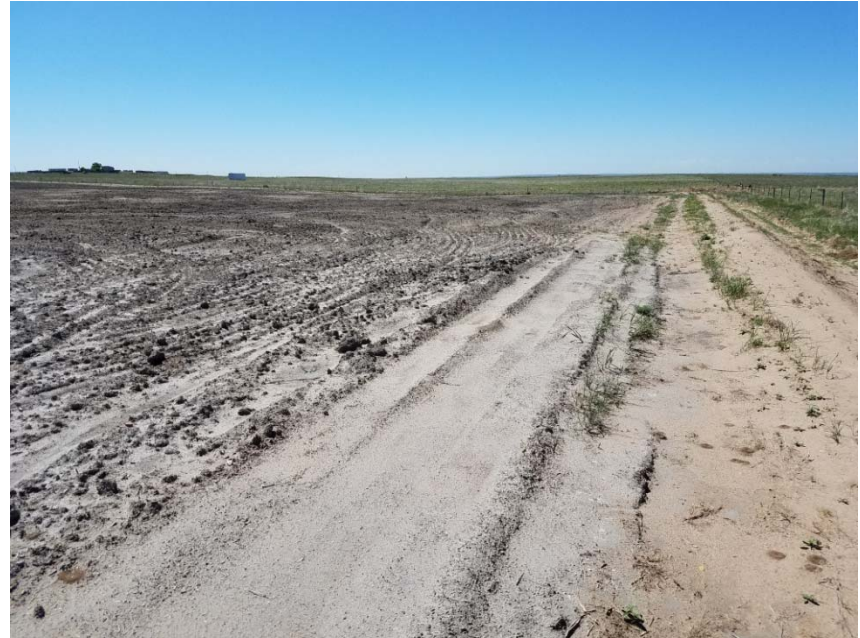
Photo 8 – From center-west edge of land application area looking south along berm and ditch on western property line.

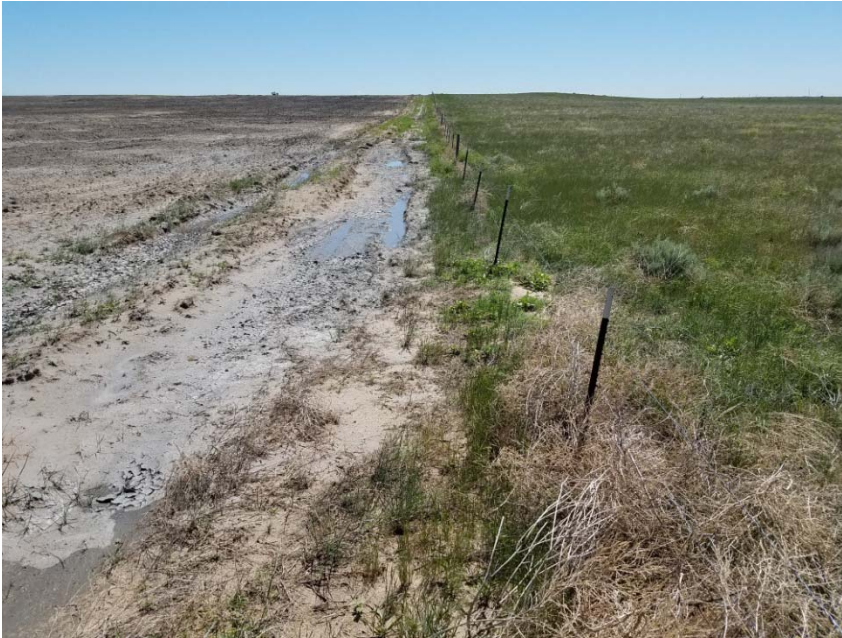
Photo 9 – From southwest corner of land application area looking east along southern property line. Winick property (Spill 454016) is to the right of fence.

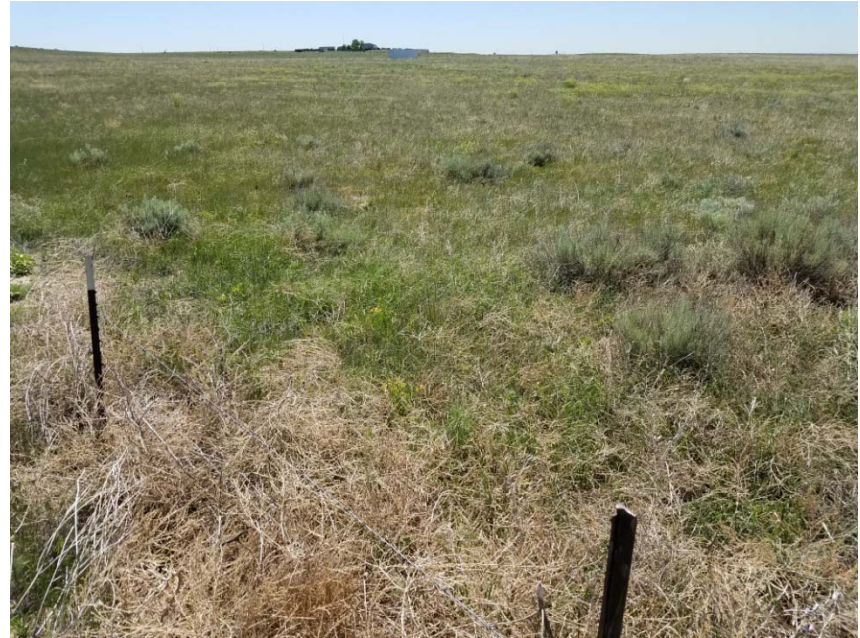
Photo 10 - From southwest corner of land application area looking southeast across southern property line. Viewing Winick property (Spill 454016) on far side of the fence.

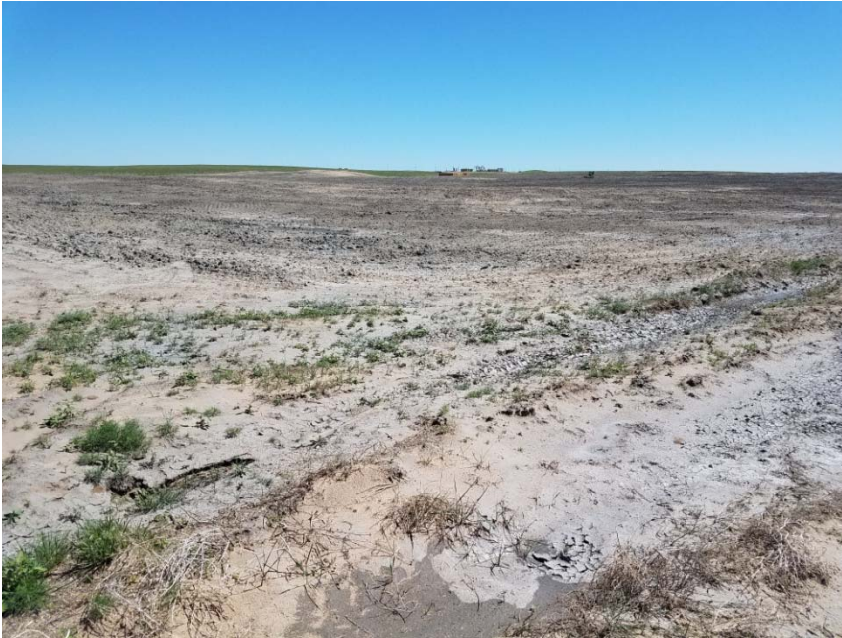
Photo 11 – From southwest corner of land application area looking northeast.

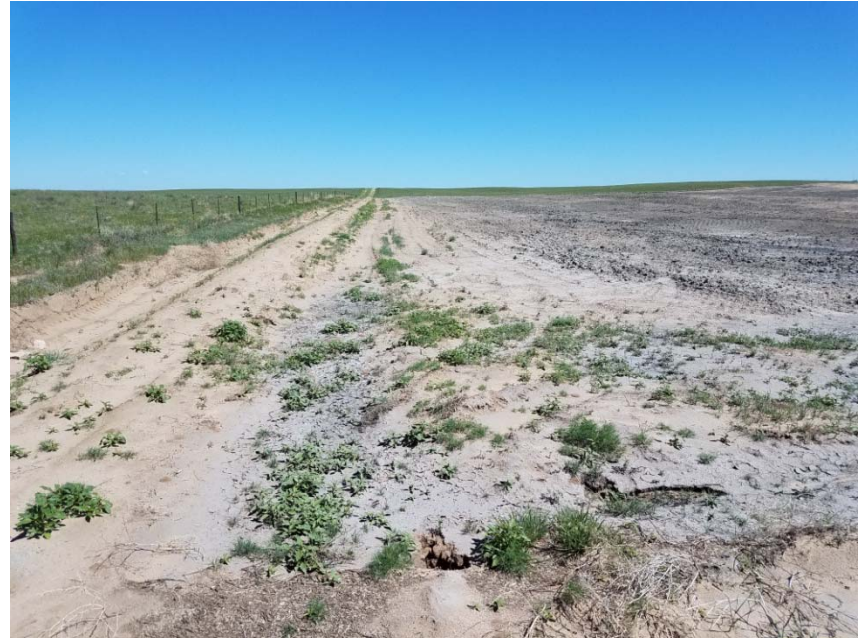
Photo 12 - From southwest corner of land application area looking north along western property line.

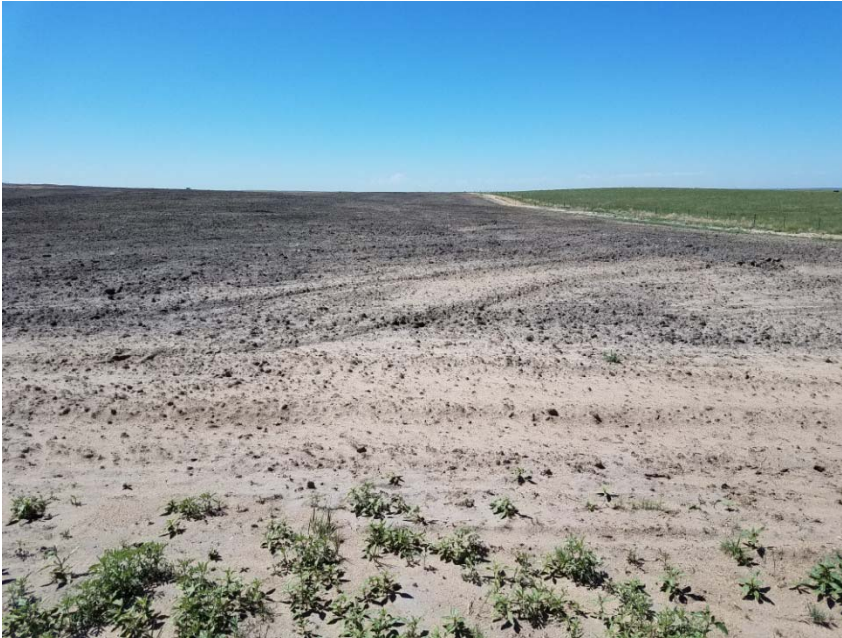
Photo 13 – From northwest corner of land application area, looking south.

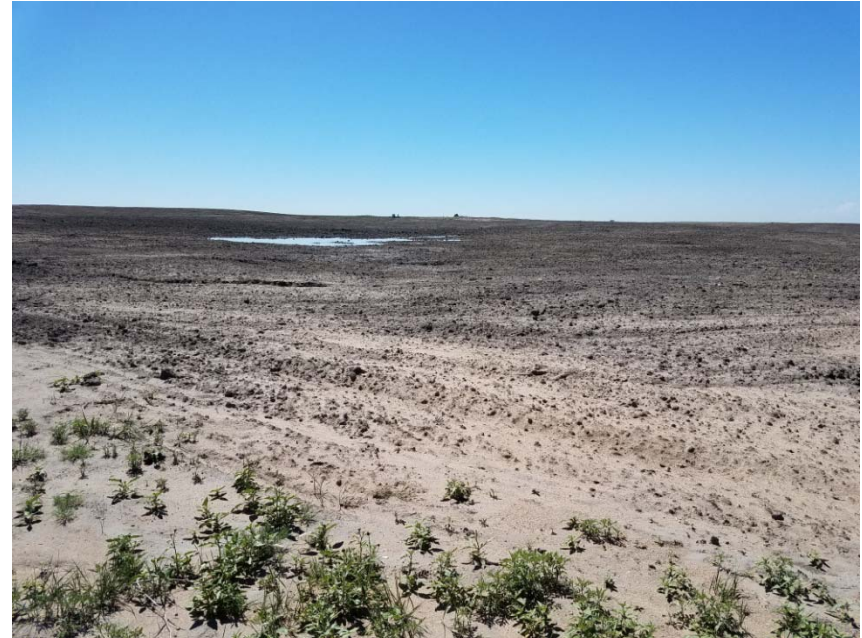
Photo 14 – From northwest corner of land application area, looking southeast.

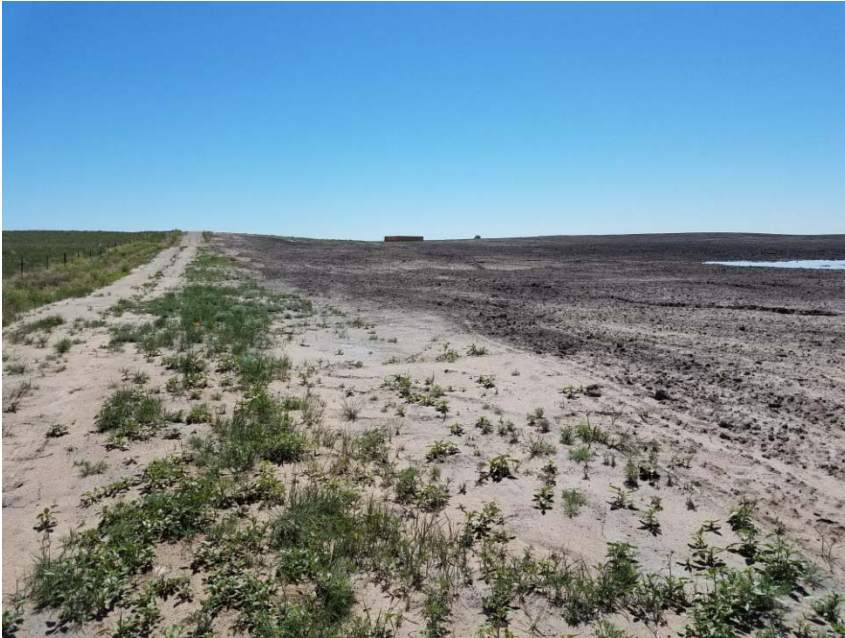
Photo 15 – From northwest corner of land application area, looking east.
