Inspection Photos

Location Name: **Fee 53AX**

API – 05-103-08612

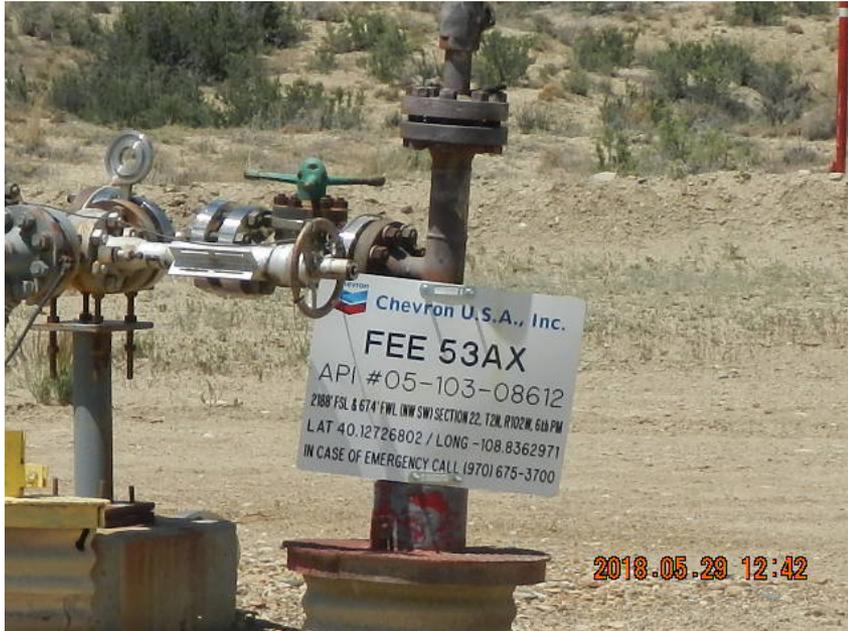
Battery sign
