SHELL 697-34-14B
Api# 05-045-17584
Inspection # 689701392

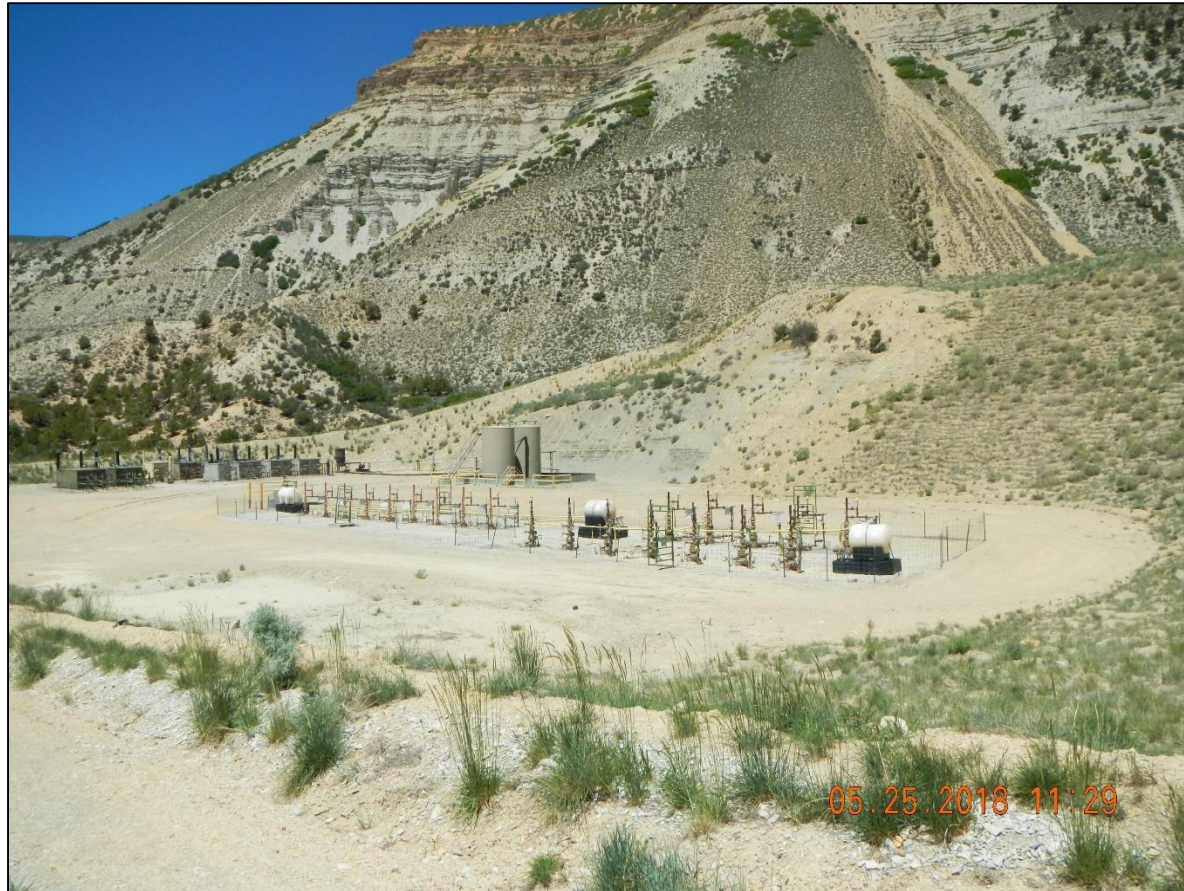
Wellsite photo

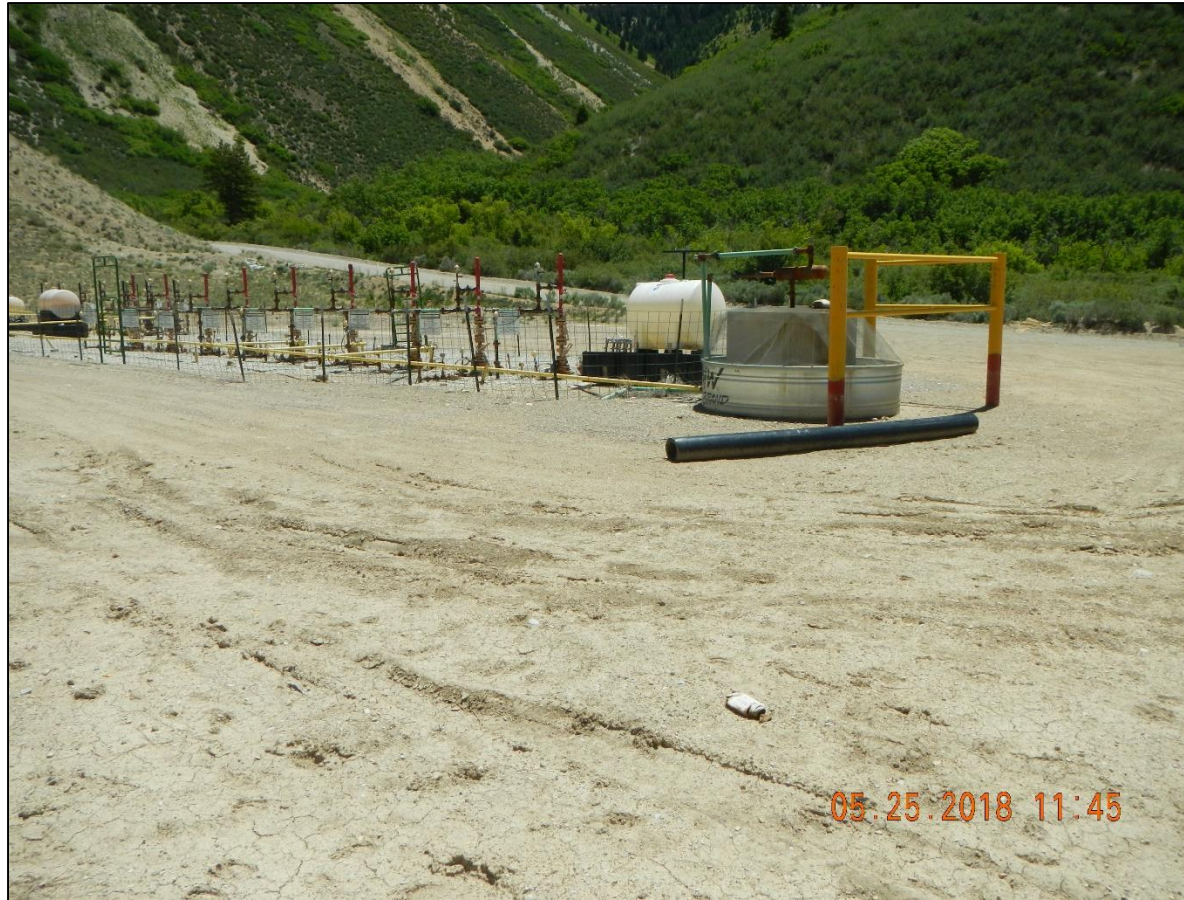
Unused equipment. Polypipe.

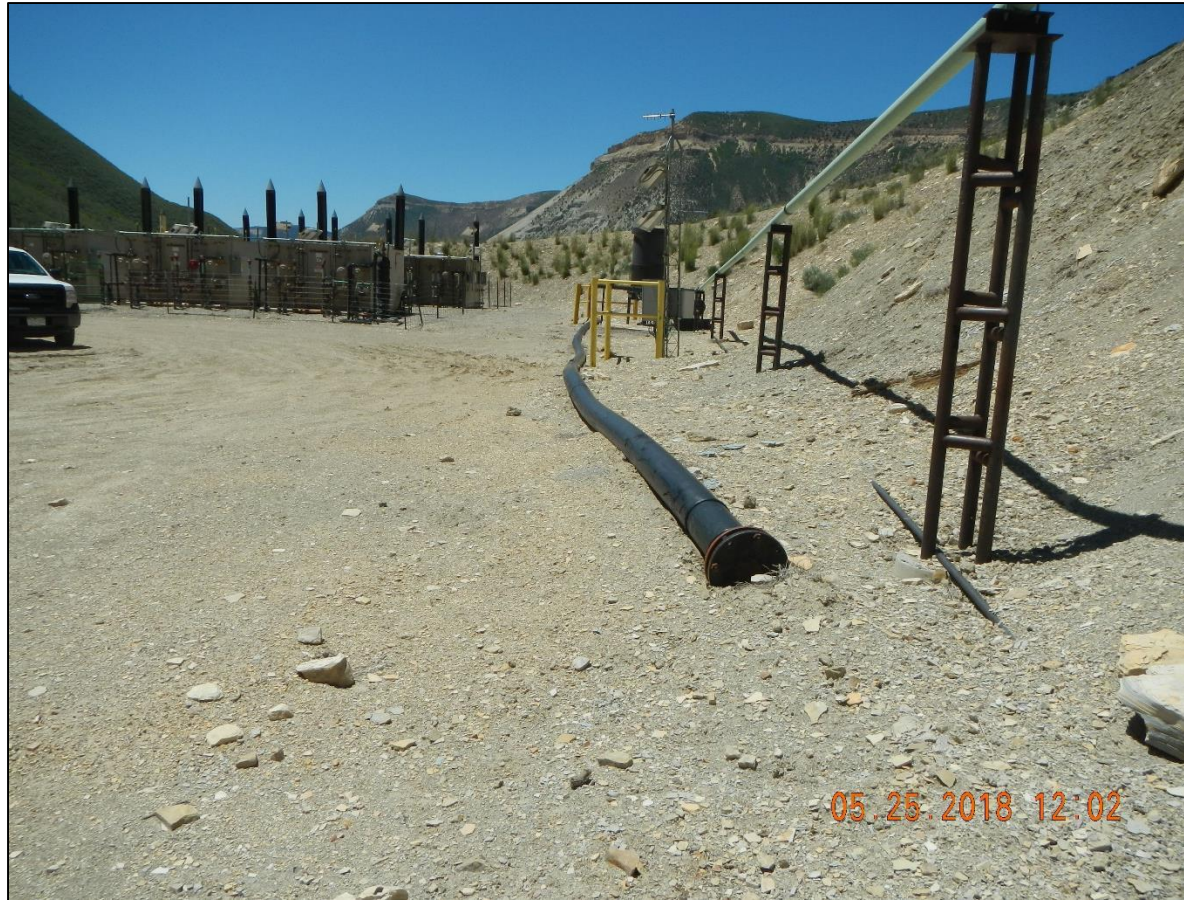
Unused equipment. Out of service poly pipe.

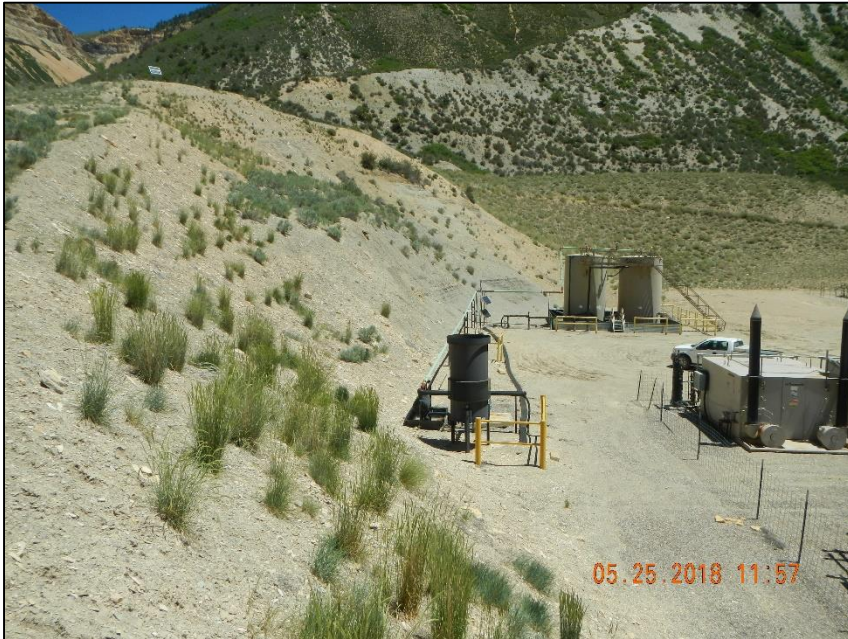
Unused equipment. Out of service poly pipe.

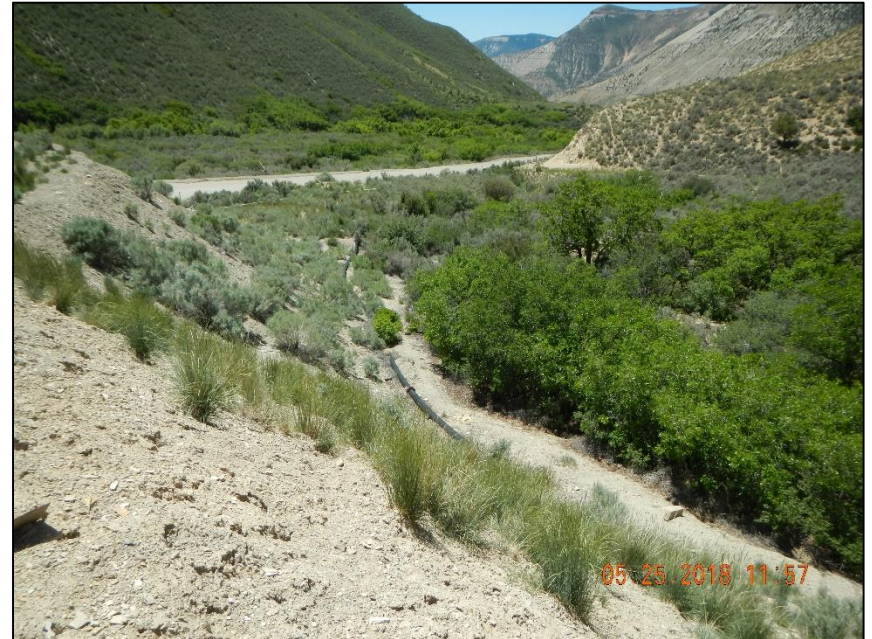
Unused equipment. Out of service poly pipe.

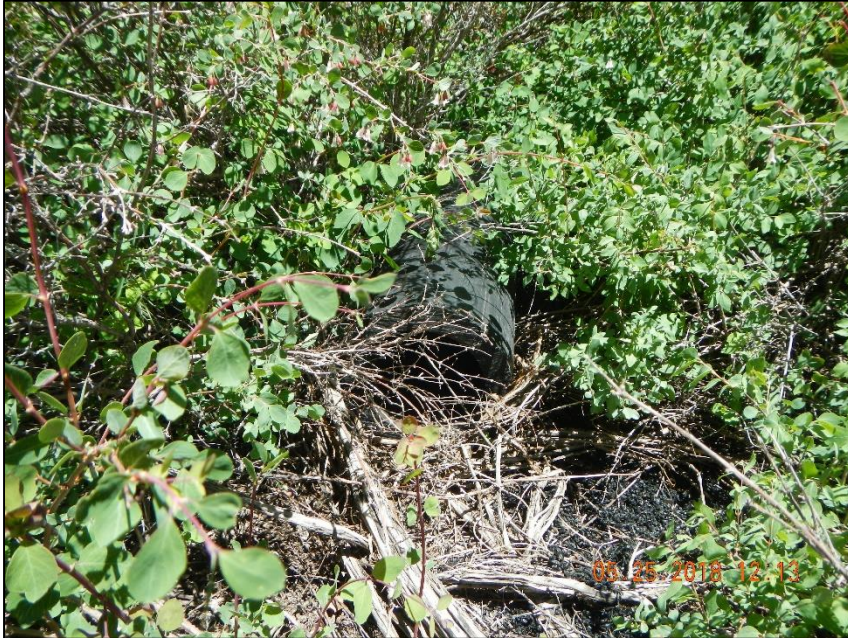
Unused equipment. Out of service poly pipe. Cut off pipe is open ended.

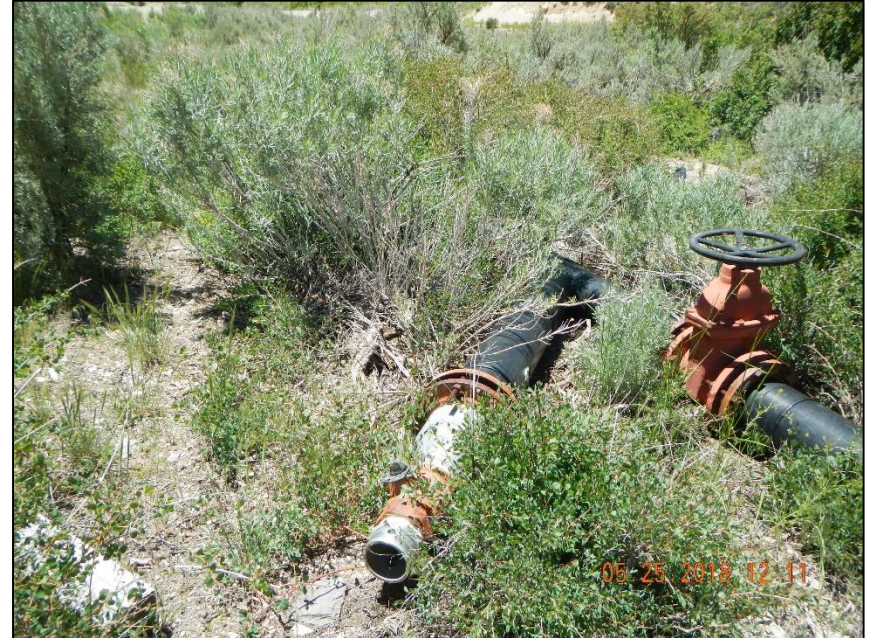
Unused equipment. Out of service poly pipe.

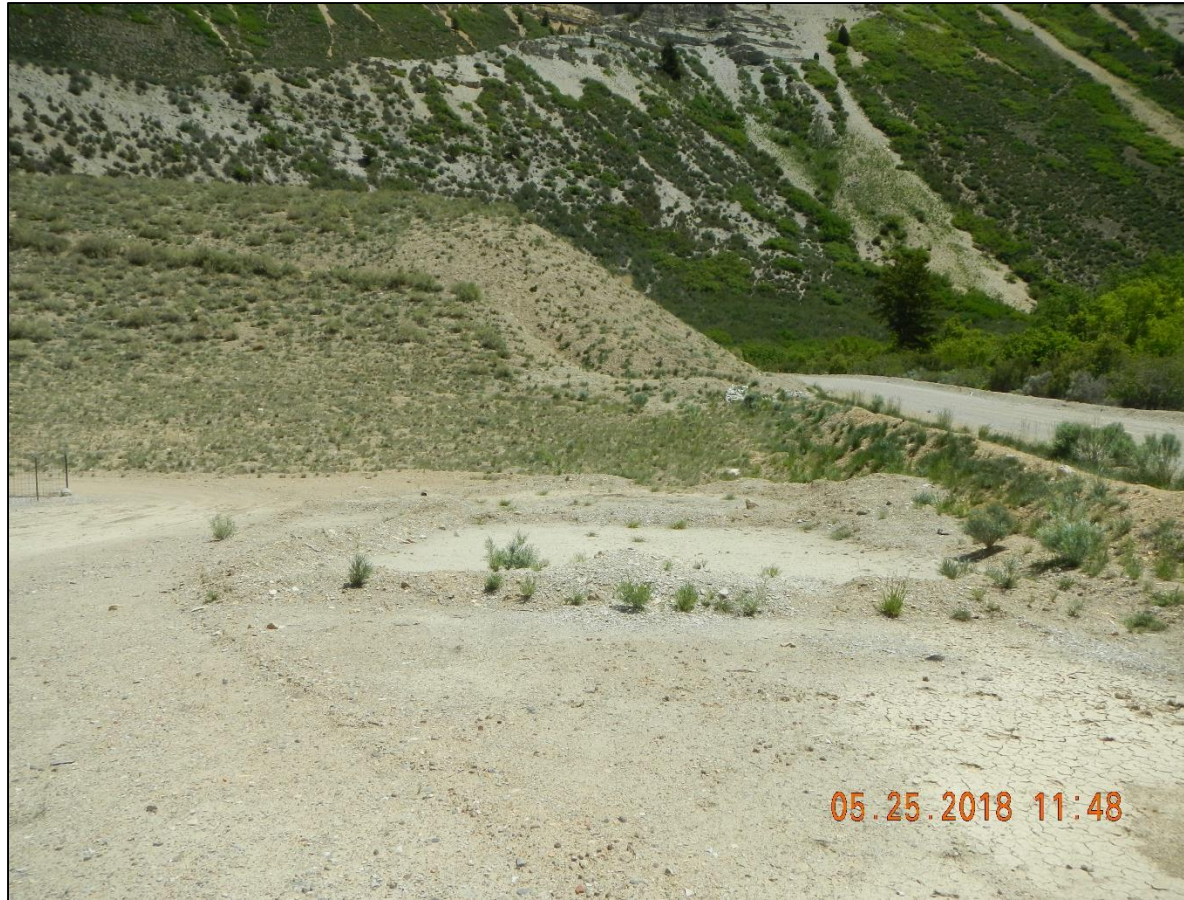
Unused dirt berm.

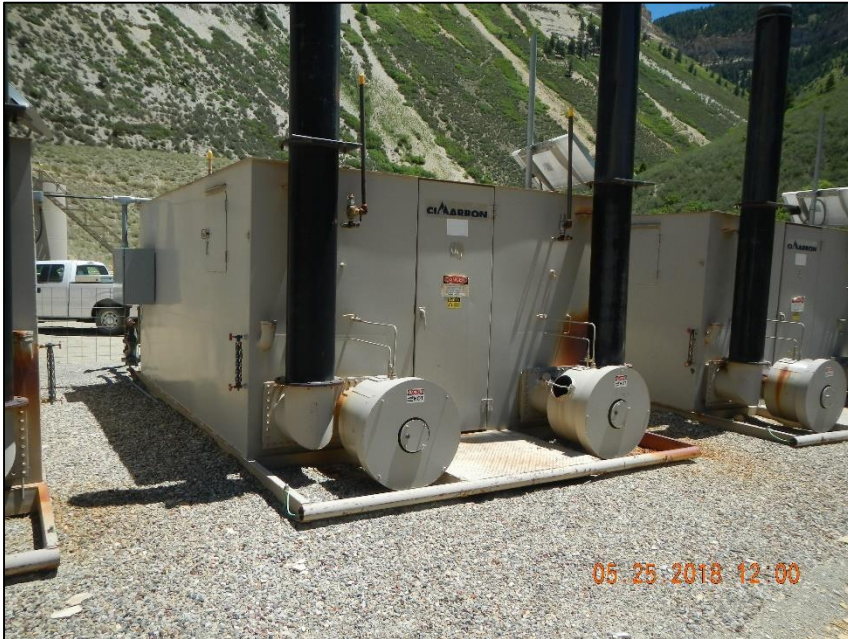
Cover missing from heat unit on separator.

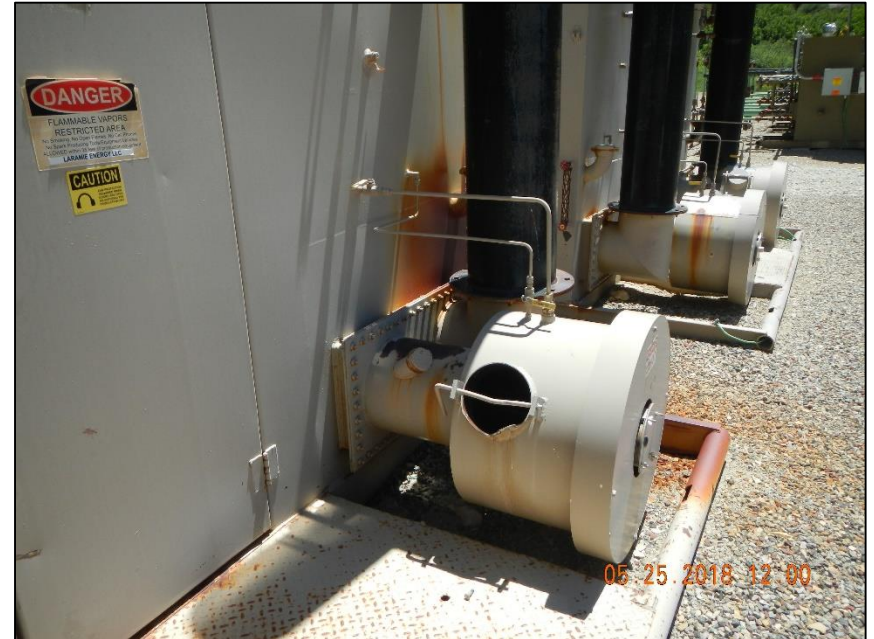
Cover missing from heat unit on separator.

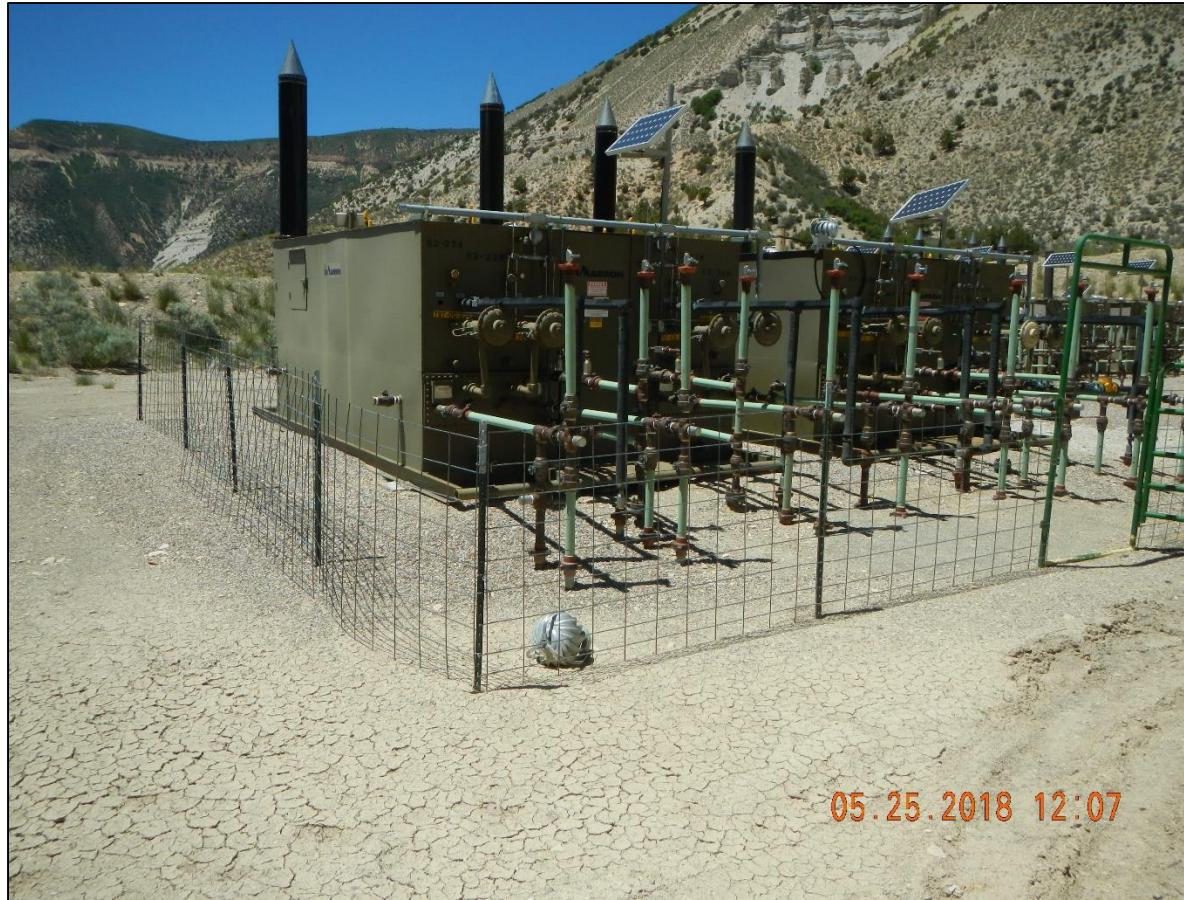
Vent turbine is off of separator unit.

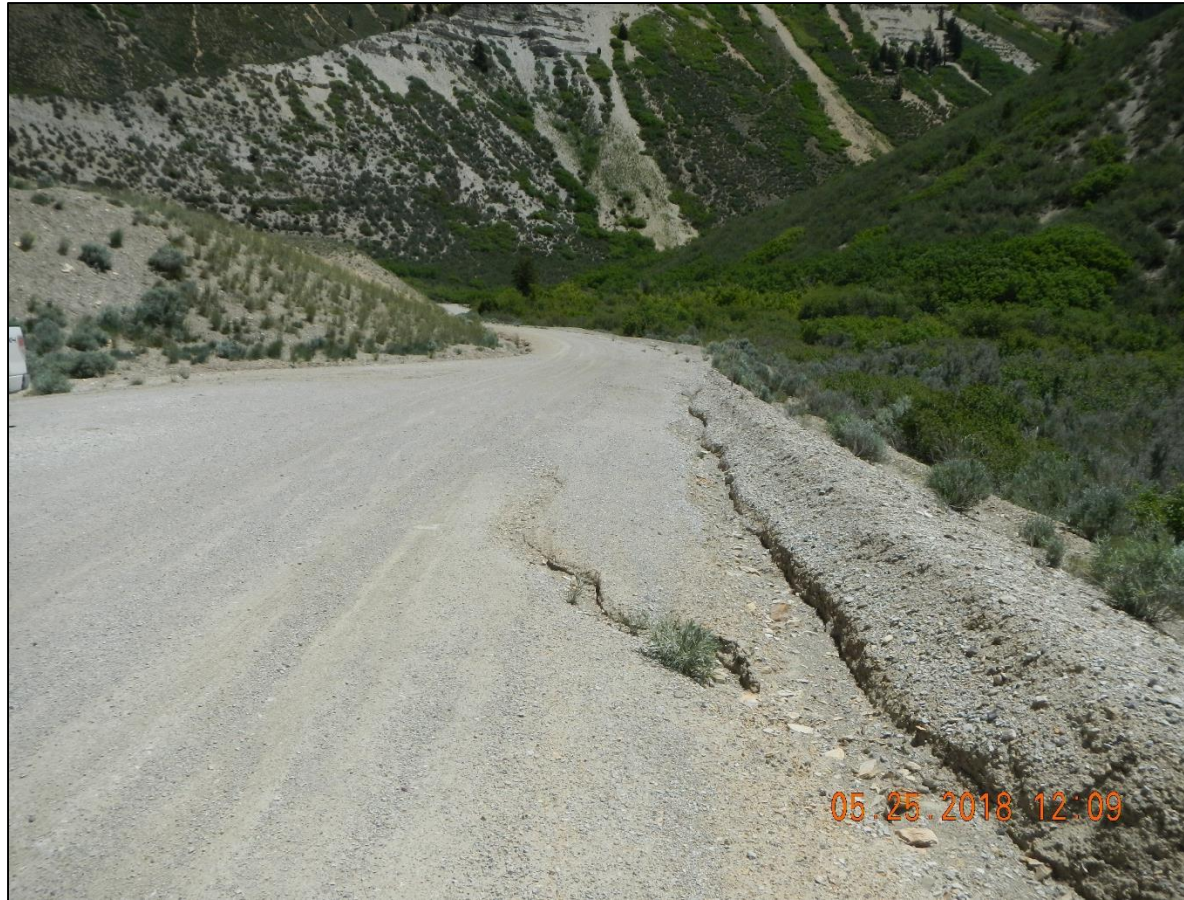
Erosion rill on lease road.

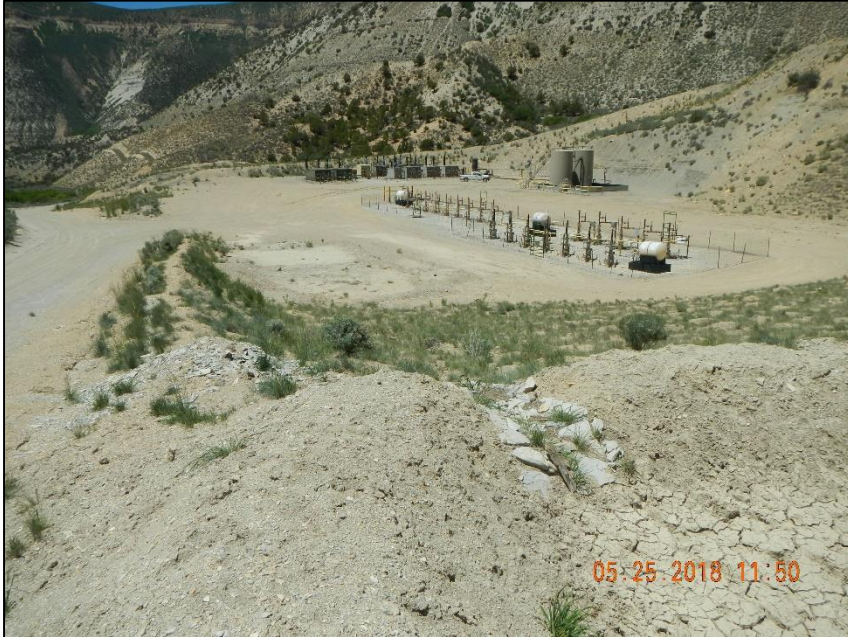
Check dam above location.

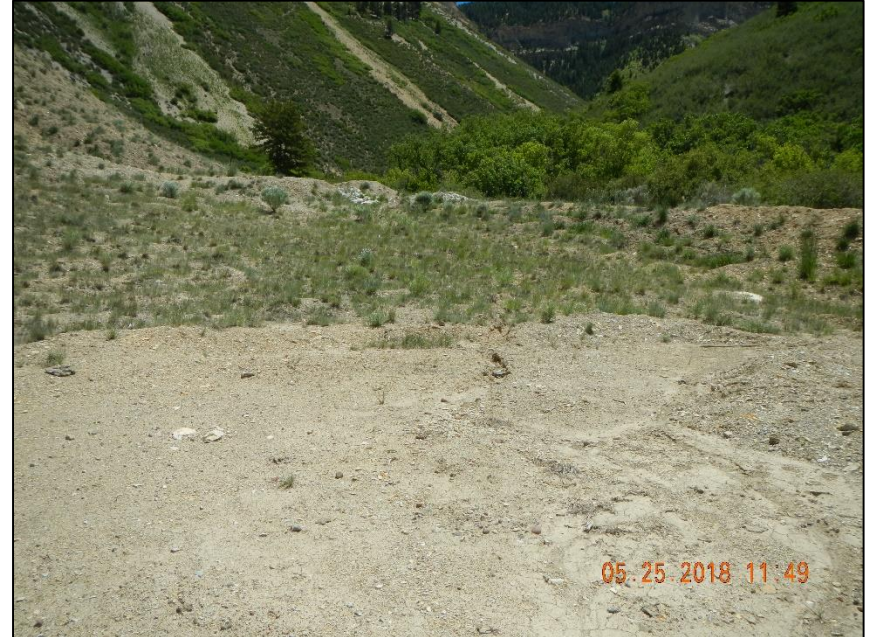
Erosion rill from check over flow.
