**Inspection Photo
Couey 32-5 (D32)
API # 045-07630
Inspection # 689301222**

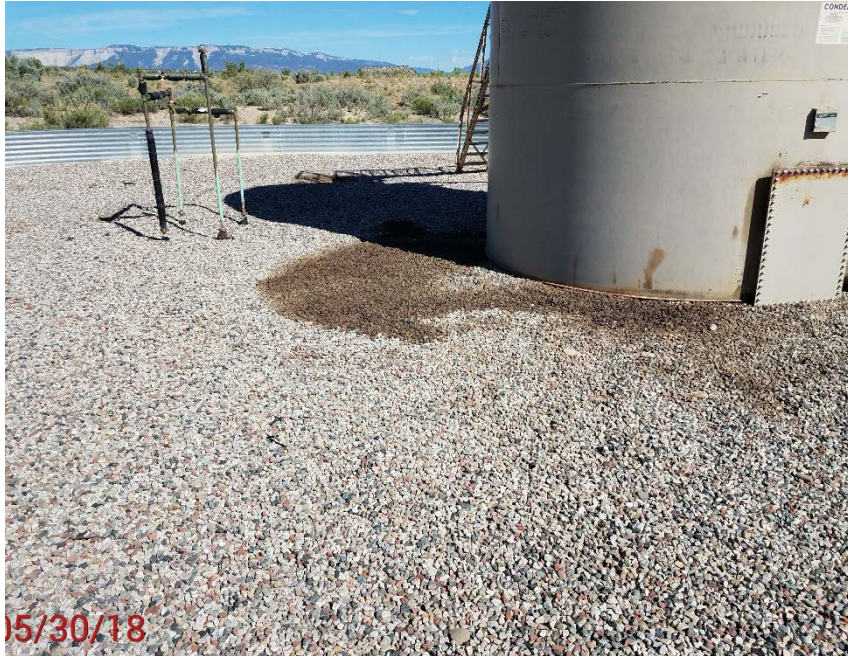
**Location Photo #1, stained rock inside tank
battery containment**
