# Inspection Photos

Variance Request for Multiple Pit Locations

Operator: Kinder Morgan CO2 Co.

MC8

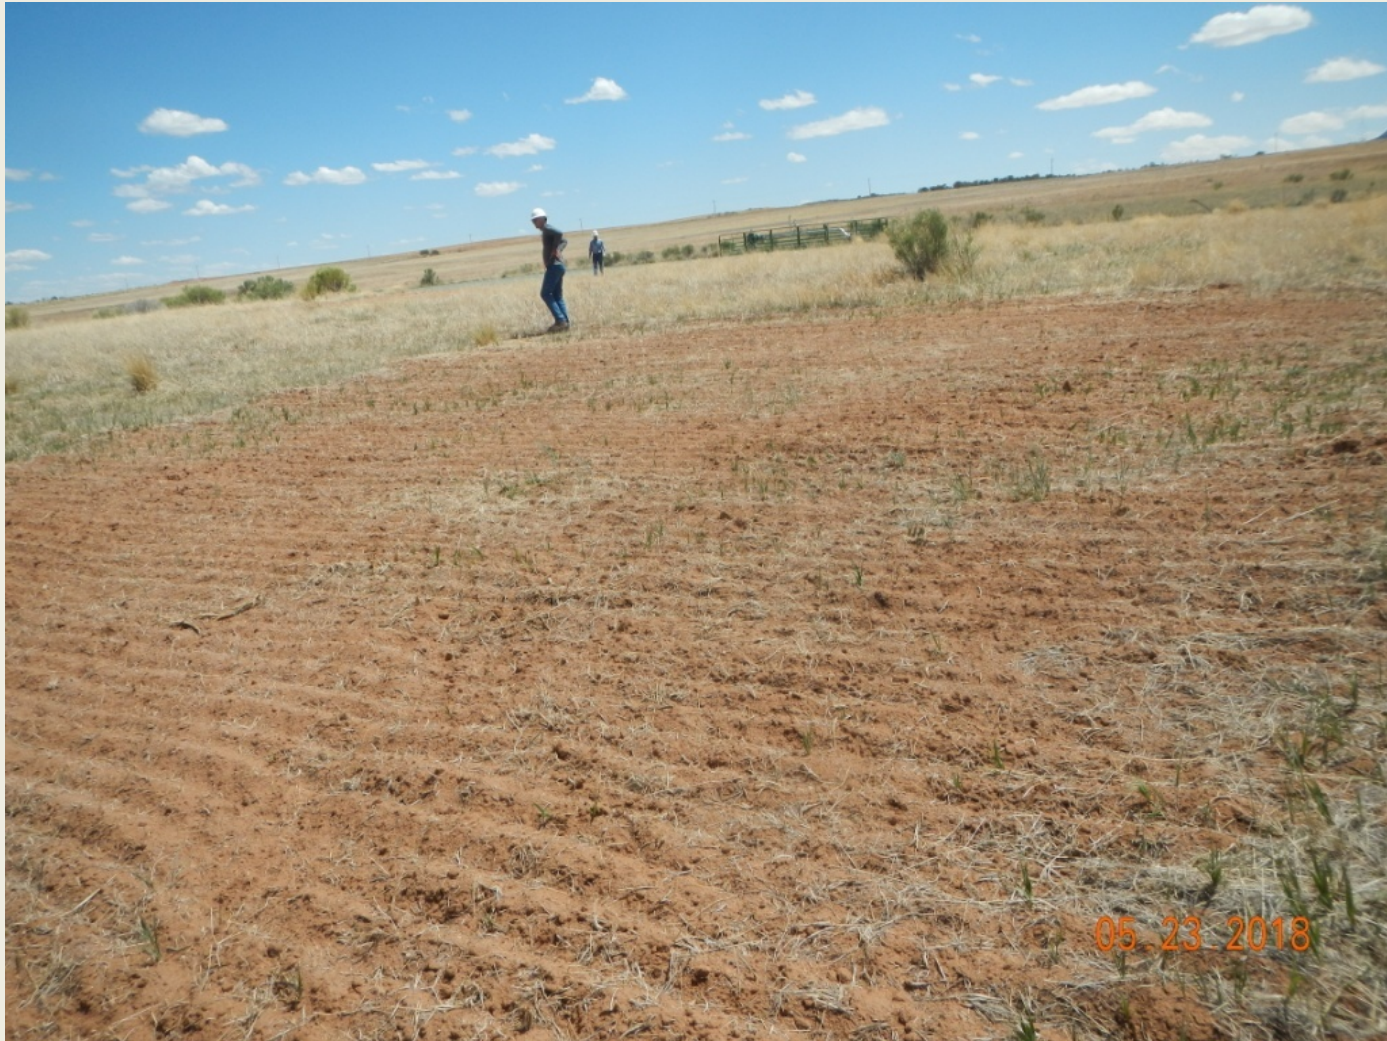
**Photo 1. View of former pit area from the northwestern portion facing toward the center of the well pad. Former pit area is north of the well pad. Area in foreground is gypsum treated. Revegetation is largely comprised of smooth brome (*Bromus inermis*).**

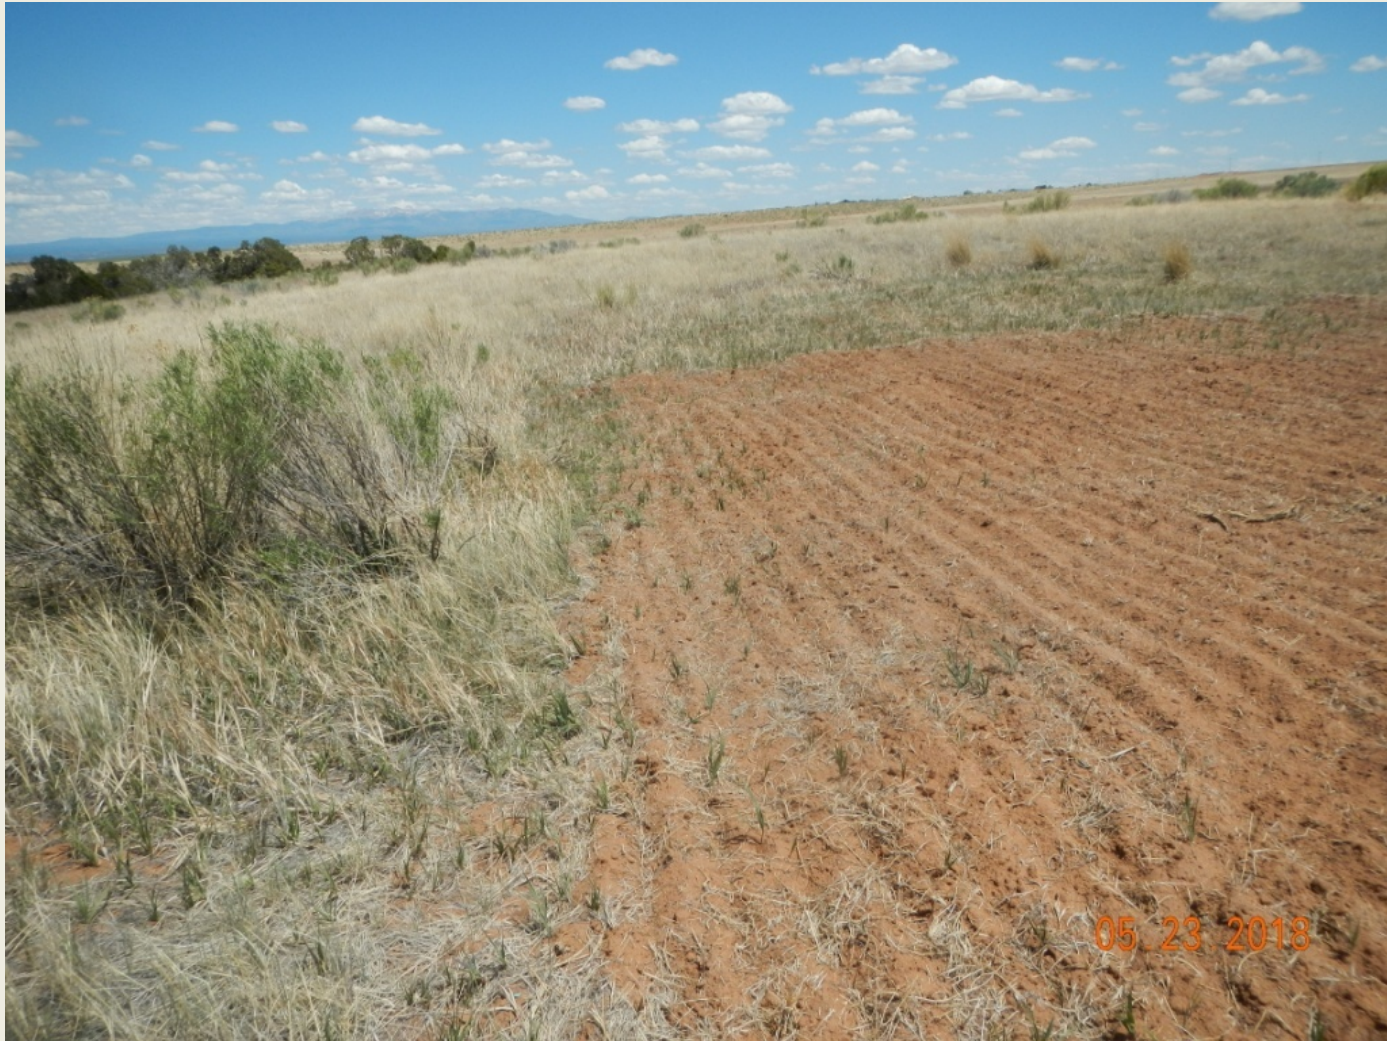
**Photo 2. View of former pit area from the northwestern corner facing eastward.**

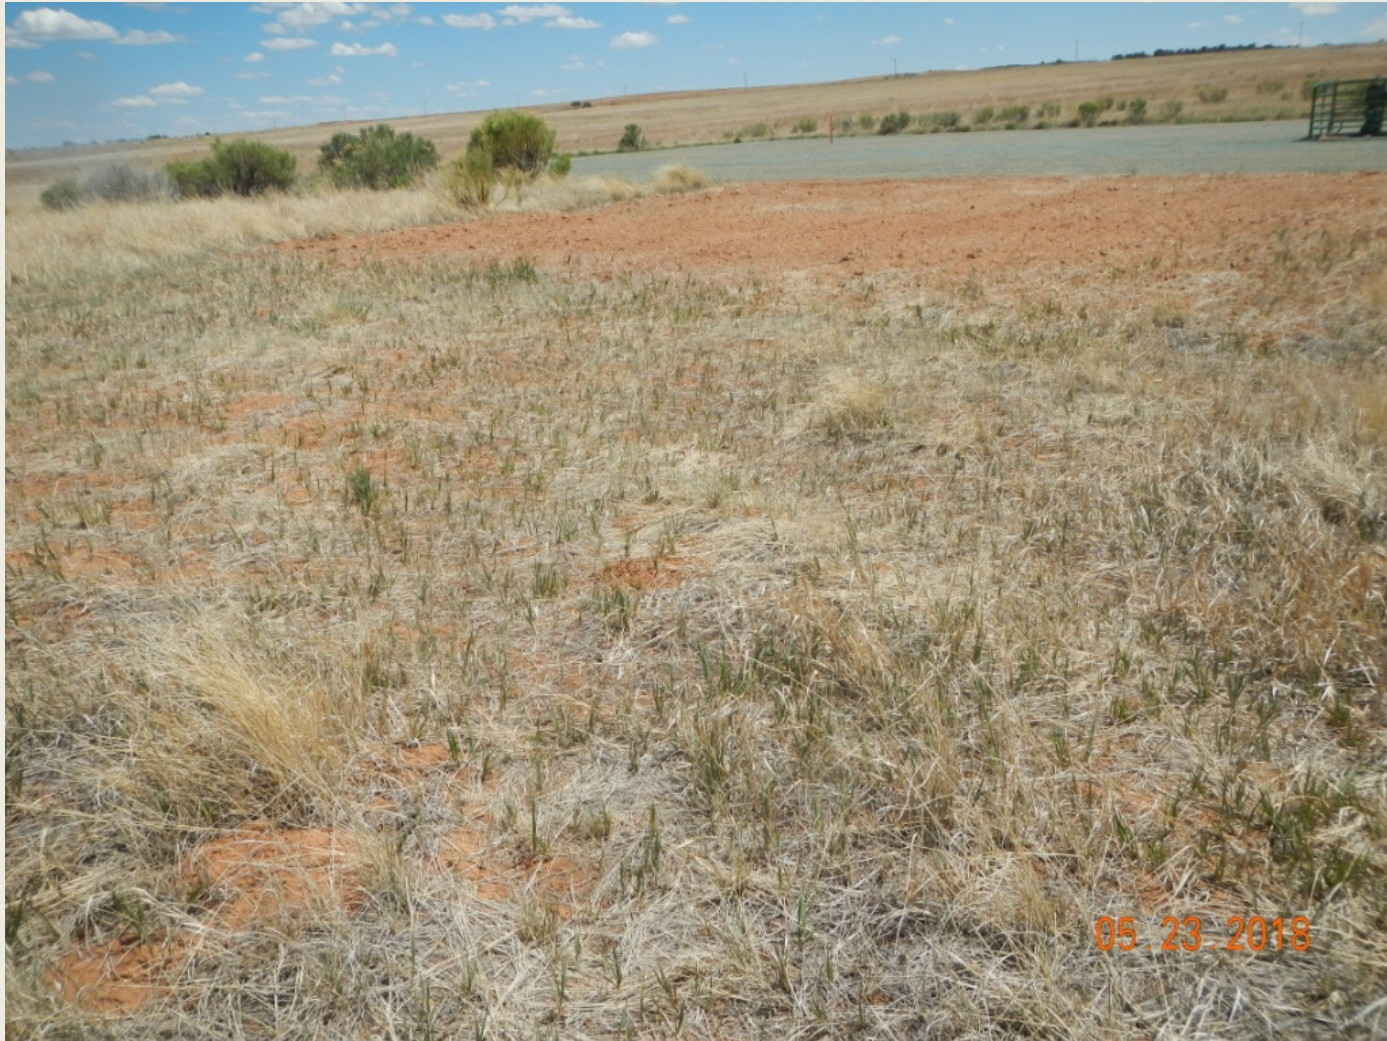
**Photo 3. View of another gypsum-treated portion of the former pit area in the northeastern portion.**

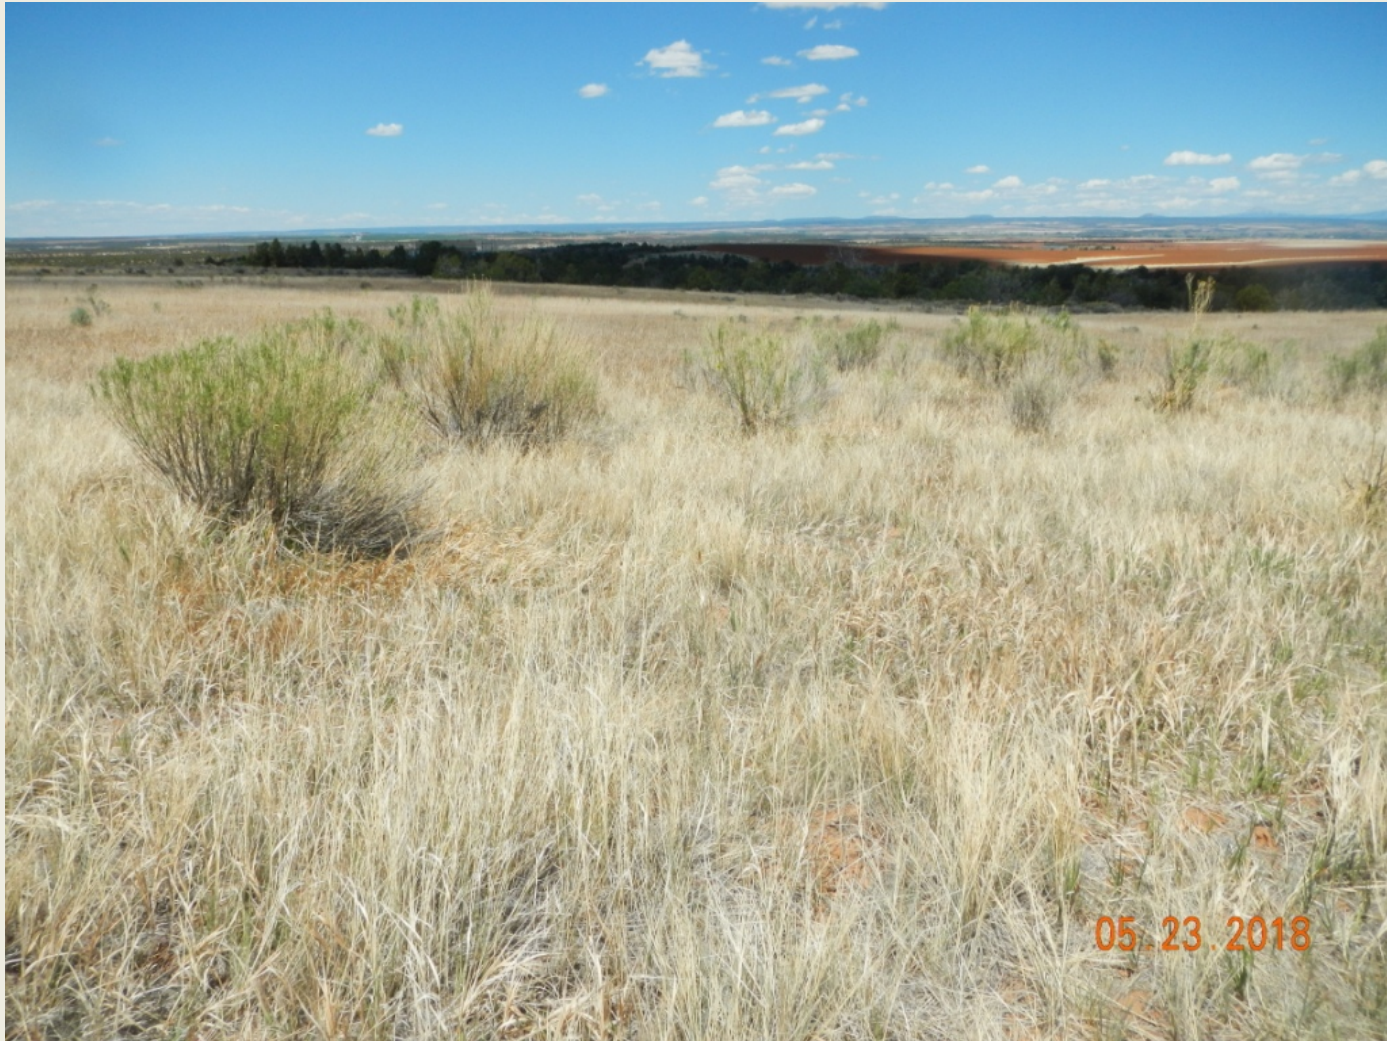
**Photo 4. View of reference area north of the project area facing northward.**
