Inspection Photos
Location Name: Spetter 5-8
API: 05-081-06548

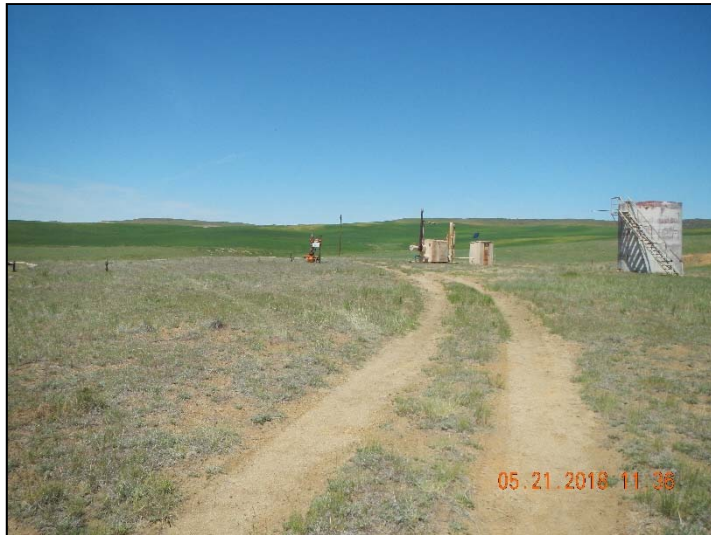
Photo 1. Overview of location taken at entrance facing north.

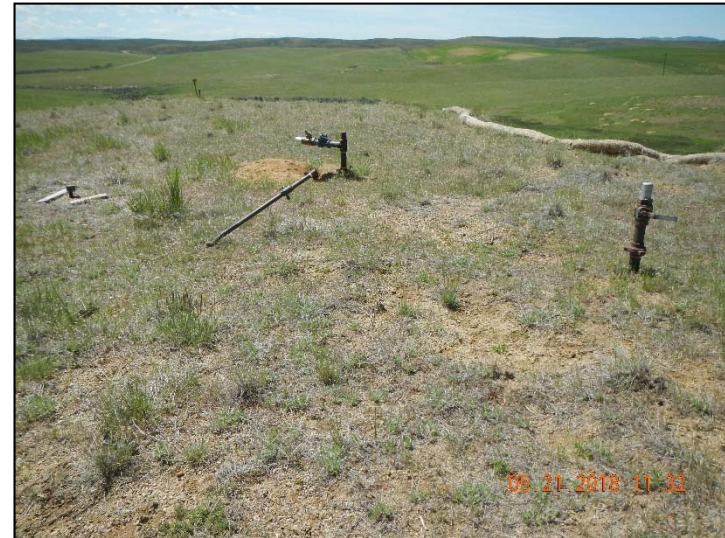
Photo 2. Risers not marked for abandonment or LOTO.

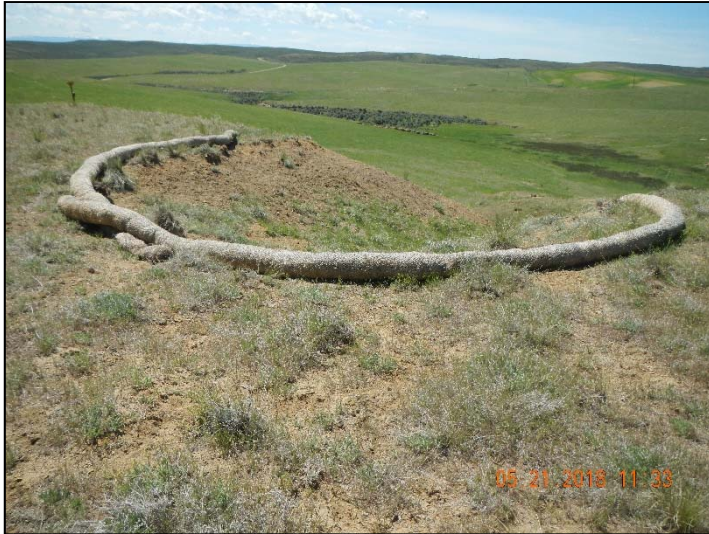
Photo 3. Waddles installed improperly.

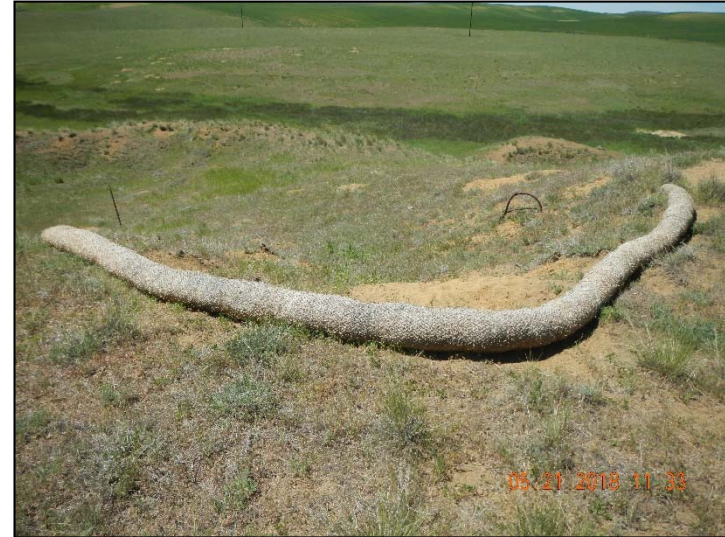
Photo 4. Waddles installed improperly.

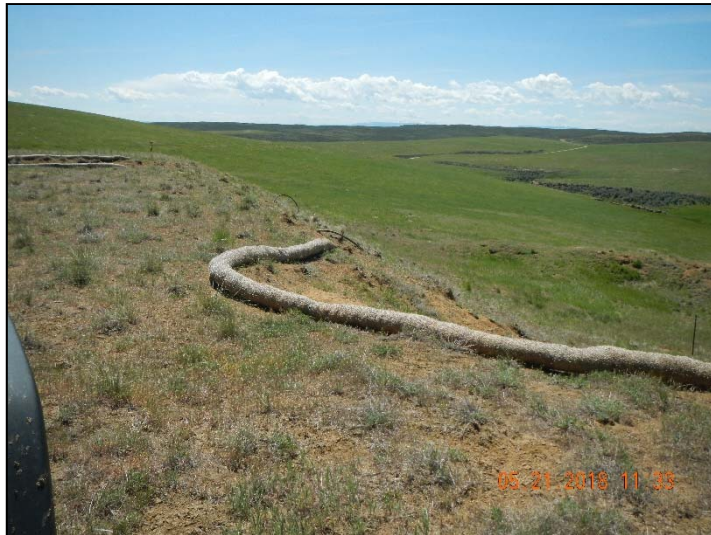
Photo 5. Waddles installed improperly.

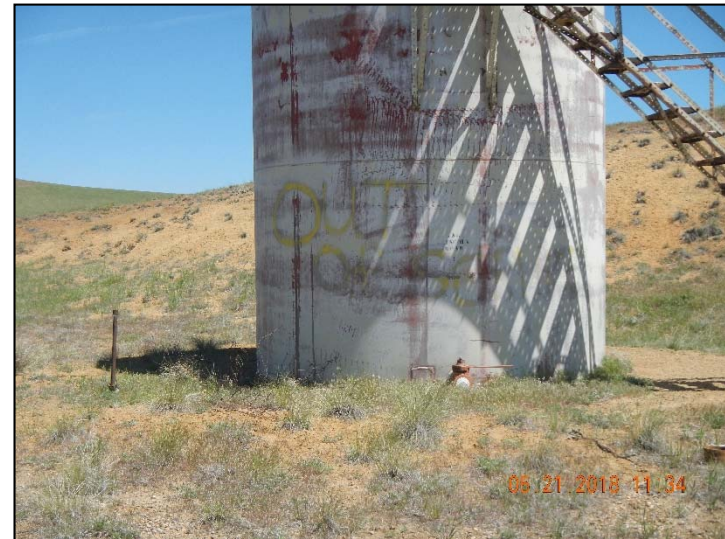
Photo 6. Tank labeled "out of service" stored on location.
