Inspection Photos
Location Name: Nielson #3
API: 05-007-06116

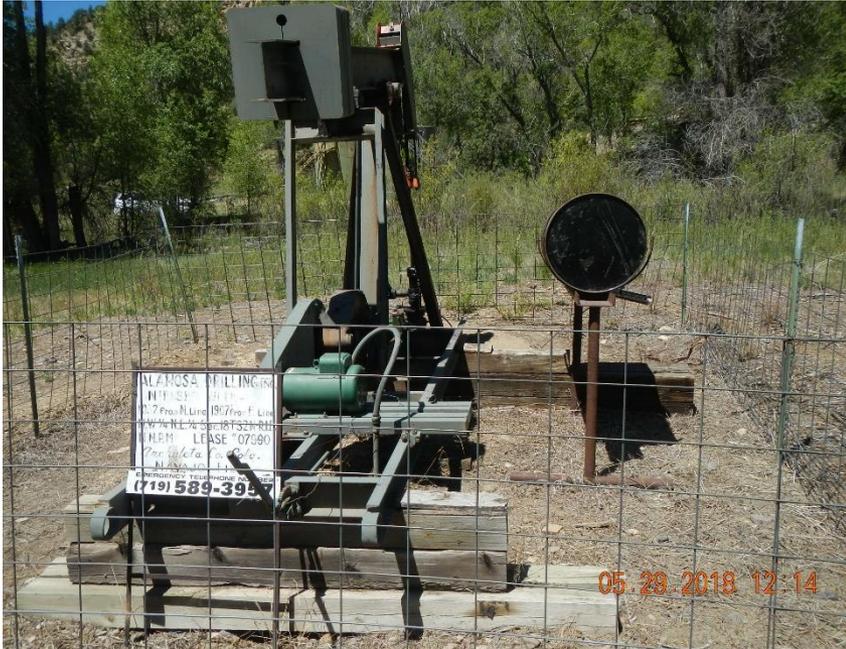
Nielson #3 pump jack and well head.

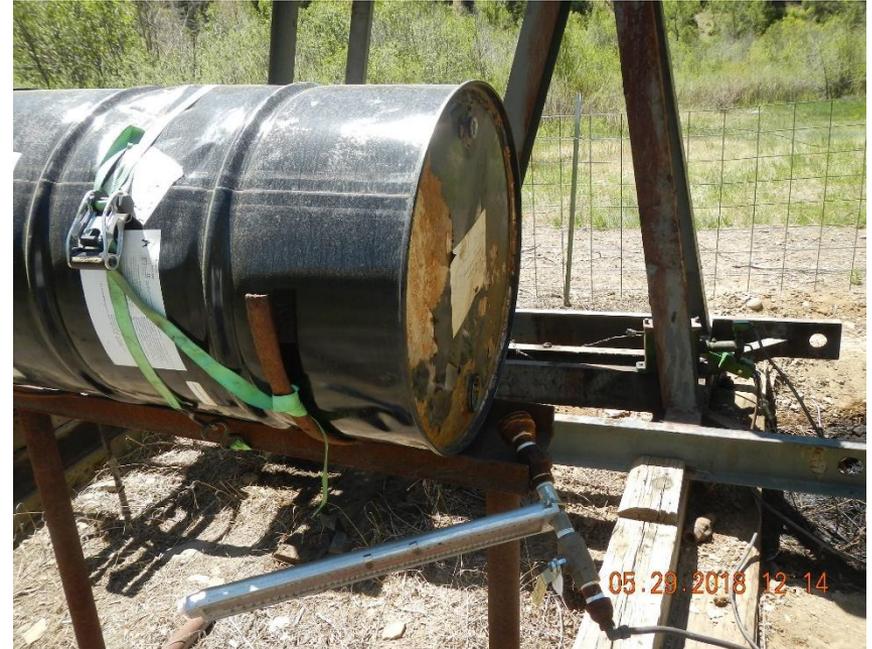
Unused chemical injection system, noted in previous inspection report.

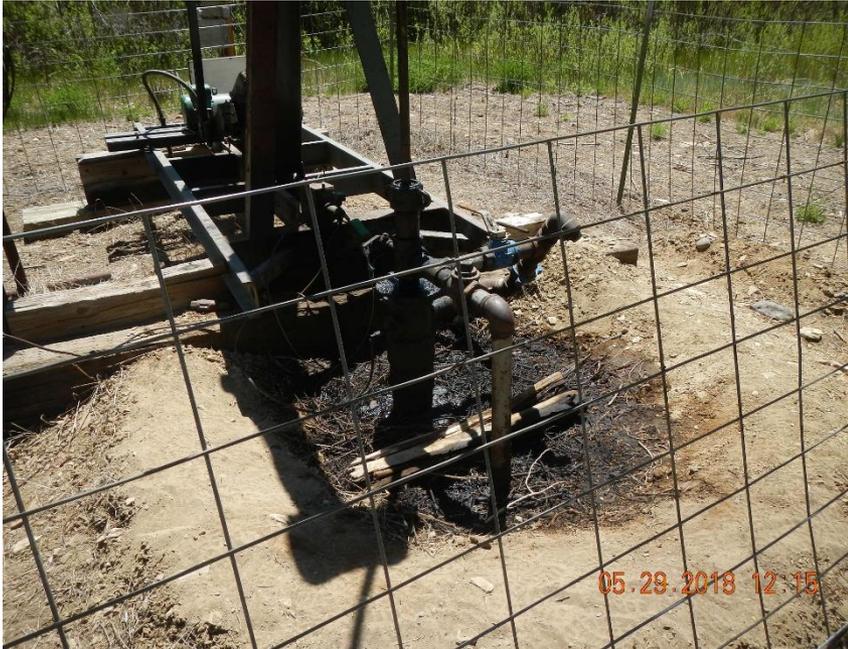
Stained soil around well head, noted in previous inspection report.

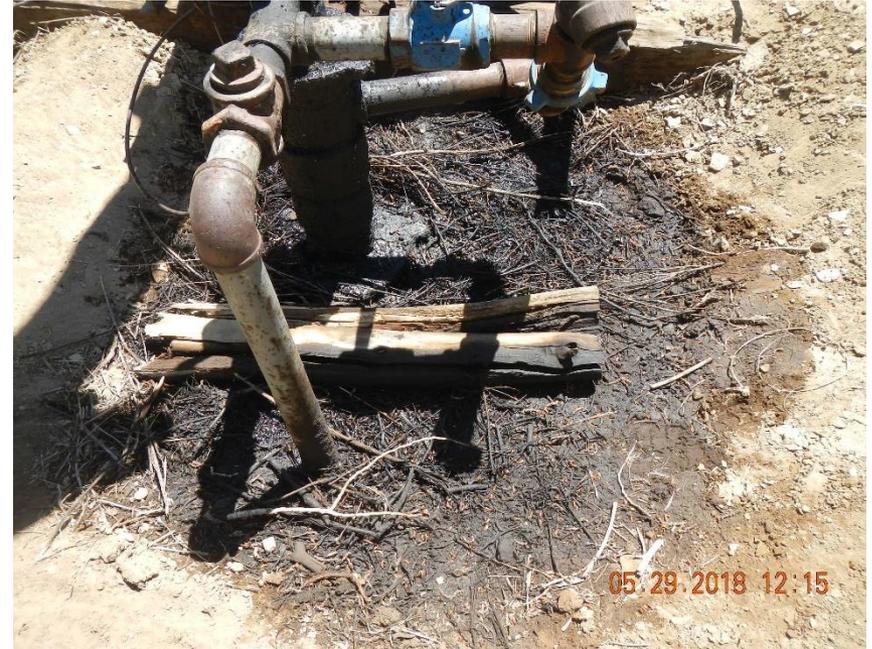
Well head is wet and surrounded by stained soil.

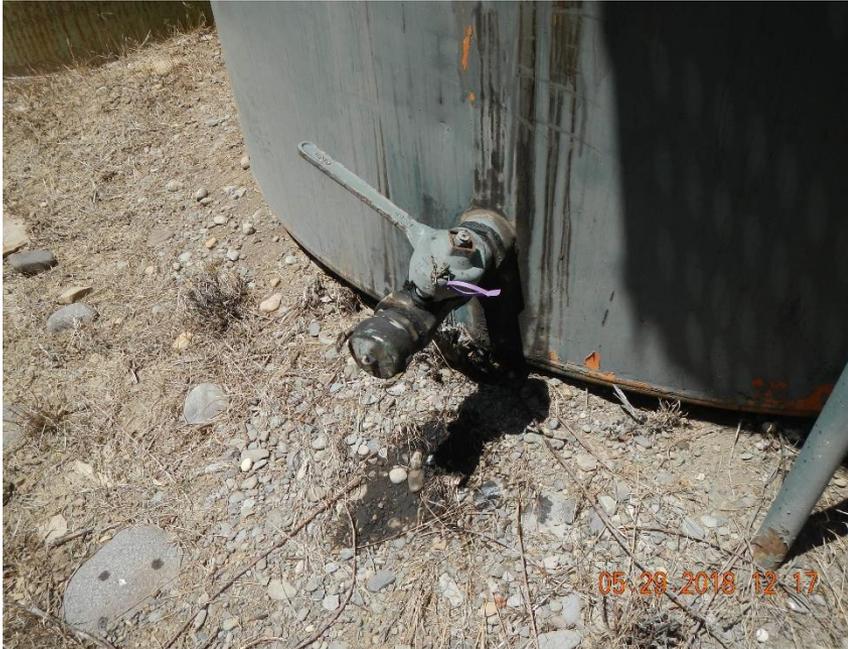
Stained soil beneath load out valve on AST. Tank is stained with oil, noted on previous inspection.

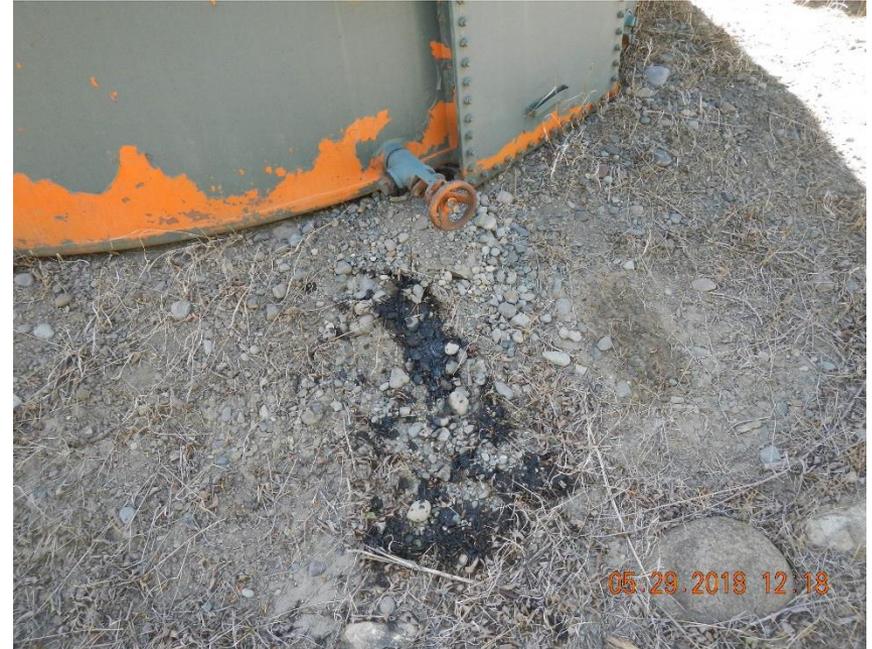
Stained soil beneath valve on AST.
