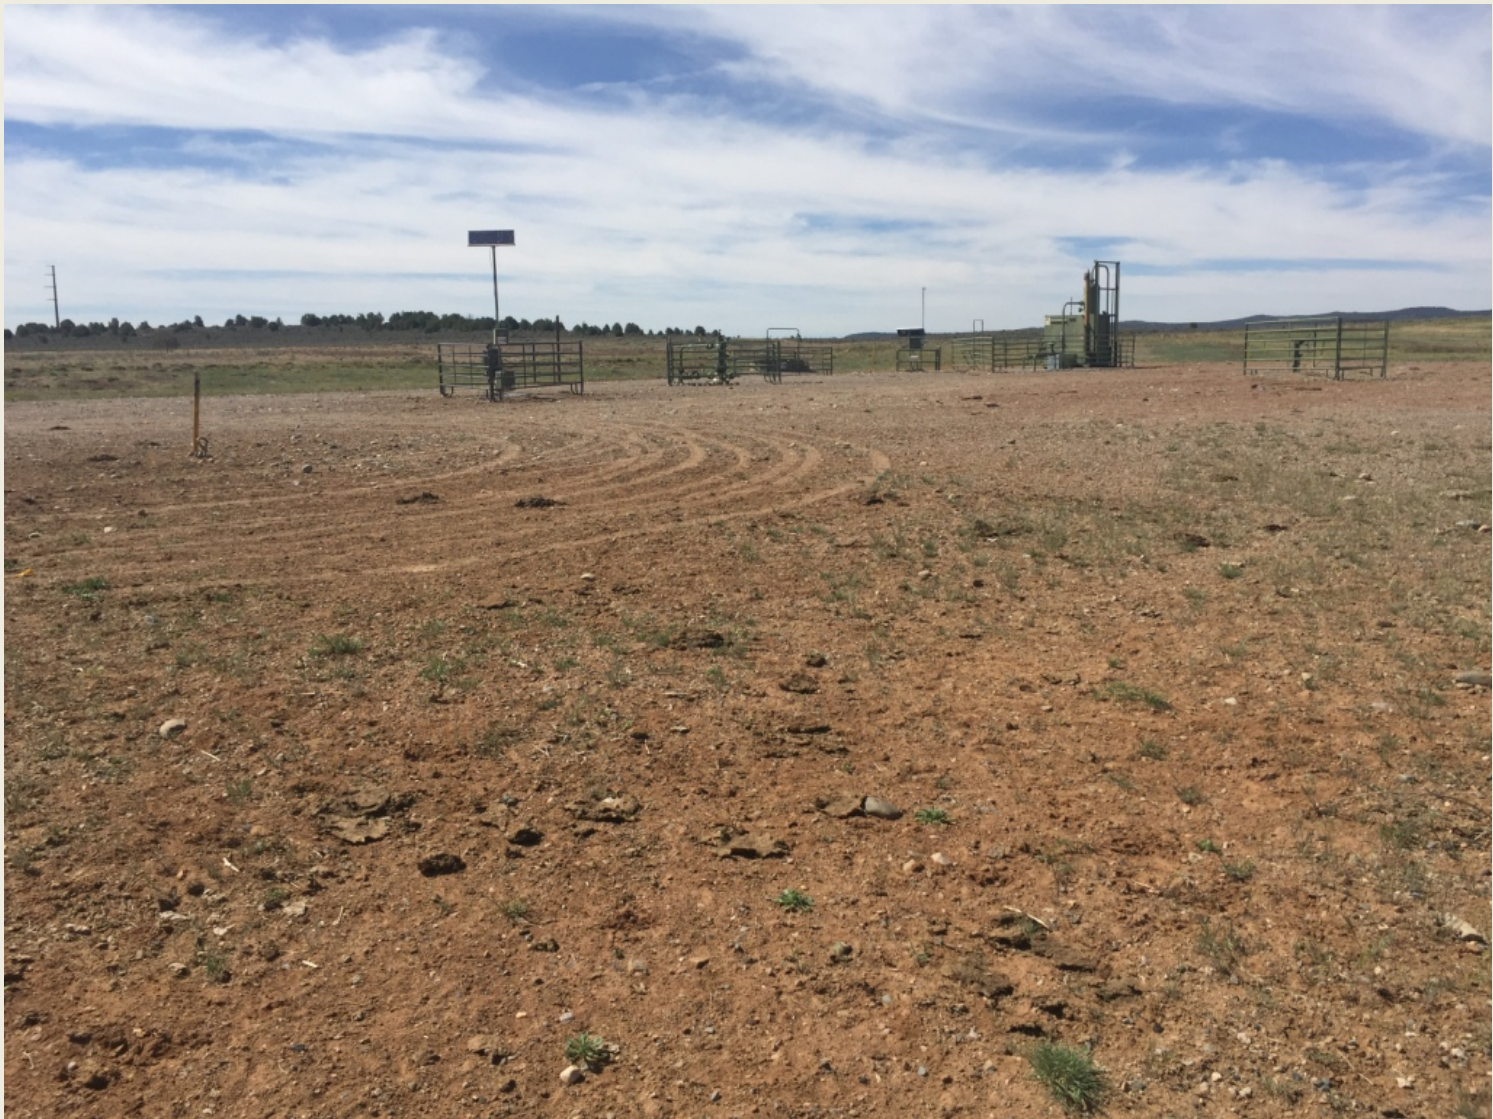
Photo 1. View of the project area from the northwestern corner facing center.

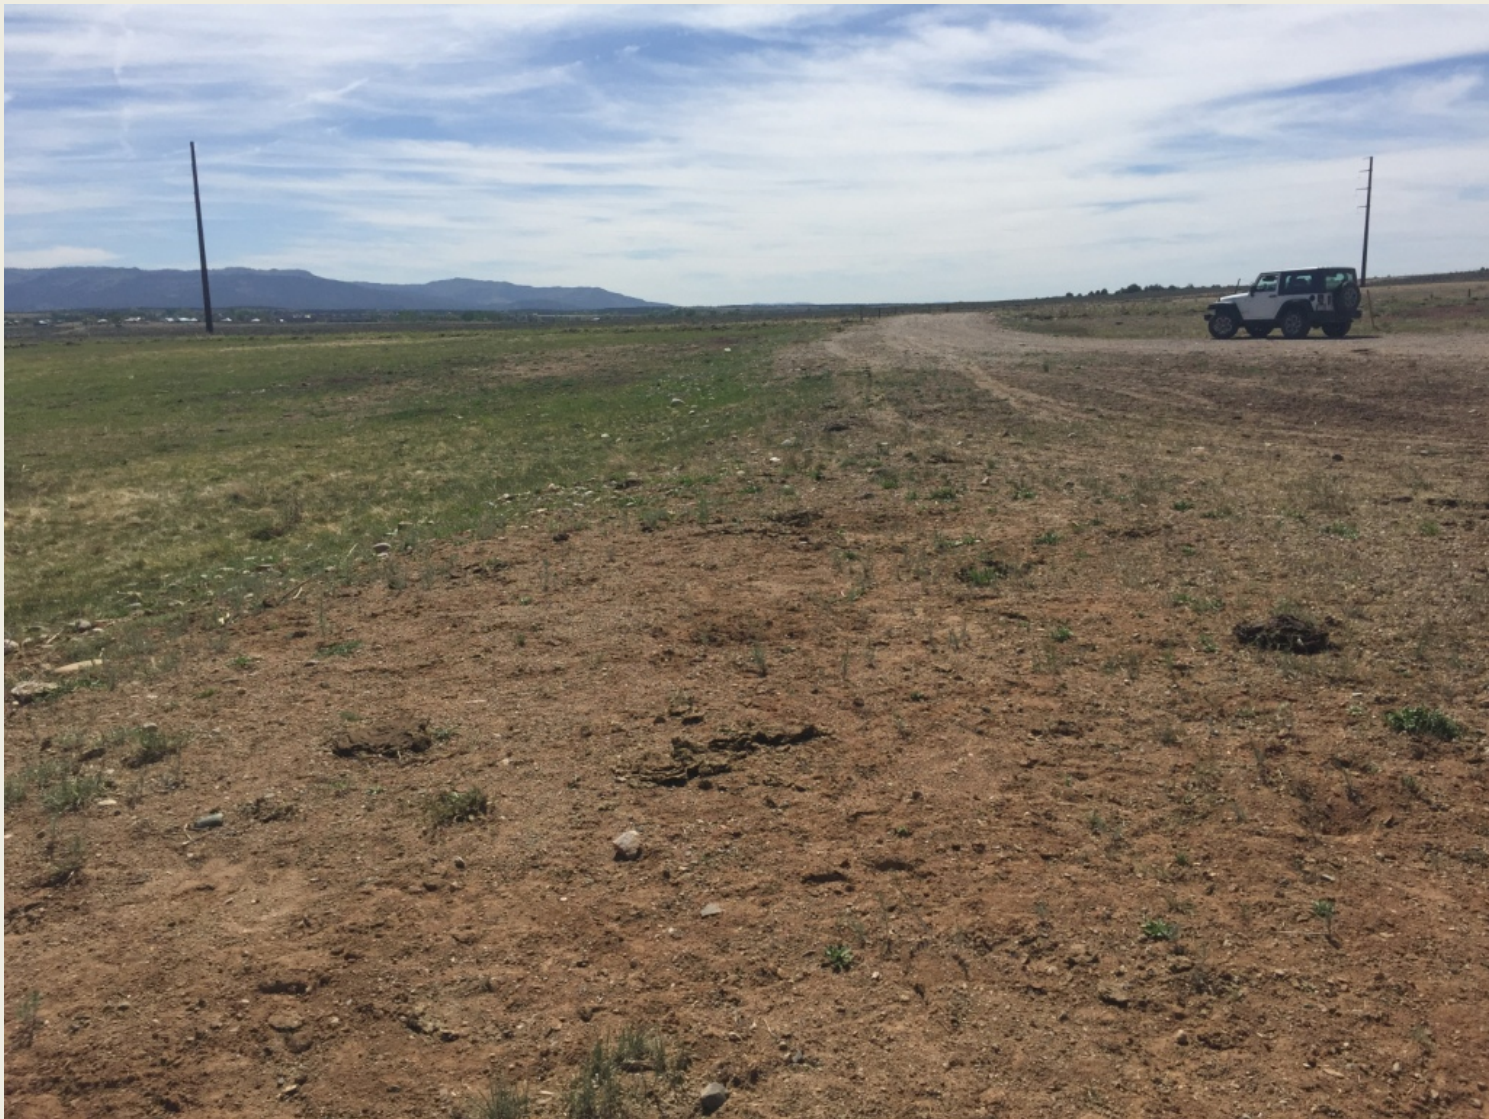
Photo 2. View of the northern portion of the project area from the northwestern corner facing eastward. Revegetation is grazed and largely not in identifiable condition. Western wheatgrass was observed (*Pascopyrum smithii*).

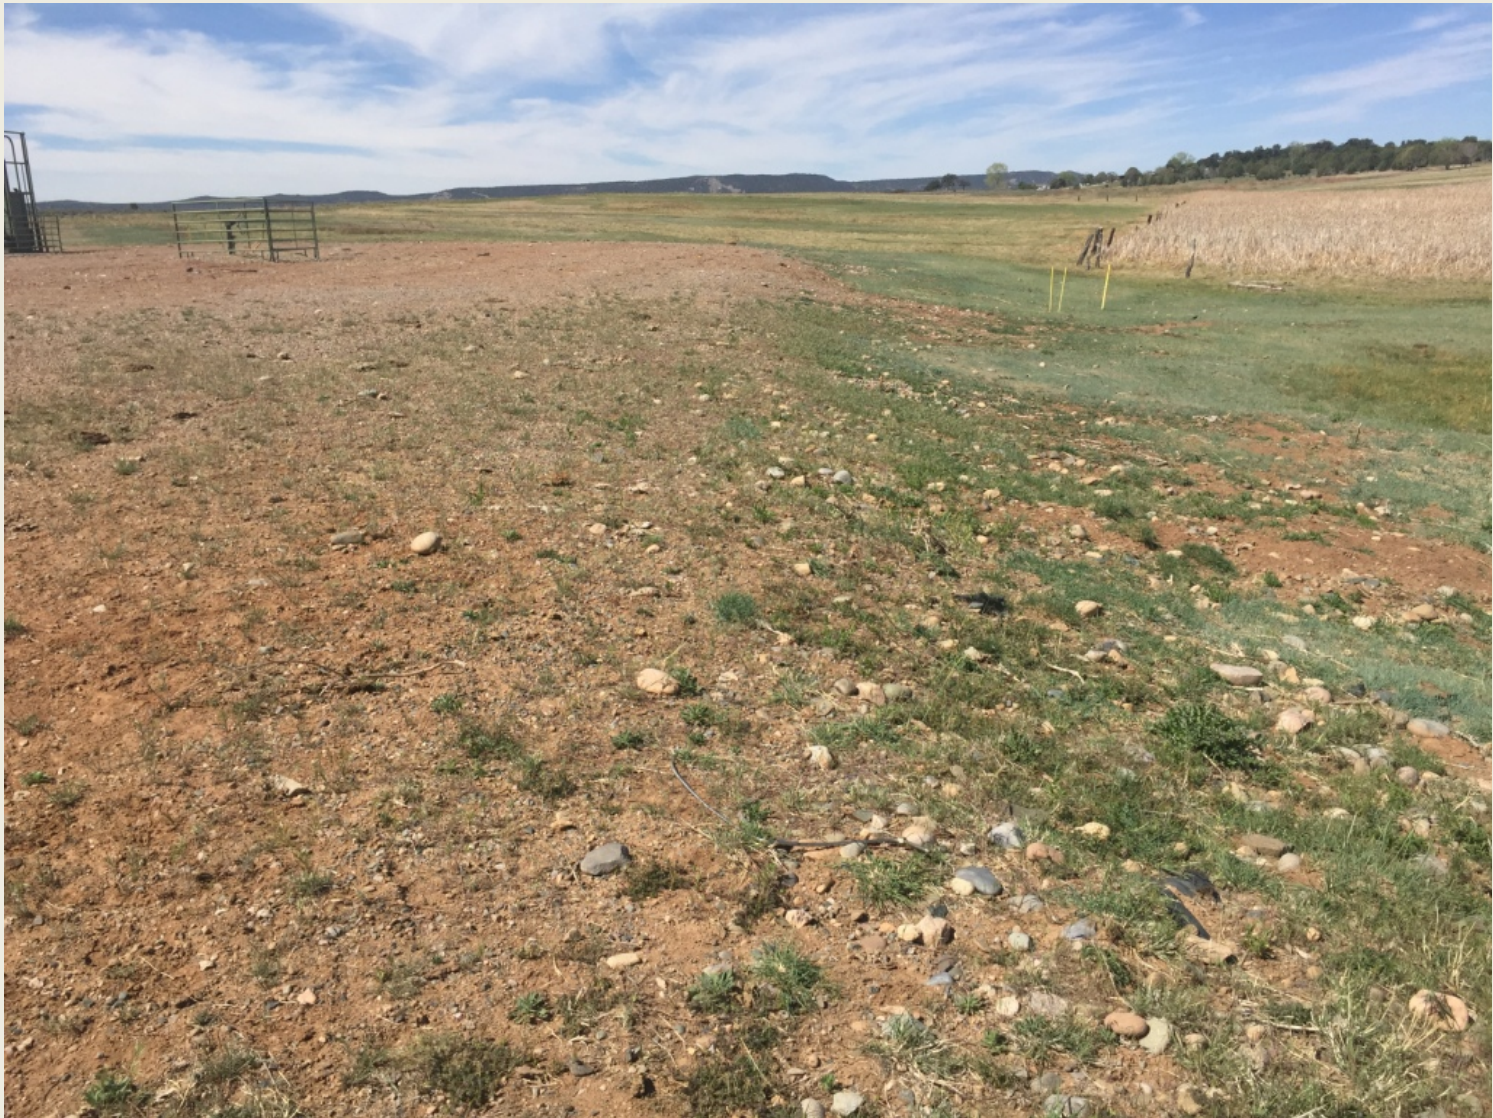
Photo 3. View of the western portion of the project area from the northwestern corner facing southward.

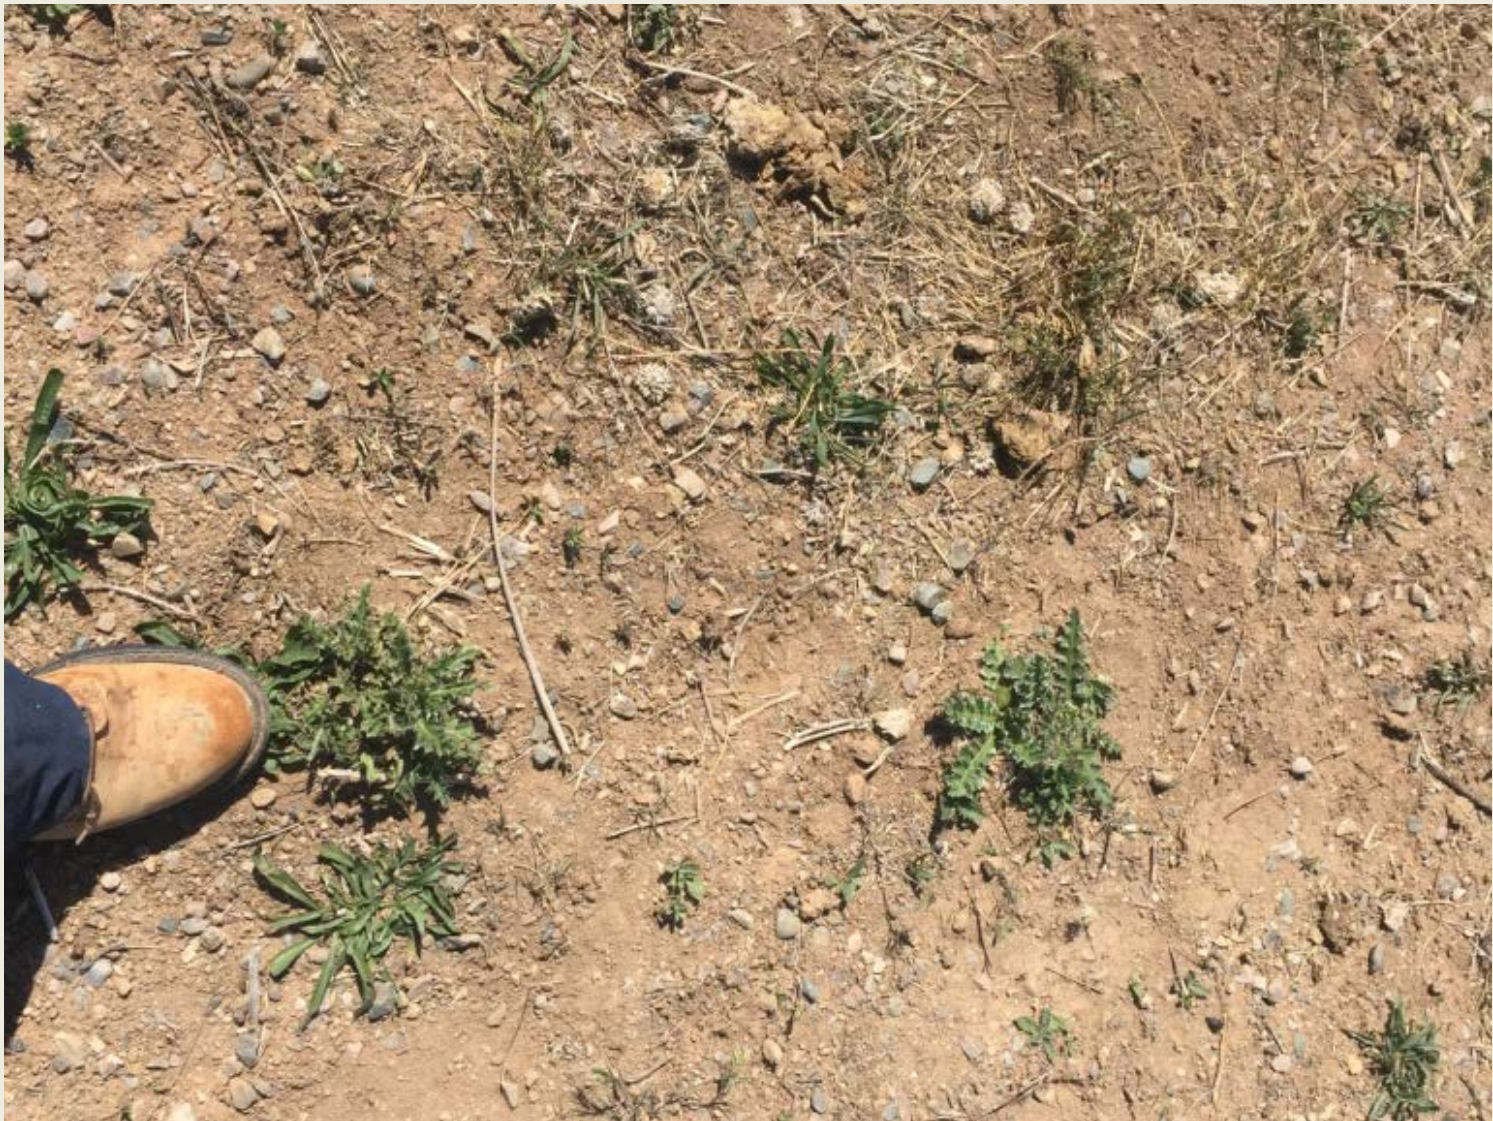
Photo 4. View of musk thistles within the interim reclamation area. Approx. 100 individuals observed.

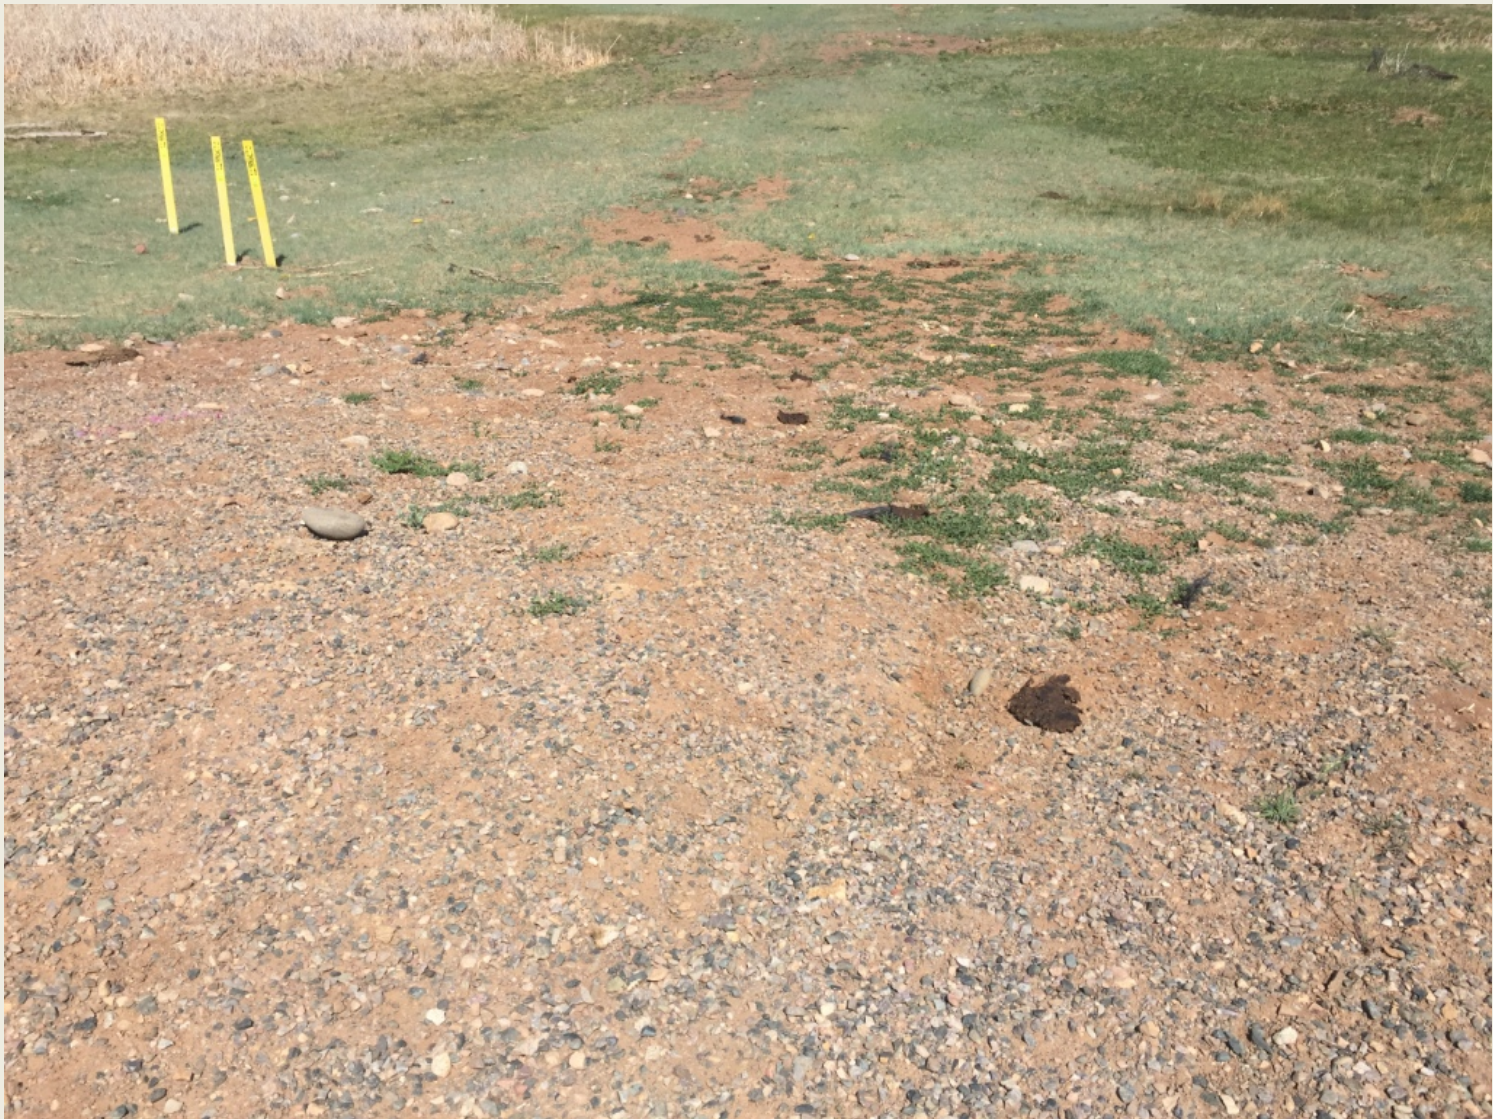
Photo 5. View of rilling along the pipeline alignment in the western project area.
