Inspection Photos
Location Name: PEOC-NVG 41-23H
API: 05-107-06173

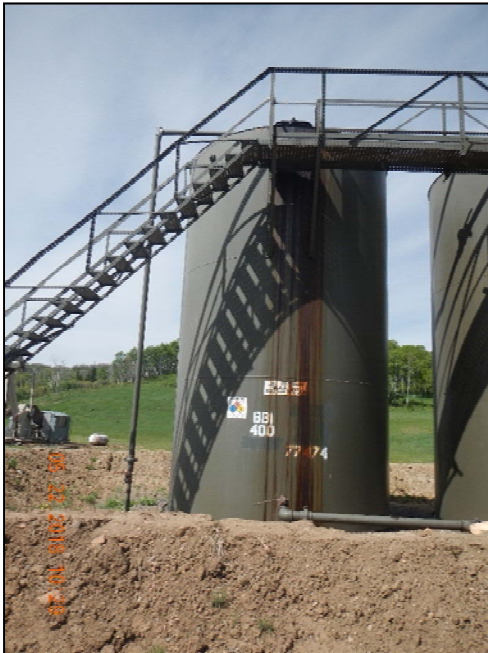
Photo 1. Overflow and staining from gauge hatch.

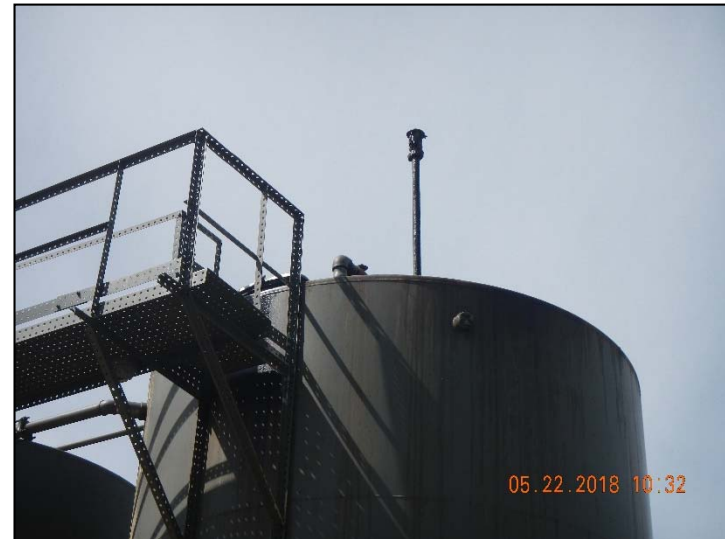
Photo 2. Overflow and staining from pop-off valve.

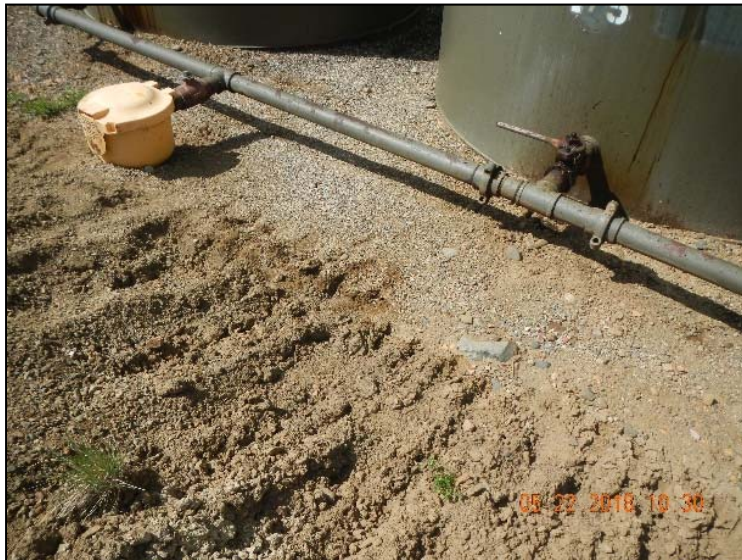
Photo 3. Soil staining in tank battery berm.

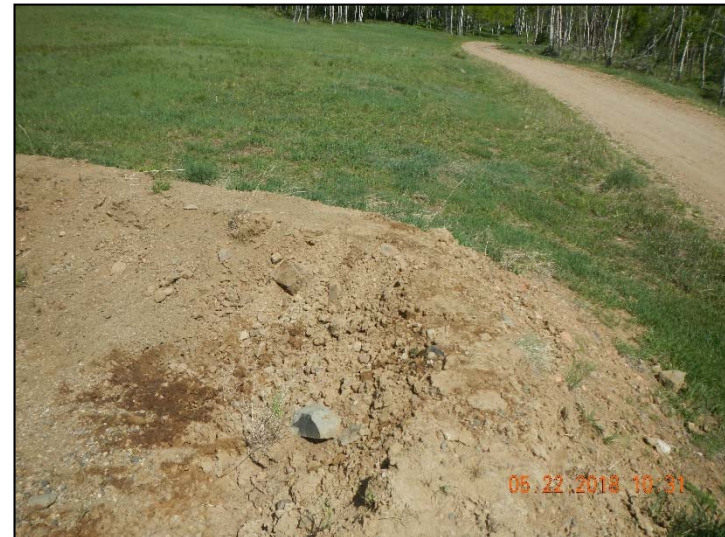
Photo 4. Soil staining in tank battery berm.

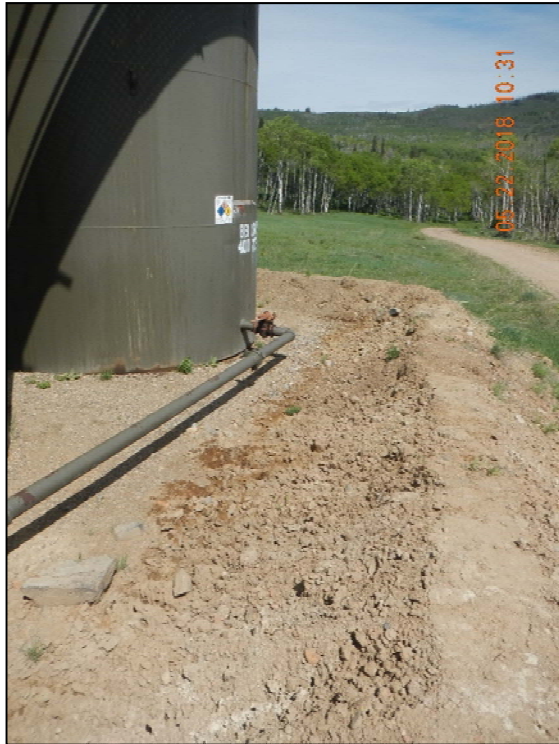
Photo 5. Soil staining in tank battery berm.

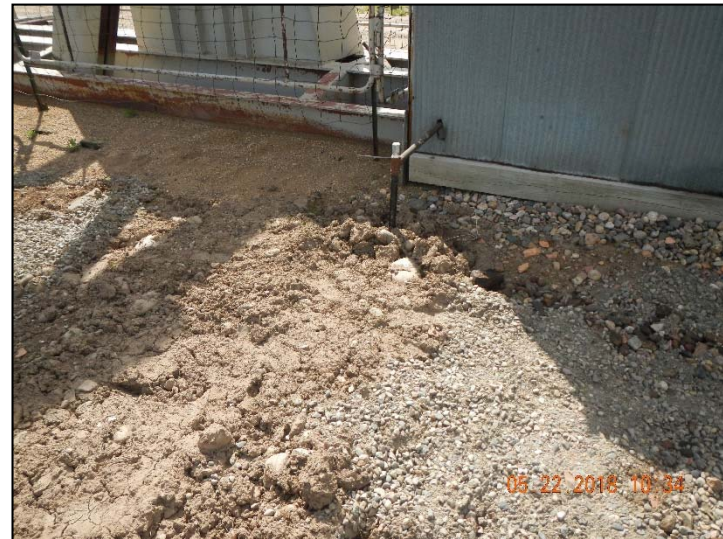
Photo 6. Fresh gravel/soil at flowline at wellhead.

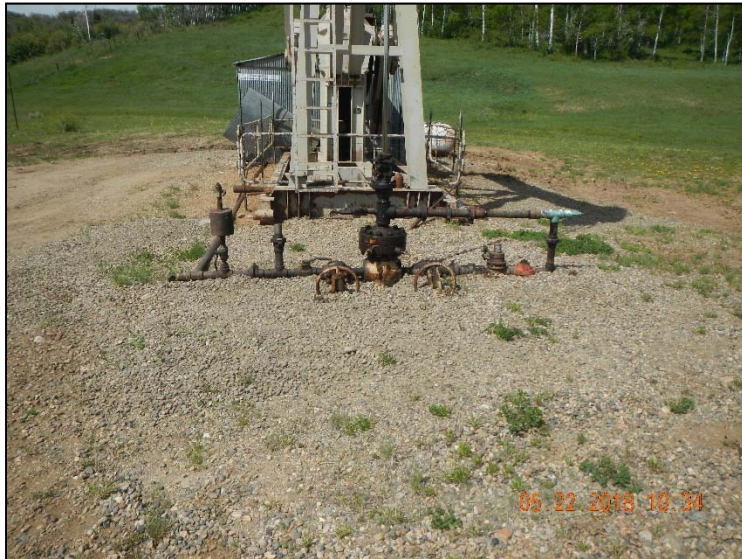
Photo 7. Fresh gravel at wellhead.

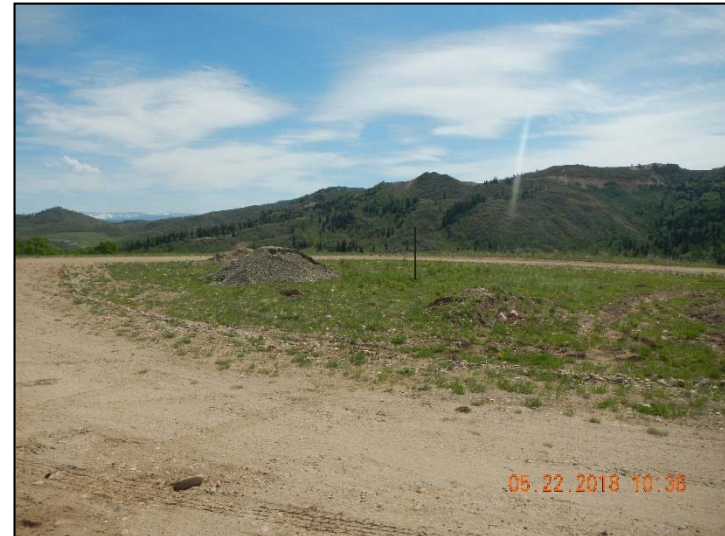
Photo 8. Gravel stored on location.
