Inspection Photos
Location Name: Moyer Unit 15-29
Location: 317531

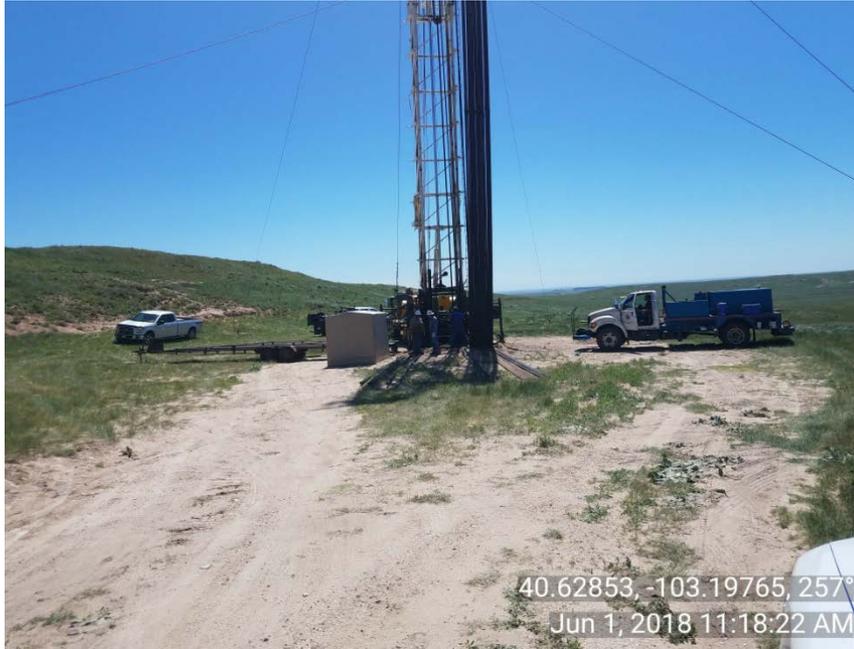
Photo 1: Wellhead, currently workover.
