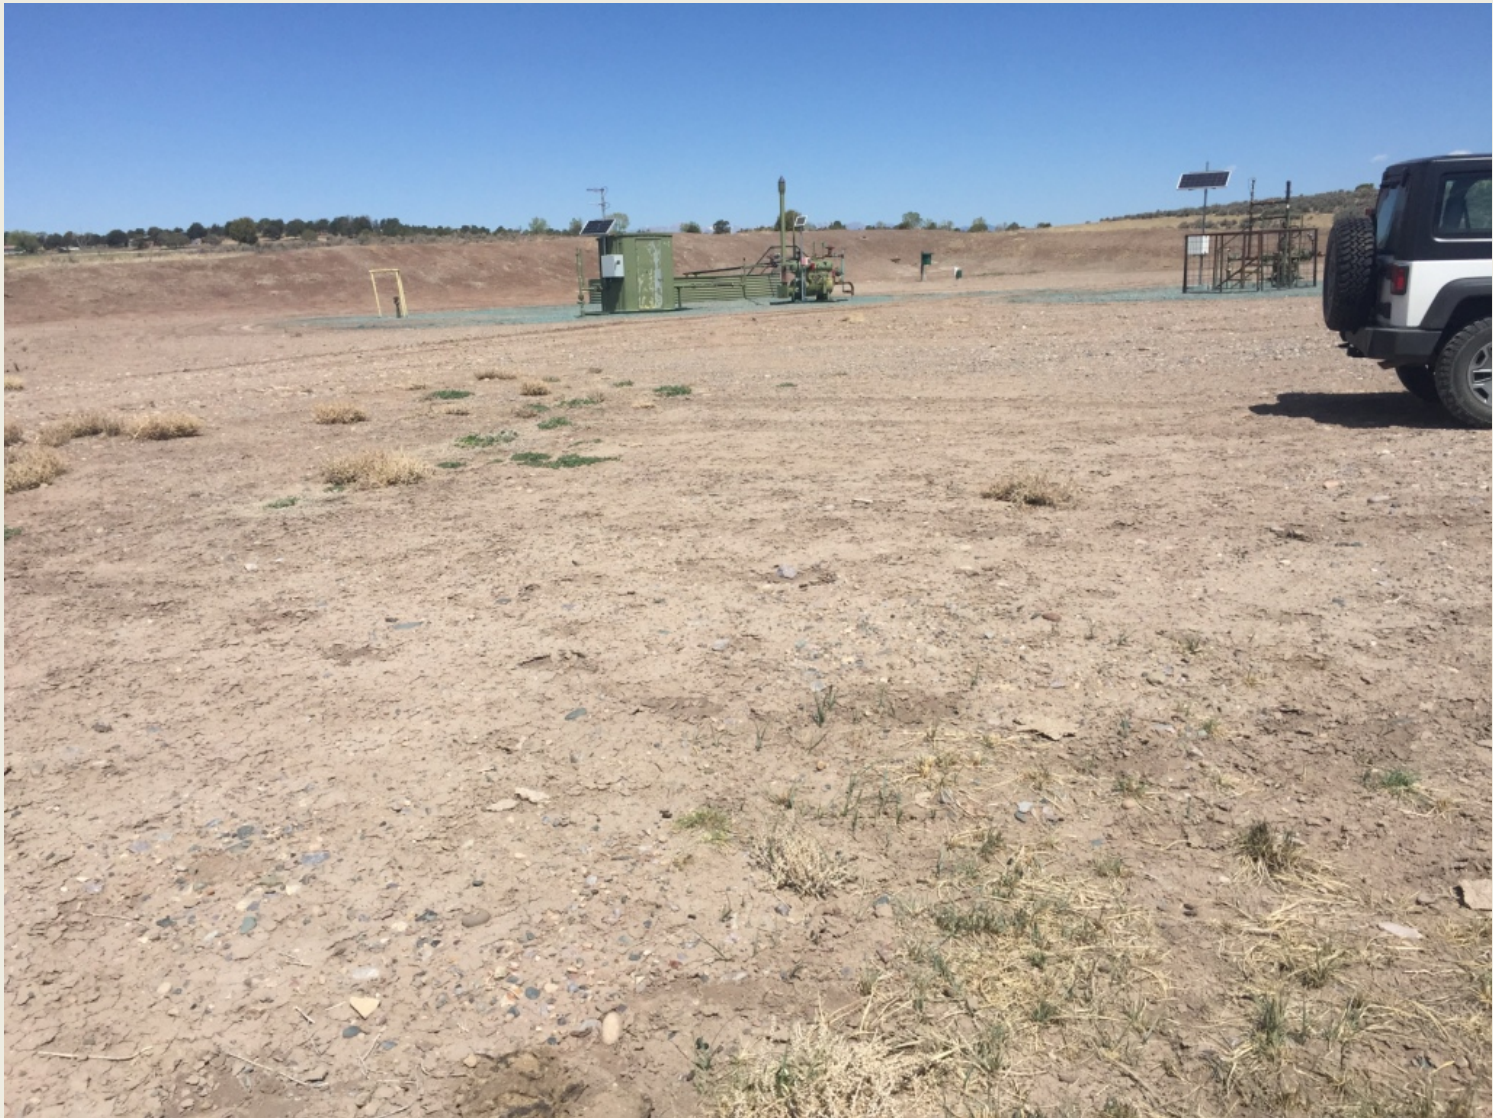
Photo 1. View of the project area from the southeastern corner facing center. Poor revegetation on western cut-slope needs stabilization.

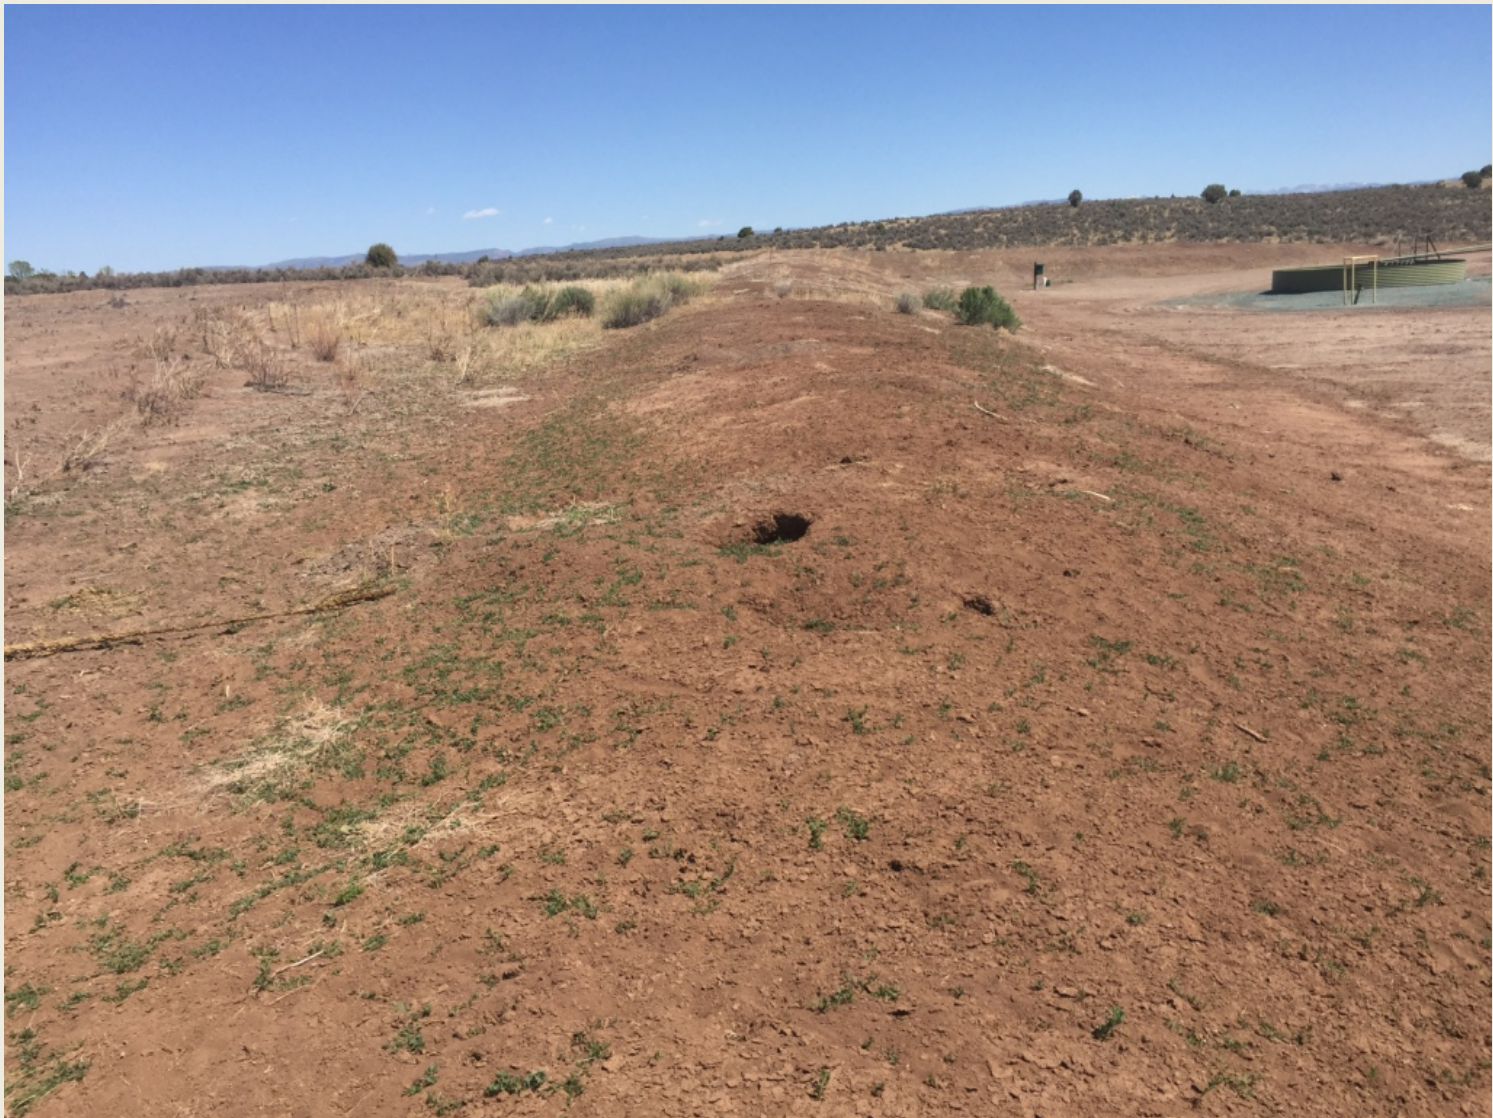
Photo 2. View of the western portion of the project area from the southwestern corner facing northward. Approx. 100 musk thistles (*Carduus nutans*) from the 2018 growing season were observed. Thistles will need to be treated this year if rosettes observed. Seeds will remain viable for 10-15 years and therefore, subsequent monitoring and treatment will be needed.

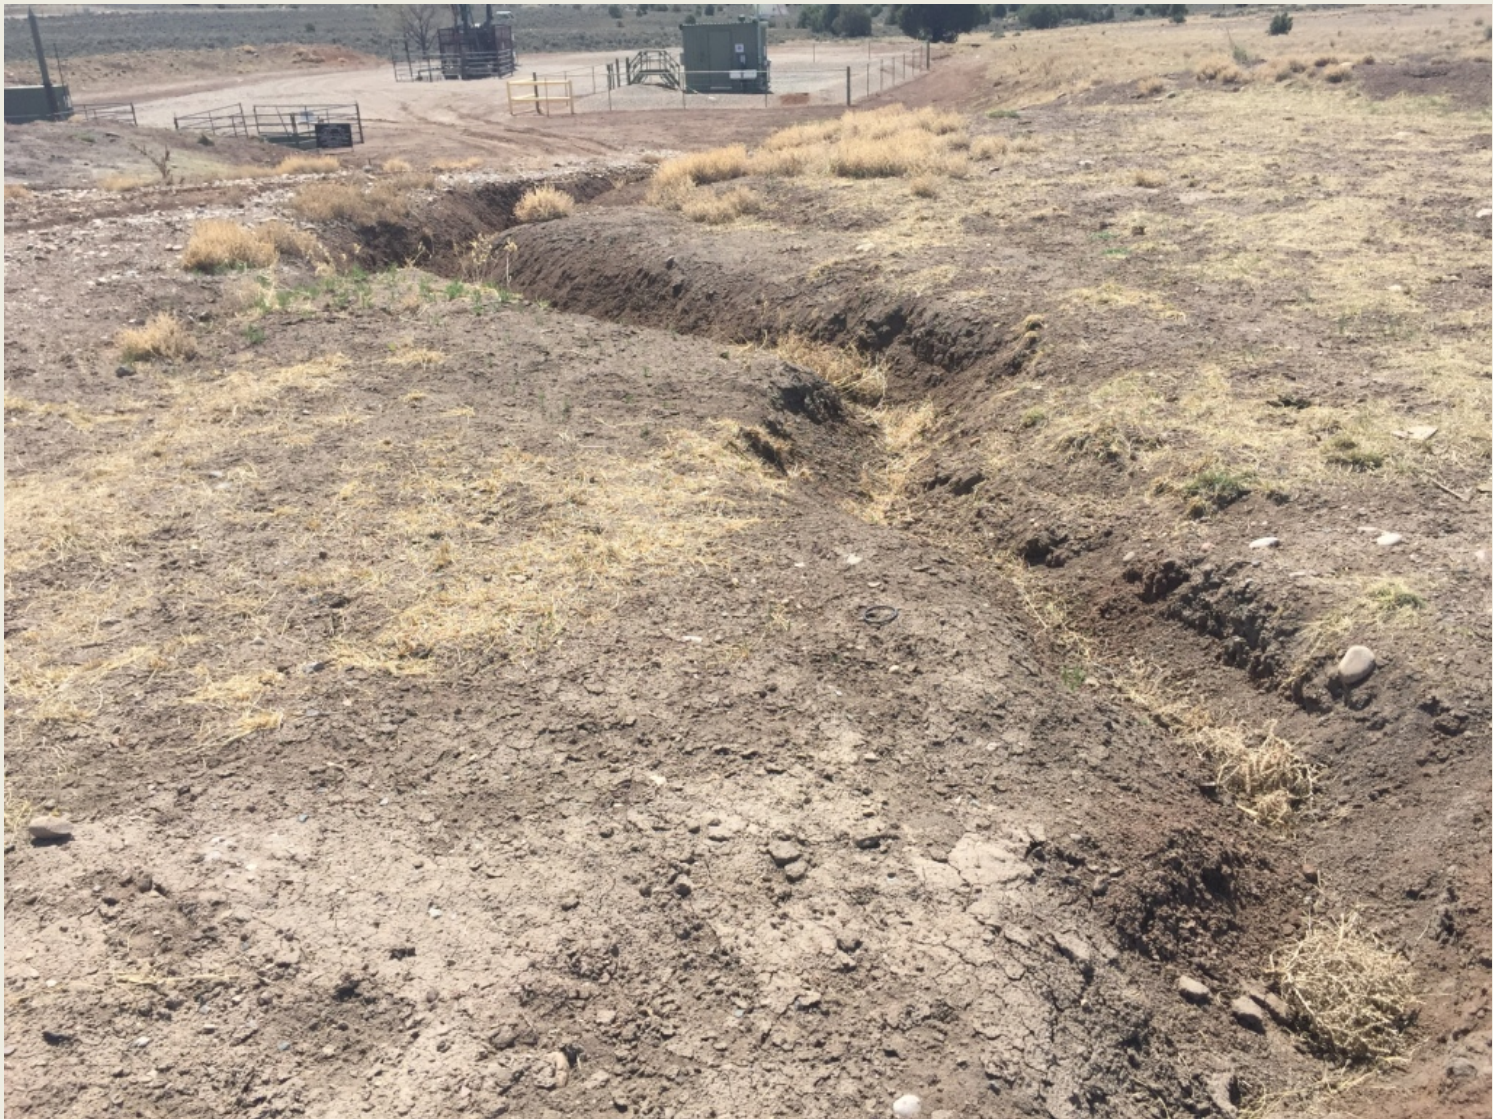
Photo 4. View of erosional channel approximately 3 feet wide and up to 2 feet deep forming where concentrated stormwater flows off of the southern portion of the project area.

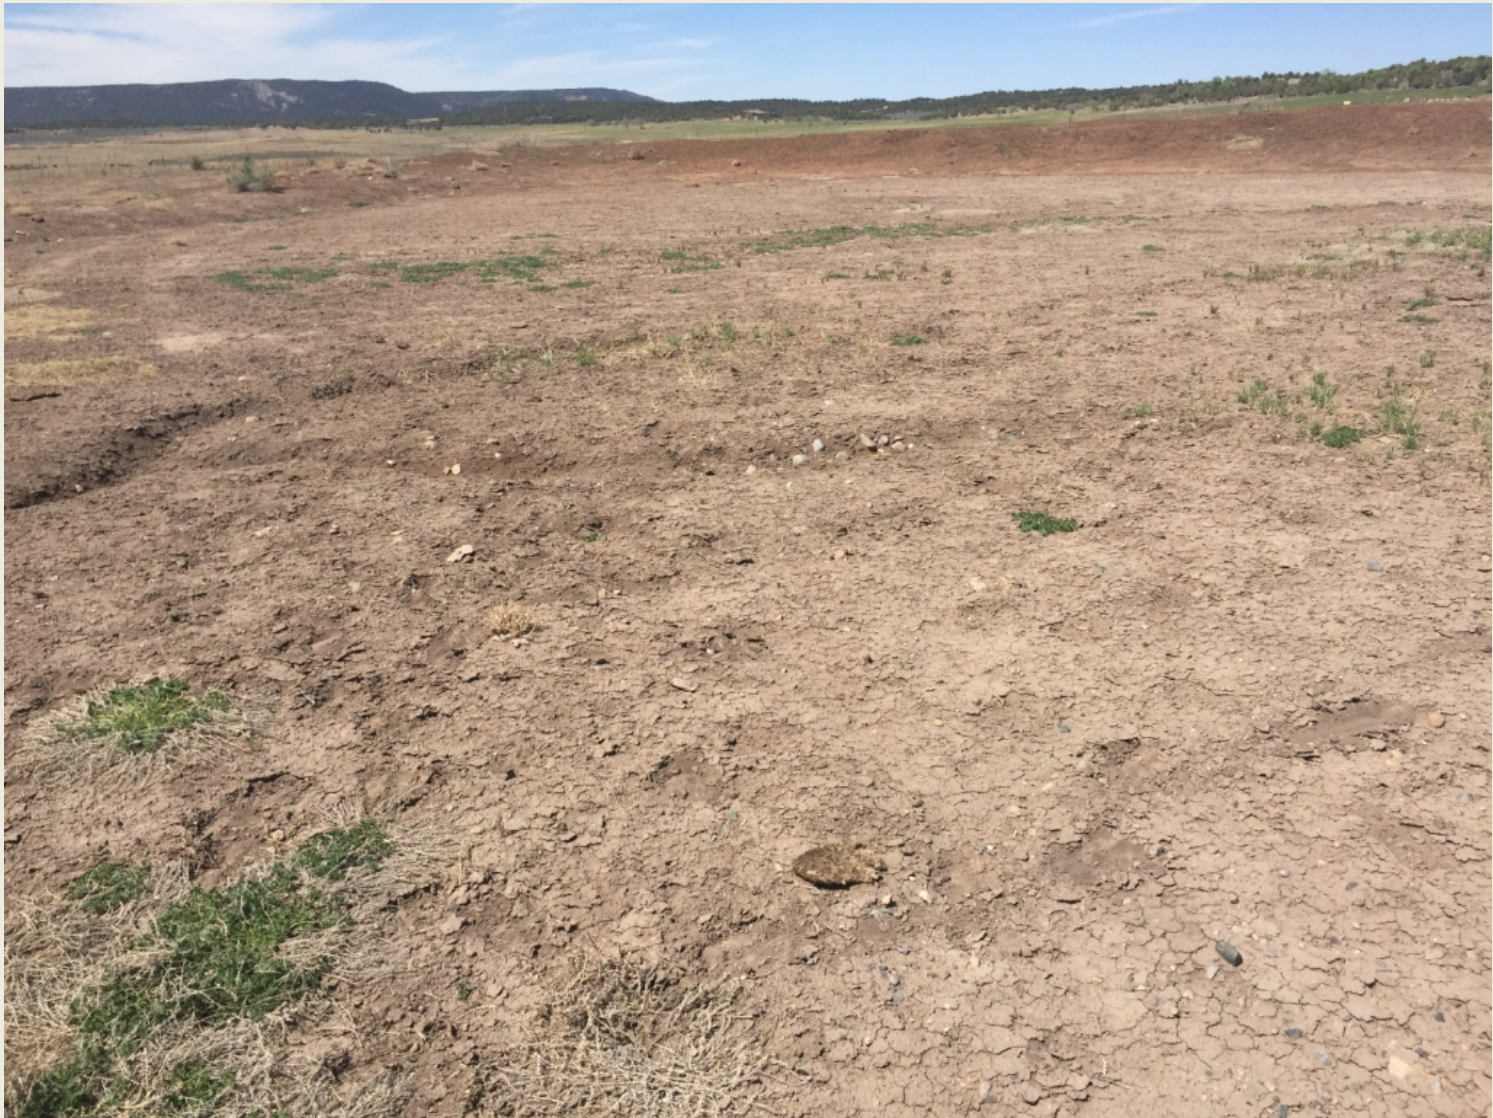
Photo 5. View of area in the southwestern portion of the project area that needs revegetation and stabilization.
