Inspection Photos  
Location Name: State 1-15  
API: 05-107-06033

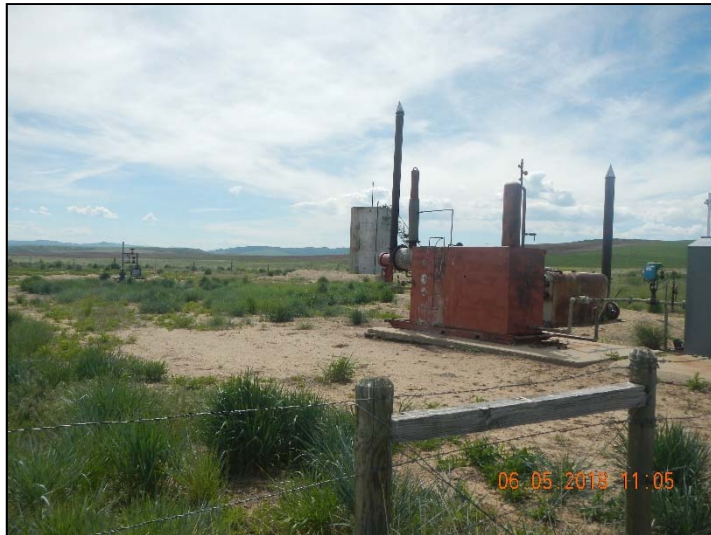
**Photo 1. Overview of location taken at entrance facing southeast.**

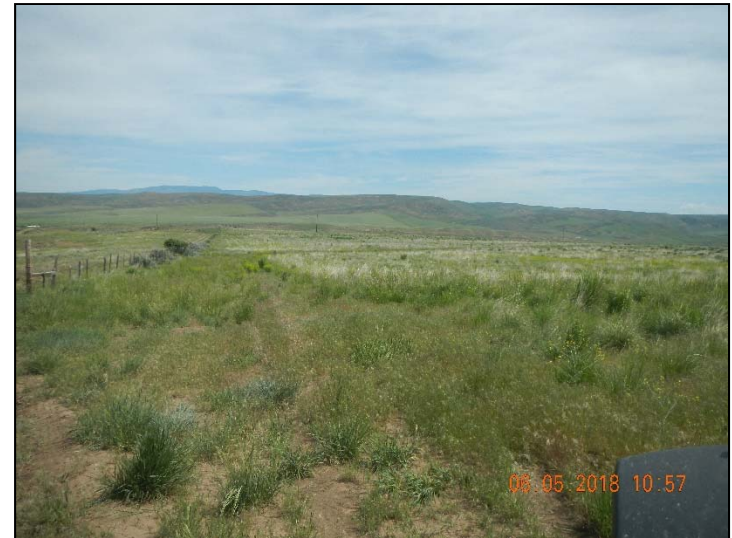
**Photo 2. Access road overgrown.**

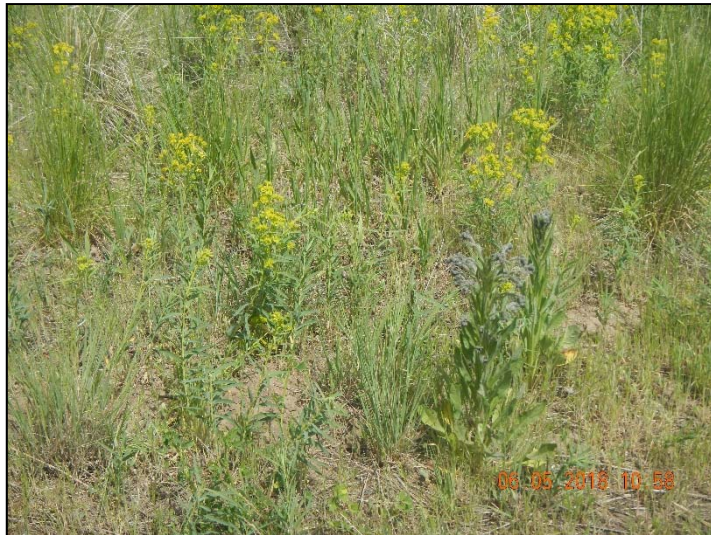
**Photo 3. Noxious weeds on access road. (Leafy Spurge, Houndstongue)**

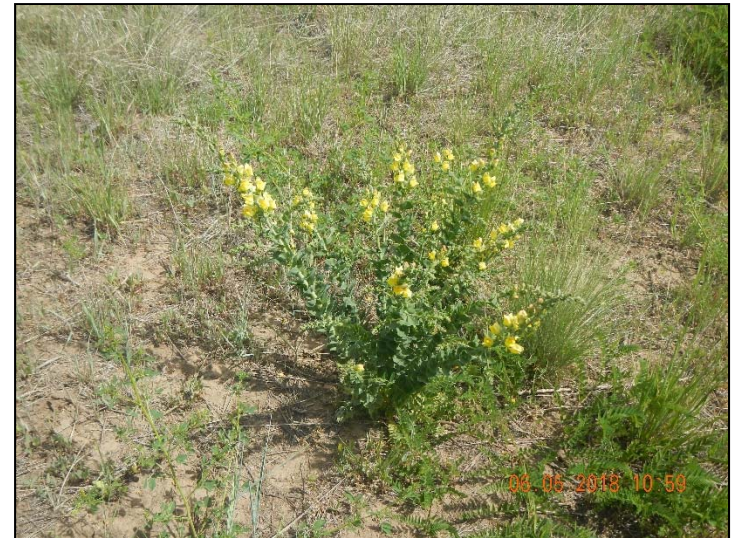
**Photo 4. Noxious weeds on access road. (Dalmatian Toadflax)**

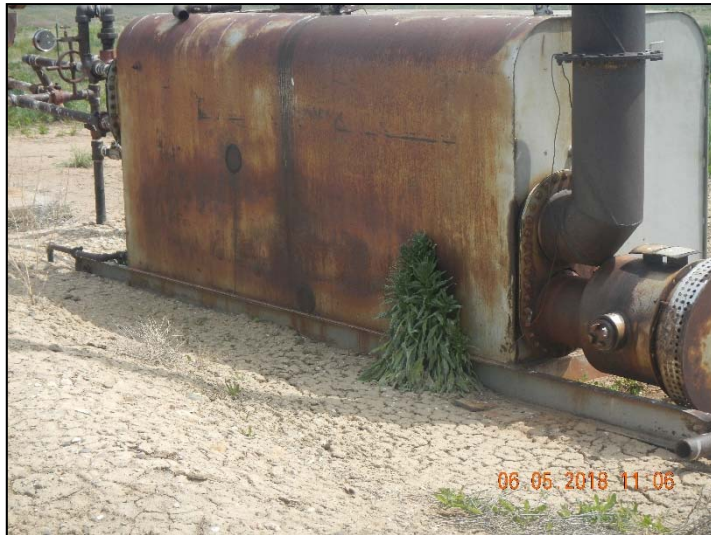
**Photo 5. Noxious weeds on location.  
(Houndstongue)**

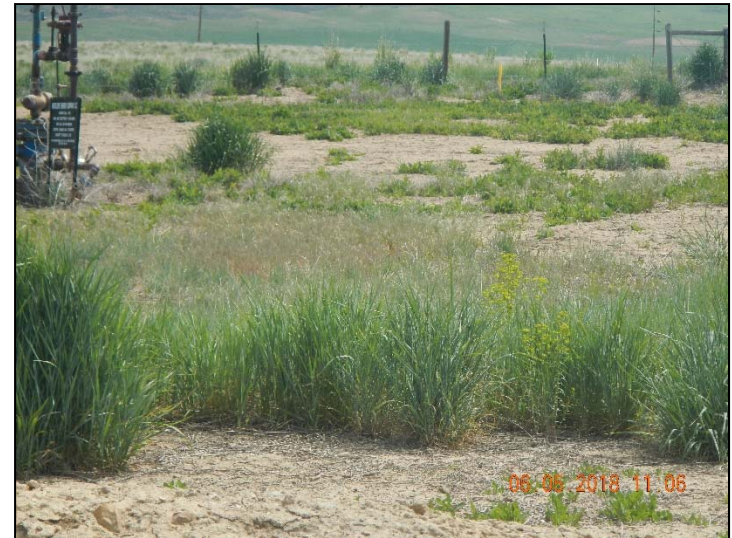
**Photo 6. Noxious weeds on location. (Leafy Spurge)**
