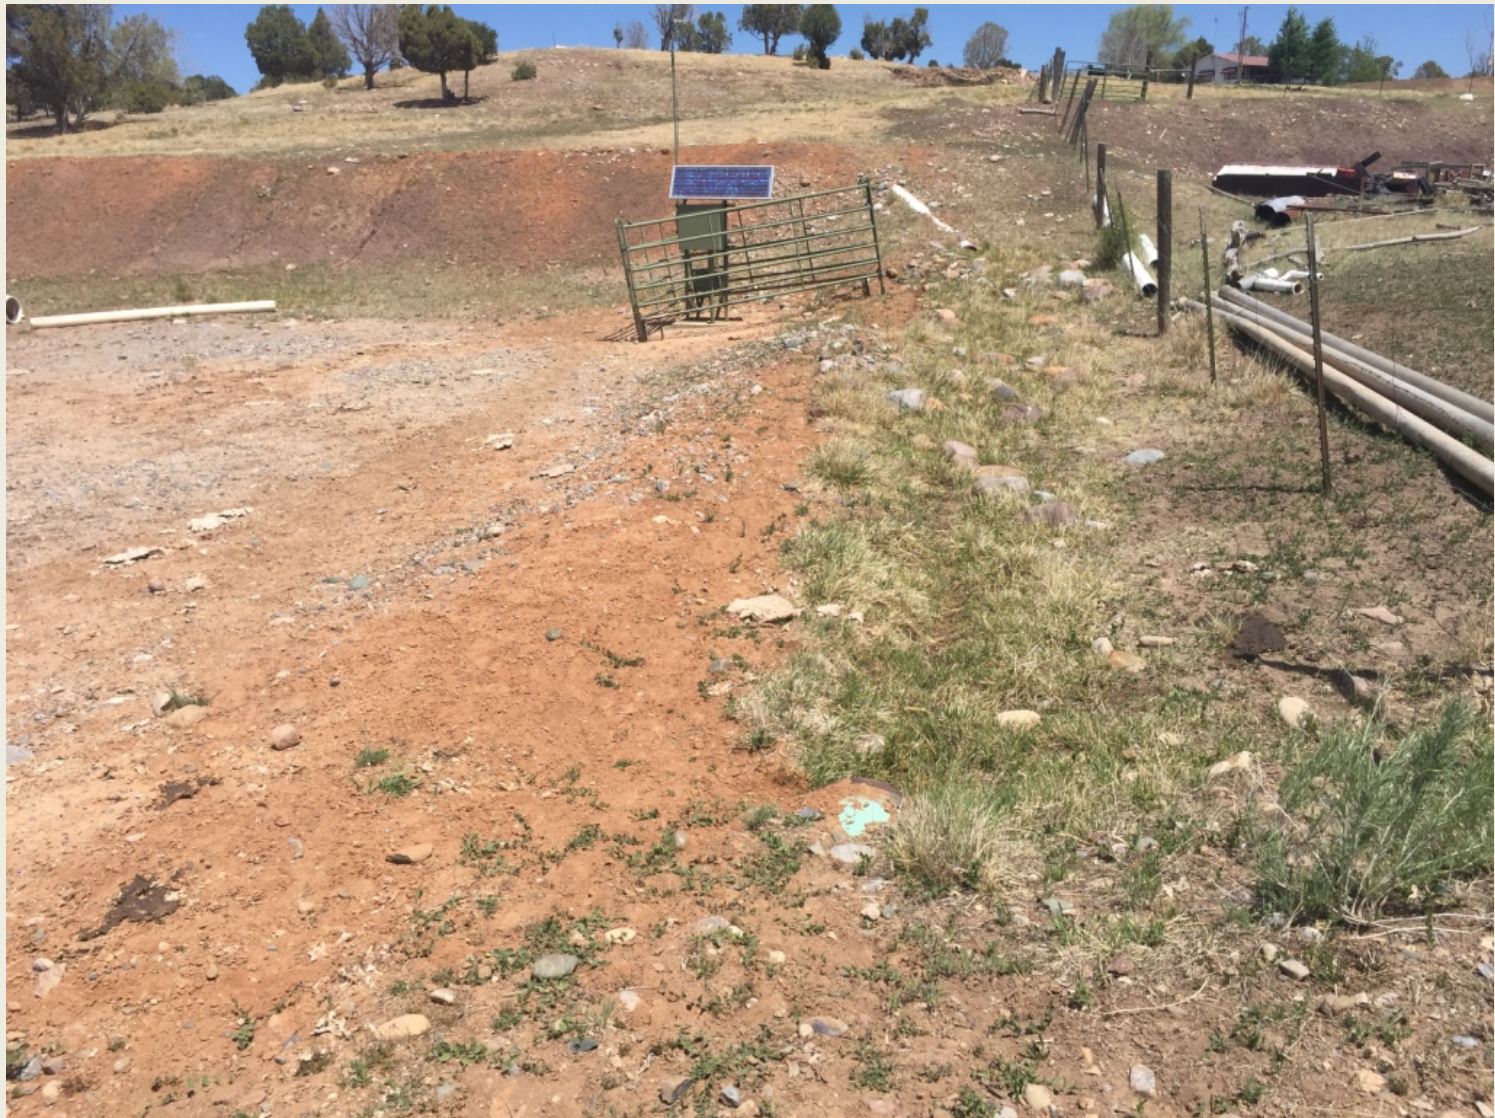
Photo 2. View of the eastern portion of the project area from the southeastern edge facing northward. Revegetation is progressing on flat areas, largely with grasses such as western wheatgrass (*Pascopyrum smithii*), intermediate wheatgrass (*Thinopyron intermedium*), and crested wheatgrass (*Agropyron cristatum*). Vegetation on cut-slope is sparse and needs monitoring and revegetation if cover is not increasing.

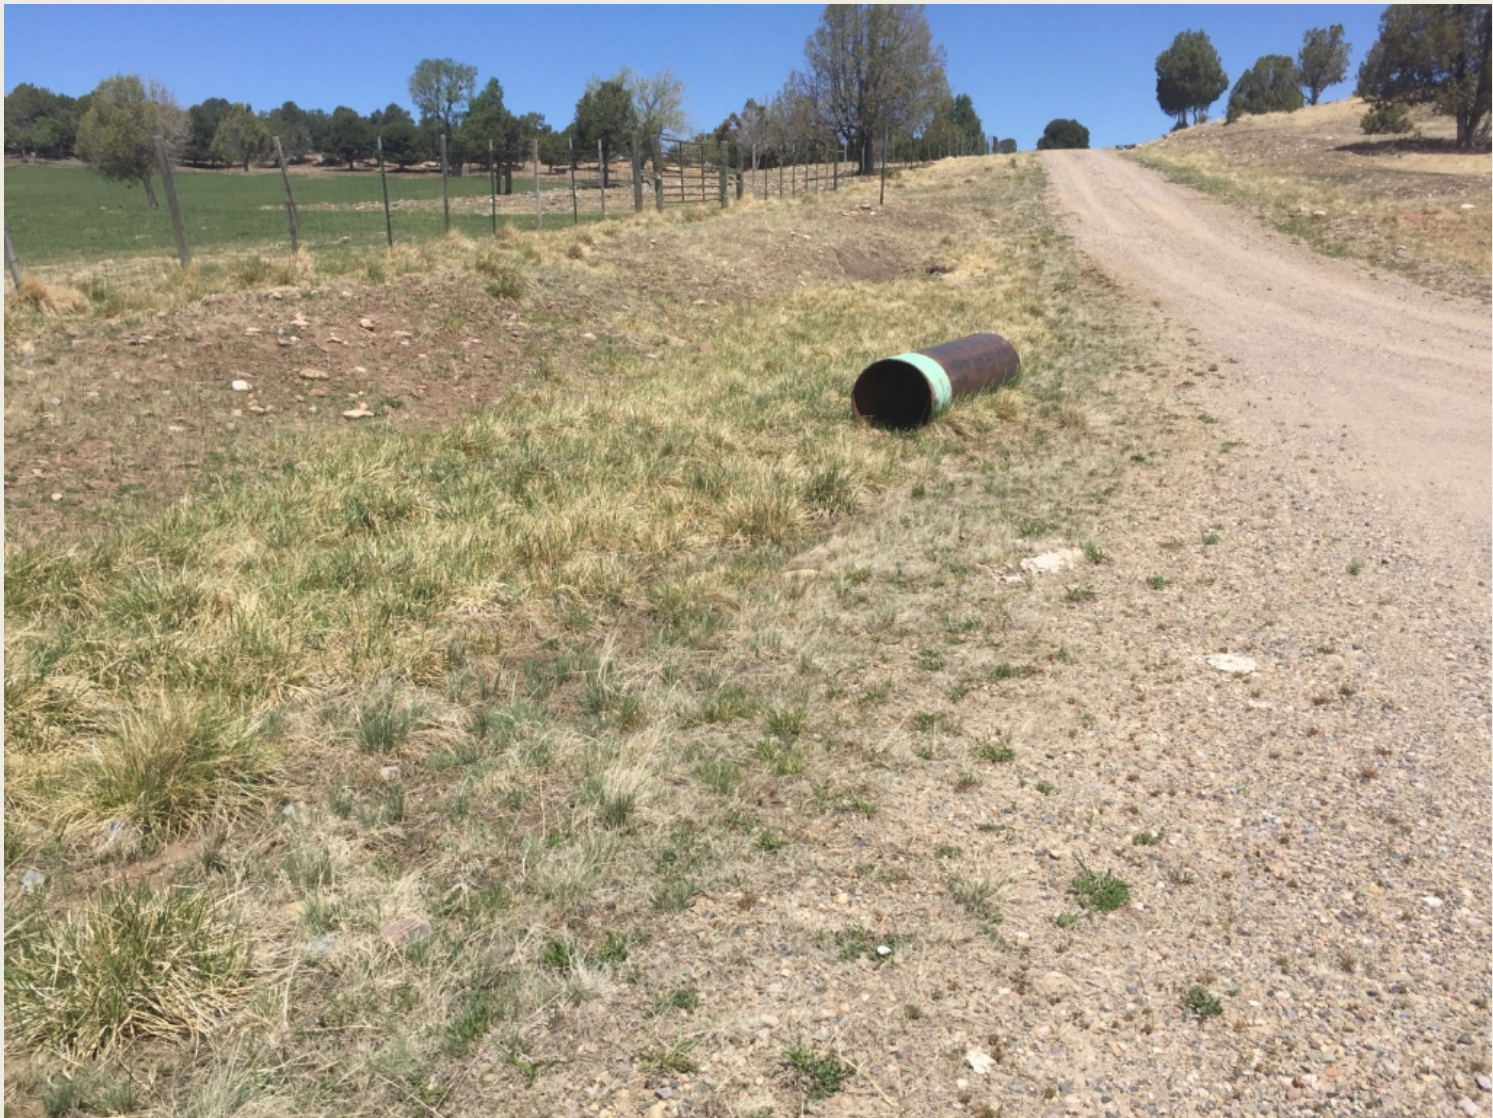
Photo 3. View of the western portion of the project area from the southwestern edge facing northward. Unused pipe needs to be removed.

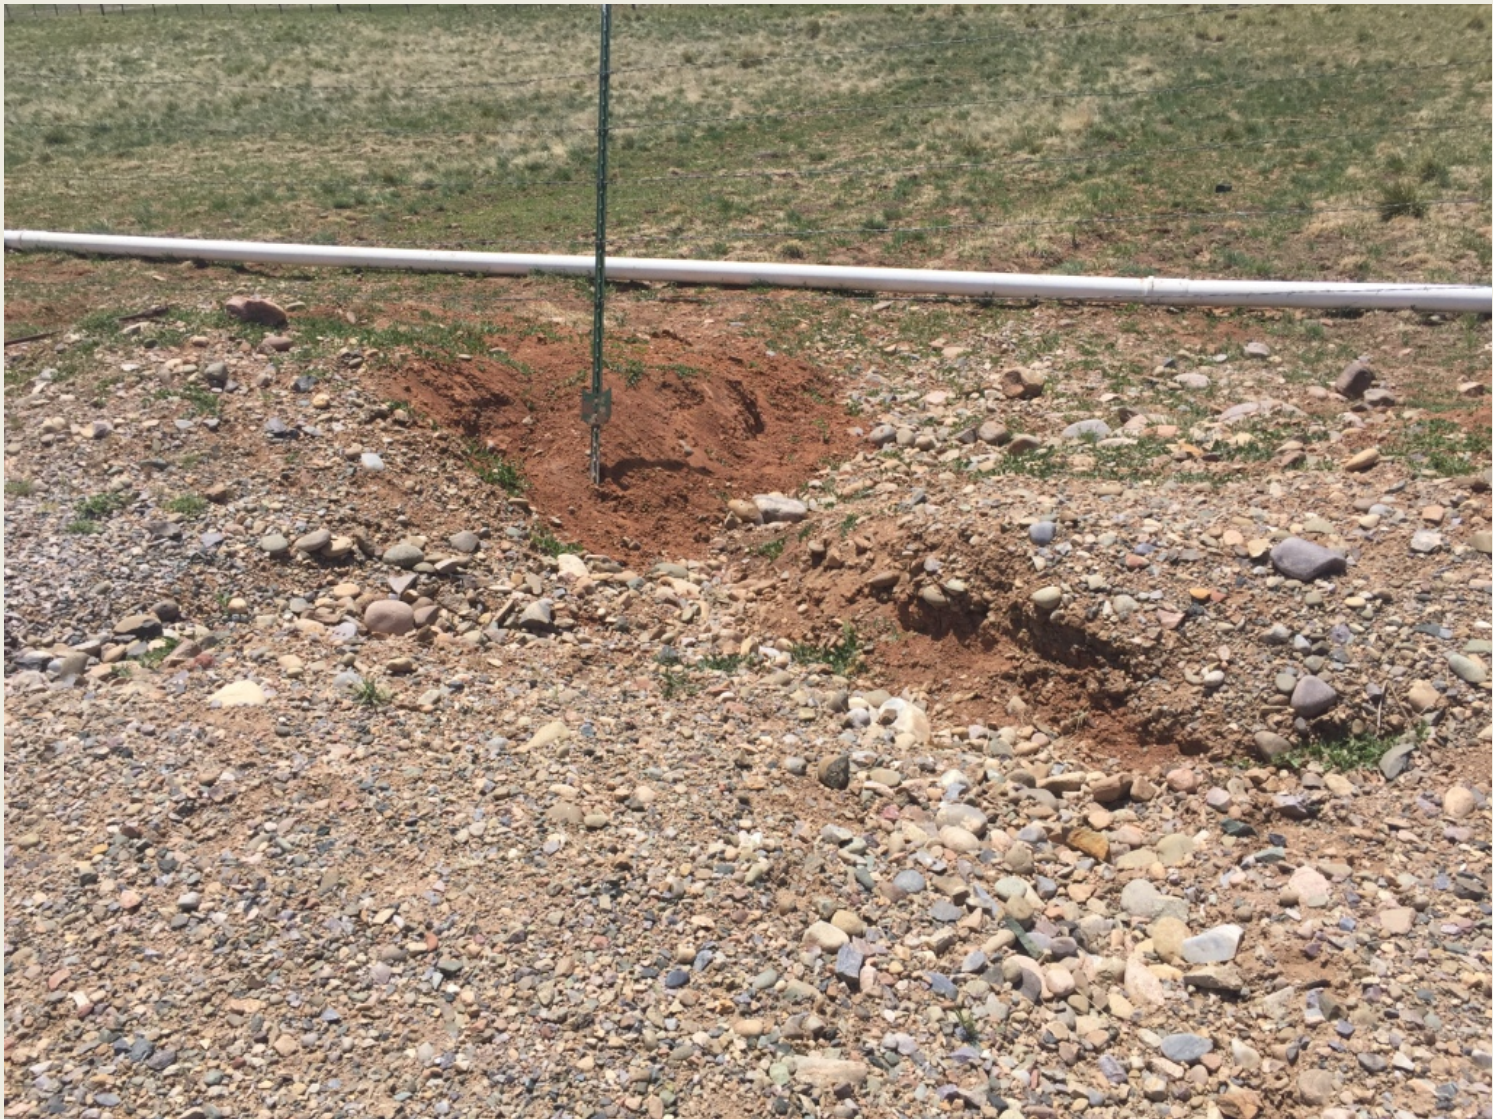
Photo 4. View of erosional channel in the southern portion of the project area.

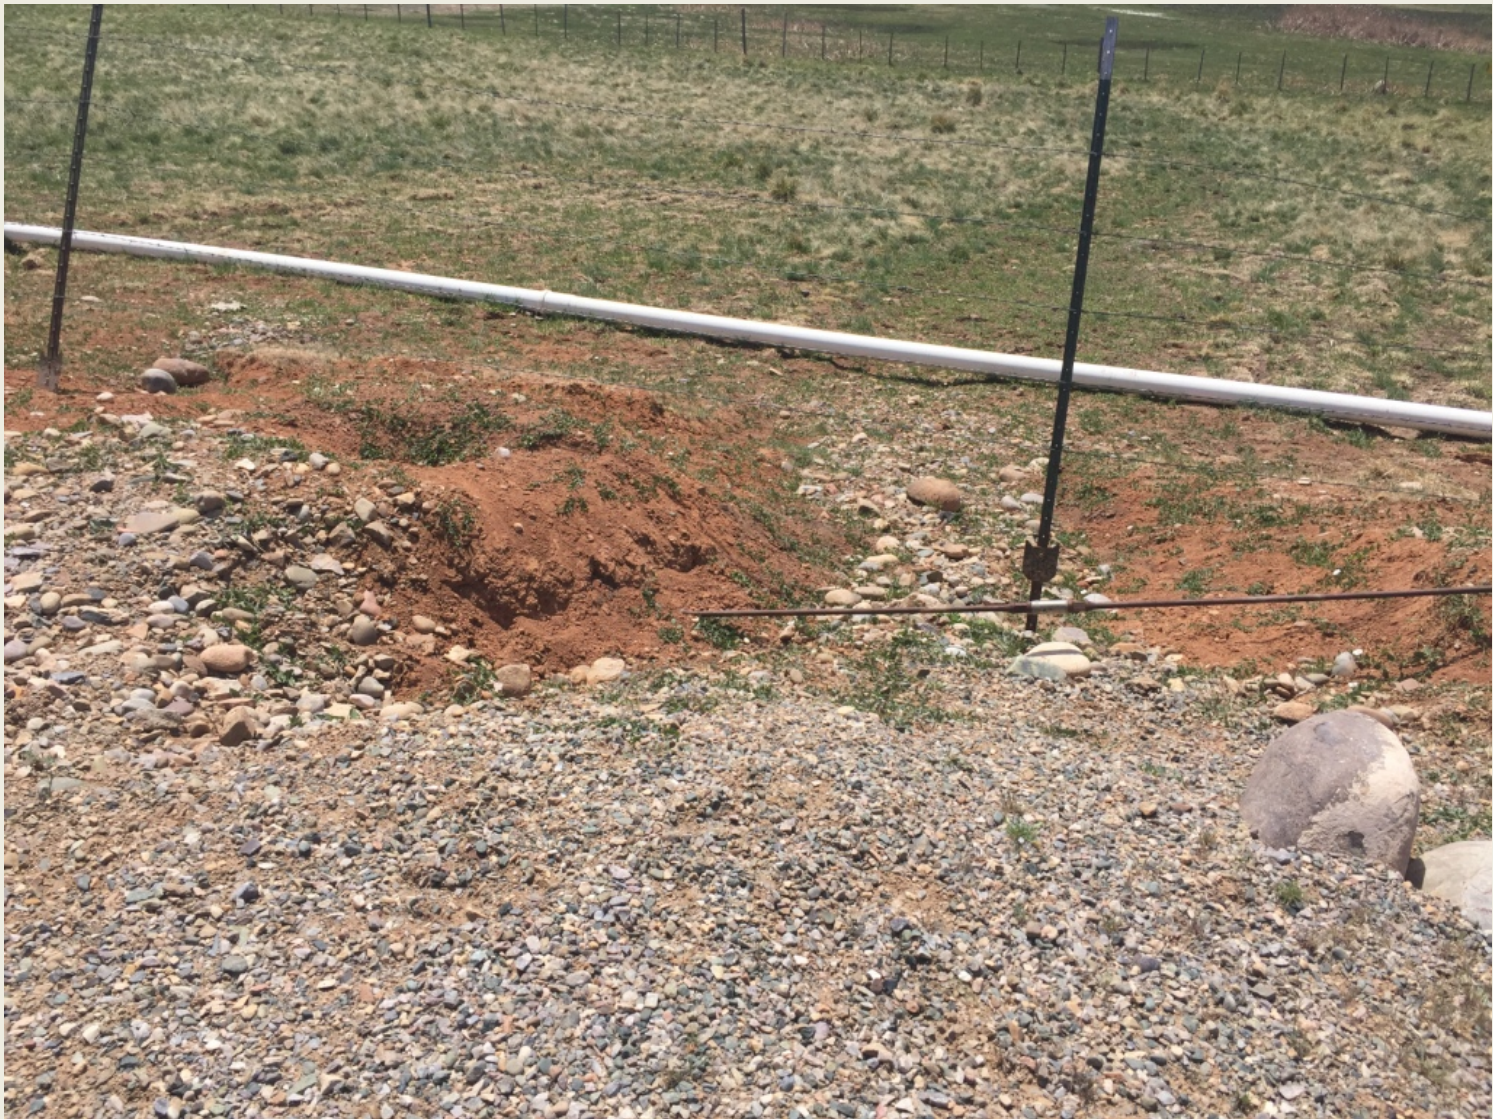
Photo 5. View of another erosional channel in the southern portion of the project area.

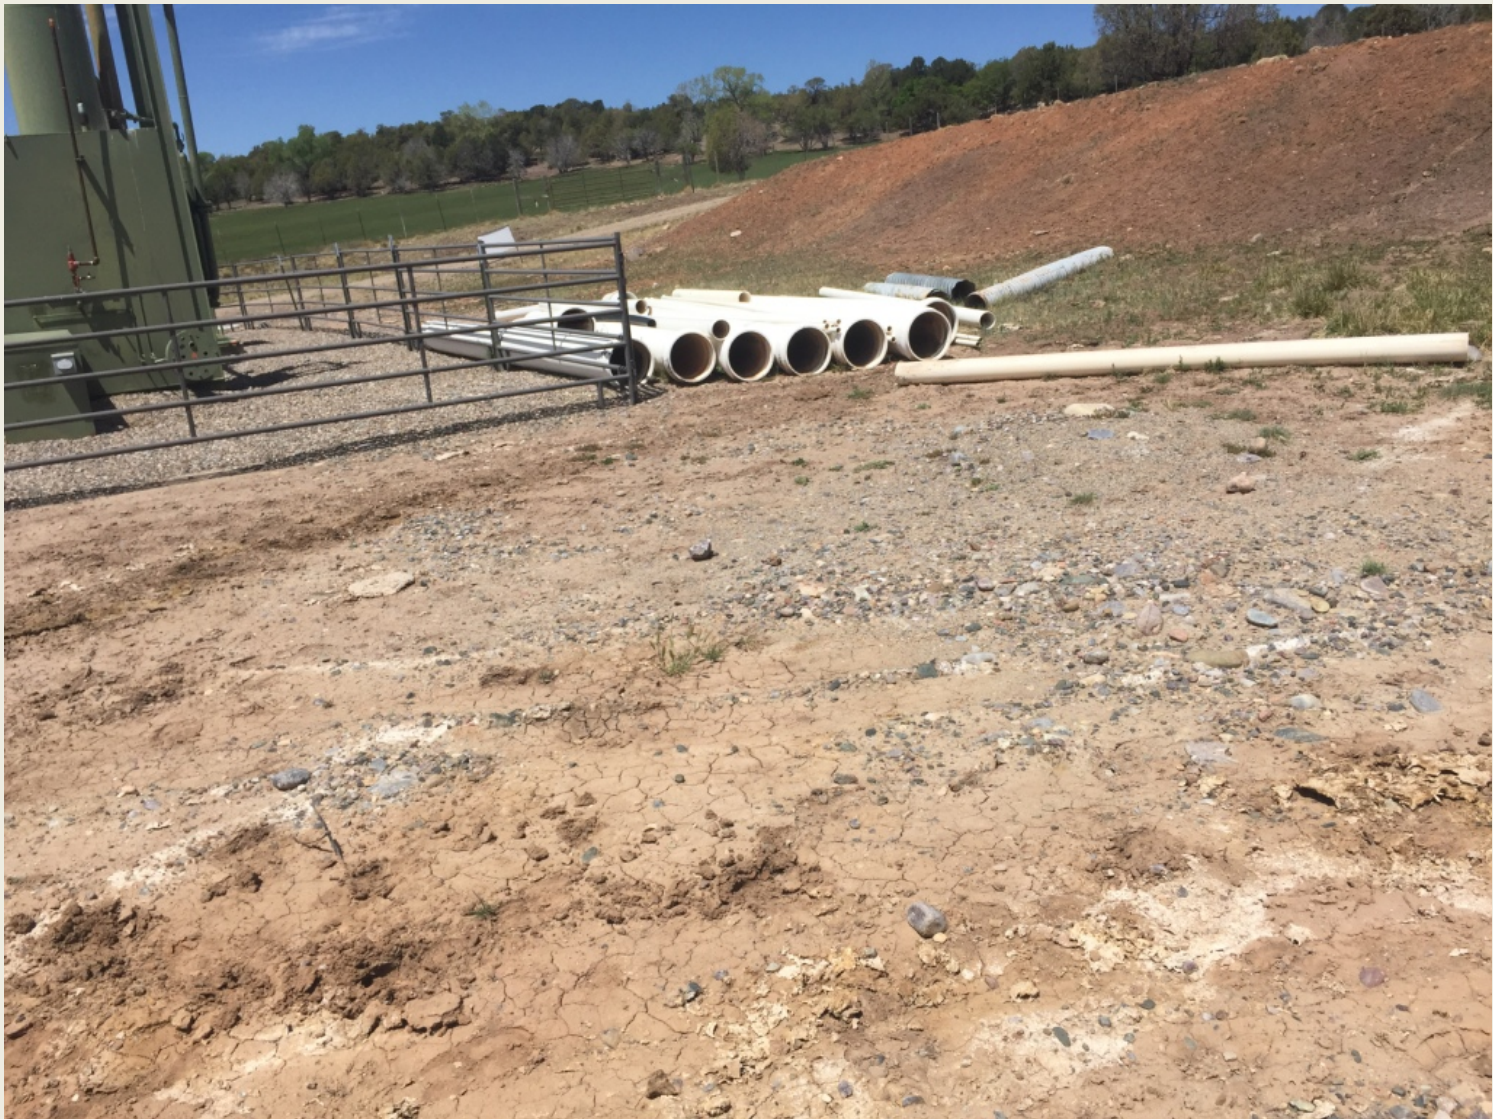
Photo 6. View of pipes in the northern project area that need to be removed.
