Interim Reclamation and Stormwater Inspection

June 4, 2018

Operator: KERR MCGEE OIL & GAS ONSHORE LP #47120

Location ID: 452820

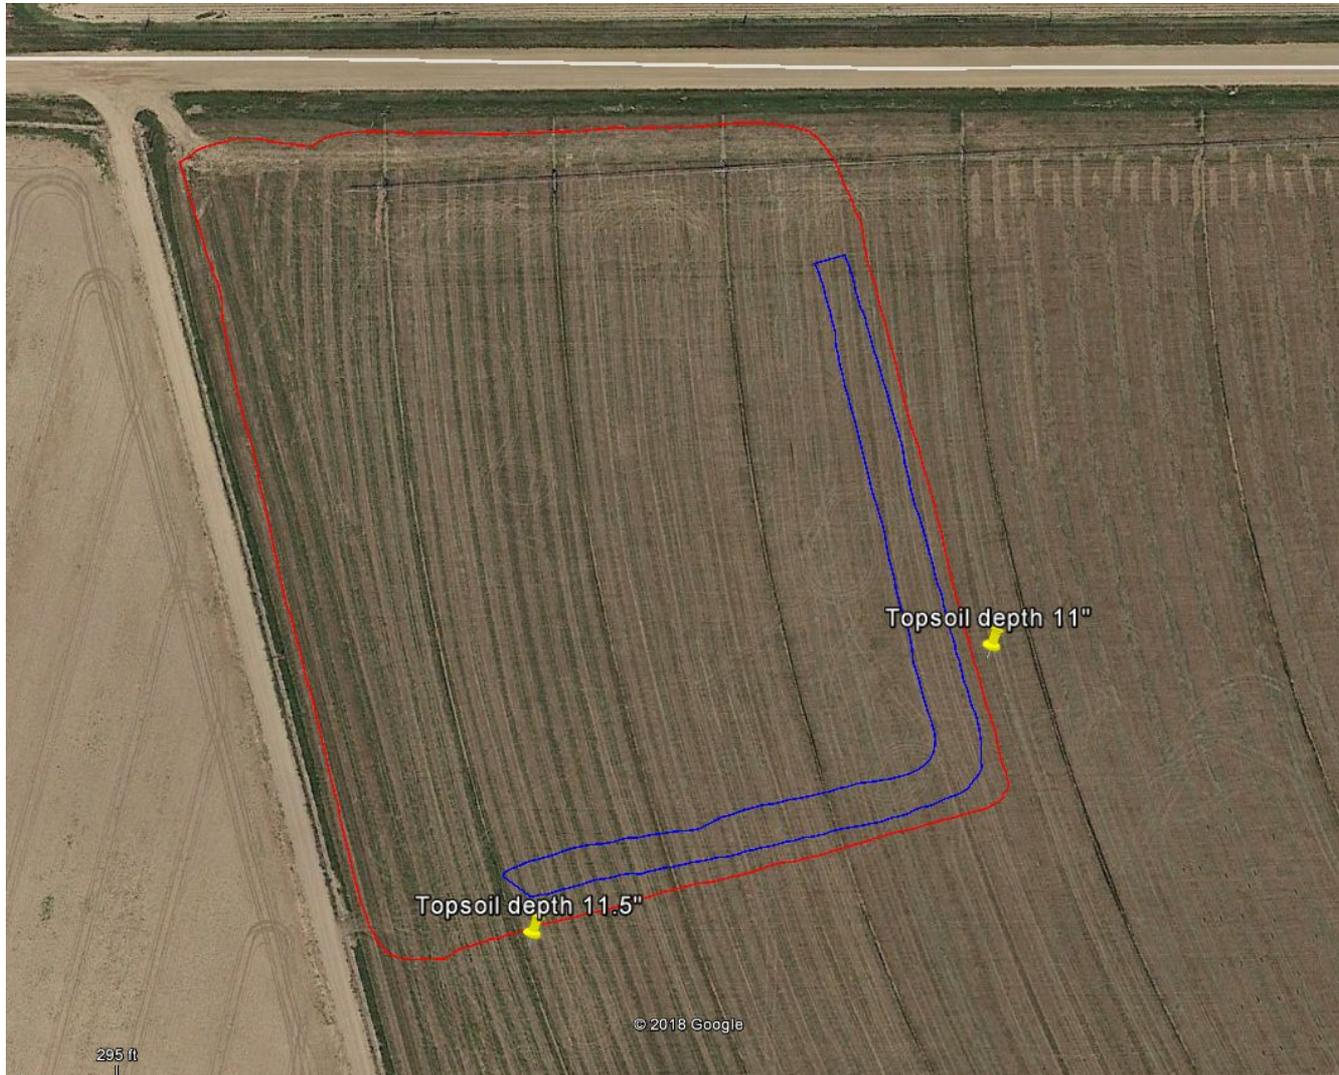
Google Earth aerial imagery taken on 6/9/2017, illustrating the total disturbance area (red line- 6.40 acres), topsoil stockpile area (blue line- 0.48 acres), and topsoil reference depths that were mapped by COGCC Staff on June 4, 2018.

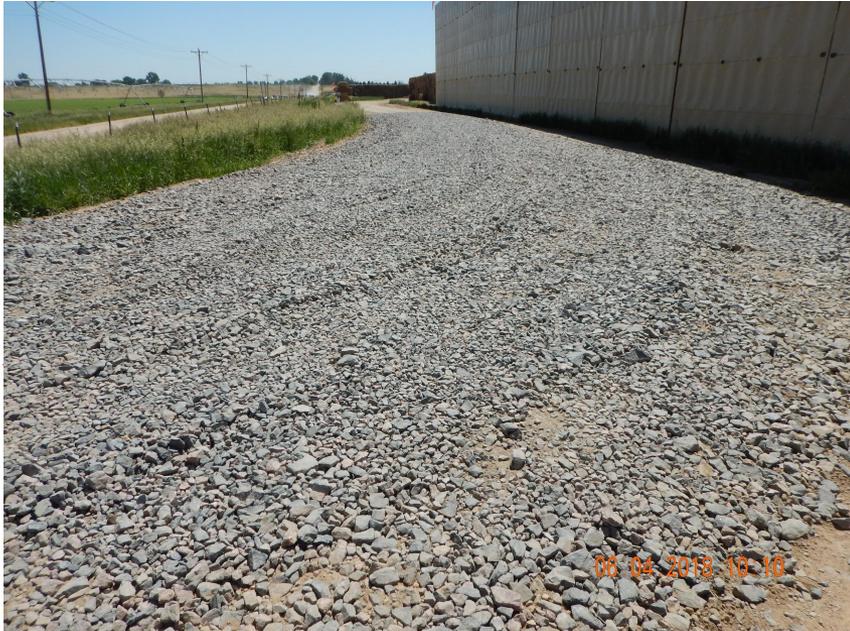
Photo 1. Photo taken from the entrance of location, facing East. Vehicle tracking device has been installed and appears to be in proper functioning condition.

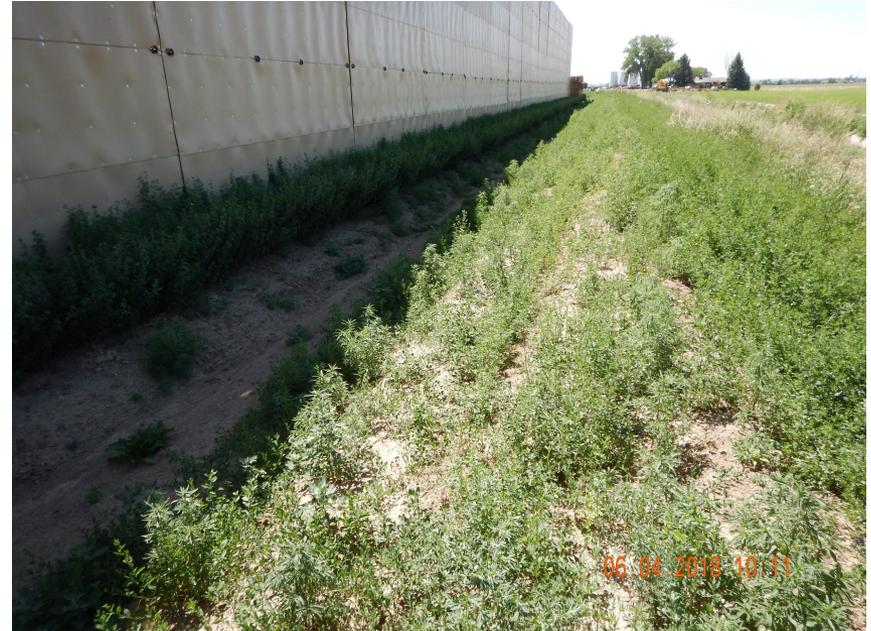
Photo 2. Photo taken from the northwest perimeter of location, facing South. Ditch and berm BMP has been installed around the entire perimeter of the location. Alfalfa has established throughout the stormwater area, including the berm BMP, but other undesirables like Kochia and Canada thistle were also observed. Operator shall control all noxious and undesirable weed species on cropland.

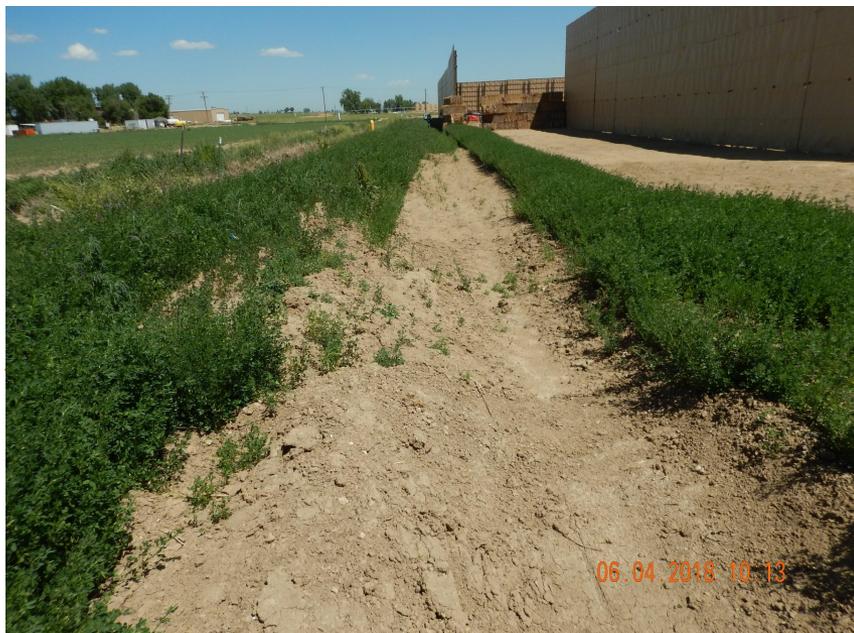
Photo 3. Photo taken from the southwest perimeter of location, facing North. See comments under Photo 2.

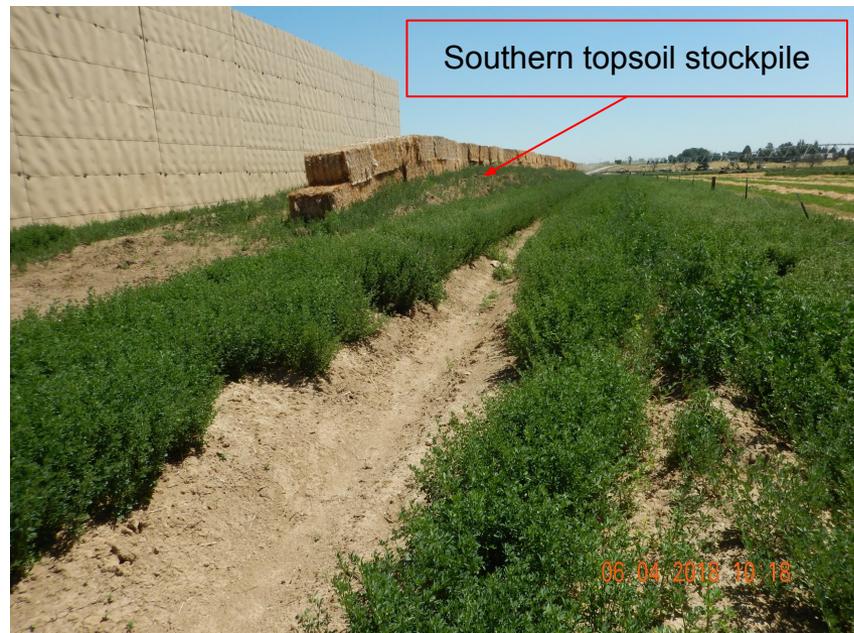
Photo 4. Photo taken from the southwest perimeter of location, facing East. See comments under Photo 2.

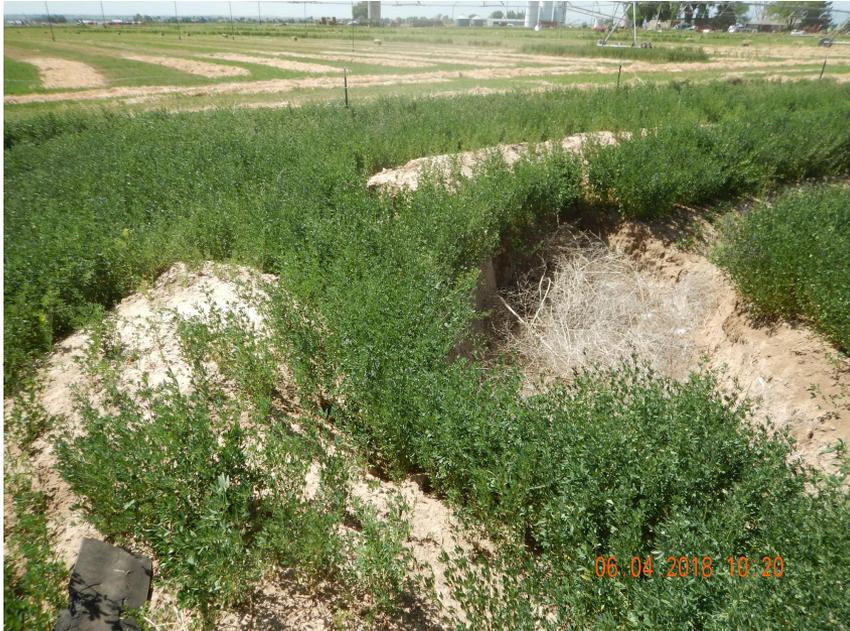
Photo 5. Photo taken from the southeast perimeter of location, facing South. Photo illustrates the southeastern sediment trap. Weed debris was observed inside the sediment trap.

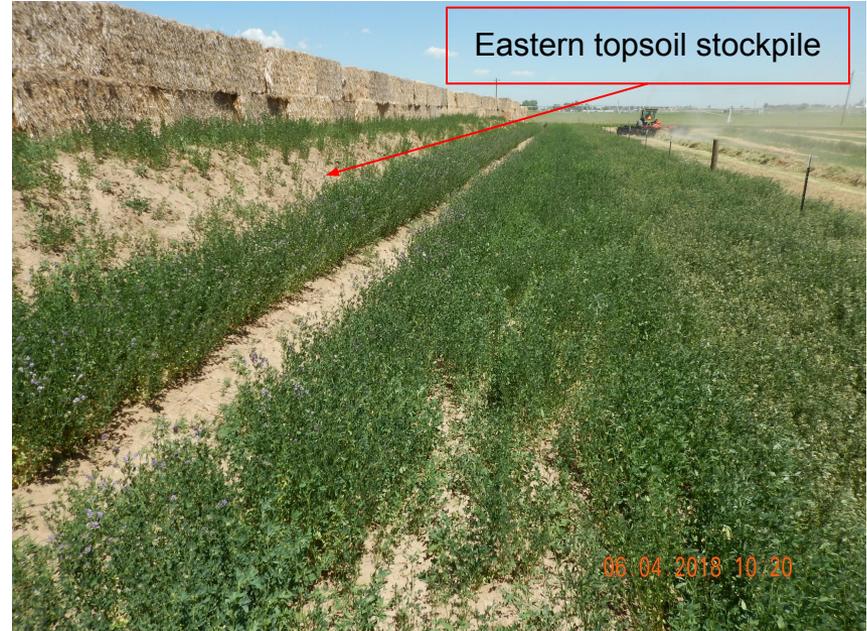
Photo 6. Photo taken from the southeast perimeter of location, facing North. See comments under Photo 2.

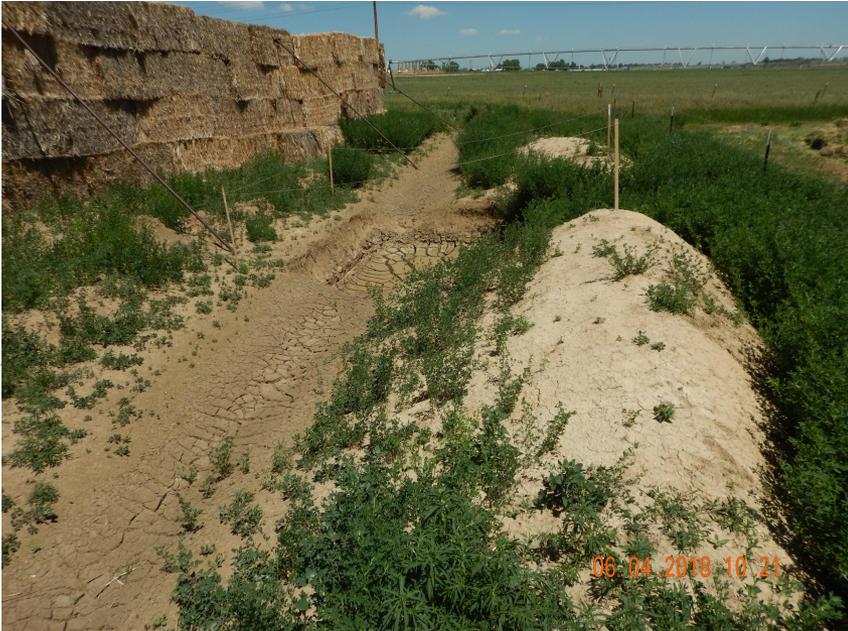
Photo 7. Photo taken from the northeast perimeter of location, facing North. Photo illustrates the northeastern sediment trap that appears to be properly functioning.

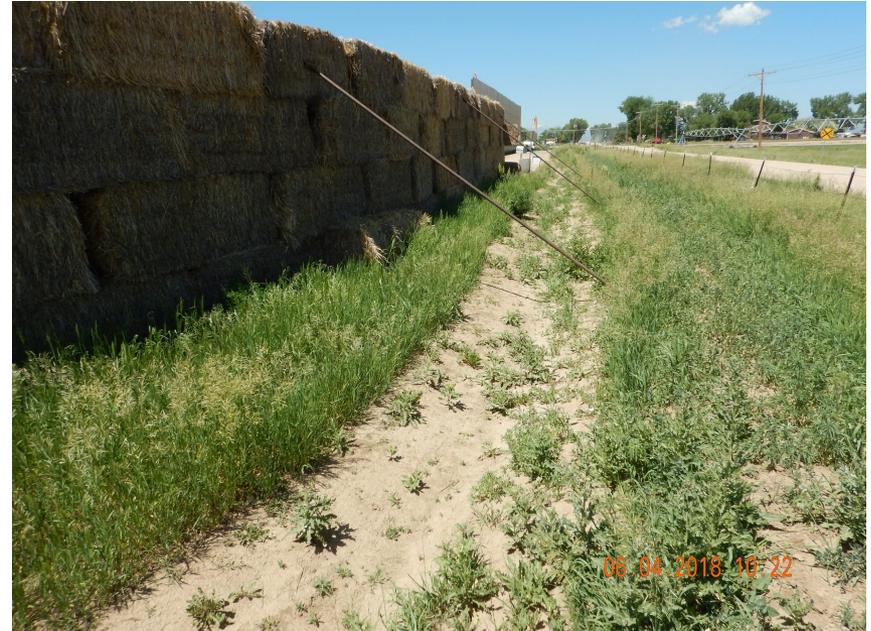
Photo 8. Photo taken from the northeast perimeter of location, facing North. See comments under Photo 2.

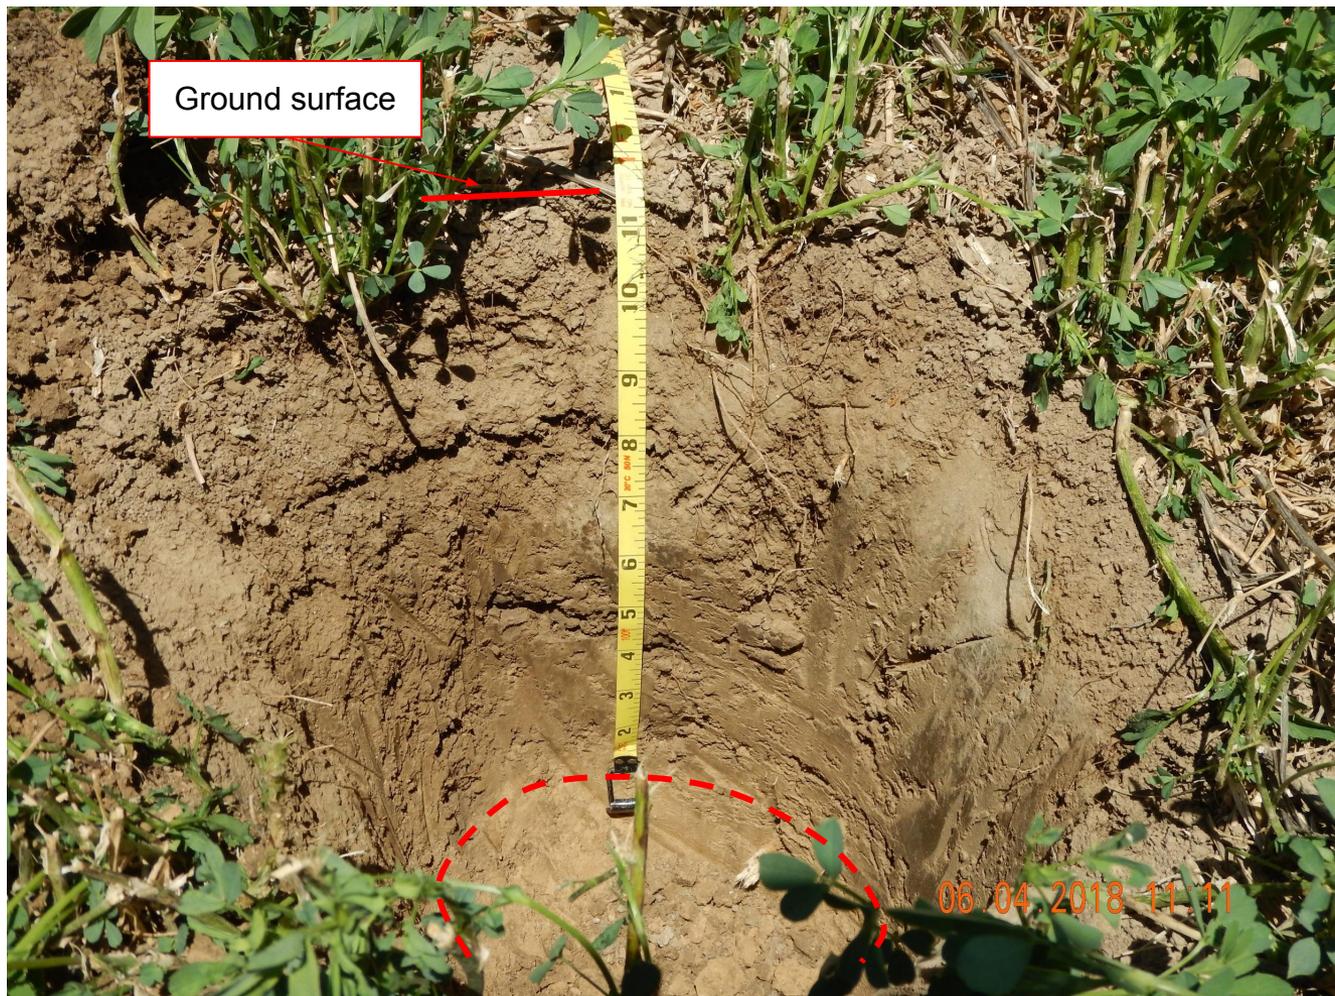
Photo 9. Photo taken of the southern soil pit, illustrating an approximate topsoil depth of 11.5 inches.

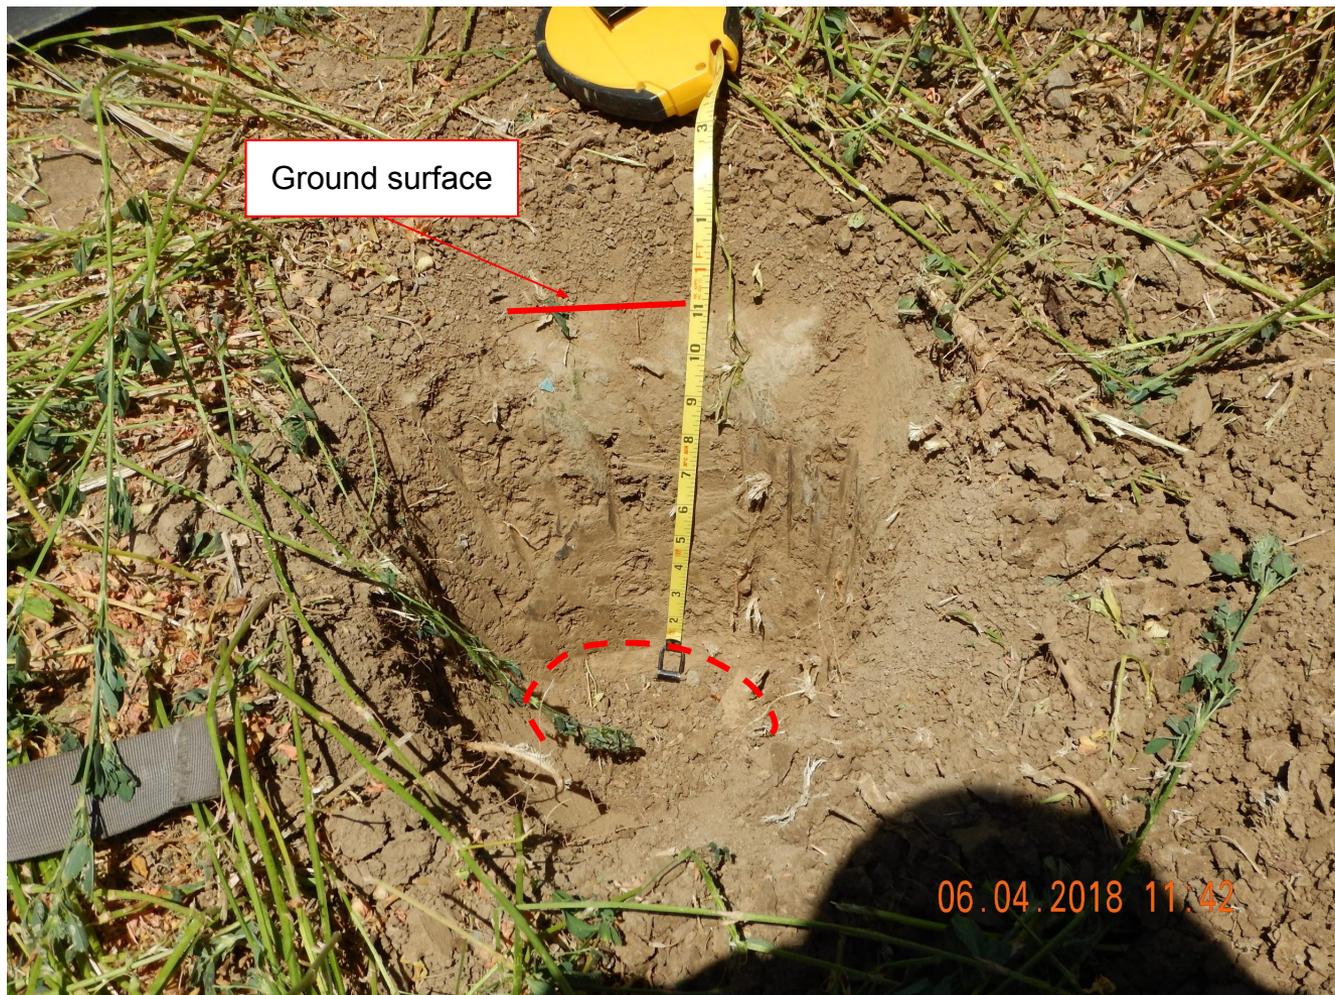
Photo 10. Photo taken of the eastern soil pit, illustrating an approximate topsoil depth of 11.0 inches.
